Analytical Investigations of XIX–XX Century Paints: The Study of Two Vehicles from the Museum for Communications of Frankfurt

This work is focused on the study of the protective paints of two vehicles belonging to the Museum für Kommunikation in Frankfurt and used by the German postal service at the turn of the two centuries. The first one is a cart for telecommunications services and is dated approximately 1920–1940 (Figure 1). This cart was constructed in the Reichspost era and was continuously used by the postal service also during the German Democratic Republic (GDR). The cart was found in the garden of a former postal employee in 2015. It was partially sunk into the ground, where it presumably stood for decades after having been taken out of service.

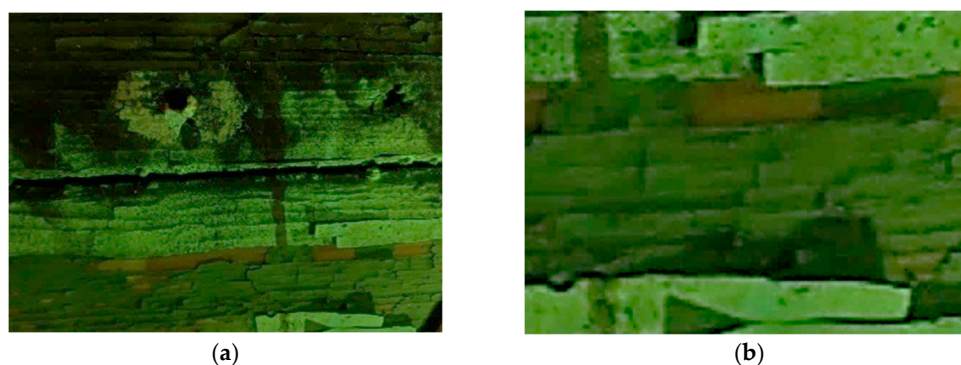
The outermost layer, which is light grey in VIS light, is characterized by a low yellowish fluorescence that contrasts with the fluorescence induced on the surface of the intermediate grey-greenish layer. The dark grey layer in contact with the wooden support does not show any fluorescence (Figure 3).

Figure 3. (a) Details of the UV fluorescence image of the paints on the right panel; (b) Enlargement (10×) of the area.

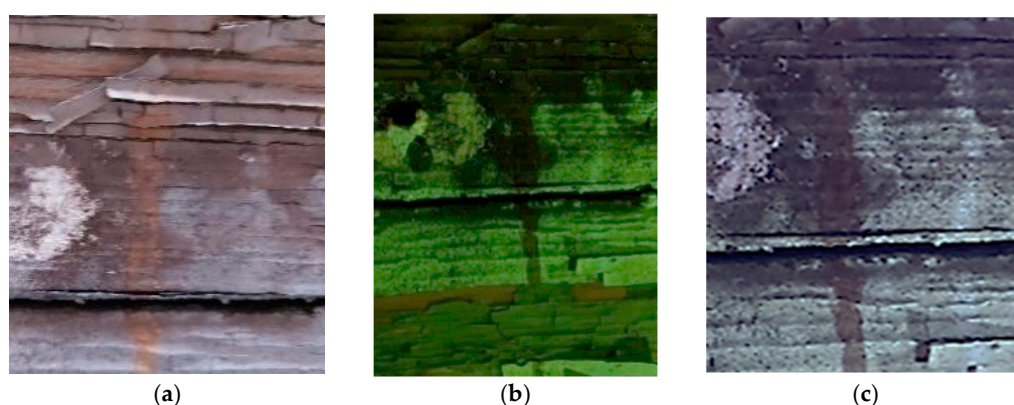
Figure 4. Details of the iron cart structure: leakage due to corrosion; (a) Image in visible light; (b) Image in UV fluorescence; (c) Image in IR reflectography.

These areas are related to the leakage that resulted from the degradation of the cart's iron structure, the solubilization of corrosion products, and the pouring of iron-ions-rich solutions.

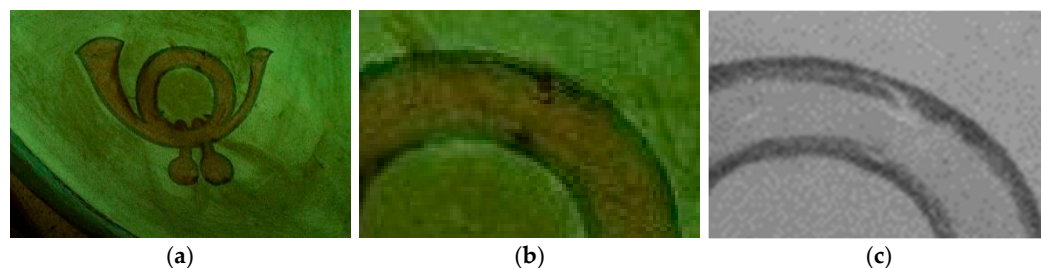
The multispectral investigation performed on the symbol present on the right and left side of the carriage underlined an uneven response under UV radiation (Figure 5a,b). Indeed, darker areas could be noticed, which appeared to be lighter in IR reflectography (Figure 5c). The areas in which the fluorescence is less marked (darker in the photo) present a greater reflection of the IR radiation, and these areas appear lighter. These differences can be presumably related to the loss of the finishing layer.

Figure 5. (a) Symbol panel of the right side of the carriage in UV fluorescence; (b) Enlargement (10×) of the area in UV fluorescence; (c) Enlargement (10×) of the area in IR reflectography.

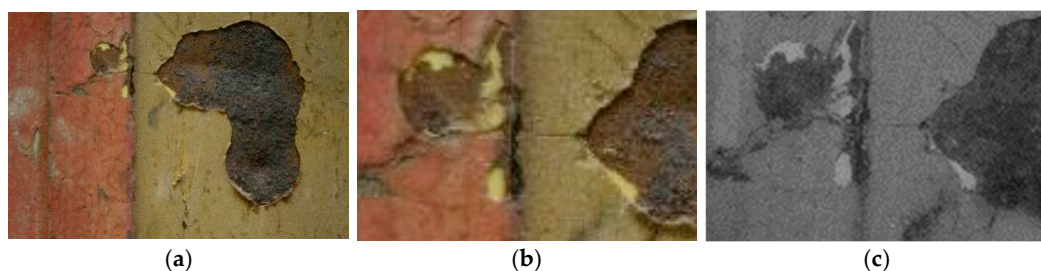
Figure 6. (a) Image of the rear panel of the carriage collected under visible light; (b) Enlargement (10×) of the area in VIS; (c) Enlargement (10×) of the area in IR reflectography. The chromatic differences between the two yellow paints, in visible light and their different reflection of the IR radiation are highlighted.

The more superficial layer appears darker in IR, while the underlying one shows a lighter tone due to the greater reflection of infrared radiation. These characteristics are attributable to the use of different paints. The same feature was also found in the rear axle of the wheels.

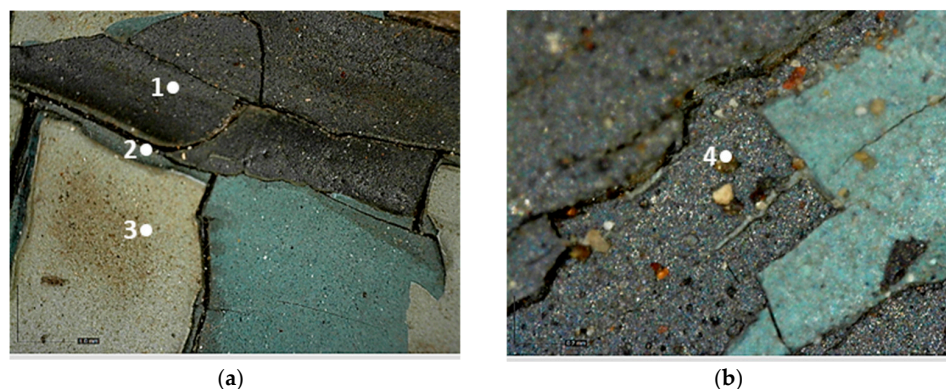
The investigation was performed using the optical microscope and allowed the stratigraphy of the grey cart to be identified alongside the presence of a deposited particulate on the surface (Figure 7a).

Figure 7. Optical microscope images of the cart's stratification. (a) Image collected at 50× magnification in which the dark grey (1), greenish grey (2), and light grey (3) layers are visible; (b) Image collected at 200× magnification where the deposited particulate is present (4).

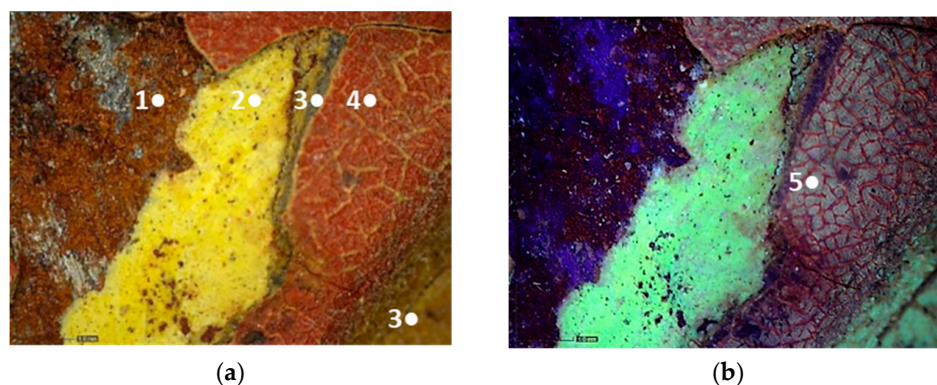
The analysis that was carried out with optical microscopy made it possible to observe the complex stratigraphy of the carriage's paints, which was mainly characterized by the superimposition of four paint layers (Figure 8).

Figure 8. Optical microscope image of the layering on the carriage: (a) Image collected in VIS light, showing the substrate (1), the bright yellow layer (2), the yellow-brown layer (3), that is above or under the red layer, and the red layer (4); (b) Image collected in UV light, where the finishing layer-with a bluish fluorescence can be observed (5) above the colored layers.

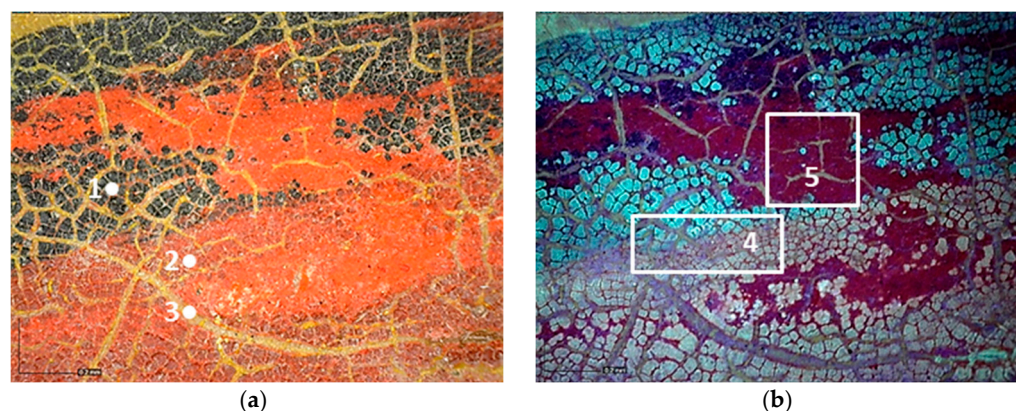
The finishing layer is characterized by a bluish-yellow fluorescence. It shows widespread cracking and degradation signs which seem to be due to anomalous contractions of the material itself (Figure 9).

Figure 9. Optical microscope image ($200\times$ magnification) of the area corresponding to the postal service's symbol. (a) Image collected in VIS light showing the cracking process with thinner (1–2) and thicker cracks (3) that reach the yellow paint; (b) Image collected in UV light highlighting the islands of different sizes and shapes where the finishing layer is present (4), and an area with different fluorescence in which the layer is absent (5).

The craquelure was presumably induced by the imperfect adhesion between the finishing layer and the underlying ones but also by exposure to UV radiation and a high level of relative humidity [34]. In the overlapping areas of the red paint on the yellow one, such cracks are not limited to the surface only, but reach the underlying yellow layer. All types of branched cracking are according to variable, straight, or concentric crosslinks. These crosslinks intersect each other, forming islands of various sizes and shapes. Some areas of the carriage, such as the panels, show that the symbols are characterized by the absence of the finishing layer (Figure 10). Indeed, in these areas, it is possible to detect the underlying paints, which have a different fluorescence when observed in ultraviolet light (Figure 10b).

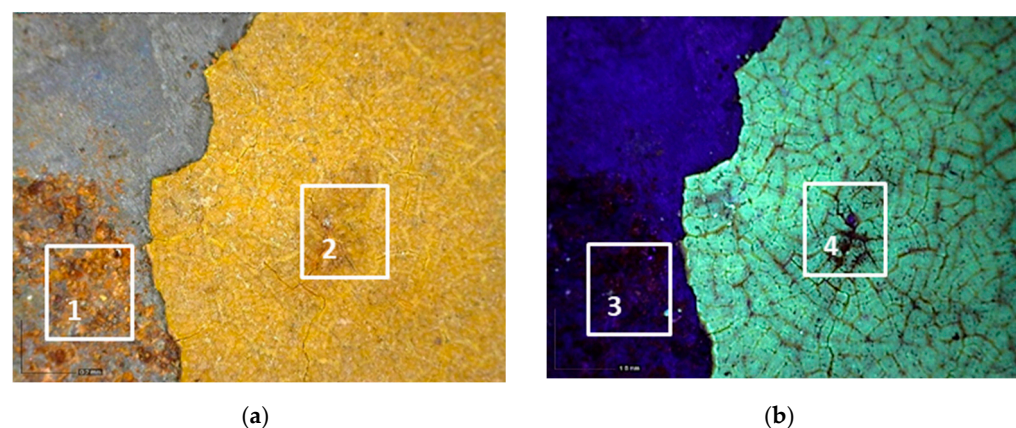
Moreover, the metal support of the carriage appears to be corroded, and some areas of the superimposed paint layers appear darker, presumably due to corrosion products of the underlying laminate (Figure 10).

Figure 10. Optical microscope images ($200\times$ magnification) of one of the metal panels: corrosion of the laminate (1–3), causing the darkening of the yellow paint (2–4). (a) Image collected in VIS light; (b) Image collected in UV light.
