Field Applications of Ultra High Frequency Techniques for Defect Detection in GIS

Jun Xiong ¹, Yuan Wang ², Guo-Ming Ma ^{2,*}, Qiang Zhang ² and Shu-Sheng Zheng ²

¹ Guangzhou Power Supply Co., Ltd., Guangzhou 510620, China; xiongj@guangzhou.csg.cn

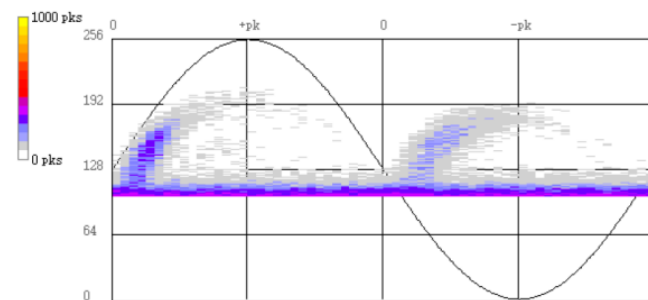
The live test results are reported in the Figure 3. It is found that among the 12 measuring points, suspected signals were only detected at measuring point A, phase C. And no suspected signal was observed at the other 11 measuring points. Figure 4 shows the phase resolved partial discharge (PRPD) spectrum of the measuring point A by online monitoring (online monitoring is under working condition all the time, no matter whether there are any possible faults). From Figures 3 and 4, it is obvious that the phase characteristics obtained by the live test were consistent with the results of online monitoring. That is to say, the abnormal signals at measuring point A of phase C needed more attentions and should have to distinguish the source of the signals. Also, this proved the reliability of the detection method.

Figure 3. DMS UHF live test PRPD spectrum of measuring point A.

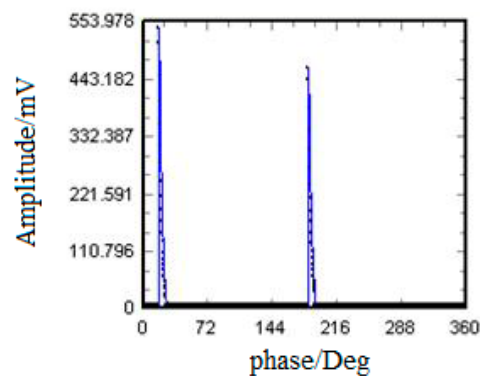
Figure 4. PRPD figure of online monitoring at measuring point A.

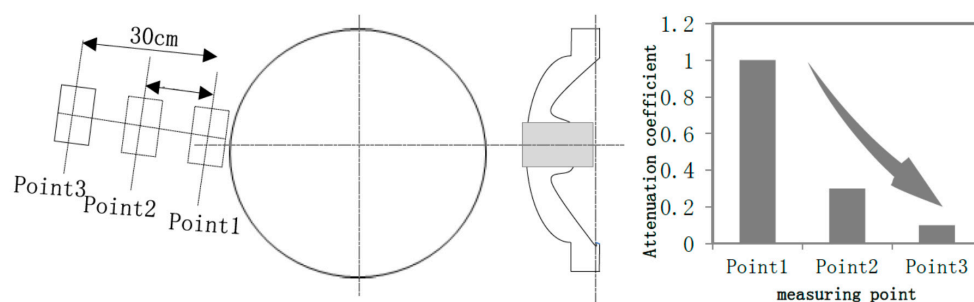
Firstly, placing the DMS UHF sensor at Point 1, Point 2, and Point 3 in turn to record the signal's amplitude, and defining the signal's amplitude at Point 1 as 1, as shown in the left figure of Figure 5. According to the measuring results, the phase characteristics of the signals measured at the above three positions were similar, but the amplitudes were decreased in order. Compared to Point 1, the signal's amplitude of Point 2 and Point 3 were only 30% and 10% respectively, as shown in Figures 5 and 6. The amplitude of the signal decreased when the distance between sensor and the spacer got increased. In addition, when the antenna's receiving direction was back to the spacer, the pre-detected signals would disappear immediately. The above results all indicated that the signals obtained at measuring point A were generated by an internal source.

Figure 5. Sensor position for detection and the attenuation characteristics.

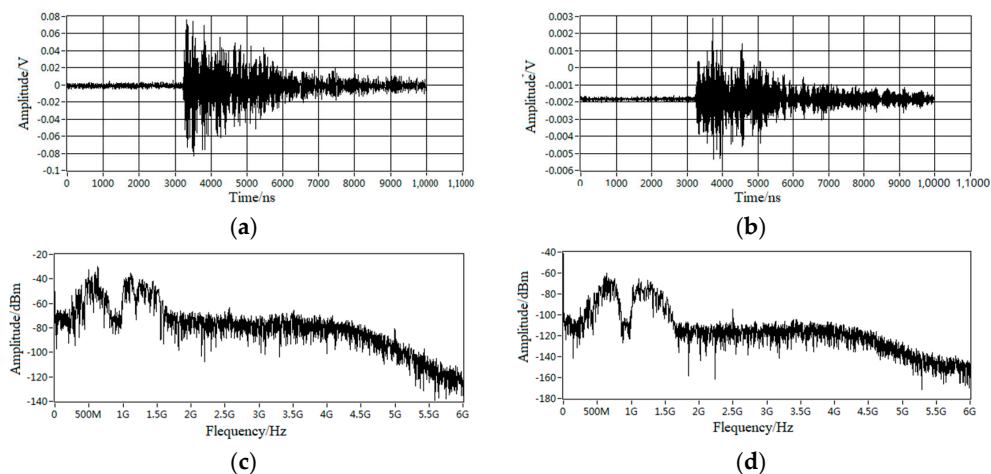
Figure 6. Signal characteristics at point 1 and point 3. (a) Time domain signal of point 1; (b) Time domain signal of point 3; (c) Frequency spectrum of point 1; (d) Frequency spectrum of point 3.

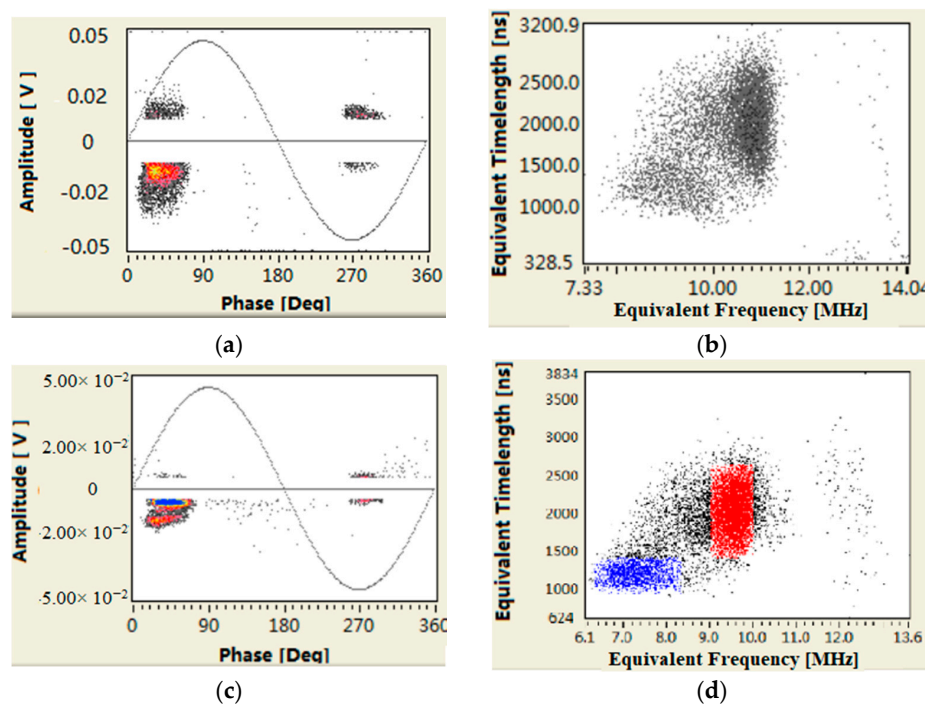
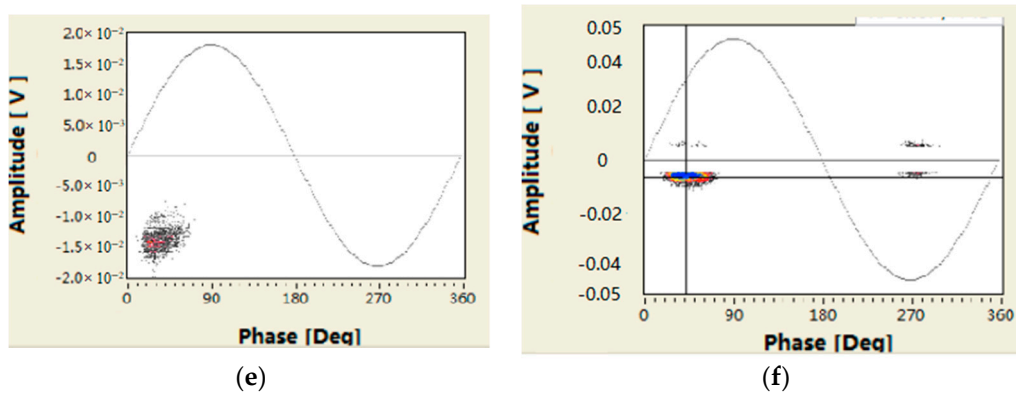
According to the data shown in Figure 7, for HFCT 2 (Figure 7a,b) installed at the cone-type spacer, the PRPD spectrum had a phase characteristic of 180° , the single pulse amplitude could up to 180 mV, and the main frequency was as high as 20 MHz to 35 MHz. It was identified as a 100% internal discharge signal. For HFCT 1 (Figure 7c,d) installed on the GIS bushing base, the obtained signals could be divided into two types, presented in red and blue. The PRPD spectrum corresponding to the blue one was identified as an external corona signal. The PRPD spectrum corresponding to the red one had a phase characteristic of 180° , the single pulse amplitude can up to 85 mV, the dominant frequency ranged from 20 MHz to 23 MHz, it was identified as an internal discharge signal. Figure 8 shows that both PRPD spectrum and single pulsed current waveforms had some similarities, and the signals received by HFCT 2 were stronger than HFCT 1. What's more, with the use of the Ultra 9000 Ultrasonic Tester, no abnormality was detected in the high-voltage side of transformer. The humidity and component were tested at bus-bar branch bushings, disconnector, and circuit breakers. No abnormal results were found. The results further indicated that the internal source obtained at the spacer (measurement point A) was not transmitted from the transformer, but it was likely happening inside the GIS.

Figure 7. Results obtained by pulse current method. (a) HFCT 2 PRPD spectrum; (b) HFCT 2 Equivalent time-frequency spectrum; (c) HFCT 1 PRPD spectrum; (d) HFCT 1 Equivalent time-frequency spectrum; (e) HFCT 1 PRPD spectrum blue cluster; (f) HFCT 1 PRPD spectrum red cluster.

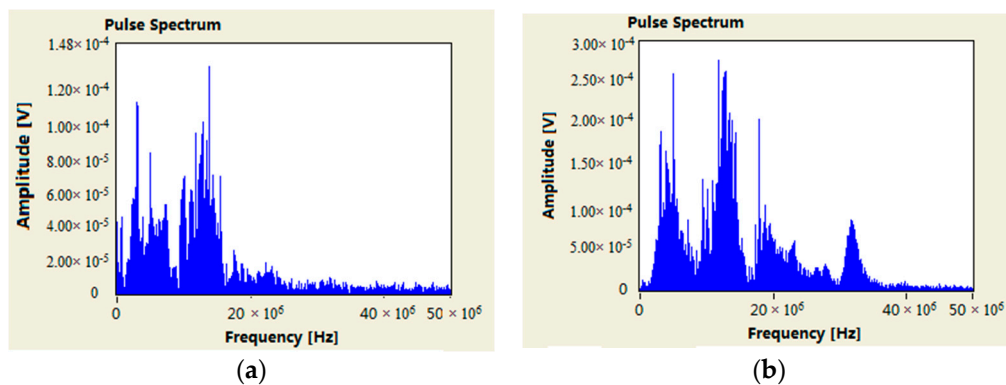
Figure 8. Pulse frequency waveform characteristics of two positions of HFCT1 and HFCT2. (a) HFCT 1; (b) HFCT 2.

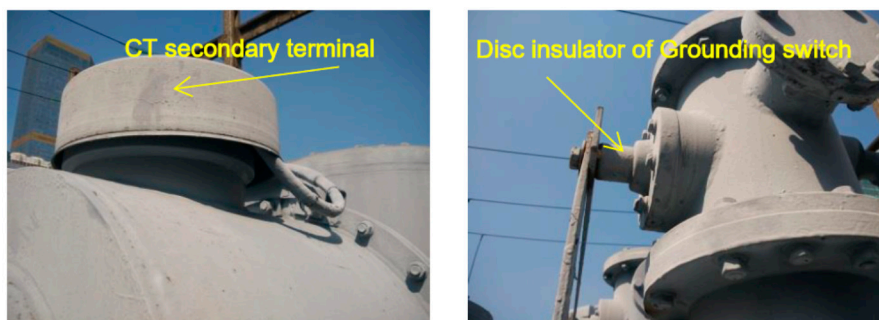
Figure 11. Appearance of CT secondary terminal and disc insulator of grounding switchgear.

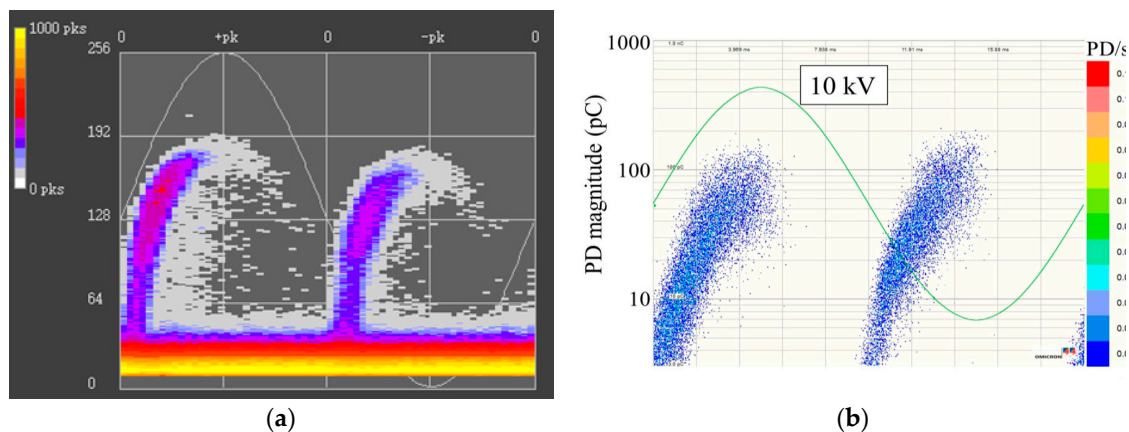
In order to find out hidden dangers and provide reference for subsequent defect analysis, it is necessary to perform discharge type identification on the partial discharge signals collected in the field. The identification results of UHF online monitoring showed that the probability of void was 45%, the possibility of floating potential was 35%, and the probability of free metal particle discharge was 20%. Comparing the measured spectrum with the typical defect pattern, the results are shown in Figure 13. It shows that the measured spectrum was close to the PRPD spectrum when there were air bubbles inside the solid epoxy material.

Figure 13. Comparison of measured spectrum with typical spectrum. (a) The measured spectrum; (b) the typical PRPD pattern when there are air bubbles inside the solid epoxy.

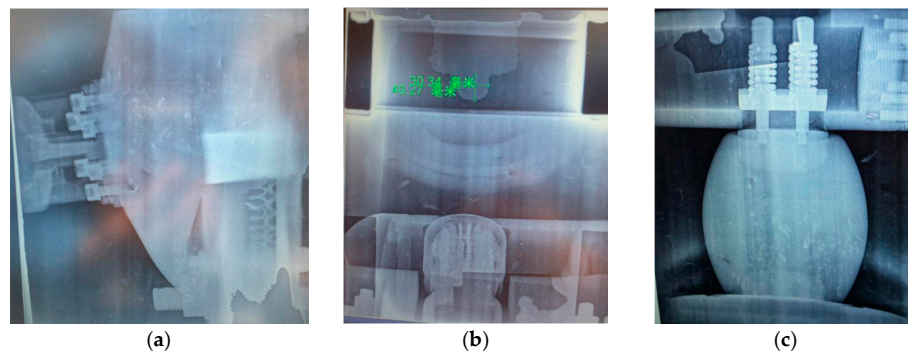
X-ray detection was performed on the possible partial discharge locations mentioned in Section 3.1.2. No obvious abnormalities were found. The X-ray detection spectrum are shown in Figure 14.

Figure 14. Typical X-ray flaw detection diagram of phase C. (a) cone-type spacer; (b) grounding switchgear; (c) supporting spacer.

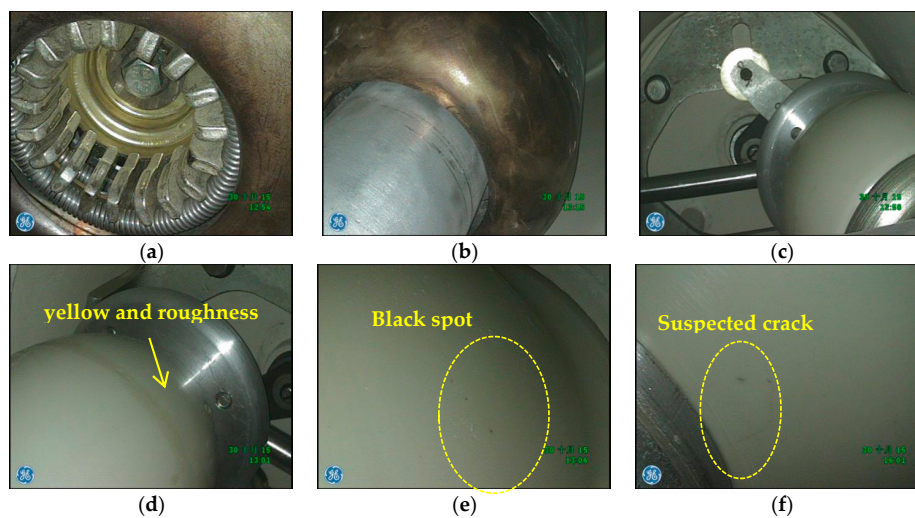
Figure 15. Appearance detection results obtained by endoscope. (a) static contact; (b) Appearance of static contact; (c) transmission spacer; (d) Synthetic seam on transmission spacer; (e) Surface of transmission spacer; (f) Surface of cone-type spacer.

The transmission part of disconnecter, conductor of grounding switchgear and static contact were inspected. There were no discharge traces among them. The main problems found in the appearance inspection include: (1) 2 to 3 cm suspected cracks on the cone-type spacer; (2) yellowing and local unevenness in the position of the transmission spacer; (3) black spots on the surfaces of cone-type

spacers, transmission spacers, and supporting spacers. The above phenomena were consistent with the problems found by the endoscope. All problematic spacers were replaced at once.

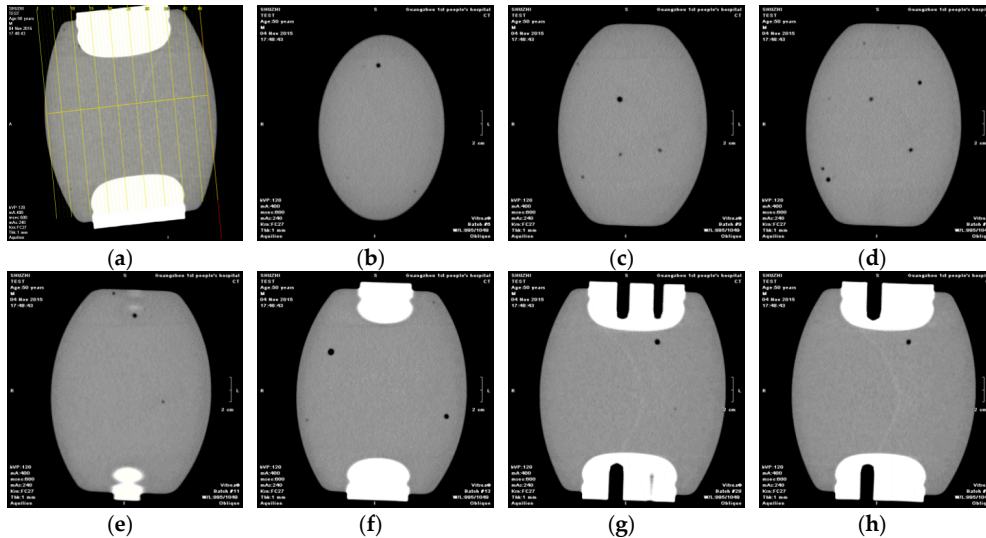
The transmission spacer was cut into 44 slices which sizes were about 1.5 mm. It was mainly found that about 1/3 of the slices contained air bubbles of different sizes (because the density of that area was -600 HU to -900 HU. The density of air was -1000 HU, the density of bone was -1 HU). Typical inspection results of transmission spacers of disconnecter are shown in Figure 16.

Figure 16. Inspection results of transmission spacers of disconnector. (a) Slice diagram; (b) 6# slice; (c) 9# slice; (d) 10# slice; (e) 11# slice; (f) 13# slice; (g) 28# slice; (h) 29# slice.

Through the medical 3D imaging technology it was found that: (1) 2~3 cm cracks appeared on the surface of cone-type spacers, and did not clearly penetrate into the interior of the epoxy material, and the cause of their formation need to be further analyzed. No faults such as air bubbles were found inside the supporting spacers; (2) there were multiple air bubbles inside the transmission spacer of the disconnecter.

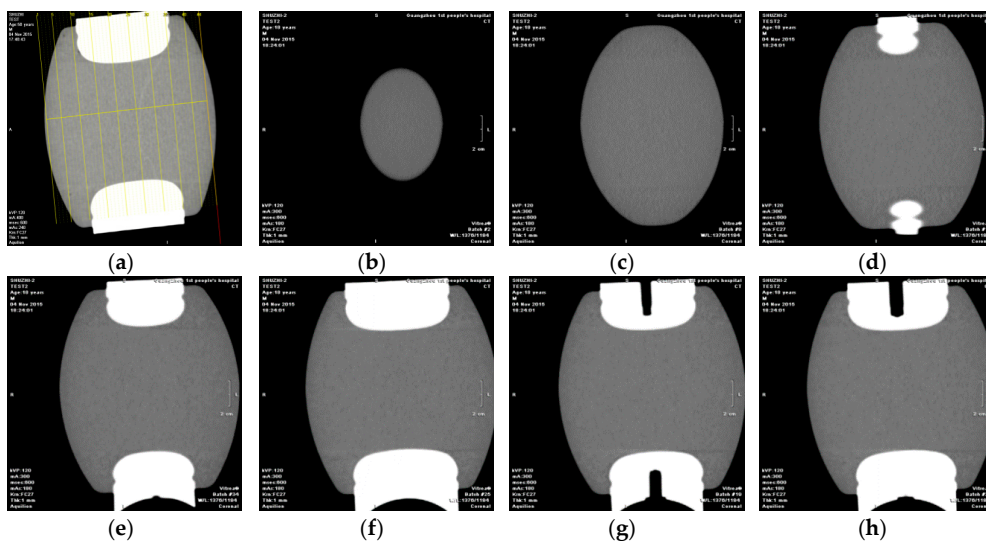
For the bus-bar supporting chamber supporting spacers, they were cut into 50 slices which sizes were about 1.2 mm, and no hidden troubles such as internal air bubbles and gas gaps were found. Typical inspection results of supporting spacers in busbar branch chamber results are shown in Figure 17.

Figure 17. Inspection results of supporting spacers in busbar branch chamber. (a) Slice diagram; (b) 6# slice; (c) 9# slice; (d) 10# slice; (e) 11# slice; (f) 13# slice; (g) 28# slice; (h) 29# slice.
