Bathymetric Monitoring of Alluvial River Bottom Changes for Purposes of Stability of Water Power Plant Structure with a New Methodology for River Bottom Hazard Mapping (Wloclawek, Poland)

Received: 27 July 2020; Accepted: 31 August 2020; Published: 3 September 2020

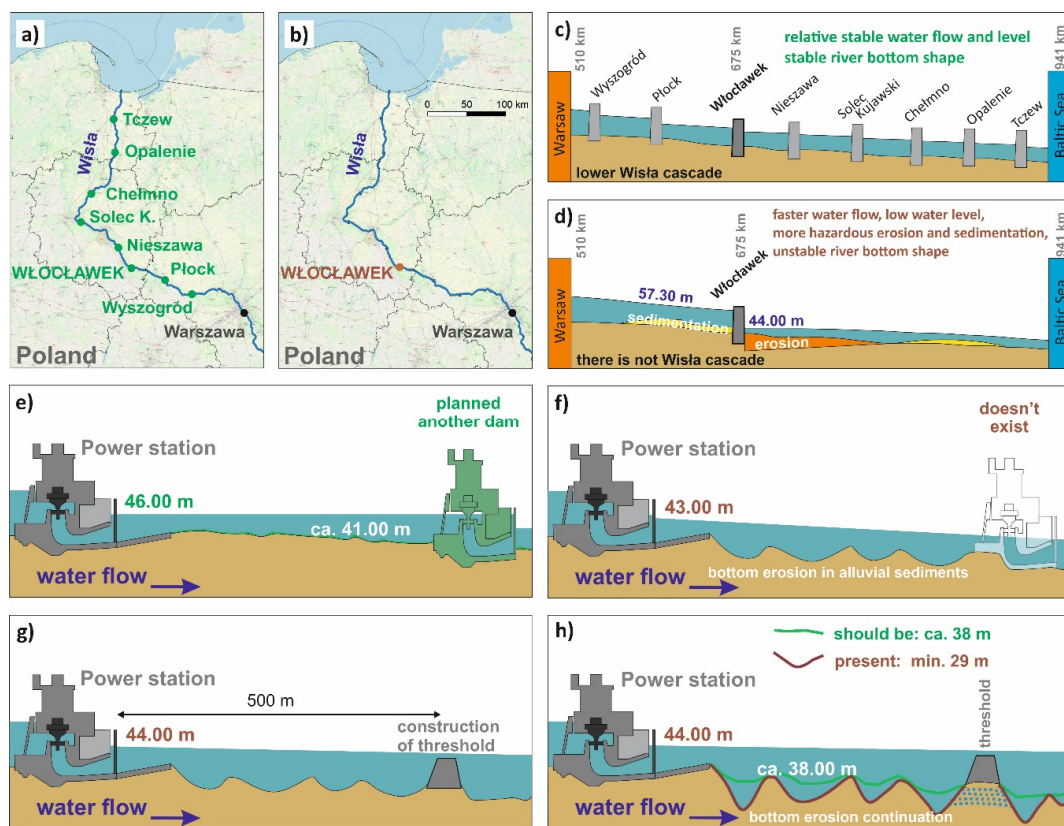
Figure 1. Cause of the problem on power plant Włocławek—motivation for research engineering-geological case of study: (a) Planned cascade of dams with optimal regime of sedimentation and erosion of the river bottom. (b) Realized dams with current problems of erosion of river bottom (only one power plant dam was constructed). (c) Planned dams in 1956. (d) Only one dam built in 1970. (e) Planned conditions. (f) Existing conditions. (g) Improved conditions as for river bottom erosion due to a threshold. (h) Erosion of the bottom continues and the threshold is endangered.

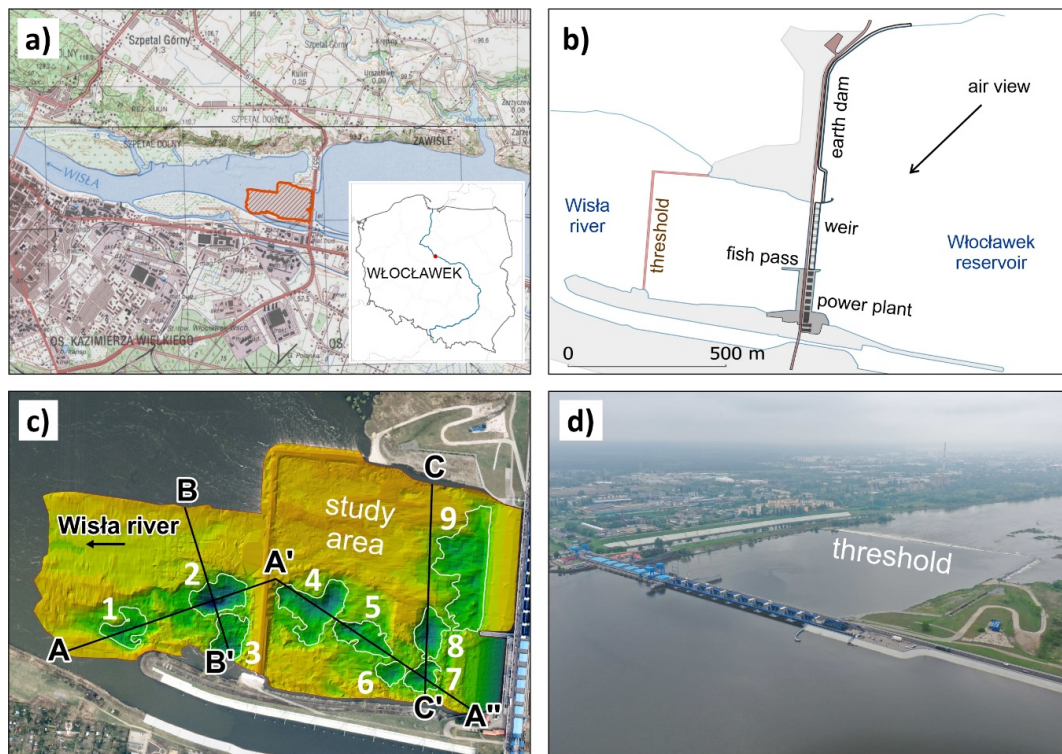
Figure 2. Study area: (a) location of power station Włocławek, (b) power station construction, (c) cross sections of the measured potholes, (d) photo-documentation of the water power station.

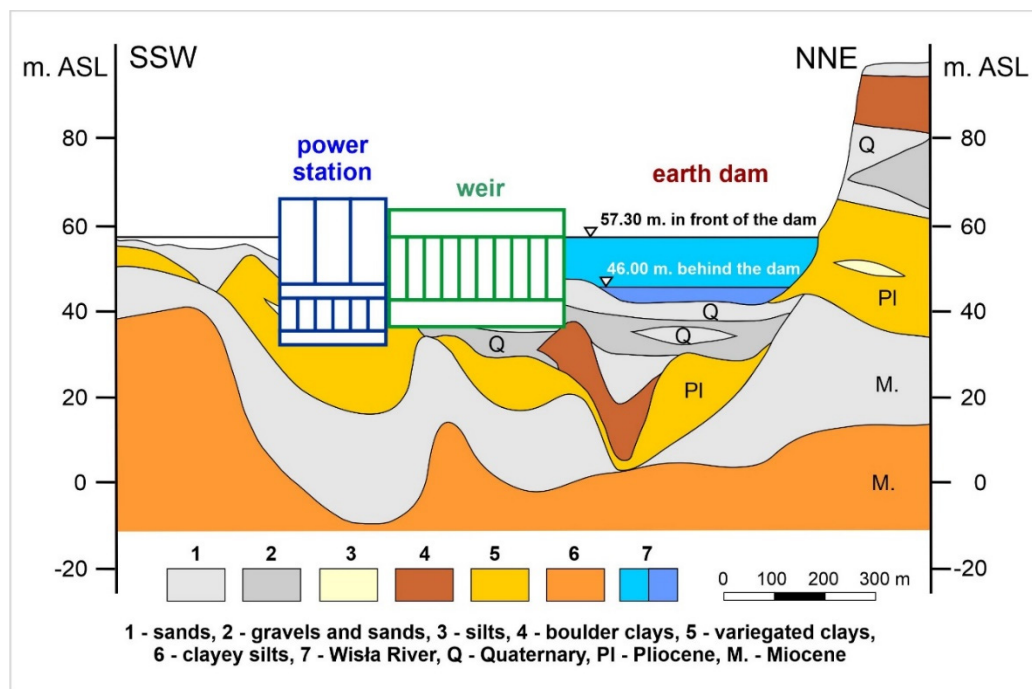
As reported in Hazell et al. [12], Delgado et al. [13], Rommens et al. [14]; Kiracofe et al. [15], and Marschalko et al. [16], the character of the rock material influences the geological structure of the alluvium, as well as the physical-mechanical parameters, enabling the planning activities in the geological environment. The foundation conditions of the Włocławek water power plant can be seen in Figure 3, while the most important section with the most prominent interaction is bound onto the Quaternary gravel and sand. The next section is characterized by Pliocene clay. In the bedrock, there are Miocene sand and clayey silts. Geological structure bedrock is one of the most important factors in the river activity. For this reason, it is decisive whether the bedrock is made of rocks or soils as it conditions the resistance of the rock massif [17–19]. In light of the above, the Wisła River bedrock is made up of low-resistant soils.

Figure 3. Geological cross section of the Włocławek water power plant.

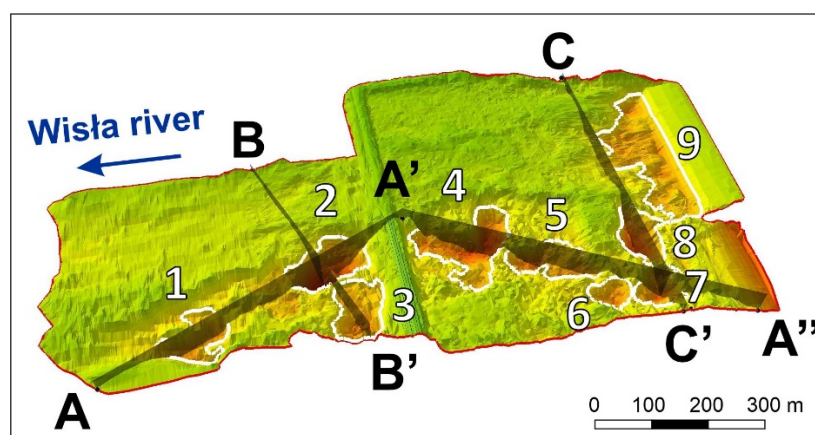
Figure 5. Study area. Potholes and cross sections.

In the area of interest, there are nine partial potholes (morphological depressions, Figures 2 and 5). The majority of them are in the south of the area of interest, which is caused by the direction of dominant discharge from the dam. On the contrary, the sedimentation is higher in the north.

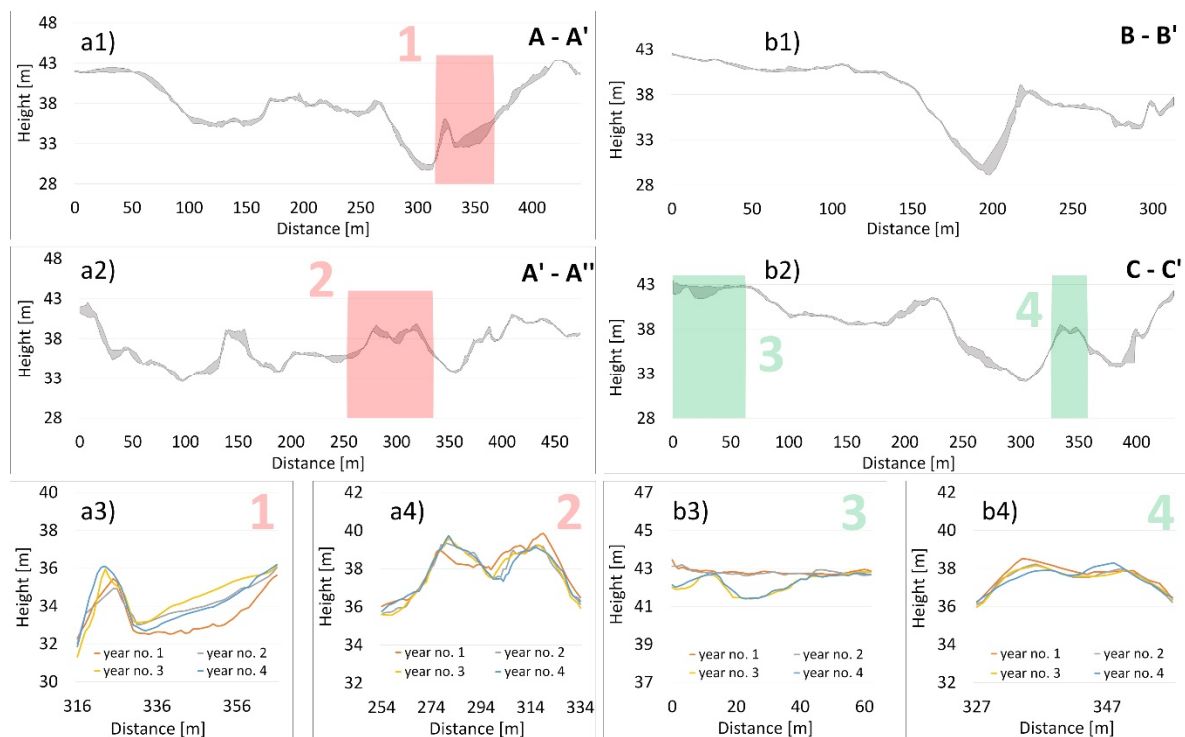
Figure 6. Changes in the river bed in (a1) cross-section A-A', (a2) cross-section A'-A'', (a3) detail No. 1, (a4) detail No. 2, (b1) cross-section B-B', (b2) cross-section C-C', (b3) detail No. 3, (b4) detail No. 4.

If we evaluate the cross-section A-A' and A'-A'' (Figure 6(a1)), we may say that the changes occurred up to 2.14 m, and the average change was 0.52 m. It is clear that conditions altered; erosion prevailed in some places, while sedimentation prevailed elsewhere. This was also related to the hydrological conditions in time in the Wisła River, including floods. It is clear from the cross-section A-A' (Figure 6(a3)) that the most prominent erosion occurred in the first year of monitoring, while later on sedimentation dominated. On the contrary, the cross-section A'-A'' (Figure 6(a4)) shows the lowest positions in some places in the fourth year of monitoring.

When evaluating the cross-section B-B' (Figure 6(b1)), the most remarkable changes occurred in the pothole of 180 to 220 m, where the biggest erosion change (2.47 m) was reported in the slope of the hole. In the cross-section C-C', the biggest changes were observed in the section from 0 to 40 m, and 260 to 280 m on the left slope of the hole. At the elevation at 250 m and at the end of the cross-section behind 400 m (Figure 6(b2)), further significant changes were noted. When evaluating Figure 6(b3), it is clear that there has been a prominent erosion change in the river bed during the monitoring, which correlated with the periods of floods (26 days of enormous water discharge before the third stage of bathymetric measurements (Figure 9a at the top)). The part of the object shown in Figure 6(b4) is significant, since it gives detail information on changes in the morphological elevation, where erosion dominates on the left side and sedimentation on the right.

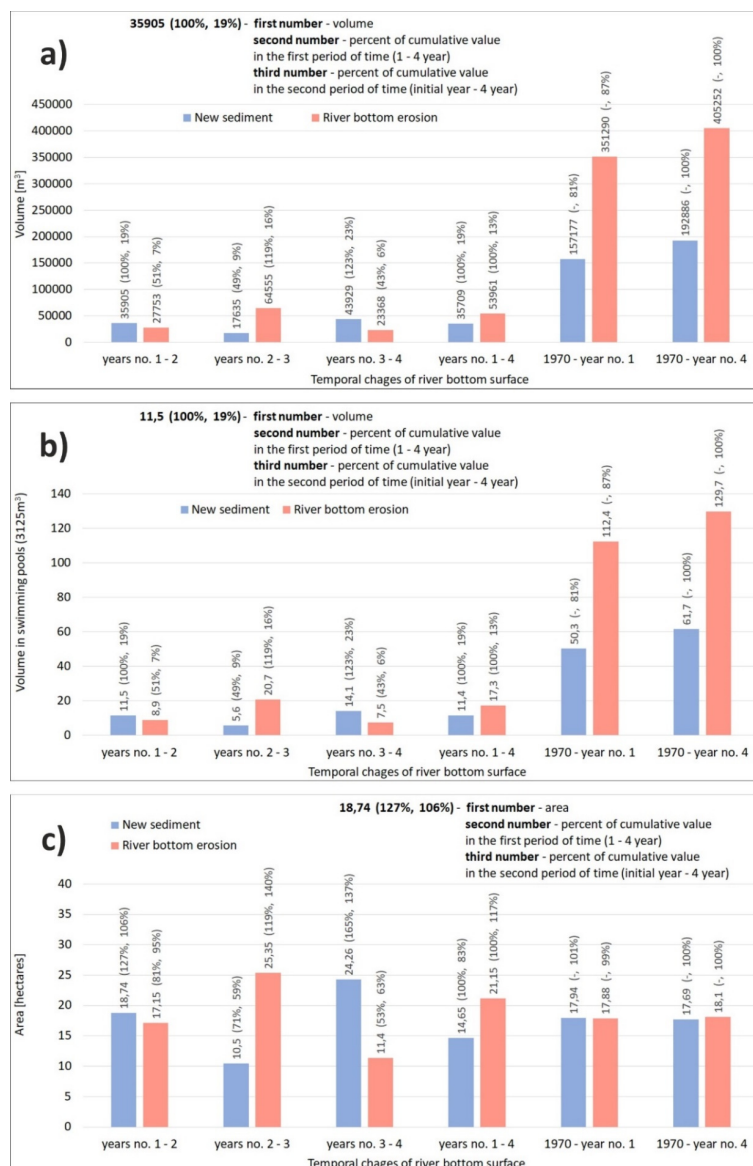
Figure 7. Changes in river bottom erosion and new sediments (a) volume (m³), (b) volume in the number of Olympic-size swimming pools (3125 m³), (c) area (m²).

During the 4-year monitoring, the final river bed erosion amounted to $53,961 \text{ m}^3$ (Figure 7a), which is a capacity of 17.3 Olympic-size pools (Figure 7b). However, the 4-year value represents only 13% of the total erosion (Figure 7a) of the river bed since the construction to the end of the monitoring. In other words, the change amounts to 87% of gravel-sand (capacity of $351,290 \text{ m}^3$, or 112.4 Olympic-size pools (Figure 7b)) since the construction (Figure 7b) to the start of the 4-year monitoring. Therefore, changes were enormous, but distributed in time (Figures 7 and 8).

When assessing the changes in the cubic capacity of new sediments in the area of interest, we found that the most prominent change during the 4-year monitoring was observed between year 3 and year 4, i.e., $43,929 \text{ m}^3$ (Figure 7a). This corresponds to 23% of all new sediments since the

dam construction. At the end of the 4-year monitoring, the amount was 35,709 m³ (Figure 7a, 11.4 Olympic-size pools (Figure 7b)), which is 19% of all new sediments since the dam was constructed. The difference was caused by erosion because the newly settled soils were reduced by intense erosion in year 3 and year 4. The overall change since the dam construction to the end of monitoring was 192,886 m³ (Figure 7a), which corresponds to 61.7 Olympic-size pools (Figure 7b).

As for the evaluation of new sediments in the area of interest, we found that the biggest quantity of sediments was identified in the area between year 3 and year 4, i.e., 24.26 ha, which corresponds to 137% of the total change since the dam construction (Figure 7c). This may be explained by the biggest flood on the Wisła River being in year 3 (Figure 9a at the top). At the end of the 4-year monitoring, the area affected by new sediments was 14.65 ha, which corresponds to 83% of the total change only. The overall area affected by new sediments is 17.69 ha (Figure 7c).

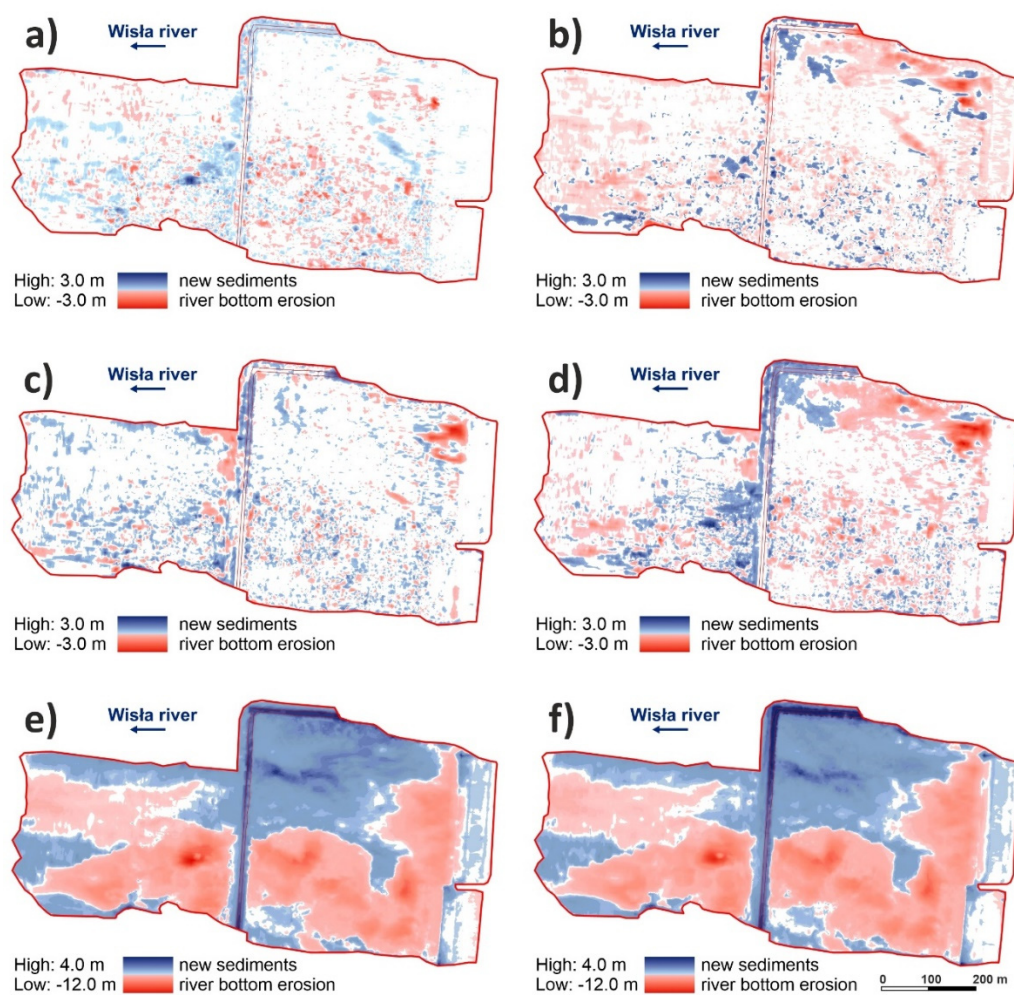
Figure 8. The situation of changes in river bottom surface (river bottom erosion, new sediment), (a) between the first and second year of monitoring, (b) between the second and third year of monitoring, (c) between the third and fourth year of monitoring, (d) between the first and fourth year of monitoring, (e) between the first year of monitoring and 1970, (f) between the fourth year of monitoring and 1970.

The most prominent spatial change in erosion (area) was observed between year 2 and year 3, i.e., 25.35 ha (Figures 7c and 8b). During the 4-year monitoring, the area affected by erosion was 21.15 ha (Figures 7c and 8d). Interestingly, the overall spatial change in erosion since the dam construction to the end of monitoring corresponds to a smaller area (18.1 ha) than the area identified during the 4-year monitoring (Figure 7c). This is explained by the fact that the area of interest is too small for the final change to manifest in this parameter during such a long period.

If we evaluate the changes caused by river bed erosion, as well as the deposition of new sediments related to the geometry of the study area (Figure 8), more significant changes were clearly observed between the year of construction (1970) and the final year of monitoring (Figure 8f) than during the 4-year monitoring (Figure 8d). At the same time, it is possible to observe the dominant direction of pothole formation on the gravel-sand bottom of the Wisła River in the area of interest, i.e., Włocławek dam. This dominant direction is east–west. The direction is an arc, which mirrors the shape of the Wisła River, while it is bound onto the left bank in the direction of water flow. The abundance of potholes is influenced by the location of discharge from the dam on the left bank, and the direction of the dominant flow (east–west) (Figures 5 and 8e,f).

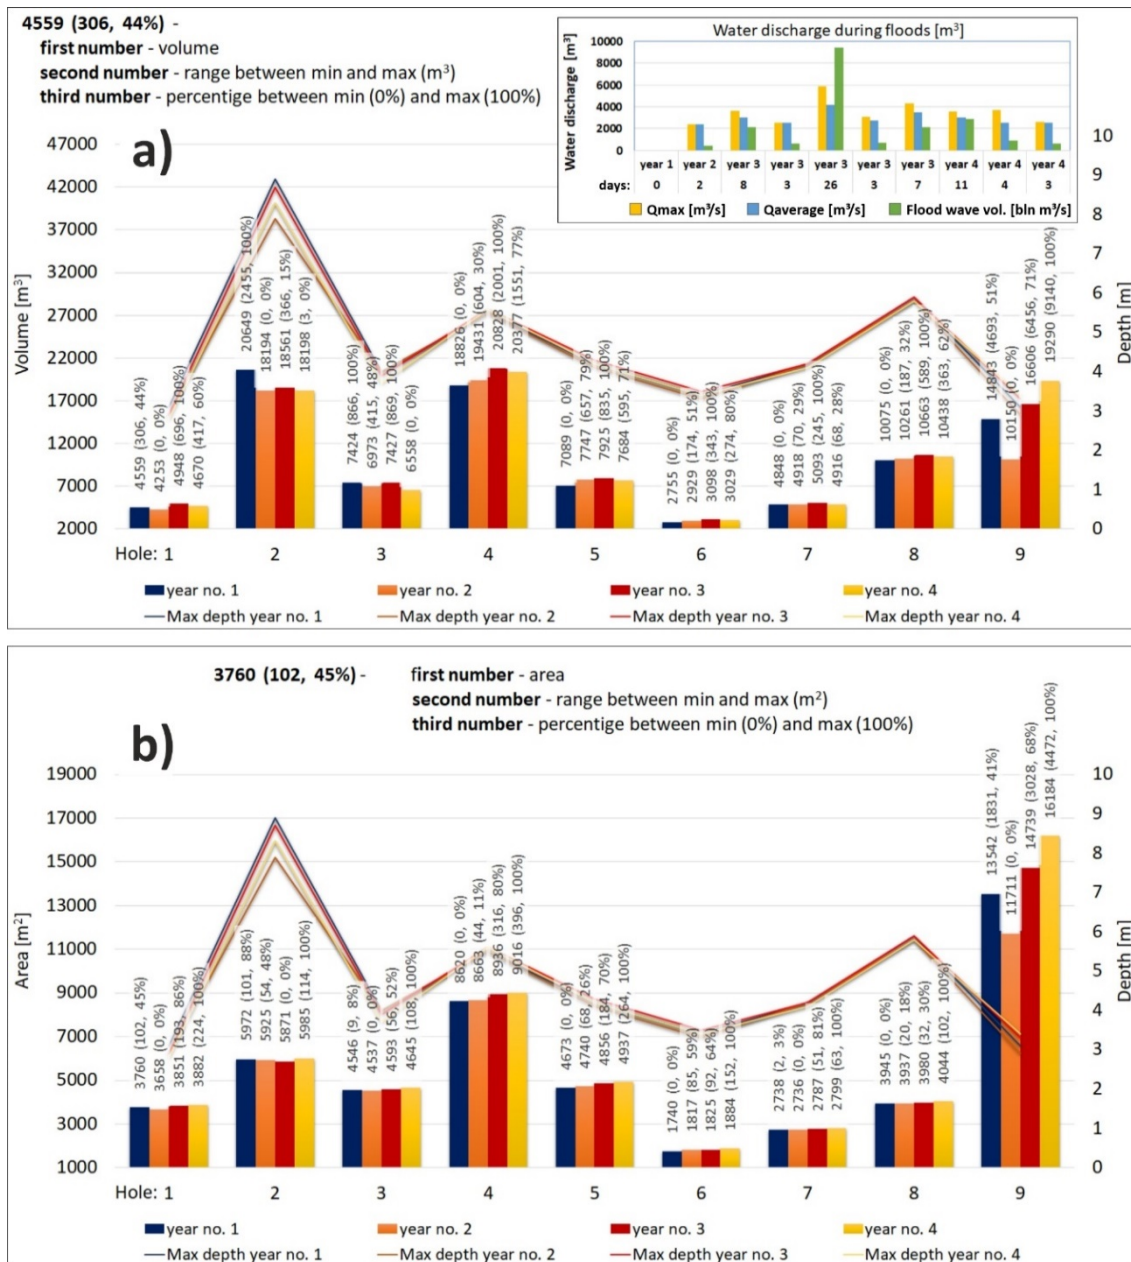
Figure 9. Graph of pothole quantification (a) volume (m³), (b) area (m²).

The graph with pothole quantification is presented in Figure 9. When evaluating the 4-year monitoring of the river bed as for the cubic capacity of the nine measured potholes, the most prominent erosion occurred in pothole 2 and pothole 4 (Figure 9a). The hazard related to the potholes lies in the fact that they are situated in the vicinity of the threshold. In year 3, we identified the capacity of 20,828 m³ in pothole 4.

The nine potholes observed in connection with the changes in the cubic capacity were classified into three groups of analogous behaviour (Figure 9). In potholes 1 to 3, which are located behind the threshold, the trend was a gradual increase and decrease in the values during the 4-year monitoring. On the contrary, in potholes 4 to 8, which are situated in front of the threshold in the direction of the dominant flow, there was a rising trend in the first three years of monitoring, followed by a slight decrease in year 4. This is related to the floods in year 3 and year 4 (see Figure 9a at the top). A specific feature is pothole 9, which is located outside the discharge from the dam. Changes manifest here only during floods, i.e., there was a gradual trend of increasing sediments between years 2 and 4.

The examination of the correlations of maximum depths in the different years of monitoring and comparing these to the cubic capacity of the potholes (Figure 9a), renders clear correlations. The only outlier is pothole 9, which is much shallower than the other potholes, which is explained by its location outside the discharge area from the power plant. This means that it gets affected only during floods, when the increased discharge influences this section too.

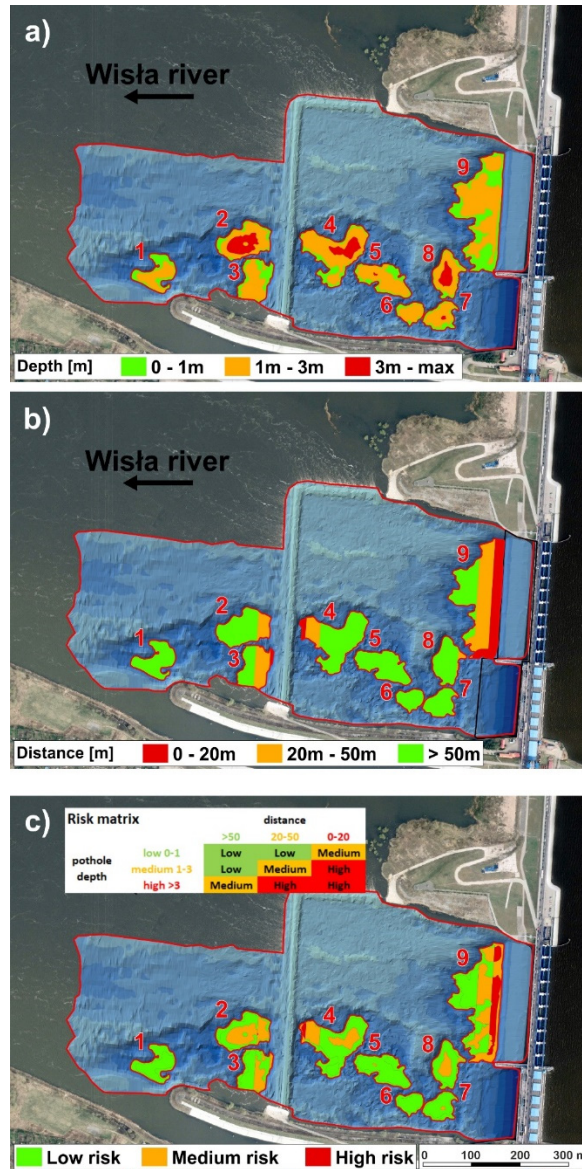
The first criterion is the pothole depth (Figure 10a), where the category of low risk is related to potholes 0–1 m based on empirical evidence. The category of medium risk is characterized by pothole depth of 1–3 m. The category of high risk includes potholes over 3 m deep.

The second criterion is the distance from the dam structures (Figure 10b), where, based on empirical evidence, the low-risk category has potholes of more than 50 m from the nearest power plant structure. The distance of potholes from the nearest power plant structures in the medium-risk category is 20–50 m. The potholes in the high-risk category are 0–20 m from the nearest power plant structures.

The final customized river bottom hazard map for remediation purposes was produced via the combination of factors of potholes' depth and their distance from dam structure. The final categories of low risk, medium risk, and high risk were plotted based on the matrix in Figure 10c.

Figure 10. River bottom hazard map (a) classification by factor of pothole depth, (b) classification by factor of distance from structure of dam and threshold, (c) final map classification by combination of these 2 factors (methodology is in risk matrix).

First, we show the first criterion of pothole depth hazard (Figure 10a) distributed in the zones. There we can see that the deepest category of high-risk concerns only some potholes, i.e., potholes 2, 4, 5, 7 and 8.

The second hazard criterion expresses the distance of potholes from the nearest power plant structure, which shows in the map in two ways (Figure 10b). The first is the distance of potholes from the dam, where only a part of pothole 9 is in the most critical zone (0–20 from the dam). In the medium-risk zone, there are parts of potholes 7 and 8. The second distance is the distance of potholes

from the threshold, where parts of potholes 3 and 4 are located in the high-risk category, while parts of potholes 2, 3 and 4 are in the medium-risk category.

In the final hazard map (Figure 10c), parts of potholes 4, 9, and a small part of pothole 2 are in the high-risk category. Pothole 9 is located close to the dam, while potholes 4 and 2 are near the threshold. The medium-risk category concerns potholes 2, 3, 4, 5, 7, 8, and 9. Remediation backfilling is recommended only in potholes that combine the high-risk and medium-risk category of pothole depth and are located within 50 m of the power plant structures, i.e., potholes 9, 7, 4, 3, and 2.

The research resulted in a remediation project plan in the form of pothole backfilling. We proposed to backfill only those potholes that combine the high-risk and medium-risk category with the distance below 50 m from the power plant structures. The 4-year monitoring helped us to understand the spatial and depth heterogeneity of pothole occurrence to be marked in a map, based on which backfilling may be implemented. The 4-year long monitoring showed there is no need for annual monitoring. It is sufficient to carry out monitoring biannually, and the monitoring may be selective only with the high-risk zone within 20 m from the power plant concrete structures.

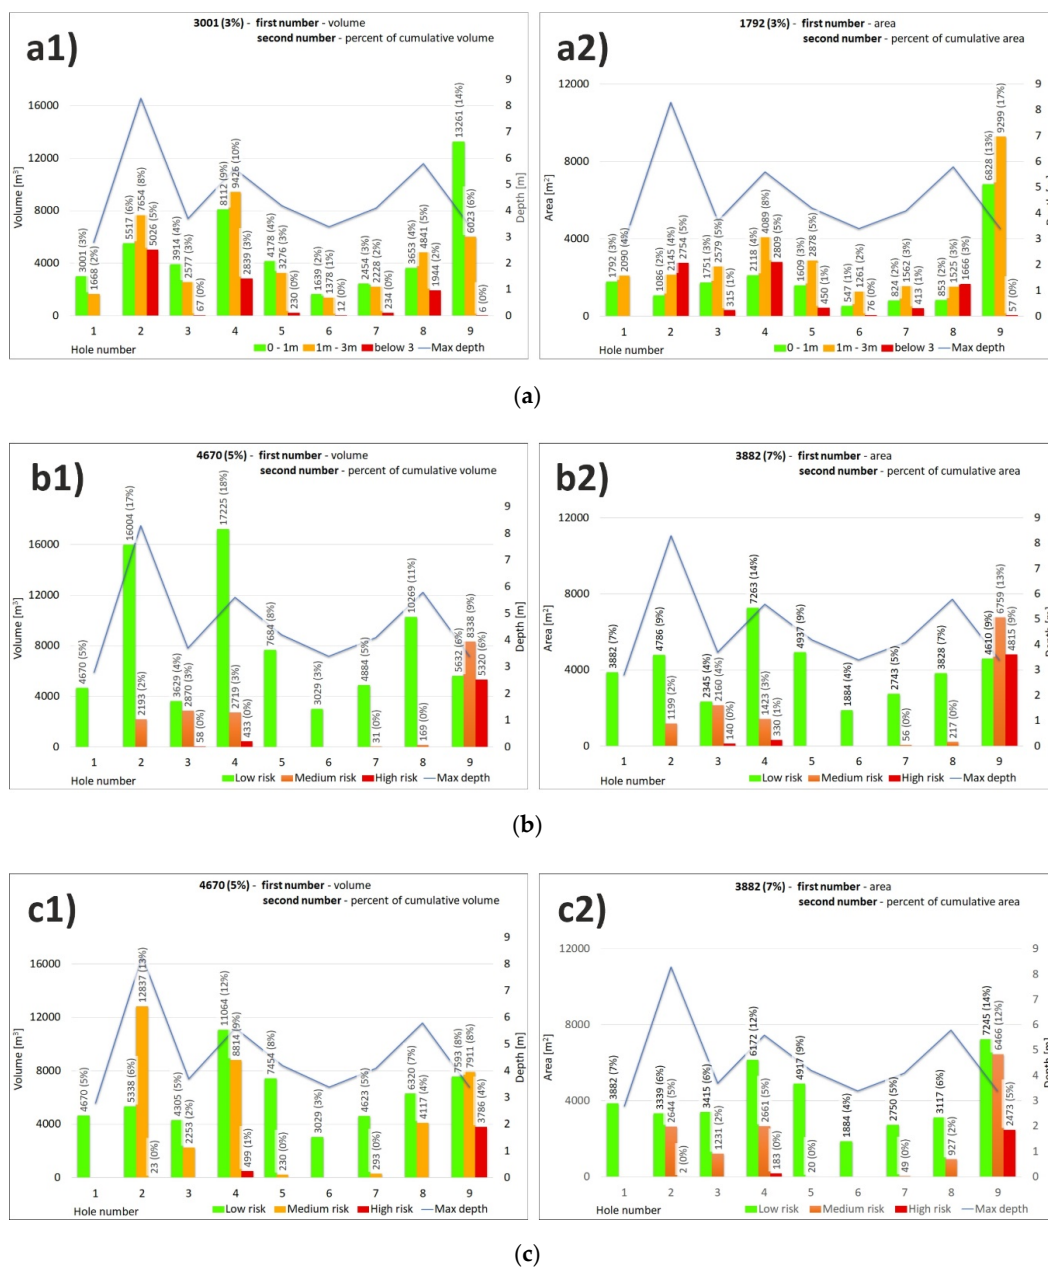
Figure 11. Quantification of risk categories in the special river bottom hazard map for every pothole (a) classification by factor of pothole depth, (b) classification by factor of distance from structure of dam and threshold, (c) final map classification by combination of these two factors: (a1,b1,c1) volume (m^3), (a2,b2,c2) area (m^2).

As for the quantification of the first factor (Figure 11(a1,a2)) using the pothole depth, we may say that as many as 7 parts of different potholes were in the high-risk category, while the highest cubic capacity and area are related to parts of pothole 2 (5026 m³), 4 (2839 m³), and 8 (1944 m³). When quantifying the second factor of the pothole distance from the dam/threshold (Figure 11(b1,b2)), the high-risk category includes pothole 9 (5320 m³), which is located close to the dam. The least concerning are potholes 4 (433 m³) and 3 (58 m³). The combined evaluation in the final map of hazard caused a redistribution of the risk categories, while the high-risk category concerns only potholes 9 (3786 m³) and 4 (499 m³) (Figure 11(c1)).

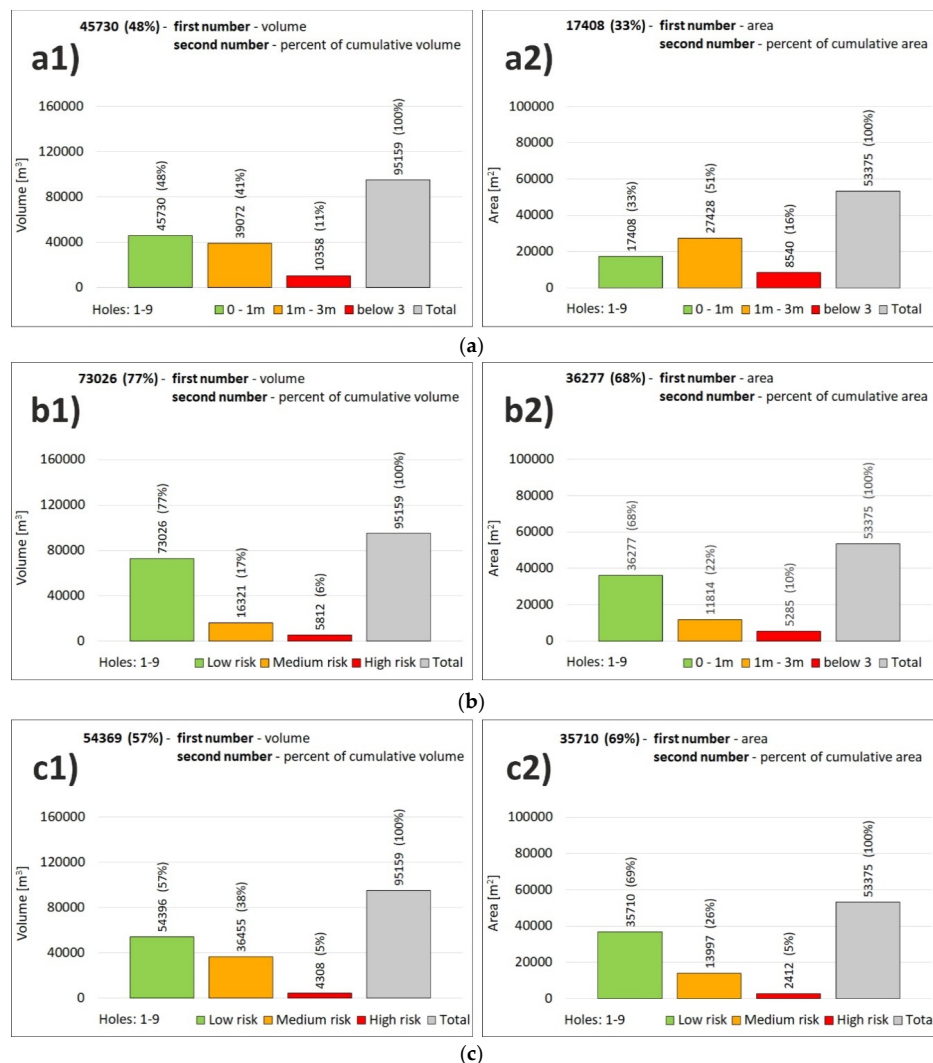
Overall, the capacity of all the potholes amounts to 95,519 m³ (Figure 12(c1)) and area of 53,375 m² (Figure 12(c2)). These two characteristics are important for the economic aspects of the remediation process as they express the maximum mass needed to be backfilled. The map in Figure 10 is relevant for the technical implementation, logistics, access roads to the potholes, and distribution of the backfill materials in the area.

Figure 12. The sum of risk categories in the river bottom hazard map (a) classification by factor of pothole depth, (b) classification by factor of distance from structure of dam and threshold, (c) final map classification by combination of these 2 factors, (a1,b1,c1)—volume (m³), (a2,b2,c2)—area (m²).

The high-risk category is the least abundant with the capacity of 4308 m³, which is 5% of all interest area pothole cubic capacity (Figure 12(c1)). As for the area, the value is 2412 m² (Figure 12(c2)). The medium-risk category is the second most abundant with the capacity of 36,455 m³ (38% of the total pothole cubic capacity). The area of the category covers 13,997 m², i.e., 26% of all pothole area. The low-risk category is related to pothole capacity of 54,396 m³ (57% of the total pothole cubic capacity). As for the area, the category concerns 35,710 m² (69% of all potholes).
