Train Hunting Related Fast Degradation of a Railway Crossing—Condition Monitoring and Numerical Verification

Xiangming Liu *

and Valéri L. Markine *

Department of Engineering Structures, Delft University of Technology, 2628 CN Delft, The Netherlands

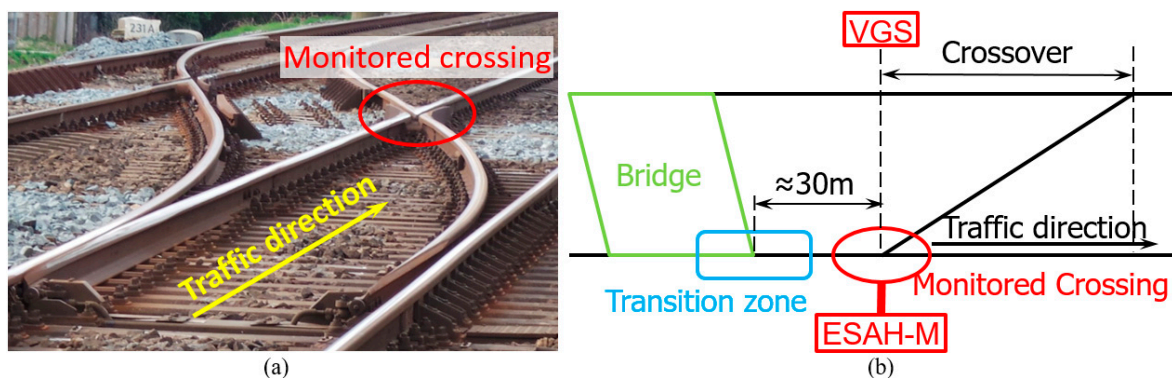
The monitored crossing was a cast manganese crossing with an angle of 1:9. As part of a crossover, trains mainly pass the crossing in the facing through route (Figure 2) with a velocity of around 140 km/h. The on-site view of the crossing is shown in Figure 10a. According to the maintenance record, this crossing was suffering from fast degradation with the service life of only around three years (18 years on average [2]). At the beginning of the condition monitoring, the damaged crossing was completely renovated.

Figure 10. Overview of the monitored crossing. (a) On-site view. (b) Sketch view.

Figure 10b gives a sketch view of the crossing, including the setup of the monitoring devices and the layout of the adjacent structures, especially the small bridge in front of the crossing. Considering that the bridge is located quite close to the monitored crossing, the performance of the crossing might be affected by the bridge, which will be discussed later.

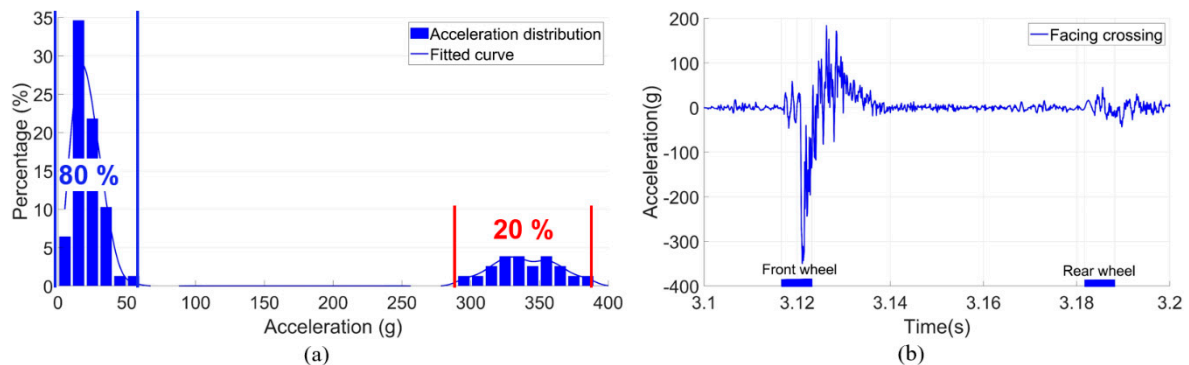
The sample size, in this case, was 78 passing wheels. It can be seen that the wheel impacts presented a bimodal distribution. Around 80% of the wheel impacts were below 50 g, while the remaining 20% of the wheel impacts were extremely high with a mean value of around 350 g. Such a polarized distribution of impacts indicates the highly unstable wheel-rail interaction in this crossing. It was demonstrated in a previous study [29] that for this type of railway crossing, the average level of the wheel impact is around 50 g, meaning that the 20% of high impacts of the monitored crossing are already more than seven times higher than the average impact level. It can be imagined that such high impacts will dramatically accelerate the degradation procedure of the crossing.

Figure 11. Vertical acceleration responses of the monitored crossings. (a) Distribution based on multiple train passages in one day. (b) Example of impacts due to one bogie.

An example of the impact acceleration response in the time-domain due to the first bogie of a VIRM train is shown in Figure 11b. It can be seen that for the two passing wheels from the same bogie, the impacts can be quite different. The impact due to the front wheel was up to 350 g, while the rear wheel activated vertical acceleration was only 20 g. It has to be noted that the high impacts were not always introduced by the front wheel, but appeared to have random occurrences. Such results further confirmed the instability of wheel-rail interaction at this crossing.

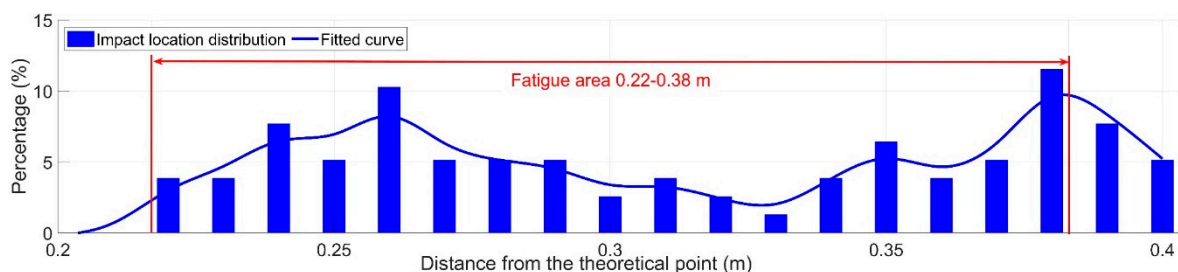
The measured fatigue area of the monitored crossing is presented in Figure 12. It can be seen that the wheel impacts were widely distributed at 0.22–0.38 m from the TP with the fatigue area size of 0.16 m. According to the previous study [28], the transition region (Figure 2) for this type of crossing is around 0.15–0.4 m. The fatigue area widely covered 64% of the transition region, which can be considered to be in line with the expectation of a new crossing profile. Such results further confirmed that the crossing rail was not worn or deformed.

Figure 12. Measured fatigue area of the monitored crossing.

It has to be noted that the fatigue area does not conform to the normal distribution (referring to the “Worn” stage demonstrated in Figure 5b). Combined with the results of the wheel impacts such a fatigue area further confirmed the instability of the wheel-rail contact in the monitored crossing.

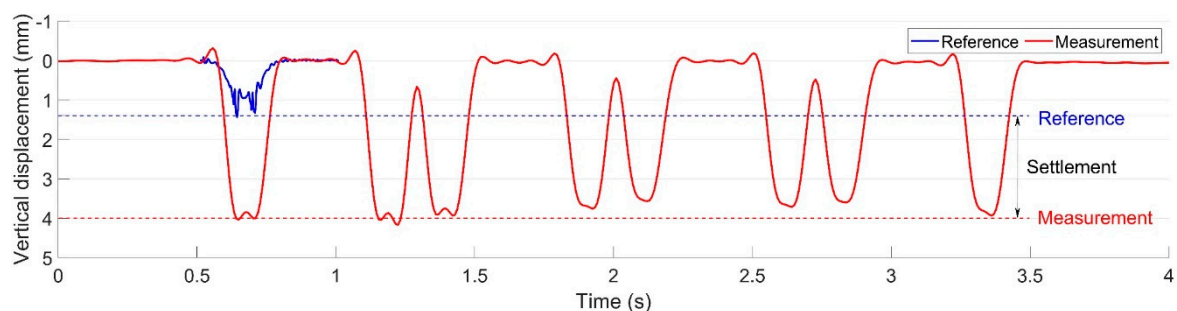
The measured vertical displacement of the crossing rail is presented in Figure 13. It can be seen that the vertical rail displacement was around 4 mm. The measured displacement result can be considered to have two main parts: the elastic deformation and the gap between the sleeper and ballast. Considering that the ballast settlement is the accumulated effect due to multiple wheel passages, the plastic deformation caused by each passing train can be neglected. Due to the high impacts in the crossing panel, the ballast is usually settled unevenly, which results in hanging sleepers. Using the validated MBS model, it was calculated that the rail displacement in the reference condition was 1.4 mm (Figure 13), which only consisted of the elastic deformation part. By comparing these two results, it could be calculated that the gap between the sleeper and ballast was 2.6 mm, which can be estimated as the settlement of ballast. It was observed that the rail displacement obtained from the MBS simulation was much higher than that in a normal track (less than 1 mm [27,31]), which indicates the vulnerability of the ballast in the railway crossings.

Figure 13. Ballast settlement in the monitored crossing.

In a previous study [27], it was found that track irregularities such as rail joints and turnout crossings can lead to the fast deterioration of the ballast, and the ballast settlement will in turn accelerate the degradation procedure of other related track components. In this study, the 2.6 mm ballast settlement was already higher than those in the previously monitored welded joints (≈ 1.5 mm) and movable crossings (≈ 2 mm), which revealed the seriously deteriorated ballast condition.

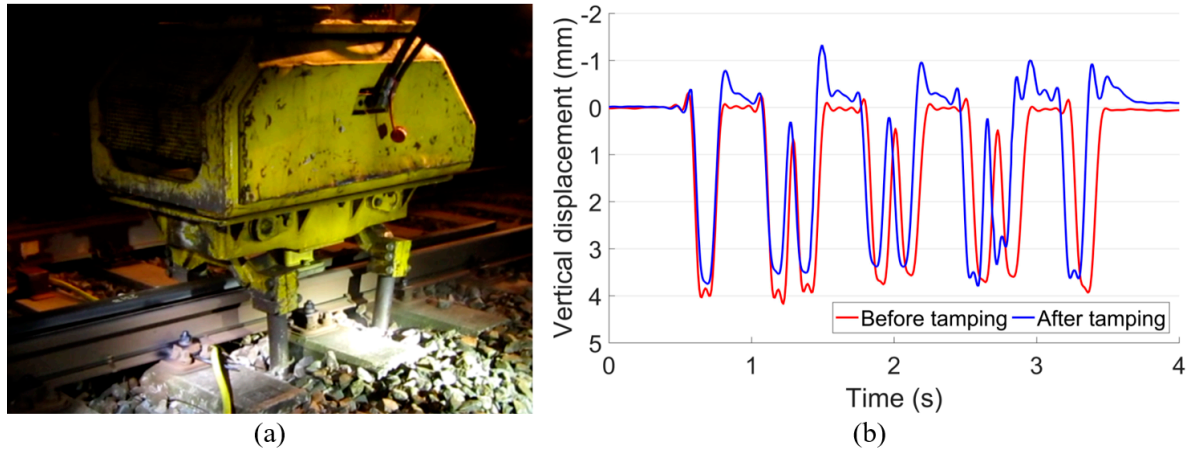
Therefore, ballast tamping actions were frequently performed in this location by the local contractor. However, due to the lack of maintenance facilities, the tamping actions were mainly performed using the squeezing machine (Figure 14a) without track geometry correction. It can be imagined that the settled ballast cannot be fully recovered with such tamping action. As shown in Figure 14b, after tamping, the rail displacement was not dramatically reduced.

Figure 14. (a) Squeezing machine used for ballast tamping in the monitored crossing. (b) Measured rail displacement before and after ballast tamping.

It can be concluded that such frequently implemented ballast tamping had no improvement in either the ballast condition or the dynamic performance of the monitored crossing. Without figuring out the root causes for the fast crossing degradation, such ineffective ballast tamping should be suspended.

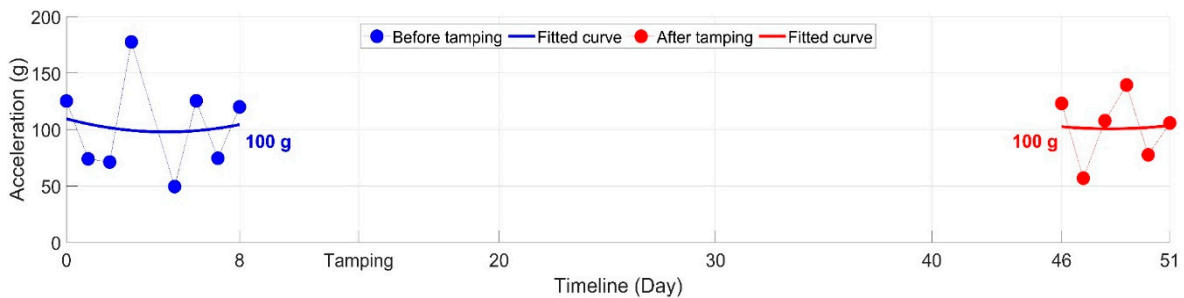
The development of the wheel-rail impacts before and after tamping are presented in Figure 15. In this figure, each point represents the mean value of the impact accelerations based on multiple wheel passages in one monitoring day. It was discussed in a previous study [28] that the fluctuation of the wheel impacts was highly affected by external disturbances such as the weather. Still, it can be seen that the regression values before and after tamping were both around 100 g.

Figure 15. Development of the wheel-rail impacts before and after ballast tamping.

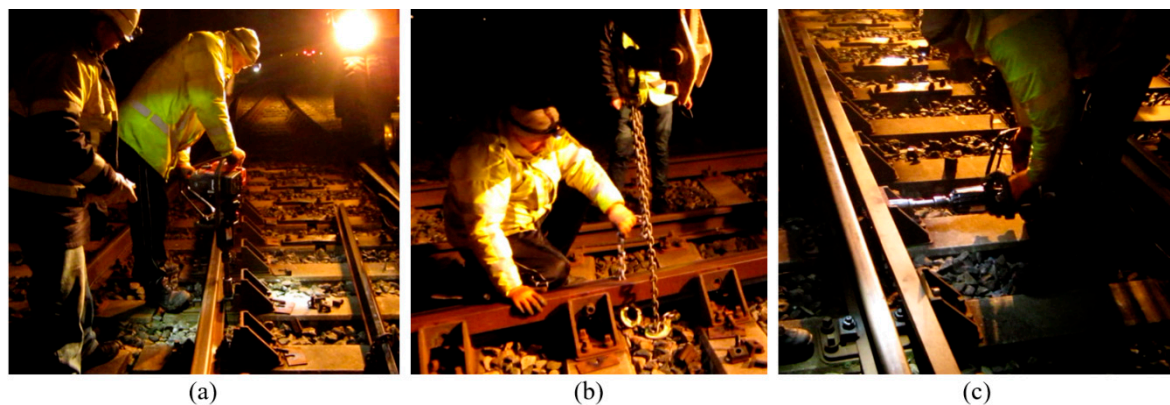
During the monitoring period, the fastening system was found to be degraded with some broken bolts. Such degradation affected the lateral stability of the track. Therefore, the fastening system, mainly the bolts in the guard rails and the clips, was renovated, as shown in Figure 16.

Figure 16. Fastening system renovation. (a) Remove the broken bolts. (b) Reposition the guard rail. (c) Install new bolts.

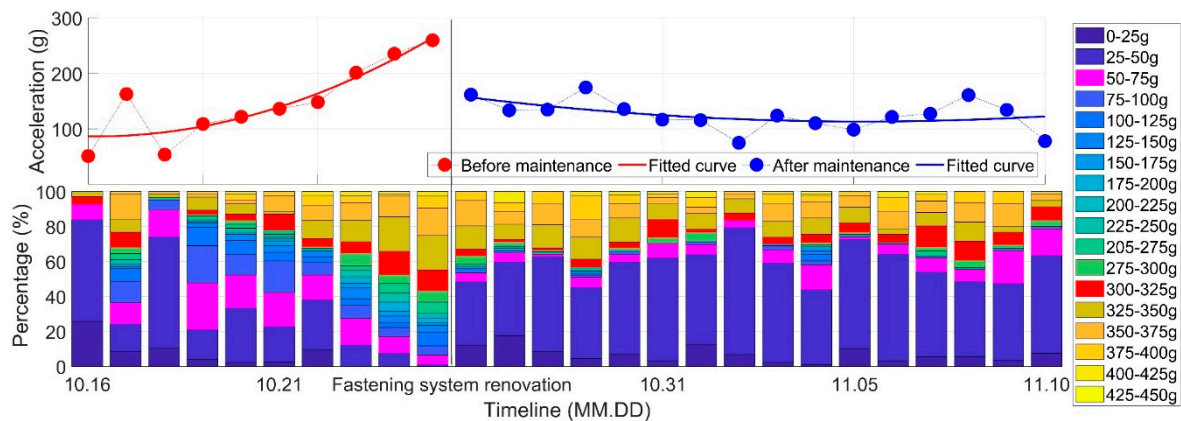
The development of the wheel-rail impacts before and after renovation is shown in Figure 17. The upper figure is the development of the mean value, and the lower figure gives the ratio of different impact levels in each monitoring day, corresponding to the value in the upper figure.

Figure 17. Effect of fastening system renovation on the dynamic performance of the crossing.

It can be seen from Figure 17 that before the renovation, the wheel-rail impact showed a clear increasing trend with the impact values widely distributed from 0 to 450 g. Such a degradation trend indicates that maintenance is urgently required due to the defects of the fastening system. After the renovation, the wheel-rail impacts were dramatically reduced in terms of the mean value and separated into two distribution modes, which is similar to those shown in Figure 11a. Such improvement is due to the enhancement in the track integrity. However, the wheel-rail impacts above 300 g were still a large proportion after maintenance, which means that the sources for such high wheel-rail impacts were not found.

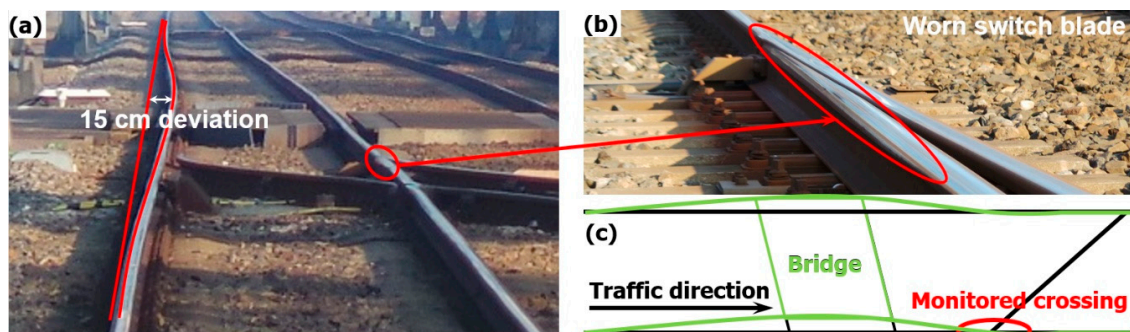
In the field inspection, it was found that the bridge was not well aligned in the track, but deviated around 15 cm, as shown in Figure 18a. Such deviation introduced a curve into the track, which was likely to be out of design since no elevation was set up in the outer rail. It can be imagined that the passing trains could not pass the track along the central line but tended to have wheel flange contact with the outer rail, which eventually leads to the severe wear in the switch blade (Figure 18b).

Figure 18. Track deviation in front of the crossing. (a) Inspected curve introduced by the bridge. (b) Worn switch rail. (c) Demonstration of the bridge deviation.

It has to be noted that although the curve in front of the crossing did not directly activate train hunting, the activated lateral shift of the passing wheels resulted in the wear in the switch blade (Figure 18b) and contributed to the track gauge deviation. Therefore, such a curve can be considered as the root cause of the fast degradation of the monitored crossing. To improve the performance of the crossing, this curve has to be first eliminated.
