Application of Fiber Bragg Grating Sensor Technology to Leak Detection and Monitoring in Diaphragm Wall Joints: A Field Study

Keywords: diaphragm wall; joint; leakage detection; fiber Bragg grating sensor; field study

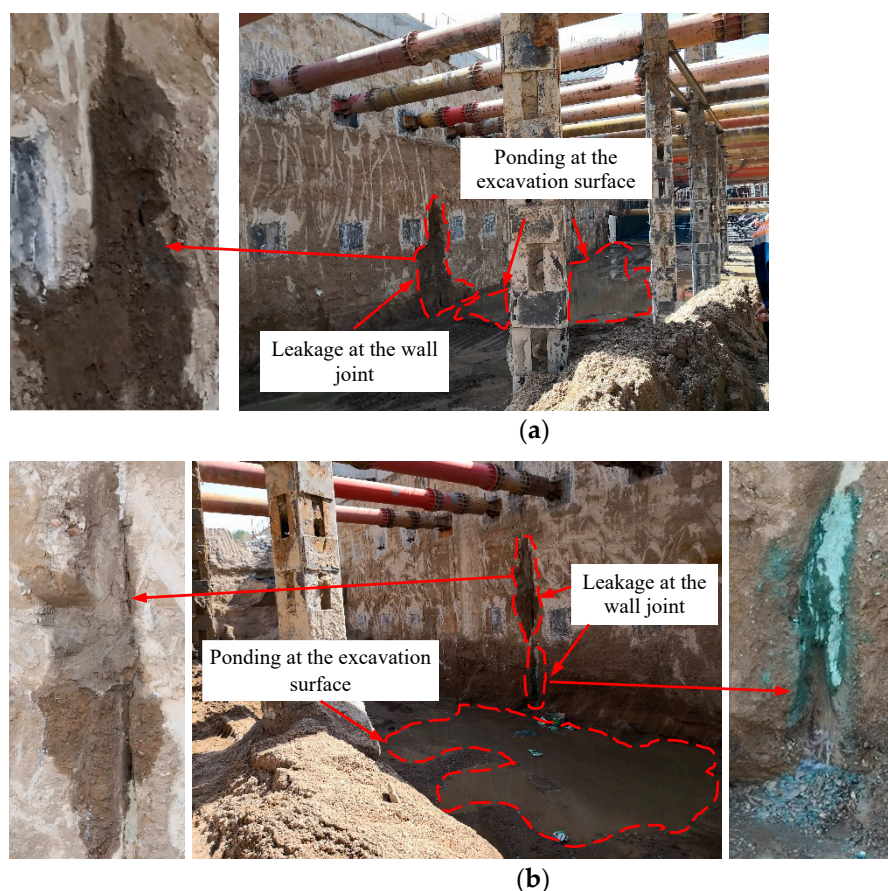
The local environment around the excavation is complex; and a welfare institute, service station, and temporary road for vehicles all lie adjacent to the excavation, as shown in Figure 2. Therefore, if the D-wall joints were to leak and result in land subsidence, it is highly likely that damage will be caused to the nearby buildings; there is even the possibility that a geologic disaster could happen. The construction site of the project was investigated prior to the installation of the LDS-DWJ. It was found that there were several groundwater leakage problems in the joints of the D-walls in the sections where excavation had been completed (Zone A in Figure 2) that were clearly visible. In particular, there was some ponding of water on the surface of the excavation, which constituted a serious threat to the safety of the excavation and surrounding buildings (Figure 5). Consequently, it is deemed necessary to find the potential leakage sites in the D-wall joints prior to excavation and apply appropriate mitigating measures in a timely manner to prevent the situation from getting worse.

Figure 5. Photographs showing water leakage occurring in the wall joints at the site. The leaks were observed in: (a) the east side wall, and (b) the west side wall.

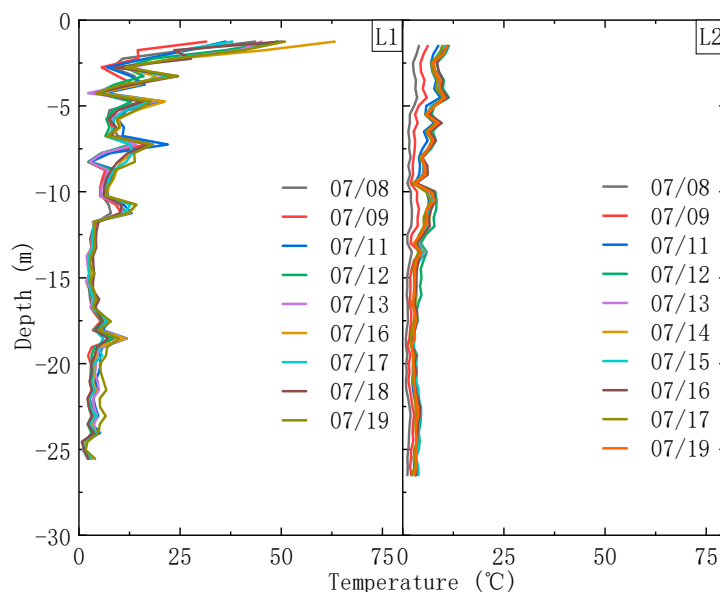
Figure 12. Temperature profile along the joint at L1 and L2 after active heating.

It is notable that the temperatures at 2.75, 4.25, 6.75, and 10.25 m below the ground level are significantly lower than those of nearby areas. The temperatures in the depth range 11.75–15.75 m and 19.05–25.55 m are also slightly lower than those in the area around 17.55 m. Therefore, there appear to be hydraulic connections between the groundwater in front of and behind the D-wall at these locations, due to the presence of defects (leakage will occur where the joint is defective and this will take heat away from the detection tube more quickly, resulting in a lower temperature around the defect compared to other, non-defective, zones). It can also be notable that temperature suddenly drops at 8.25 m at some times. This suggests that the defects at this position may not exist or be repaired due to bentonite inclusions or slightly decomposed concrete of lower strength. Their occurrence in the joints prevents water inflow through the joints. However, this situation may change instantaneously when the water pressure reaches a certain value that causes damage of the inclusions and slightly decomposed concrete [16].

It can also be seen from Figure 12 that the temperature suddenly drops at the points 5.5 m, 6.5 m, 8 m, 9.5 m, and 13 m below the ground level. This suggests (according to the operating principles of the system outlined above) that there is probably a leak occurring in the joint at this depth.

It can also be seen from Figure 12 that the temperature distribution curve fluctuates significantly. The primary reason for this is that there is leakage occurring in several places at L1. Furthermore, uneven heating by the heating belts also causes the temperature distribution curve fluctuating along the D-wall joints at both of the detection points.

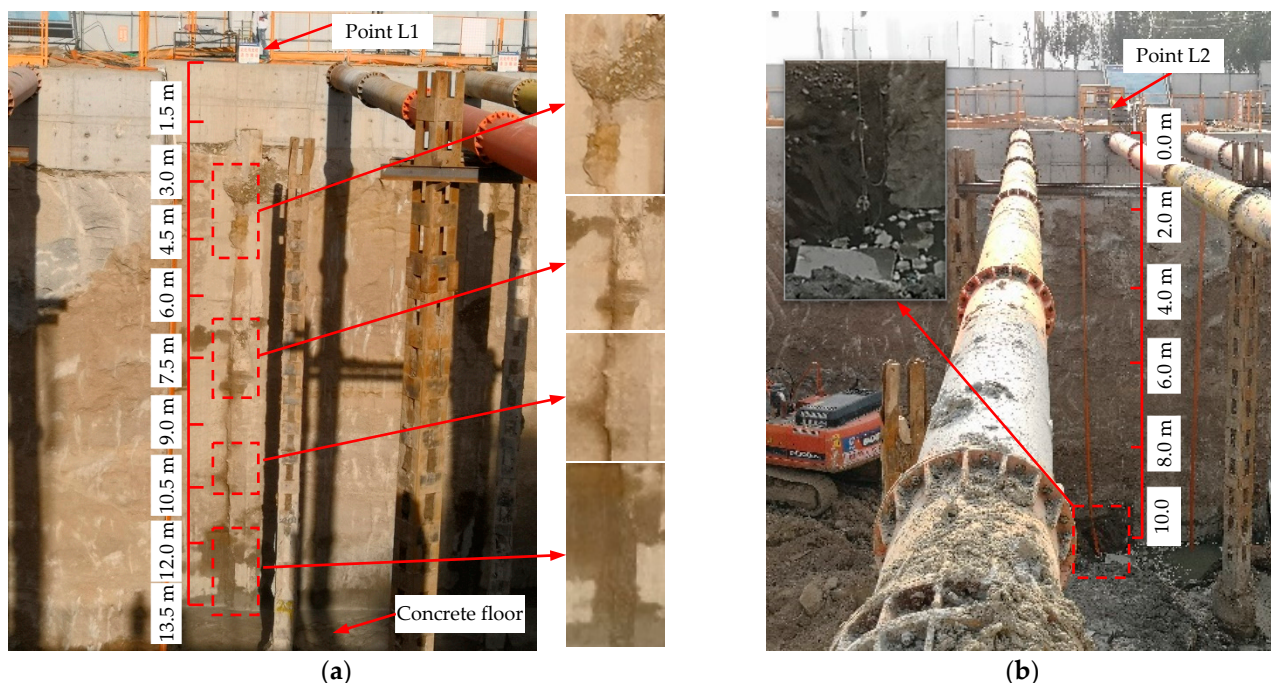
Figure 13a shows the leakage observed at L1 after the excavation of the pit was finished and the casting of the concrete floor (1.5 m thick) was completed in the pumping station on August 13th. Several water leaks, including leakage at 8.25 m (meaning that inclusions or slightly decomposed concrete in the defect are washed away by water inflow after excavation), can be seen in the figure occurring at the joint between the two wall panels above the concrete floor (13.5 m below ground level). Table 1 summarizes a detailed comparison of leakages between predictions and field observations. The comparison suggests that the locations of these leaks are consistent with the detection results at L1. The detection results of the points below the bottom cannot be verified because over-excavation was forbidden. But, it can still be concluded that the LDS-DWJ using a stainless-steel detection pipe can effectively detect the potential leakages.

Figure 13. Leakage occurring in the wall joint after finishing excavation. (a) leakage occurring at L1; (b) leakage occurring at L2.

Figure 13b is a photograph of the leakage observed at L2 after the pit was excavated. It can be seen from the picture that water infiltration is occurring 9.5 m below the surface of the ground, indicating that leakage is occurring in this area. This is again consistent with the detection results. However, there is no leakage or water infiltration occurring at 5.5 m, 6.5 m, or 8.0 m depths, which is inconsistent with the detection results. Consequently, the detection results based on the LDS-DWJ using the tubeless configuration are unreliable, as summarized in Table 1.
