# Preservation and Protection of Cultural Heritage: Vibration Monitoring and Seismic Vulnerability of the Ruins of Carmo Convent (Lisbon)

**Abstract:** Preservation of cultural heritage sites is of paramount importance. The ruins of Carmo Convent in Lisbon stand as a poignant reminder of the city's rich history, but challenges regarding structural integrity and safety are present in a highly populated and touristic area. In this paper, a comprehensive study of the Carmo Convent is presented, focused on non-destructive testing (NDT), structural health monitoring (SHM) and numerical modelling. Given its state of ruin and historical relevance, the study relied heavily on NDT. Additionally, a metro line passing underneath the convent raised concerns regarding potential hazards from induced vibrations. Thus, metro vibration monitoring (MVM) was implemented to assess the impact of induced vibrations on the structure. One of the challenges was the scarcity of standards specific to historic structures. However, through a combination of finite element method (FEM) and discrete element method (DEM) numerical modelling, valuable insights into the current condition of the structure were obtai

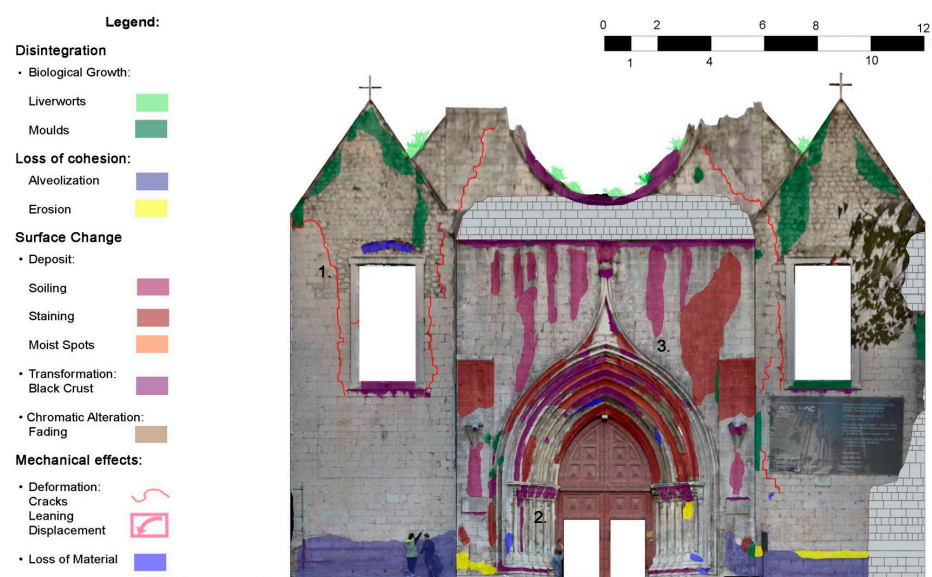
four elevations, both for the interior and exterior surfaces, were performed. The results were plotted onto the photogrammetry images. The damage survey assesses the extent of the damage and/or loss observed during the visual inspections. It is noted that Carmo Church presented damage caused by several seismic events, which was repaired after the 1755 earthquake. The damage is mainly associated with material decay over time. The damage survey allowed us to prepare the damage patterns based on the ‘Illustrated Glossary on Stone Deterioration Patterns’ [14]. The church of the Carmo Convent does not show severe damage, but some aspects have to be taken into account. The south-east corner is the most affected by decay, and some problems are related to the architectural changes that occurred during the history of the Carmo Convent. Moreover, some damage is associated with the properties of soil and the partial slope failure of Carmo hill induced by the 1755 Lisbon earthquake [1]. The main effect is visible on the portals, which are heavily broken down and associated with a global leaning. It is noted that, after this work, conservation and restoration works were performed in the main façade and Gothic arch.

**Figure 7.** Example of damage pattern for the main façade before conservation and restoration works.

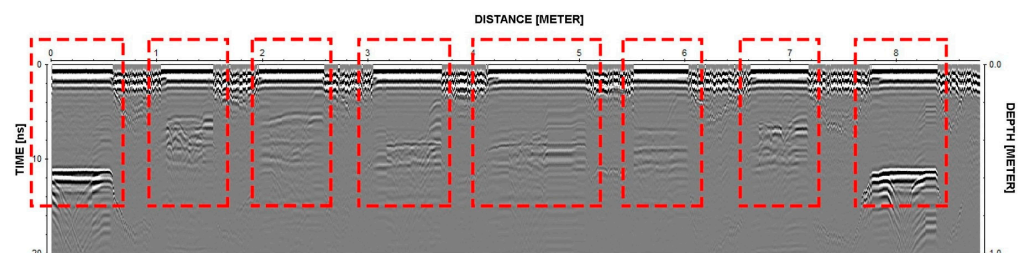
The clarity of the scans (Figure 13) made it reasonable to conclude that the stones seen on the column's exterior are solid and extend approximately 28–30 cm into the column. Beyond the singular stones, the scans are less clear. These portions of the scans, represented by the hatch, show significant wave reflection, which indicates that the interiors of the columns are likely not made of solid stone, nor does it appear that these are clean-cut stone blocks fitted together. Rather, it is likely that the interiors are at least partly filled with limestone rubble and compacted with good-quality mortar. It is possible that the upper portion of the column extends into the base or that there are larger solid stones at the interior that were not reached by the electromagnetic wave from the GPR.

**Figure 13.** Data acquired by a scan on column C, representative of the vertical scans taken on the columns. The data shown in red dashed rectangles correspond to the red arrows shown in Figure 12b.

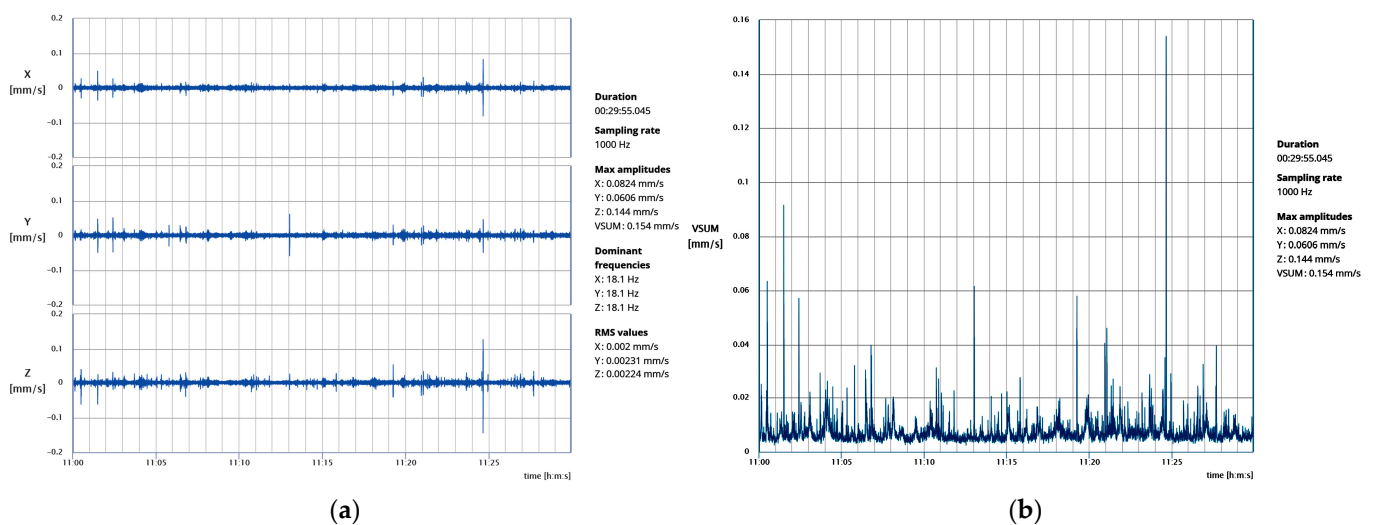
**Figure 15.** V3 acquisition during 11:00–11:30 am: (a) time plot of particle velocities in three directions; (b) time plot of vectorial sum.

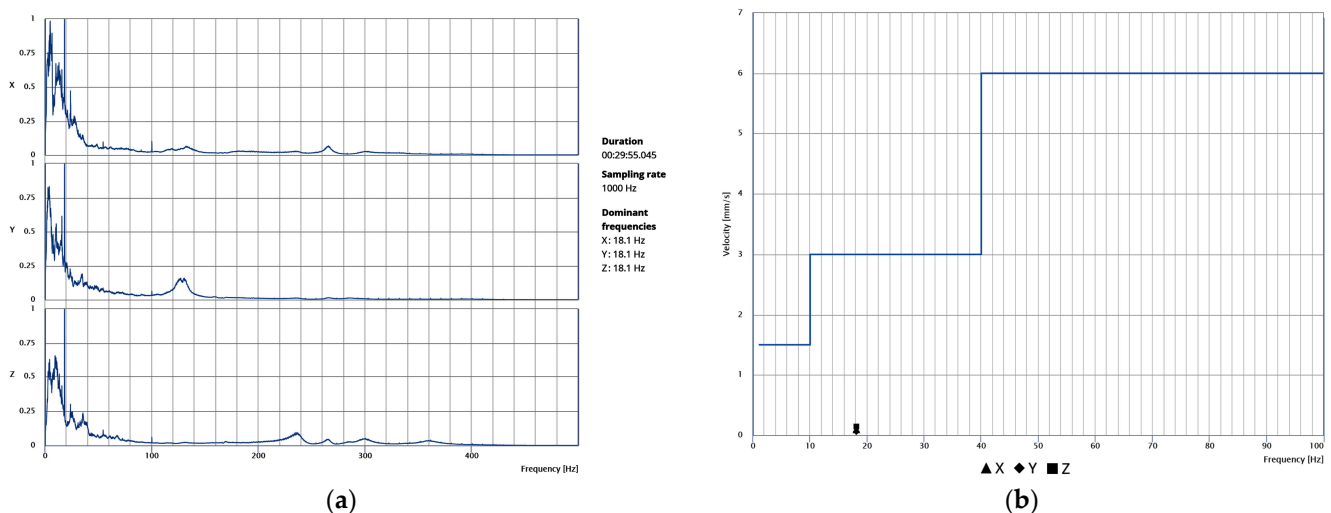
**Figure 16.** V3 acquisition during 11:00–11:30 am: (a) FFT plot; (b) maximum particle velocities and limit thresholds from NP 2074 [23].

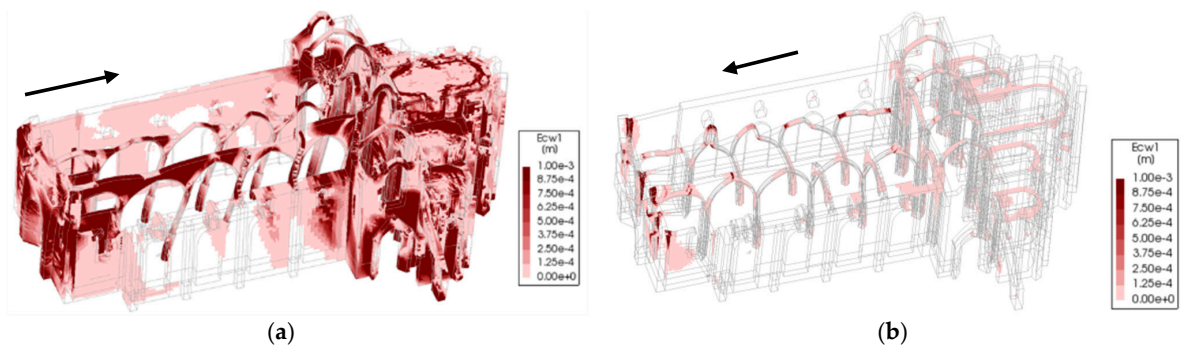
Accounting for the crack width plot in Figures 19 and 20, the north arcade is the most vulnerable portion of the structure (0.10 g). The two transverse arches in the south aisle, connecting the south arcade with the lateral nave wall, are critical for providing transverse stiffness to the south arcade and improving its seismic performance.

Figure 19. Pushover in the longitudinal direction for the FEM model (crack width resulting from pushover analysis: (a) positive longitudinal direction; (b) negative longitudinal direction (the arrows indicate the seismic action direction)).

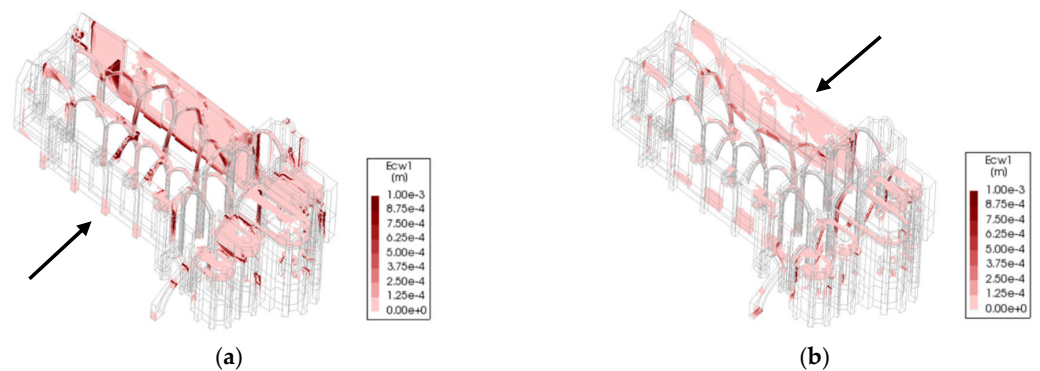
Considering all the conducted pushover analyses, the least vulnerable for the structure is in the positive longitudinal direction (0.37 g), mainly due to the in-plane stiffness provided by the arcades, longitudinal wall and chapels. The arcades can deform more in their plane before the structure fails. However, severe damage is endured in the process (Figure 19a). Instead, in the negative longitudinal direction, the capacity is equal to 0.12 g, with the north arcade failing under comparatively little displacement due to the differences in stiffness and strength between the free span of the arches and the nave room walls together with the front façade (Figure 19b) given by the transverse arches. For the pushover applied in the negative transverse direction, the structure presents a low increase in capacity (0.11 g) with respect to the positive one (Figure 20b). Hence, the transverse direction structure is considered the most vulnerable for the structure, even if by a small

Figure 20. Pushover in the transverse direction for the FEM model (crack width resulting from pushover analysis: (a) positive transverse direction; (b) negative transverse direction (the arrows indicate the seismic action direction)).

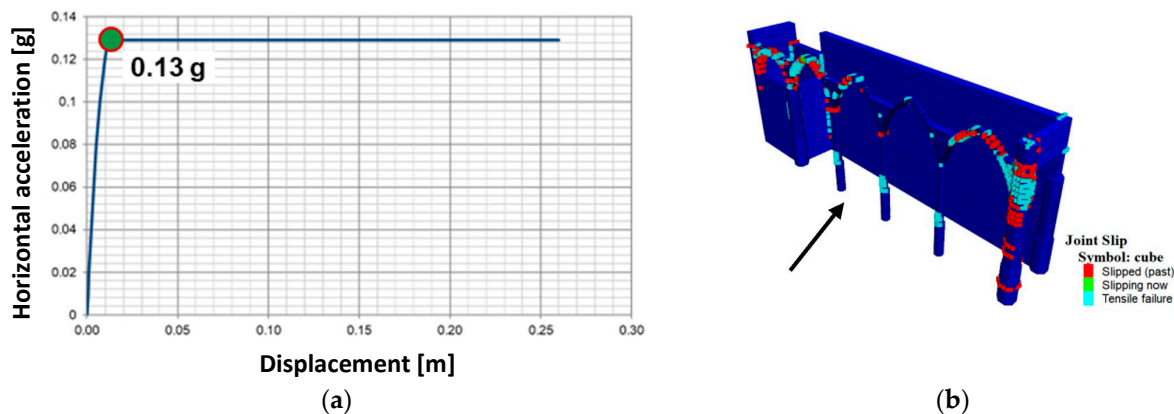
obtained from the partial DEM model, equal to 0.13 g, is similar to the one from the FEM (0.10 g) (Figure 24). The displacements at failure are nearly identical for both analyses. Even if similarities in the response are to be expected as the two models use the same material properties, when applicable, it also validates the comparison of the damage mechanisms, namely the out-of-plane collapse of the north arcade (crack width for FEM and joint slip for DEM). The two numerical approaches present similar failure mechanisms, with the most severe damage concentrated in the arches closest to the walls and transept and at the columns close to the base, locations with high differences in stiffness between adjacent elements and the least ability for structural deformation.

**Figure 24.** Pushover in the positive transverse direction for the DEM model: (a) capacity curve (see control point in Figure 18), (b) joint slip action in the structure at the maximum load (the arrow indicates the seismic action direction)..
