Flow Angularity Investigations in an Automotive Slotted Wall Wind Tunnel

Abstract: The Volvo Cars aerodynamic wind tunnel has had a vortical flow angularity pattern in the test section since its original commissioning in 1986. The vortical flow nature persisted after an upgrade in 2006, when the fan was replaced and a moving ground system was introduced. It has been hypothesized that the cause for this flow angularity pattern was leakages around the heat exchanger installed in the settling chamber. The present paper tests this hypothesis by measuring the flow angularity in the test section before and after sealing the leakages. The findings show that the leakage path around the heat exchanger does not influence the flow angularity, and that the current pattern is different compared to the commissioning after the upgrade. This prompted an investigation of the influence from the turbulence screens, which were changed after the upgrade commissioning. These investigations indicate that the probable cause of the vortical flow angularity pattern is residual swirl from the fan. Force measurements on a reference car with and without extra induced flow angularity show that the flow angles

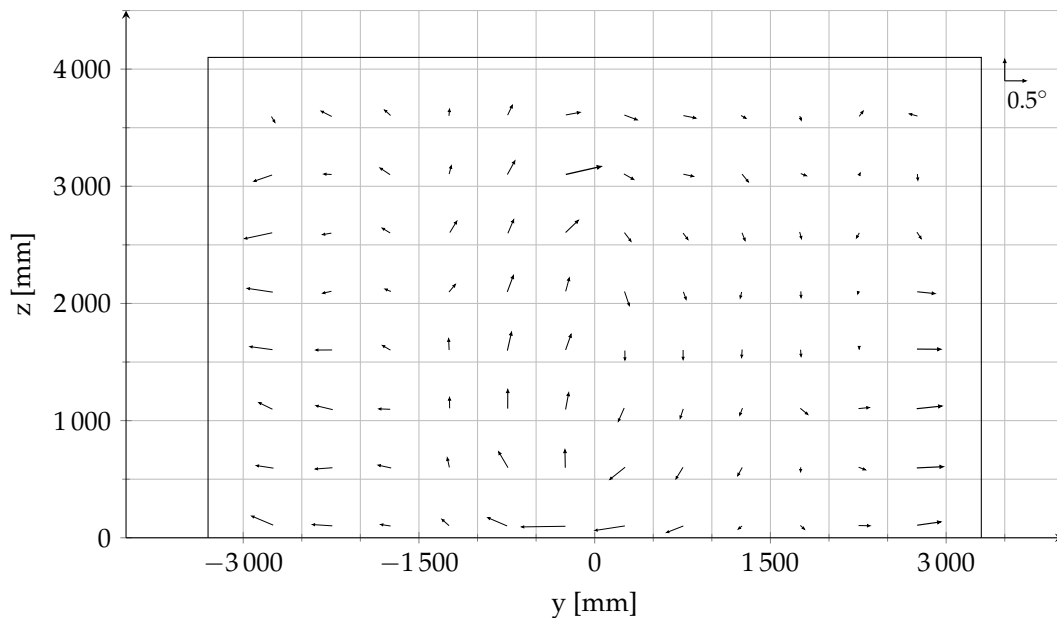
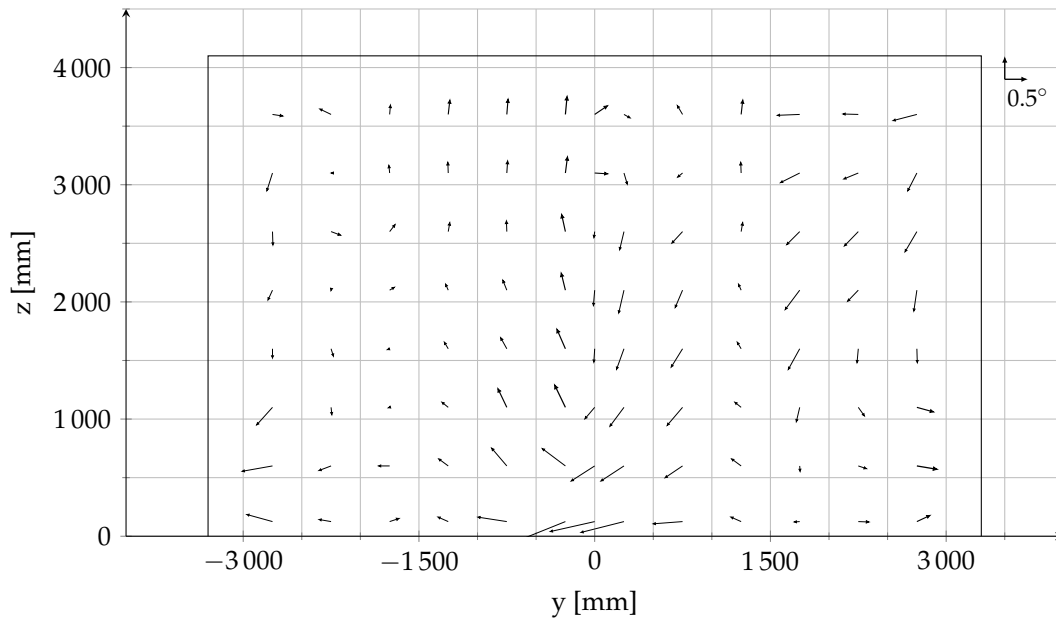
The flow angularity measured at the turntable center plane during the commissioning in 1986 can be seen in Figure 4a, and the corresponding data from 2006 is found in Figure 4b. It can be seen that the vortical structure in the center of the test section is similar, with a slightly weaker rotation and more downwash seen in the lower region for the 2006 data. The downwash is caused by the installation of the distributed suction in the boundary layer control system. The flow pattern also differs in the upper corners of the test section, with a more inward and downward flow in 2006, the cause of which was not discussed in the upgrade commissioning. Furthermore, the measurements performed in the two commissioning campaigns are not corrected for strut interference, and the same commissioning strut was used for both measurement campaigns.

The direction of the vortical structure seen in the test section corresponds to the rotational direction of the fan, and it is thus plausible that the flow pattern is caused by residual swirl from the

(a) Original commissioning in 1986, measured at 180 km/h.

(b) Upgrade commissioning in 2006, measured at 140 km/h.

Figure 4. Flow angularity at the turntable center plane as measured during the two commissioning campaigns. Data from the respective commissioning reports [21,22]. Arrows in upper right corner show the magnitude of 0.5° flow angularity in pitch and yaw.

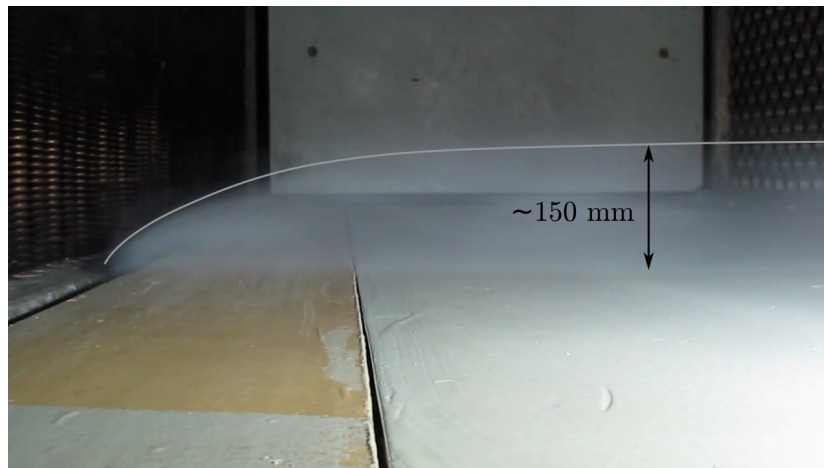
The installation of the heat exchanger, schematically shown in Figure 3, resulted in a possible flow path around the heat exchanger core. The width of the slot through which the air leaked was not uniform along the height of the heat exchanger, ranging from about 10 mm to 40 mm, which has been hypothesized to have caused the swirling motion seen in both 1986 and 2006. The local effect of this leakage on the near wall flow between the heat exchanger and the honeycomb can be seen in Figure 6, where smoke is used to visualize the air reentering into the airline from the service vestibule. In order to quantify the effect from this leakage on the flow in the test section, the leakage was sealed using tubular pipe insulation and tape, and the flow angularity was then measured.

Figure 6. Leakage flow downstream of the heat exchanger reentering the airline.

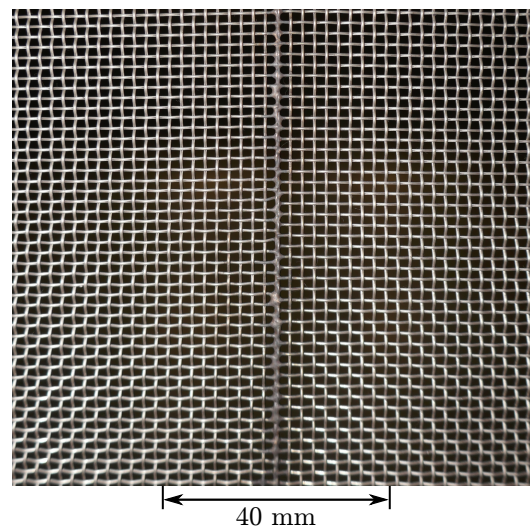
As described, each turbulence screen consisted of two sheets welded together vertically at the centerline. This was done thread-by-thread as shown in Figure 7 in order to minimize the blockage. Despite this precaution, it has been hypothesized that these welds might have had an impact on the test section flow, especially since they lined up for the three screens. This was tested by exaggerating the width of the weld by adding a strip of 40 mm-wide tape to the upstream side of the downstream screen, as shown in Figure 8, and then measuring the flow angularity.

Figure 7. Close-up view of the joint between the two halves of a turbulence screen.

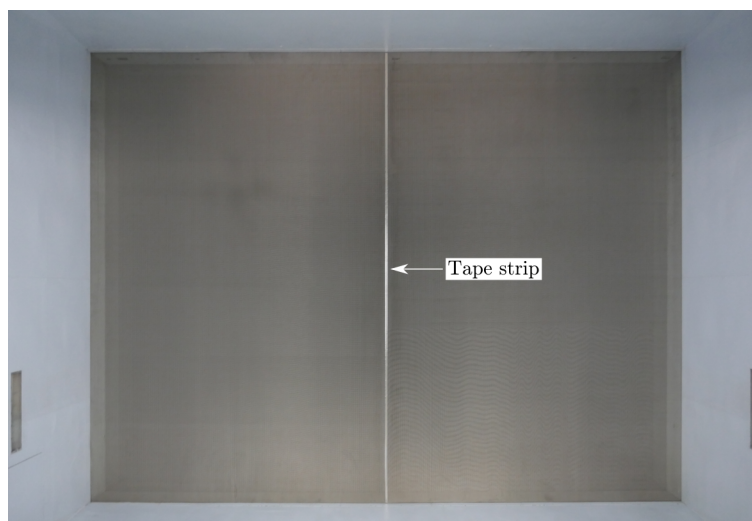
Figure 8. Tape strip added to the upstream side of the most downstream turbulence screen.

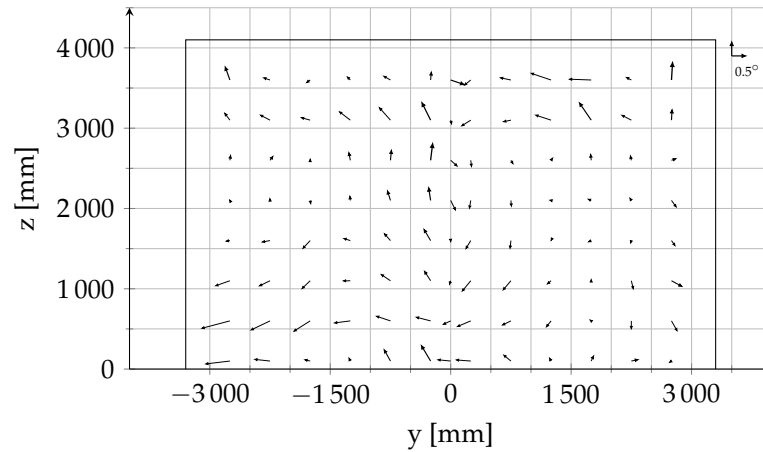
The flow angularity for standard operating conditions is shown in Figure 10a. Since the airpath has not been altered in any major way after the moving ground upgrade, Figures 4b and 10a should be very similar. However, a significant difference can be seen in the upper half of the right side of the test section, where the inward and downward flow seen in 2006 is not visible in the present data. A similar flow pattern is visible in all of the measurement planes for the 2006 data [22]; for the most upstream planes the whole right hand side has a strong in- and downwash. The clear difference between the two lateral halves for the most upstream plane does not appear to be physical, and it is believed that this was caused by issues with the references used for the optical measurements of the probe mounting angles. These measurements were performed using a total station, which was likely mounted on different sides of the test section depending on the lateral position of the vertical strut. Hence, it is plausible that different reference points were used for the two lateral halves, thus causing the observed offset of the angles if one set of reference points were misplaced.

Comparing to the 1986 data in Figure 4, it can be seen that the present flow pattern in Figure 10a is not as symmetric between the lateral halves as the old data. The recent measurements indicate a flow that was more directed to the left in the lower part of both the left and the right side. Furthermore, much of the outwash seen in the upper part of the left hand side in the 1986 data was absent already in 2006 and is still so here. It is thereby likely that this change occurred during the upgrade, which means

that either the fan or the boundary layer control system was the cause. It is not plausible that any of the sub-systems in the boundary layer control system and moving ground, which are all located at the floor, had such an impact in this part of the measurement region, which indicates that at least some of the flow angularity was caused by the fan.

(a) Baseline, standard operating conditions.

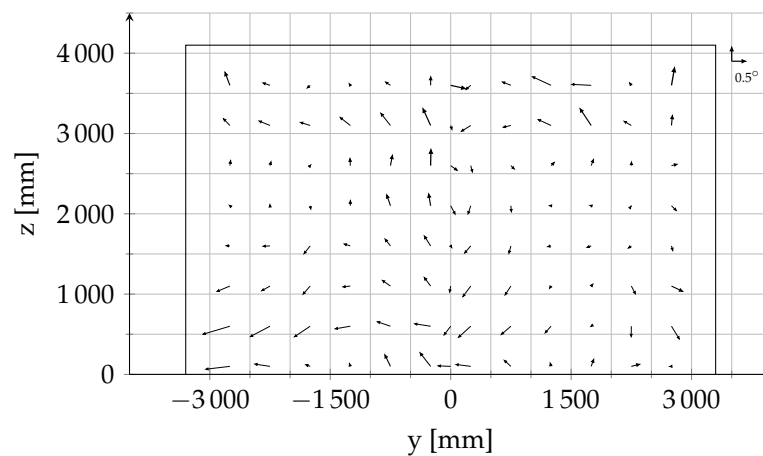
(b) After sealing leakages around the heat exchanger.

The influence on flow angularity from the performed modifications to the flow conditioning devices in the settling chamber can be seen in Figure 10. Comparing Figure 10a and Figure 10b, it can be seen that sealing the heat exchanger leakage does not impact the flow angularity in the test section. It is likely that the disturbance from the leakage flow is small enough to be dampened out by the three turbulence screens mounted downstream of the heat exchanger, and thus not result in any measurable impact on the test section flow field.

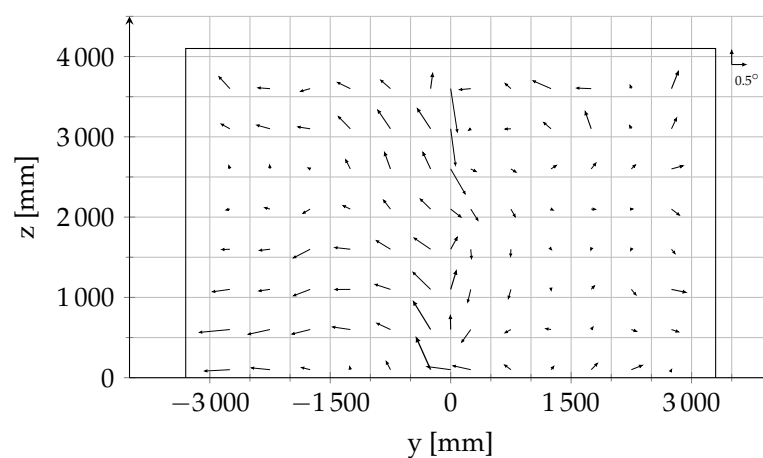
(c) With tape on turbulence screen seam.

Turning to Figure 10c, it can be seen that adding the tape to the turbulence screen had a clear influence on the flow angularity at and around $y = 0$, but did not change the overall behavior of the flow pattern in a major way. Since the tape was significantly wider than the screen weld, the flow influence from the weld itself was much smaller than that caused by the tape. Thus, given that the overall influence from the tape was relatively small, it is concluded that the weld might have a minor influence on the flow angles at the lateral center, but that it is not a significant contributor to the swirling flow pattern in the test section. This is expected, since the weld is very small compared to the total size of the settling chamber.

Since both the heat exchanger leakage flow and the screen welds have been ruled out as the cause of the rotating flow angularity pattern in the test section, the reason has to be found elsewhere. The fact that the rotation of the observed pattern corresponded to the rotational direction of the fan, and that the flow pattern changed slightly when the fan was changed during the moving ground upgrade, indicates that the rotation stemmed from residual swirl from the fan. This corresponds well to the statement by Barlow et al. [17], saying that vortex-like flow patterns could be caused by non-uniform flow upstream of the third corner. In order to confirm this, measurements would have to be performed throughout the airpath of the tunnel.

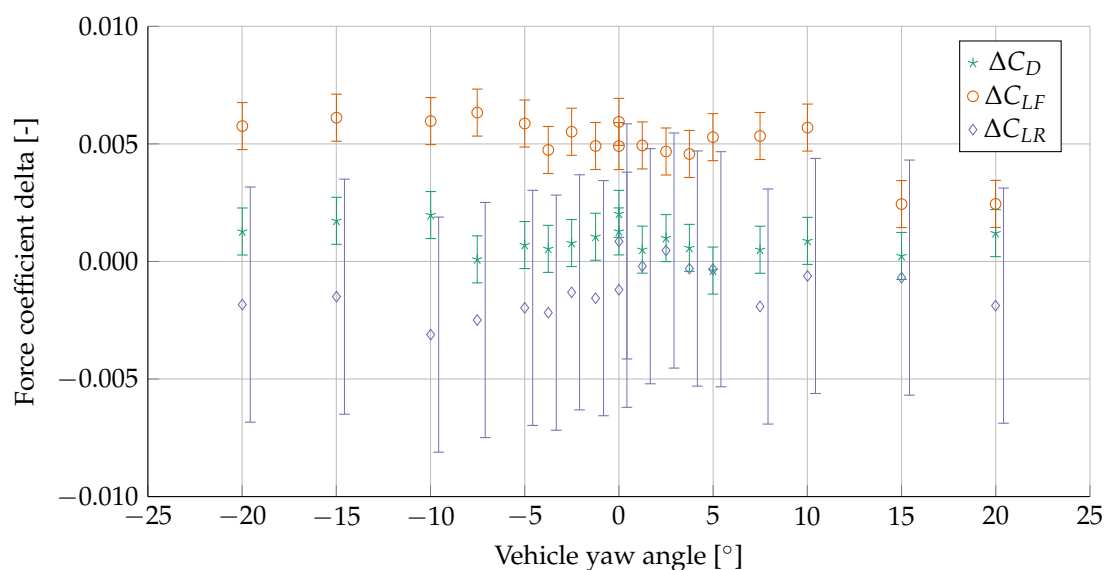
Figure 11. Force coefficient deltas between the case with tape on the downstream turbulence screen and standard operating conditions for the reference vehicle over a yaw sweep.

From the figure, it can be seen that ΔC_D is within the in-test repeatability for most yaw angles, with a notable exception being the largest negative angles. However, the maximum delta is still within the between test repeatability. Considering the rear axle lift, the measured difference is within the in-test repeatability for all yaw angles. This is not the case for the front axle lift, which was consistently increased by $\Delta C_{LF} \approx 0.005$ over the full yaw angle range, with the exception of the two largest positive angles. This increase is expected, given that the tape induces an upwards flow in the lower central region of Figure 10c. However, both ΔC_D and ΔC_{LF} are within the between test repeatability of the wind tunnel throughout the full yaw angle range, and thus not considered substantial. Furthermore, the difference in flow angularity introduced by the tape was of a similar magnitude as the flow angularity under standard operating conditions. Thus, it is likely that the present flow angularity did not have a significant influence on the forces measured on a vehicle, compared to an ideal flow without angularity.
