Practical Experience of Operational Diagnostics and Defectoscopy on Photovoltaic Installations in the Czech Republic

Petr Mastny *, Jan Moravek and Jiri Drapela

Department of Electrical Power Engineering, Brno University of Technology, Technicka 12, Brno 61600, Czech Republic; E-Mails: jan.moravek@phd.feec.vutbr.cz (J.M.); drapela@feec.vutbr.cz (J.D.)

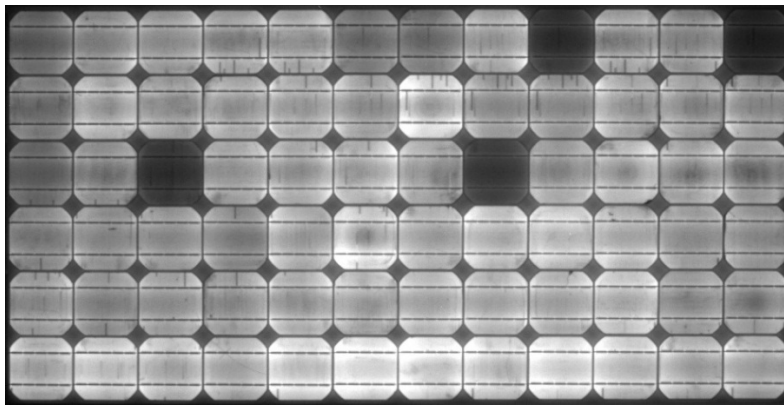
Figure 3. PV panel with visible defects of internal structure [12].

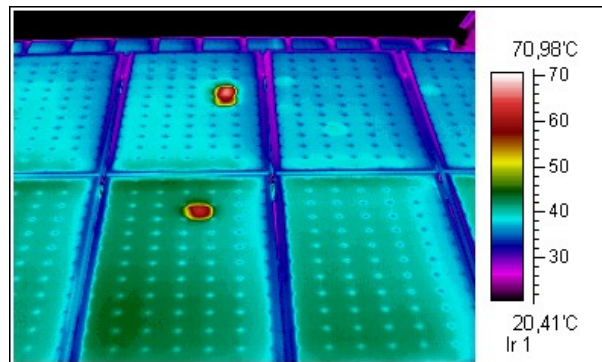
As an example of the utilization of IRT we present the results of measurements on a PV roof installation. The result of the performed operational IRT measurement is the detection of defective parts of each PV panel within the PV power plant. Out of the total amount of 83 pieces of PV panels, 13 defective panels were detected. In Figures 4 and 5 there are visibly marked defect areas on selected

Figure 4. Defects of PV panels identified by infrared thermography (IRT) analysis [13].

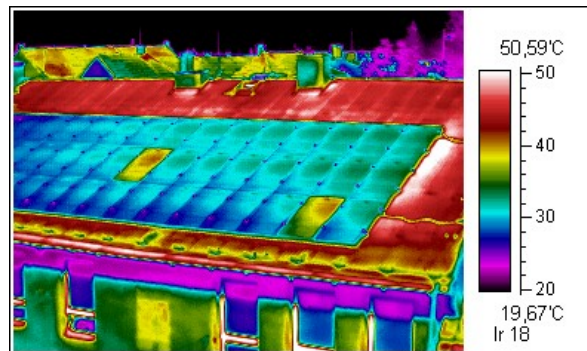
PV panels. In Figure 5 two panels are presented, which proved to be totally faulty and thus influenced the decrease of PV power plant performance the most.

Figure 5. Defective panels identified by IRT analysis [13].

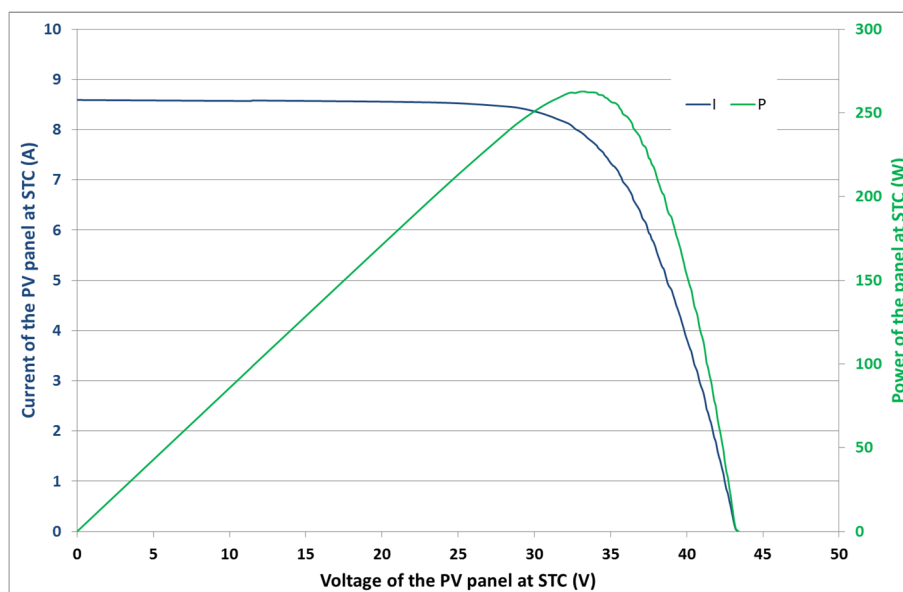
An example of the I - V curve measured is shown in Figure 8. There is no mismatch on the curve caused by the defects or shadowing of the panel.

Figure 8. I - V curve of the tested PV panel [24].

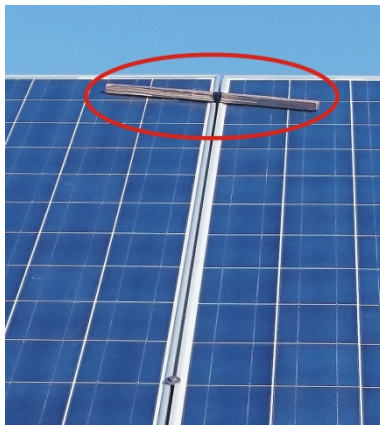
The inspection also confirmed that there are additional defects, maintenance and design errors on the panels. An example of defects and improper mounting can be seen in Figures 9 and 10. The error of design is in the parallel interconnection of three strings on each inverter. During the inspection, parallel connections of strings with different numbers of panels in series were detected [24].

Figure 9. Improper panel mounting [24].

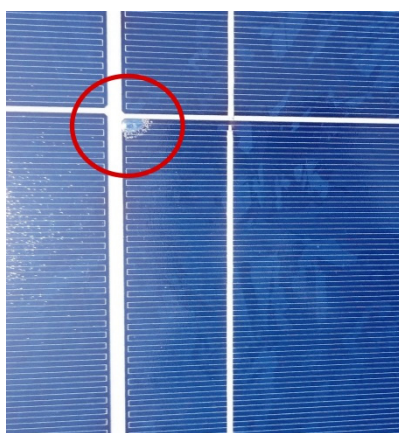
Figure 10. Delamination in the structure of the panel [24].

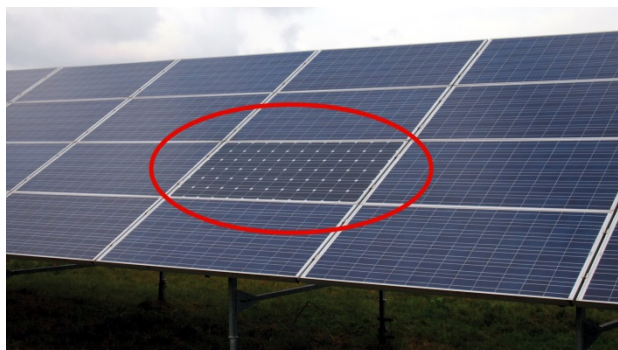
The main detected problems include the wrong interconnection of PV panels, where multi-crystalline and mono-crystalline types of PV panels in one string with significantly different parameters are combined (Figure 11) [25].

Figure 11. Monocrystalline PV panel used in string with Multi-crystalline PV panels of different parameters [25].

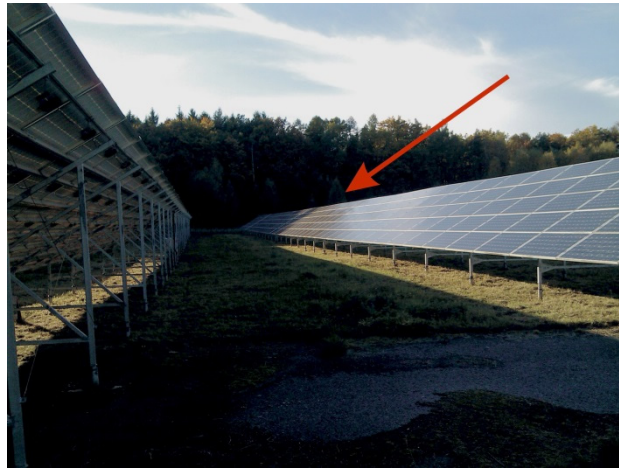
The overshadowing of entire sections of the PV plant by nearby trees is the result of poor design and has a serious impact on the OP (Figure 12).

Figure 12. Trees overshadowing the section of the PV plant [25].

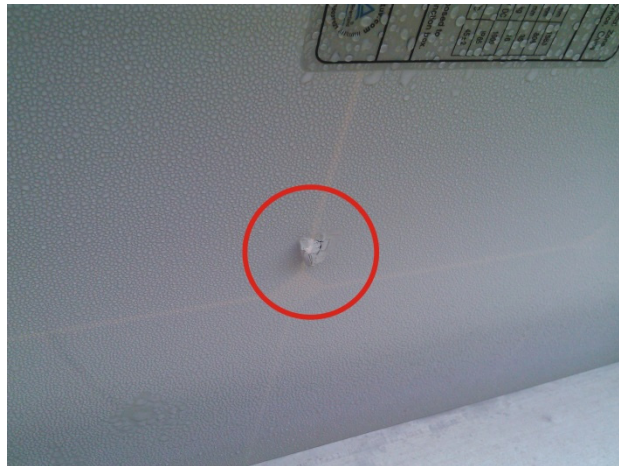
Mechanical damage to PV panels caused by the stones chucked while mowing grass has also been detected (Figure 13) [25].

Figure 13. Mechanical damage to PV panel caused by chucked stone [25].

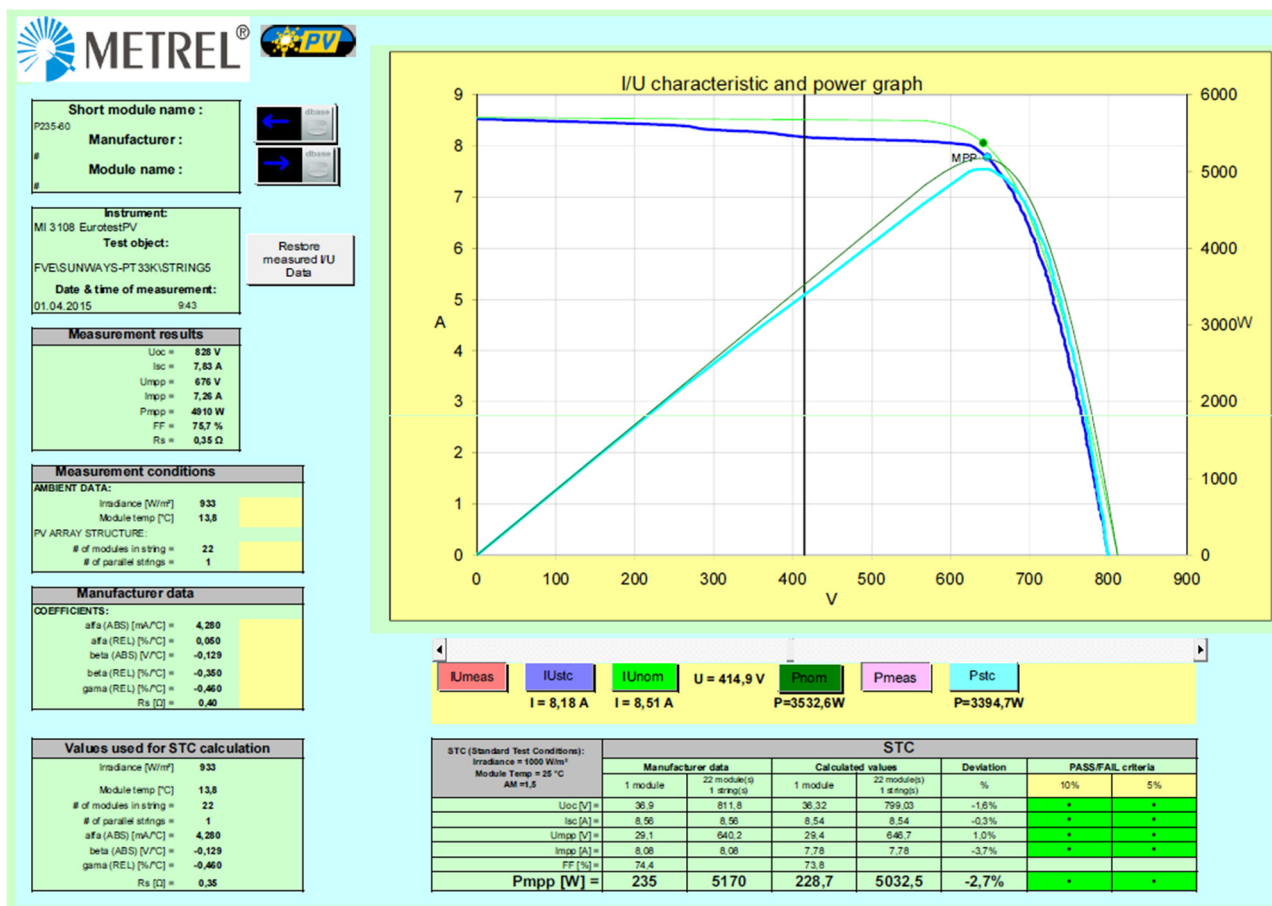
This PV plant is situated on the roof of an industrial object. The PV plant indicated no problems, only slightly dusted panels (visible as a current decrease on the $I-V$ curve). Proper functioning was verified by the measurement of $I-V$ curves (Figure 14). The selected string indicates a power decrease of 2.7% compared to its nominal values after four years of operation [26].

Figure 14. I-V curve measurement of the entire string with no problem detected [26].

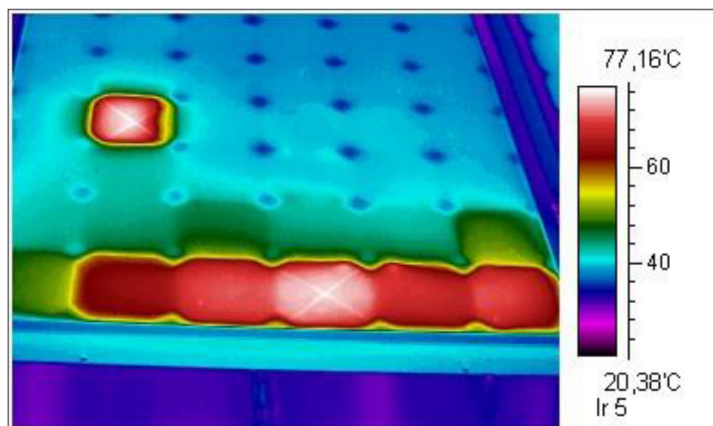
The selected PV plant indicated low OP, therefore measurement by IR camera was performed. As a result, panels containing defective cells (Figure 16) and overheated DC wires (Figure 17) were detected [28].

Figure 16. PV panels with hot spots [28].

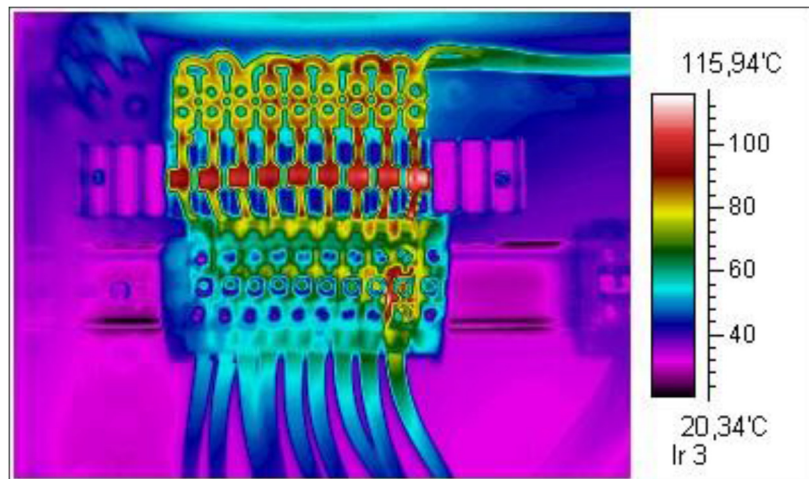
Figure 17. Overheated wires in DC string box [28].
