Failure Analysis of a Humeral Shaft Locking Compression Plate—Surface Investigation and Simulation by Finite Element Method

Abstract: A case study of a failed humeral shaft locking compression plate is presented, starting with a clinical case where failure occurred and an implant replacement was required. This study uses finite element method (FEM) in order to determine the failure modes for the clinical case. Four loading scenarios that simulate daily life activities were considered for determining the stress distribution in a humeral shaft locking compression plate (LCP). Referring to the simulation results, the failure analysis was performed on the explant. Using fracture surface investigation methods, stereomicroscopy and scanning electron microscopy (SEM), a mixed mode failure was determined. An initial fatigue failure occurred followed by a sudden failure of the plate implant as a consequence of patient's fall. The fracture morphology was mostly masked by galling; the fractured components were in a sliding contact. Using information from simulations, the loading was inferred and correlated with fracture site and surface features.

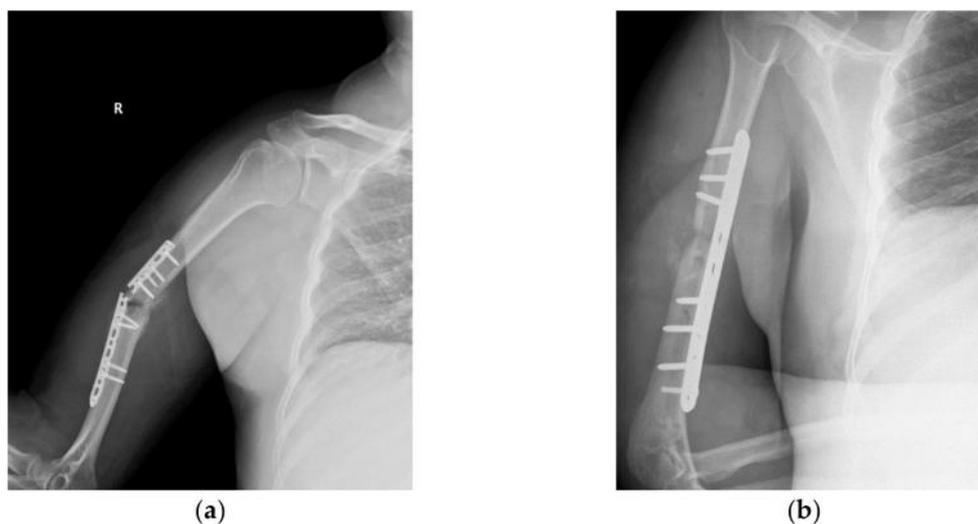
Figure 2. Clinical details: (a) X-ray: implant failure with subsequent plate breakage; (b) X-ray post-operative control after revision.

A second surgery was performed. The initial LCP implant was replaced with a new implant, a dynamic compression plate (DCP), seven fixation screws, and an iliac bone graft addition. The surgical result can be observed in Figure 2b. The DCP is used as an internal fixator of the fractured tibia and/or femur bones (the biomechanics of the humeral shaft is similar to the majority of long bones). This is an accepted technique for the healing of broken bones. These implants in modern orthopedics have proven their efficiency in restoring the anatomical union of broken bones. However, there are some factors that may lead to implant failure, followed by repetitive surgeries: selection of the wrong implant type, excessive loadings during the osteointegration period, deviation from

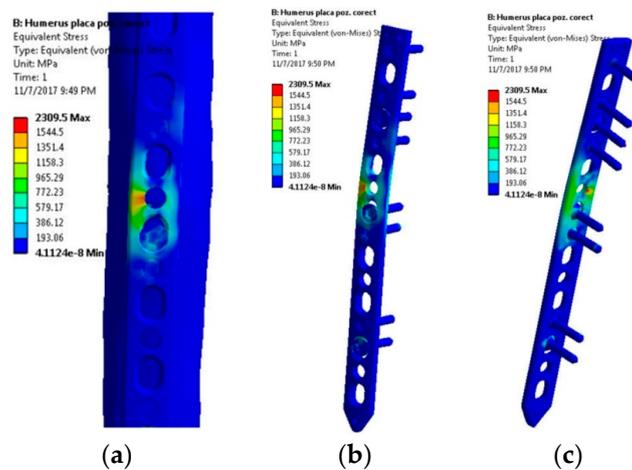
The first scenario implies a flexion tendency of the humerus by activation of the anterior deltoid muscle, while at palm level the following weights are acting discretely: 1, 3, 5, 8, and 10 kg. The stress distribution presented in Figure 5 reveals high stresses at the hole positioned in the immediate vicinity of the bone fracture. Regardless of the weight values input, the insertion and direction of loading, together with the complexity of the assembly [41,42], cause a non-uniform and asymmetric stress

distribution to appear in the plate. The plate is subjected to bending. Depending on loading values, von Mises stresses vary in magnitude according to the plot shown in Figure 6.

Figure 5. Stress distribution within the LCP when a 10 kg mass is lifted—flexion movement tendency: (a) Lateral view, bone-plate; (b) Lateral-front view, plate-screws; (c) Lateral-back view, plate-screws.

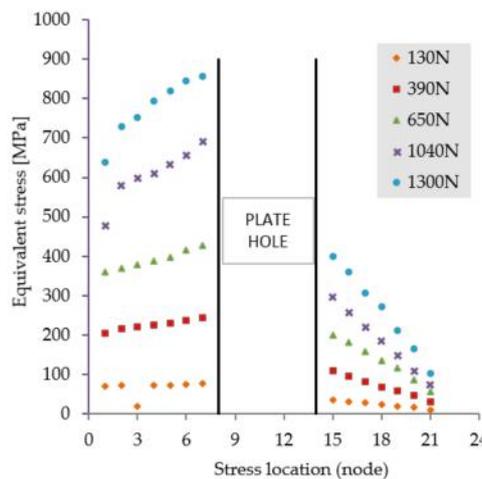
Figure 6. Stress distribution in the critical region. Scenario I.

Following the loading scenarios, it can be stated that the LCP would fail if the humerus was flexed while holding weights above 50 N. The failure mode would be bending—push/pull actions which generate reaction forces above 100 N in the elbow joint would cause implant failure, similar to the first scenario. A bending failure aspect would be expected in the retrieved implant—when the humerus is purely abducted there is a very small chance of failure, since the fracture site tends to close. The stresses here are mainly becoming tensile stresses. In torsion, no sudden failure would occur given the torque values used for simulation. Regardless of loading type, the same region is under heavier stress every time—the hole near to the bone fracture site.

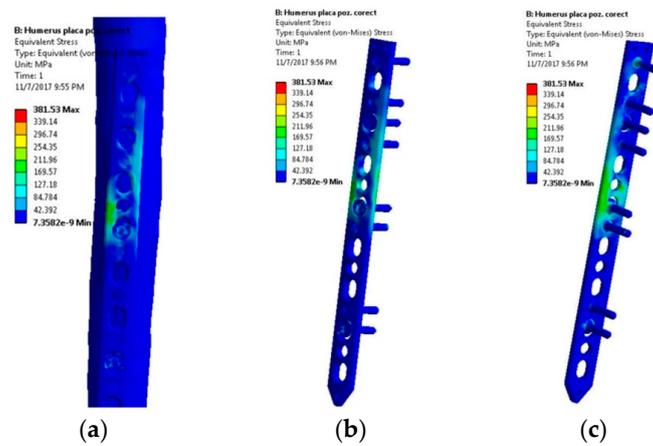
The stress distribution in the LCP shown in Figure 7 suggests a dominant tensile stress manifesting an even distribution. Regardless of the external weight, in this loading scenario the plate will not fail, as the equivalent stress values indicate in Figure 8.

Figure 7. Stress distribution within the LCP when a 10 kg mass is lifted—abduction movement tendency: (a) Lateral view, bone-plate; (b) Lateral-front view, plate-screws; (c) Lateral-back view, plate-screws.

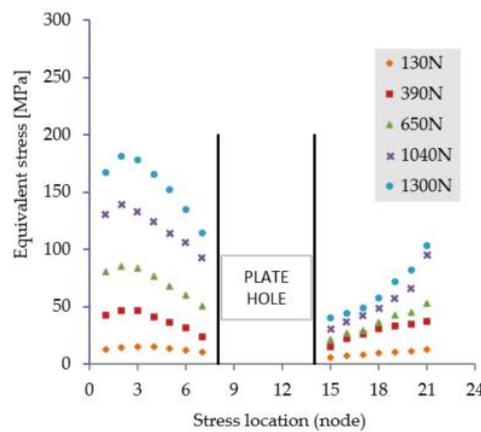
Figure 8. Stress distribution in the critical region. Scenario II.

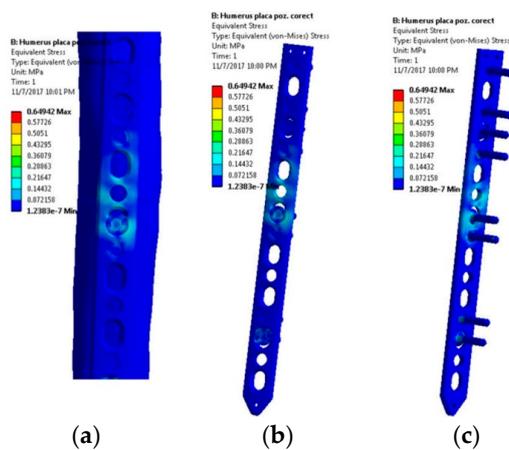
Another frequent movement of the upper limb is the rotation of the arm, accomplished by the rotator cuff and deltoid muscles. The load was input as a torque vector around the Z axis, with a constant value and application point on the distal epiphysis. The torsion effect induces uniform stresses distribution in plate, that are presented in Figure 9. When loading 5 Nm of torque on the humerus, plate failure is unlikely, as the equivalent stress show in Figure 10.

Figure 9. Stress distribution within the LCP when a 5 Nm torque is applied—rotation movement tendency: (a) Lateral view, bone-plate; (b) Lateral-front view, plate-screws; (c) Lateral-back view, plate-screws.

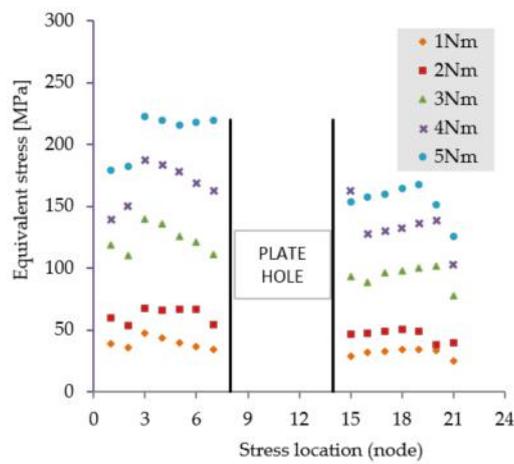
Figure 10. Stress distribution in the critical region. Scenario III.

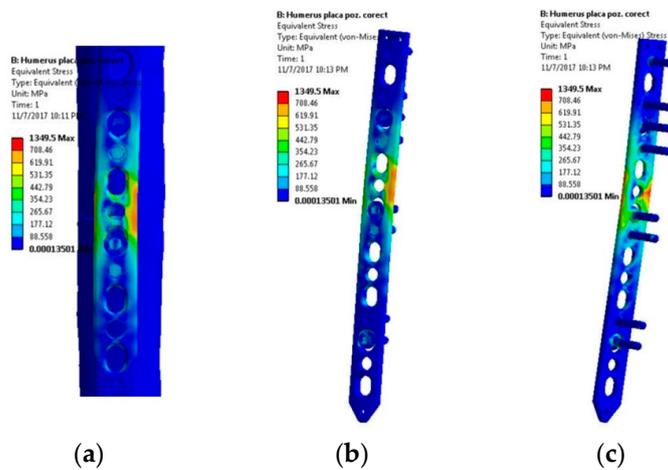
The posterior positioning of the plate with respect to the humerus and the direction of the reaction force lead to high stresses on the top surface of the plate and lower values on the opposite face (Figure 11). In Figure 12, stresses in the critical region are presented in relation to the loading values.

Figure 11. Stress distribution within the LCP when a 200 N transversal joint force acts: (a) Lateral view, bone-plate; (b) Lateral-front view, plate-screws; (c) Lateral-back view, plate-screws.

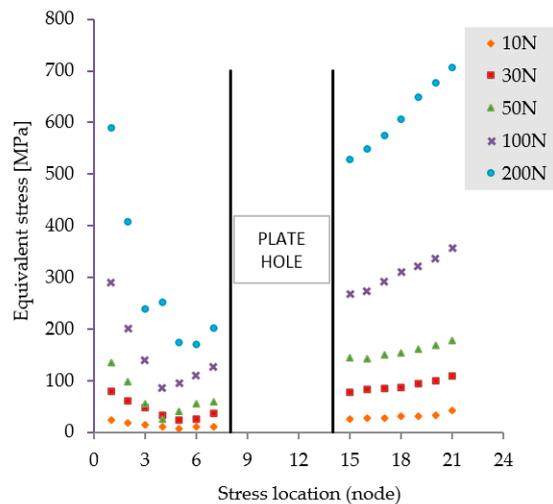
Figure 12. Stress distribution in the critical region. Scenario IV.

According to the simulations, a load larger than 100–120 N will generate stresses that exceed the yield strength of CP titanium (377 MPa depending on processing) [29], which will subsequently lead to implant failure.

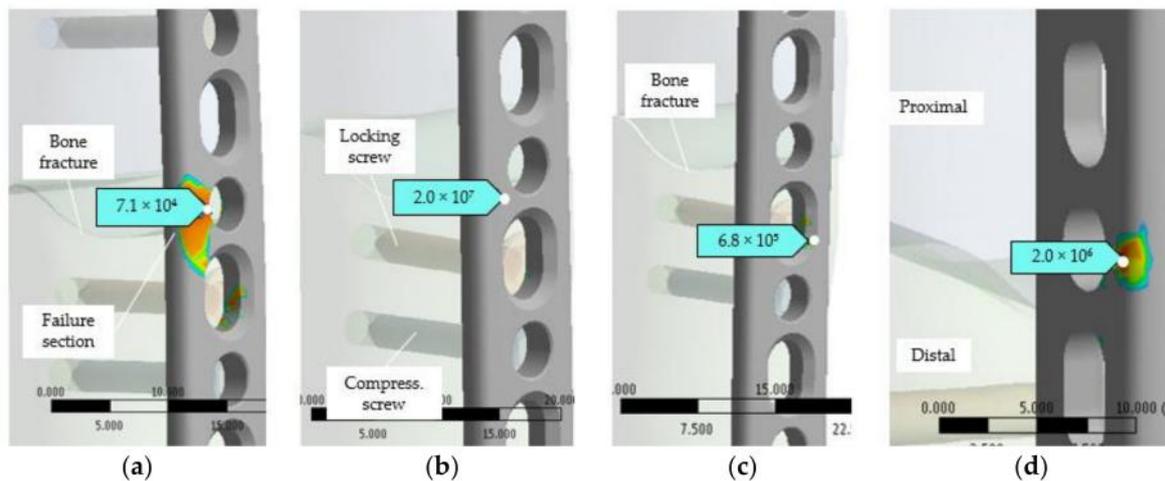
Based on the same simulation model and loading scenarios, a fatigue analysis was conducted. The FEA fatigue simulation results are presented in Figure 13, where a representative picture of the LCP life for each loading scenario can be observed. The plate life for all loading values in each scenario is presented in Table 4.

Figure 13. Fatigue life in critical section of the plate: (a) Scenario I, 1040 N loading; (b) Scenario II, 1300 N loading; (c) Scenario III, 5 Nm loading; (d) Scenario IV, 100 N loading.

The minimum cycles to failure occurred naturally in the section of high stresses, which are currently in the vicinity of the plate hole that is located near to the bone fracture site. The equivalent elastic stress obtained by static simulation and the critical areas indicated by fatigue analysis are validated by the visual and fractographic examinations (Figures 14 and 15). The failure occurs in the same spot as the simulation predicts.

As the simulation predicts, excepting scenario II where the fatigue limit was not exceeded for any loading values that we used, the rest of the scenarios may cause the fatigue failure of the palate, if a certain number of cycles and loading values are exerted (Table 4).

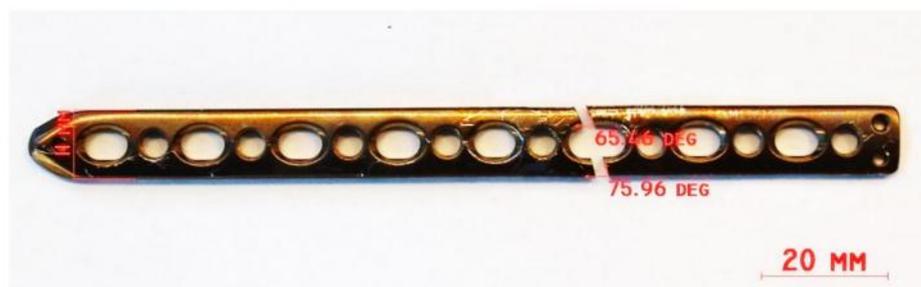
The first observations show heavy scratch marks around the fracture zone, which occurred during implant retrieval and were produced by the surgical devices used for surgical retrieval. No corrosion features were observed by investigation with the naked eye.

Another interesting feature was the apparent straight-line failure at the 6th hole counted from the proximal end of humerus. The fracture line forms a 76° angle on the right and a 65° angle on the left side in relation to the longitudinal axis of the LCP. Three possibilities of failure may occur. The first failure mode consists of a bending failure of the right side of the plate, followed by an overloading failure on the left side. This implies that the first failure occurs on a section that has the highest moment of inertia (strong axis of the plate). The second failure mode may occur by bending along the weak axis of the plate. In this case the two sides will break at the same time. The third failure mode can be brittle torsional failure, produced by a torque applied on the longitudinal axis of the plate. This case also produces a one-step failure. By looking at the results of the numerical simulation and connecting those with the observational one we can affirm that sudden failure of the plate may be possible in bending on the strong axis of the plate. This kind of loading can be achieved in scenarios I and IV while the loading exceeds 100 N. A sudden torsion failure is not likely to happen for daily routine loads up to 5 N·m. Fatigue fracture, on the other hand, may occur in all loading scenarios through crack propagation modes (opening, in-plane shear, or out-of-plane shear) [43], as we will describe in the following section.

Figure 14. The retrieved LCP implant.

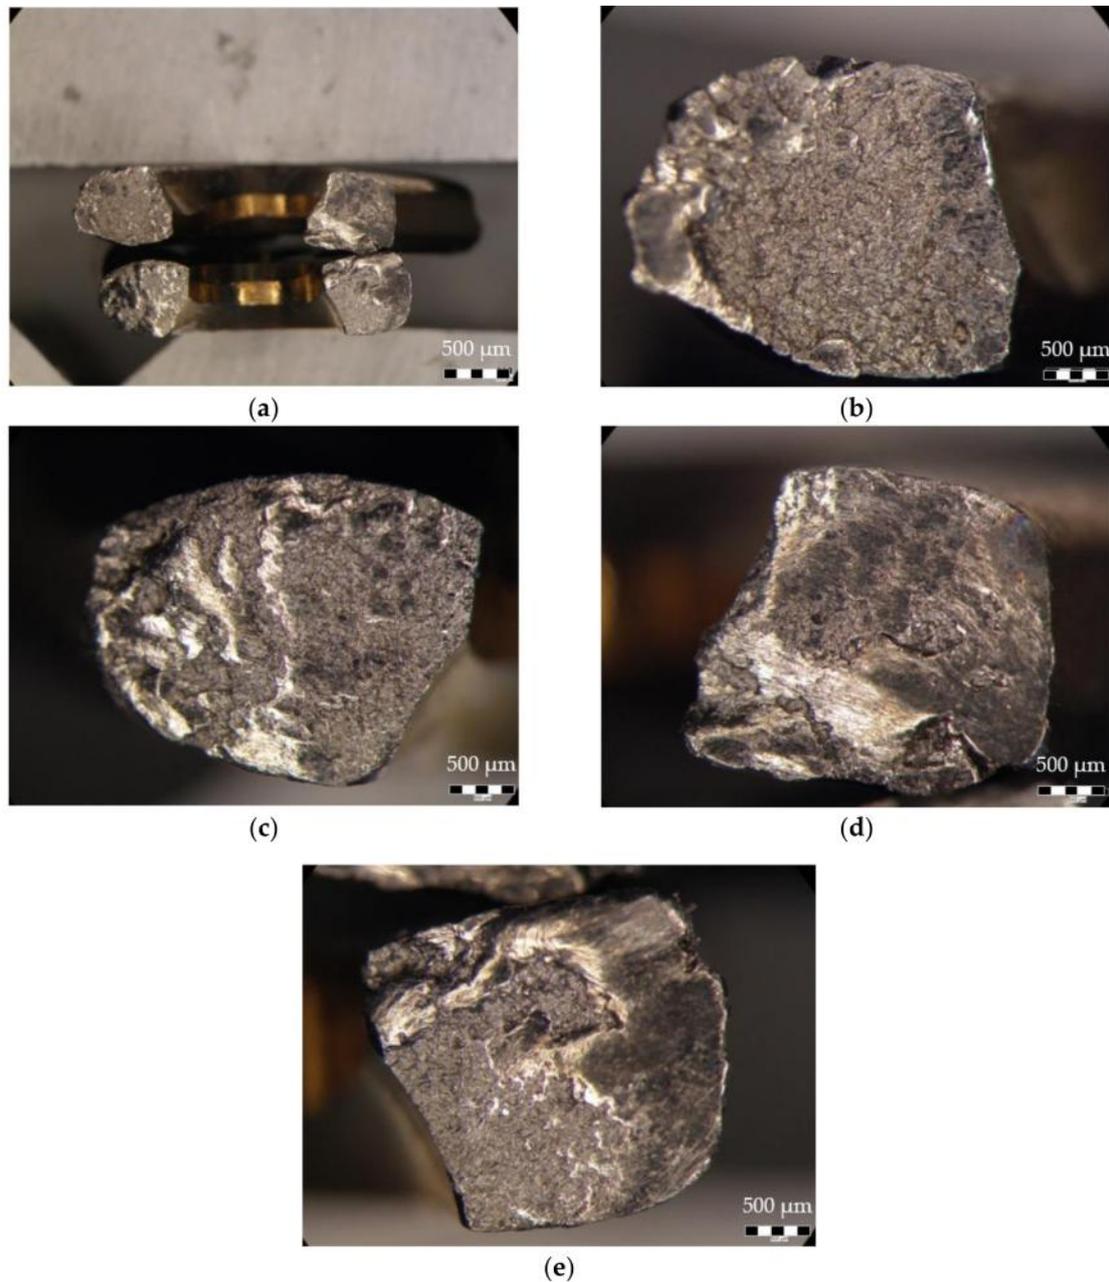
On the fracture surfaces shown in Figure 15a, obvious signs of galling with friction welded material can be seen, mostly near to the margins. The surfaces were in sliding contact under compressive forces for a prolonged time, with the true fracture features being obscured by fretting.

Figure 15. Fracture surface observed by stereomicroscopy: (a) overall fractographic image; (b) proximal side-posterior wall; (c) distal side-posterior wall; (d) proximal side-anterior wall; (e) distal side-anterior wall.

The fracture surface in Figure 15b shows galling in the proximal side-posterior wall region followed by a wide area with a crystalline aspect revealing a sudden failure. It was inferred that the crack grew in the posterior-anterior direction of the plate.

In Figure 15c, the opposite surface to the one shown in Figure 15b, galling also appears on the exterior region of the plate, suggesting a crack path from distal side-posterior wall towards distal side-anterior wall. The presence of several large voids is a sign of a ductile fracture, caused probably by sudden loading.

The fracture surface shown in Figure 15d reveals a significant amount of galling. The morphology, although most features obscured, still resembles the one for a fatigue failure. The crack origin location can be inferred in the top right corner where there is a feature similar to a “blue spot” [44], a fracture aspect which was observed in stress corrosion cracking in a NaCl environment. Given this aspect, an NE–SV crack growth direction was considered. Sudden failure occurred when the section was severely reduced, and the surface showed a crystalline aspect.

On the fracture surface shown in Figure 15e, galling can be observed and a significant proportion of the fracture area reveals a crystalline aspect, suggesting a brittle fracture.

The fracture morphology on the four investigated surfaces describes the following mode of failure: the plate failed first by fatigue, the right-side revealed traces of fatigue striations and a small crystalline area. The galling covered a large portion of the surface, showing that after first failure the left side of the plate bore the majority of the load.

Based upon the morphology of the fracture the loading scenarios of the plate can be inferred. The right side failed by torsion fatigue, while the left side failed by bending fatigue with the final fracture caused by sudden overloading.

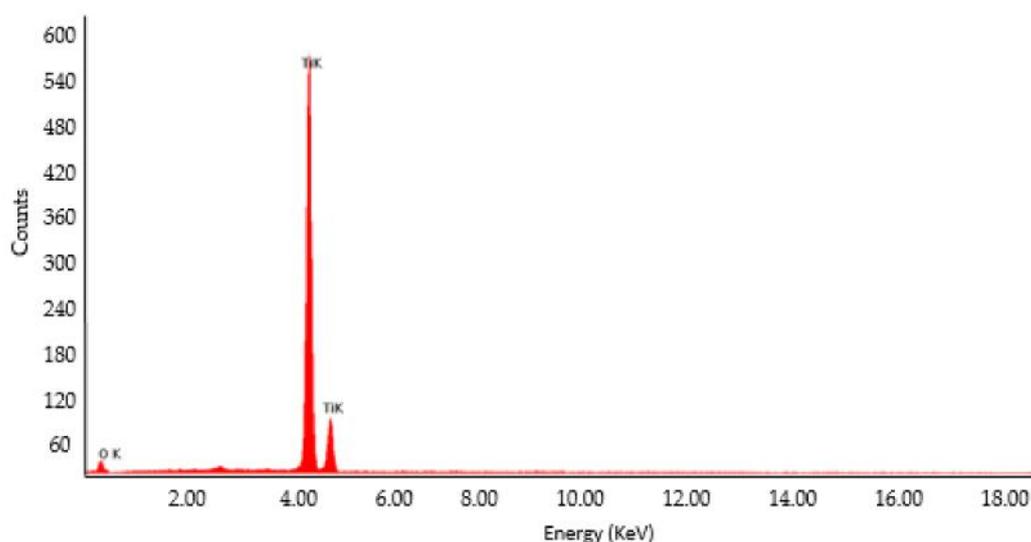
The fracture surface was observed using an SEM, and a chemical composition of the bone plate was studied using Energy-dispersive X-ray spectroscopy (EDS). The spectra shown in Figure 16 confirmed the presence of commercially pure titanium and oxygen, dissolved in the interstices in the LCP.

Figure 16. EDS spectra showing Ti and O specific peaks.

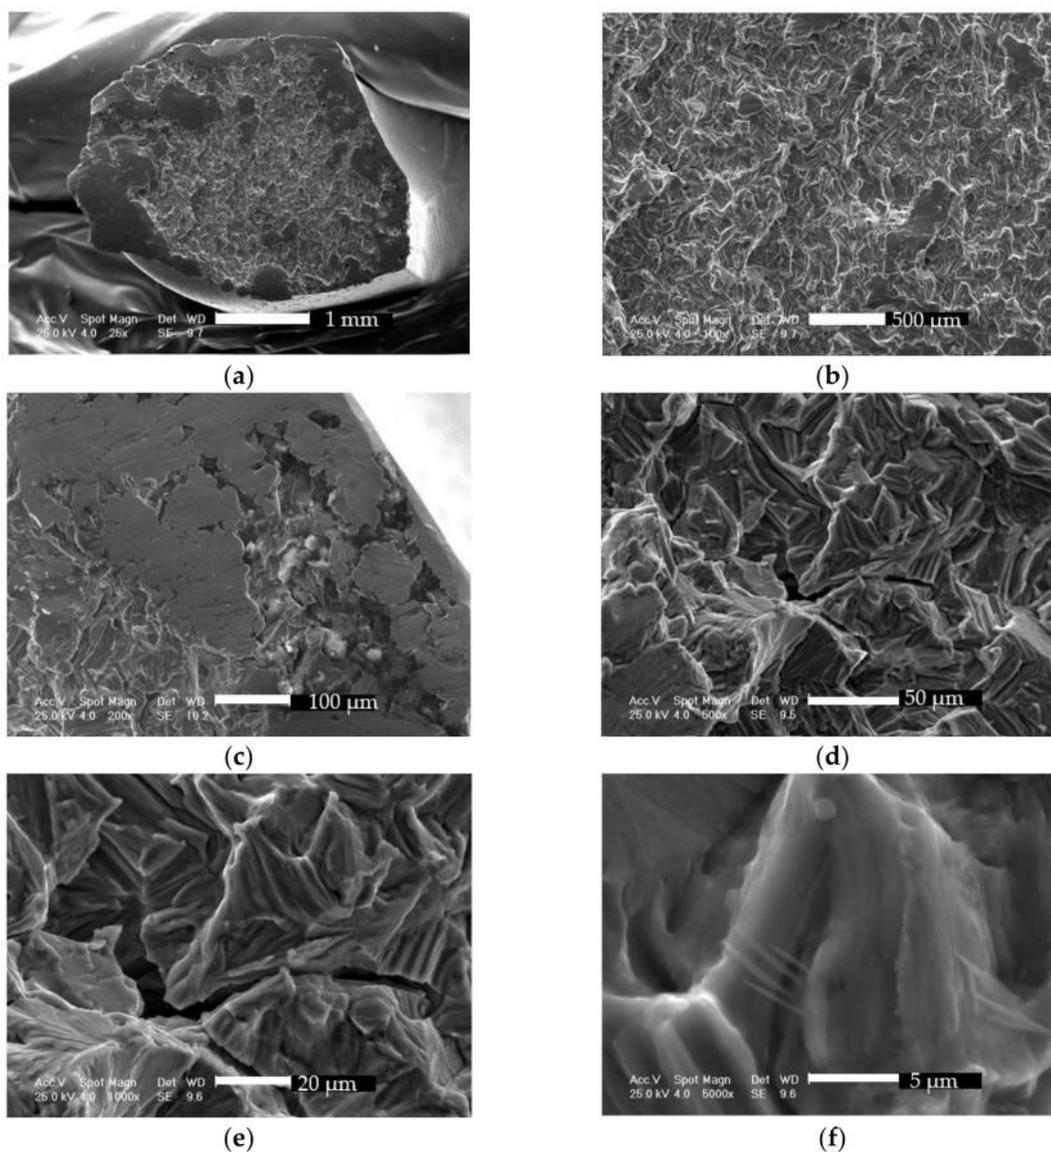
The fracture surface shown in Figure 17a was thoroughly investigated in various sites at different magnifications in order to clearly determine failure and fracture mode. First observations were the lips, which appeared as a consequence of torsion failure. The galling features were magnified in Figure 17c where sliding marks can be seen, with an orientation which confirms a load in torsion. The crack origin was thought to be located at the exterior corner of the plate at the sixth hole. Surface reduction and torsion loading caused a sliding contact, which in turn caused galling.

Figure 17. Scanning electron micrographs showing fracture morphology: (a) overall aspect of the fracture surface at 25 \times ; (b) intercrystalline and transcrystalline fracture features at 100 \times ; (c) sliding marks on galling features at 200 \times ; (d) intercrystalline and transcrystalline fracture features at 500 \times ; (e) fine cleavage steps on cleavage facets at 1000 \times ; (f) fine cleavage steps on cleavage facets at 5000 \times .

The center region, inspected at different magnifications (Figure 17b,d), reveals intercrystalline and transcrystalline fracture features, specific to fatigue failures in titanium [48,49], along secondary

cracks. The feather markings, an array of fine cleavage steps on cleavage facets pointing back in the direction of the local crack, can be clearly seen in Figure 17e,f.

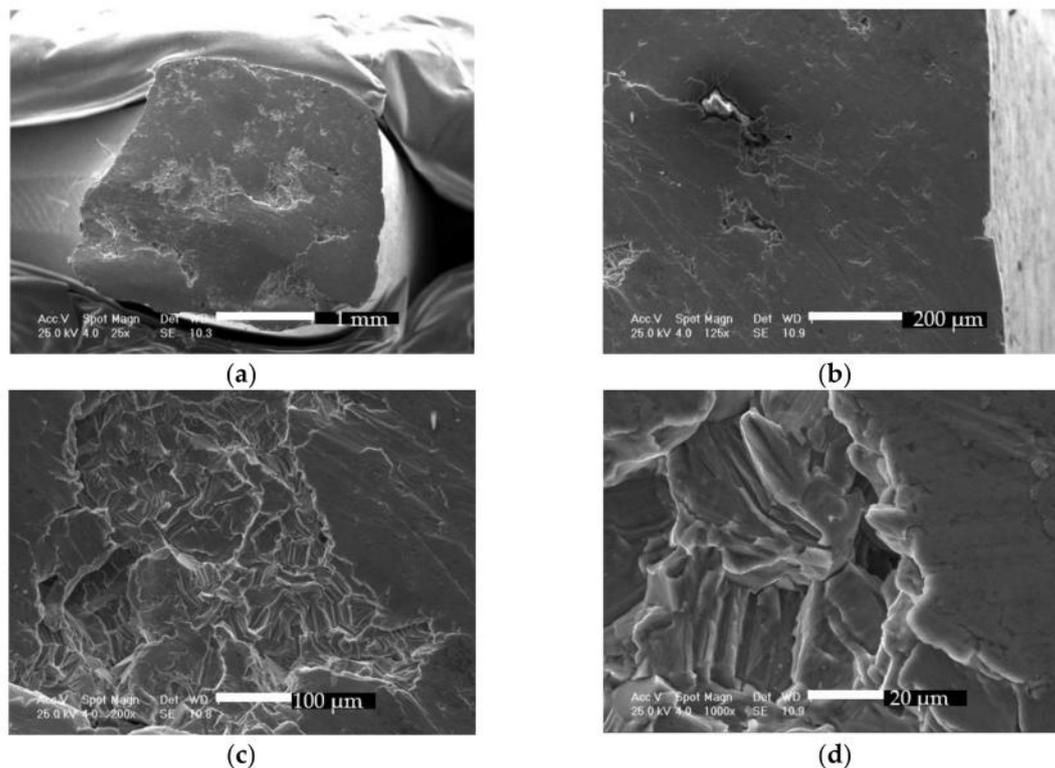
Studying the part which failed first, shown in Figure 18a, the galling covers most of the surface. Again, lips which suggest torsion failure can be observed, while in Figure 18b, at higher magnifications, the sliding marks and lips show the relative movement of the facets. The central region reveals typical brittle failure aspects with cleavage, details of which are presented in Figure 18c,d. Fracture origin could have been identified by backtracking the rough faceted fracture features/cleavage steps, coarse microstructure [50,51], and the fatigue striations with cracks which point to initiation site, but most features were obscured by galling.

Figure 18. Scanning electron micrographs showing fracture surface morphology on first failure region: (a) first failed section at 25×; (b) sliding marks and lips at 125×; (c) typical brittle failure of the central region at 200×; (d) typical brittle failure of the central region at 1000×.
