# Evaluation of the Fatigue Behavior and Failure Mechanisms of 4340 Steel Coated with WIP-C1 (Ni/CrC) by Cold Spray

**Abstract:** Fatigue behavior of standardized 4340 steel samples uniformly coated with WIP-C1 (Ni/CrC) by cold spray was investigated. In particular, when a crack appeared at the interface between the base material and the coating, the cause of it as well as its shape and size were investigated. Fatigue loading was applied by alternating symmetrical cycles. Scanning electron microscopy was used to study the onset of failure and the subsequent propagation of cracks. The interface between the two materials performed well—in all samples, the initial crack propagation occurred on the surface of the base material, continuing into the coating material and in the interior of the base material. The fatigue durability curve of stress vs. number of cycles (S-N) presented a conventional form for a metallic alloy and the coating material had an influence only on the damage on the surface of the base material.

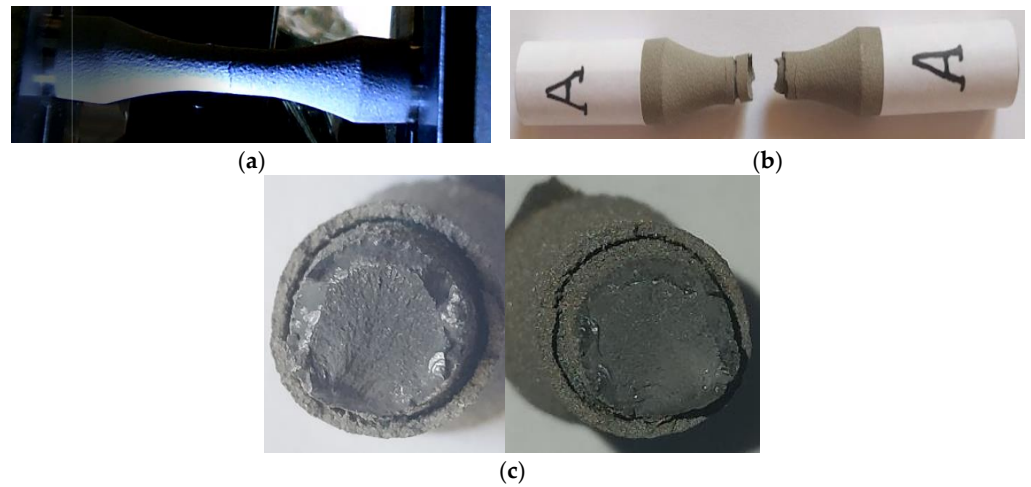
Images from the static tensile test are shown in Figure 3, and include the specimen immediately after the macrocrack becomes visible (Figure 3a), the broken specimen (Figure 3b) and the fracture surfaces (Figure 3c). Figure 4 shows the point determined by the visible macrocrack (Figure 3a) on the stress–strain curve. Both from the examination of the fracture surfaces of the static tensile analysis and from the study of the stress–strain variation given by the characteristic curve, the following conclusions are highlighted: (i) The way in which stress varies in relation to the strain, presented in Figure 4, is mainly due to the behavior of the base material. The coating material does not greatly influence the shape of the stress–strain curve; (ii) the elastic region reaches the maximum stress, thus reducing deformations in the elastic field; (iii) after recording the ultimate tensile strength ( $\sigma_{\text{UTS}}$ ) the stress–strain variation decreases, registering a significant elongation of the sample, with no apparent hardening zone; (iv) with a total elongation of 13% at breakage, the base material presents significant plastic deformations, which is also visible in Figure 3b; (v) the coating material has significant deterioration due to the brittle behavior at high elongations; (vi) the fracture surfaces for both the coating material and the base material are approximately perpendicular to the geometric axis of the sample (Figure 3b,c) and are perpendicular to the direction of loading. Consequently, both materials exhibit brittle behavior under tensile stress; (viii) the coating material detached from the base material at the time of breaking the test samples; in the area of breakage there is a separation between the coating and the base material, with no contact between them; (ix) the yield limit ( $\sigma_{p0.2}$ ) was determined to be 852 MPa, a value taken into account when calculating the first maximum fatigue stress value.

**Figure 3.** Sample A—static tensile test. (a) View of the sample during the tensile test. (b) Sample broken in static tensile test. (c) Front views of the fracture surfaces of the tensile specimen.

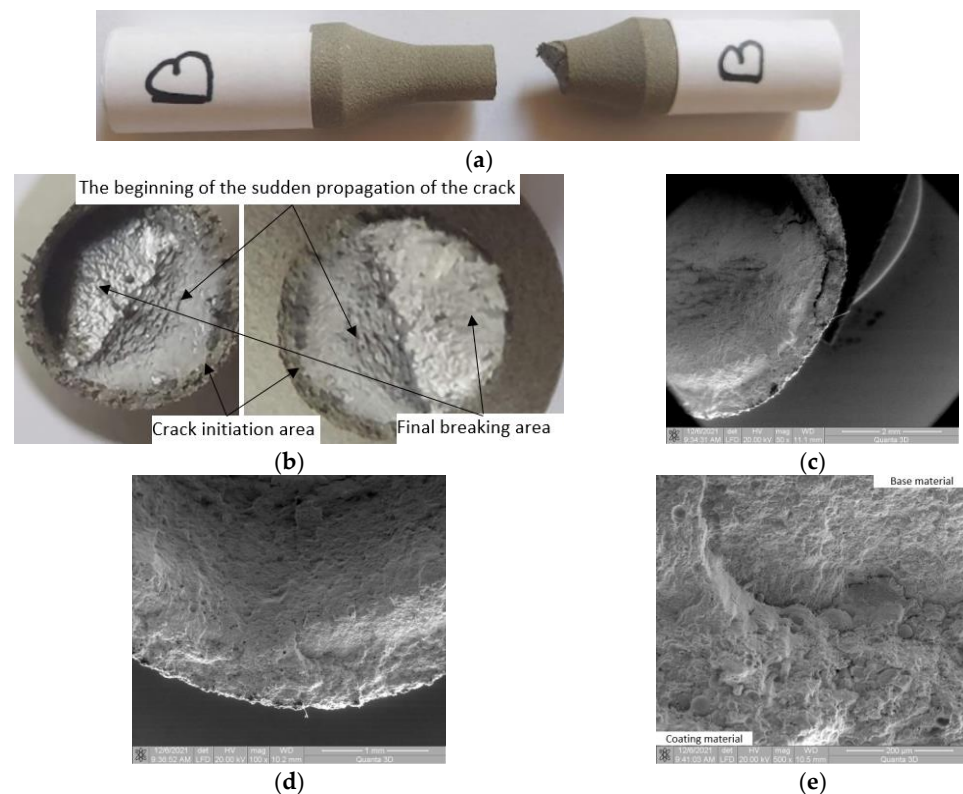
As was observed for all 4340 coated samples in the fatigue tests, towards the end of the crack propagation area, the cracked surface moves from the perpendicular plane to the test direction and goes by an angle of approximately  $45^\circ$  (Figure 6a–c). It was discovered that the fracture front exhibits resistance throughout its line of progression. In the unbroken area, the accumulated stresses are very high due to the fact that the section area is much smaller than the initial one, and the propagated crack constitutes a powerful stress concentrator. As a result, the plastic deformations in the unbroken area are high and almost the entire region is plastically deformed. In these conditions of stress asymmetry and large plastic deformations, the crack front is oriented in the direction of the minimum resistance encountered.

**Figure 6.** Macroscopic and microscopic images of broken surfaces for samples B and C. (a) Specimen B: Side view of the broken sample. (b) Specimen B: Macroscopic images of surfaces resulting from breakage. (c) Specimen B: SEM image ( $50\times$ ) of the broken surface at plane deflection. (d) Specimen B: SEM image ( $100\times$ ) of the interface area. (e) Specimen B: SEM image ( $500\times$ ) with damage in the interface area.

Significant damage occurs in the coating material in the moment the crack front propagation changes direction (Figure 6c). The crack initiation area is at the surface of the base material, at the interface between the base and coating material. At the interface, the formation of a large crack is not observed (Figure 6d,e). There is significant detachment and damage of the coating material in the initial area of crack deflection (Figure 6c). In the area of crack initiation (at the interface—Figure 6d,e), significant damage is found in the coating material. Greater damage is at the interface between the coating material and the base material—a confirmation that the crack begins at the surface of the base material and extends into the coating material. This is possible due to high stresses, in which case there was no crack-type detachment between the two materials. This characteristic implies a serious coating material deterioration.

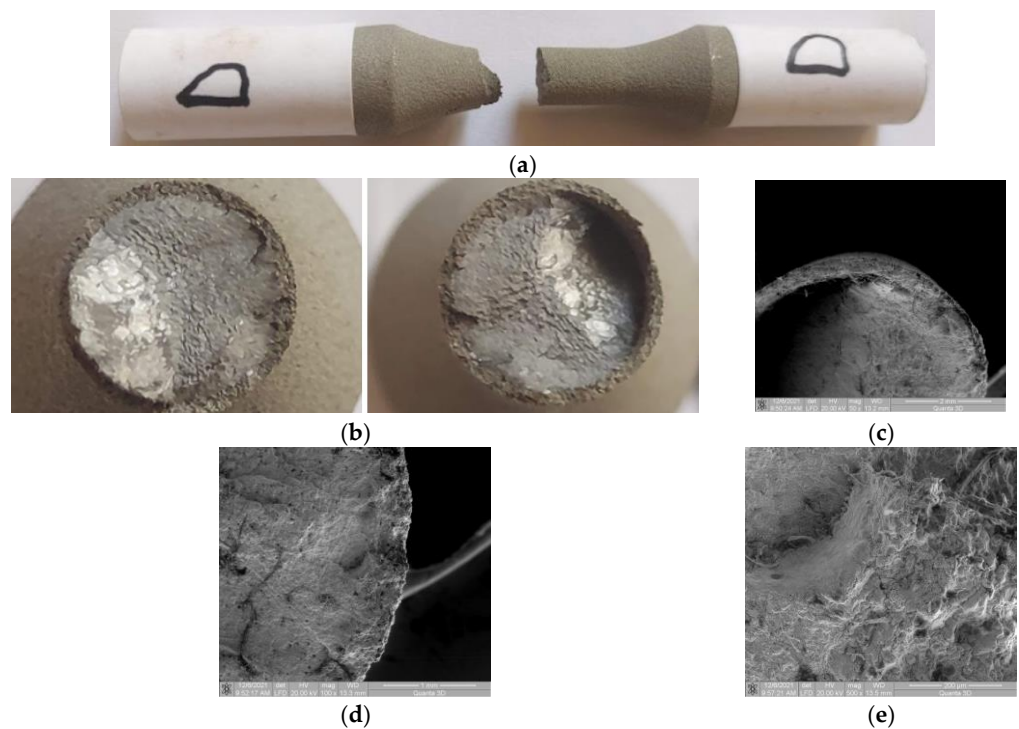
For these samples, the angular deflection of the fracture surface is observed in Figure 7a–c. The stable fatigue propagation area of the crack is bigger (Figure 7b) because the stress value is lower than in the previous samples. From a macroscopic point of view, the coating material damage is observed only in the final fracture area. No significant damage was found at the moment the crack propagation changed direction (Figure 7c).

**Figure 7.** Macroscopic and microscopic images of fracture surfaces for samples D and E. (a) Specimen D: Side view of the broken sample. (b) Specimen D: Macroscopic images of surfaces resulting from breakage. (c) Specimen D: SEM image (50 $\times$ ) of the broken surface at plane deflection. (d) Specimen D: SEM image (100 $\times$ ) of the interface area. (e) Specimen D: SEM image (500 $\times$ ) with damage in the interface area.

Due to the lower stresses, the damage to the area of the beginning of cracked surface deflection (Figure 7b,c) is smaller than in the previous samples. In the area of crack initiation, the same detachment from the coated material is observed (Figure 7d,e). Moreover, in the coated material, an intergranular radial crack is observed, which starts from the fracture initiation area (Figure 7d). Figure 7e presents average detachment from the coated material (as seen in the previous samples). The inter/intragranular cracks from the initiation area are much smaller than those of samples B and C.

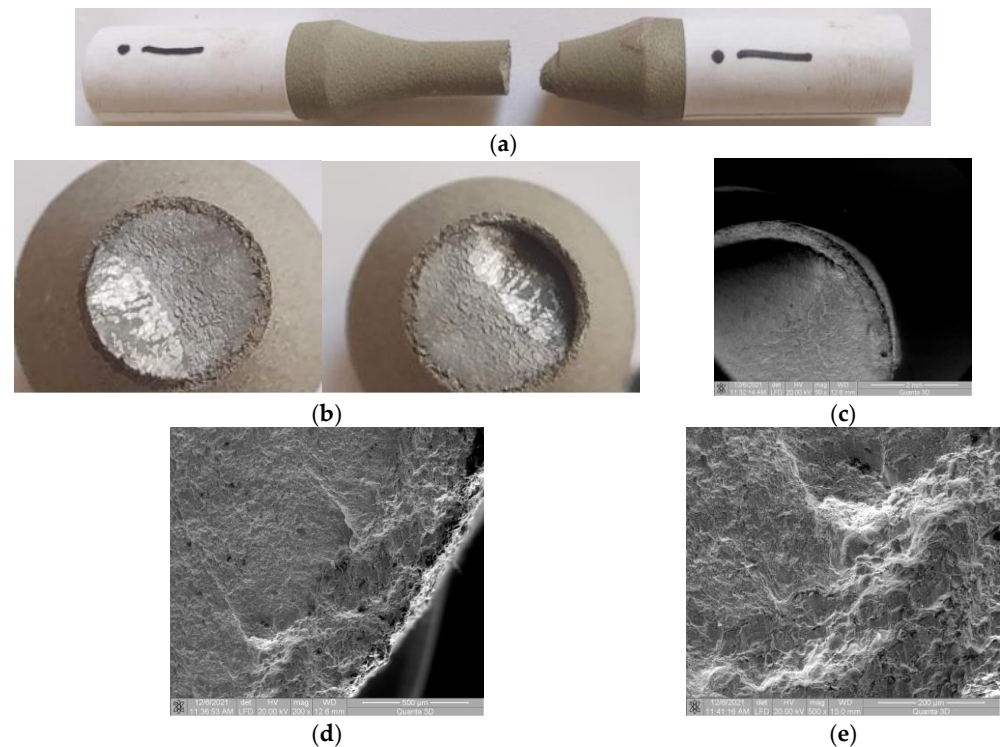
As the stress value decreases, the stable propagation area of the fatigue crack increases, and the area where the angled deflection of the cracked surface occurs becomes smaller (Figure 8a,b). The destruction of the cylinder formed by the coating material occurs only in the final area of the damage (Figure 8b,c). There are distinct regions of coated material and base material in the beginning of the crack front deflection area, but in the cracked surface deflection area, a detachment of the coating material from the base material is

observed (Figure 8c). In this area, the large plastic deformation of the base material cannot be matched by the coating material.

**Figure 8.** Macroscopic and microscopic images of broken surfaces for samples I and J. (a) Specimen I: Side view of the broken sample. (b) Specimen I: Macroscopic images of surfaces resulting from breakage. (c) Specimen I: SEM image (50 $\times$ ) of the broken surface at plane deflection. (d) Specimen I: SEM image (200 $\times$ ) of the interface area. (e) Specimen I: SEM image (500 $\times$ ) with damage in the interface area.

In the area of fatigue crack initiation (at the surface of the base material—Figure 8d,e), no significant damage to the coating material is found. The propagated crack front through the coating material is not straight, having certain deviations from the approximately flat surface. It was found that the deviation of the crack front from perpendicularity to the applied force starts at the interface between the base material and the coating material. Apart from the crack initiation area, no inter- and/or intragranular cracks were observed in the rest of the coated material.

Figure 8d shows that in the area of crack initiation there is no damaged surface between the base and coated material. However, Figure 8e shows a small detachment of the coated material from the surface of the base material. This detachment is minor and it is influenced by the microstructure of the coated material in correlation to the initialization of the crack front. For the last samples, due to the low stress values, the fracture of the coated material was induced by the large crack opening in the base material. In this area, the coated material behaves well, with no inter/intragranular cracks or detachment from the material.

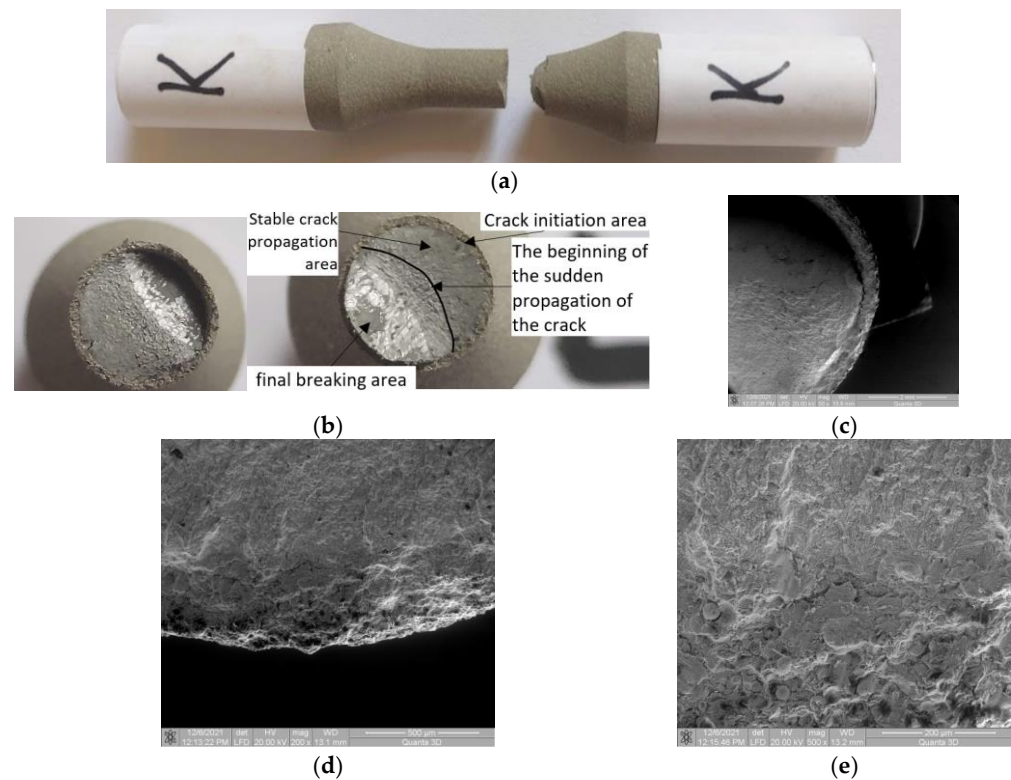
In the case of 4340 coated materials, all analyzed samples showed changes in the crack front direction at an angle of approximately 45 $^{\circ}$ , relative to the initial crack front, which was perpendicular to the stress direction. This is due to the characteristics of the base material which, at a certain stress value, shows significant plastic deformation. Thus, a more intense displacement of dislocations is achieved, which can form a barrier to the propagation of fatigue cracks. In the case of the samples K and L, a change in the direction of crack propagation front is seen. The area of deflection is smaller and there is a detachment between the coating material and the base material at the beginning of the deflection area of the fracture surfaces. The area of stable propagation of the crack is clearly highlighted; the flat and perpendicular surface to the direction of stress also presents a surface of unstable crack propagation, which is near to the deflection of the crack front area (Figure 9c). In the crack deflection area, the same detachment is observed between the coated and the base material.

**Figure 9.** Macroscopic images of broken surfaces for the samples K and L. (a) Specimen K: Side view of the broken sample. (b) Specimen K: Macroscopic images of surfaces resulting from breakage. (c) Specimen K: SEM image (50 $\times$ ) of the broken surface at plane deflection. (d) Specimen K: SEM image (200 $\times$ ) of the interface area. (e) Specimen K: SEM image (500 $\times$ ) with damage in the interface area.

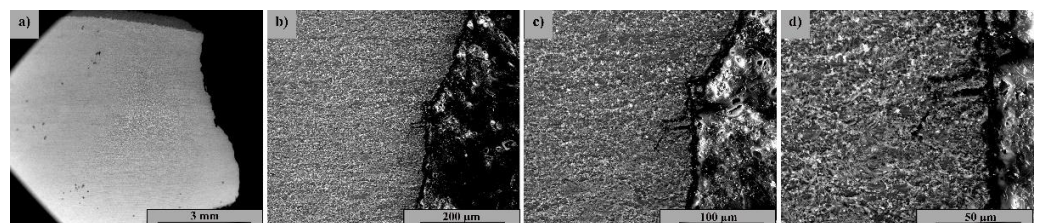
The microstructure and cross-sectional breakage appearance of the K and H samples are shown by electron microscopy in Figures 14 and 15. Figure 14a–d show crack propagation in the substrate and not at the interface between the coating and the base material, with the crack propagation occurring in a predominantly pearlitic zone with increased brittleness. The structure of the base material (Figure 1) shows a fibrous structure specific to the lamination process, with grains in ferrite and perlite strings.

**Figure 14.** Microstructures from sample K in the breakage area: (a) Macroscopic view; (b) 500 $\times$ ; (c) 1000 $\times$ ; (d) 2000 $\times$ .

In the region of the crack zone (Figure 14d), fine equiaxial grains are evident due to recrystallization processes during fatigue testing. The breakage is intracrystalline and preceded by microcracks at the boundary between the grains. In the case of sample H (Figure 15a–d), which after more than 5 million cycles has not cracked, the microstructure shows a fibrous appearance with ferrite and perlite grains in the direction of stress, without cracks or other local defects.

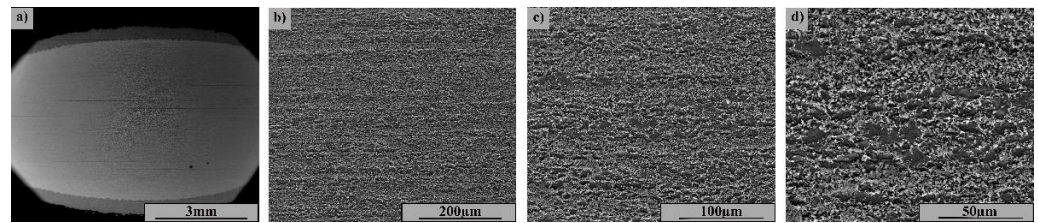
**Figure 15.** Microstructures in sample H fatigue stressed and unbroken: (a) Macroscopic view; (b) 500×; (c) 1000×; (d) 2000×.

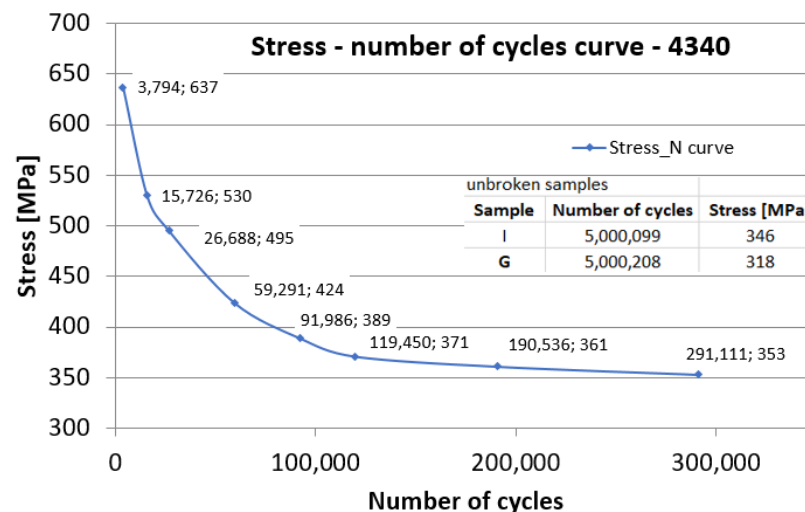
The Wöhler diagram (stress vs. number of cycles—Figure 16) is based on the stress values at the number of cycles until fracture in cyclic fatigue tests. Samples H (346 MPa) and G (318 MPa) did not break after 5 million cycles. The layout of the diagram is a conventional one for a metallic material, with semi-brittle behavior at break, having an estimated fatigue limit around 346 MPa.

**Figure 16.** Wöhler diagram for fatigue tests of the 4340 steel coated with WIP-C1 powder.

- Given that, at high stresses, the damage to the coating material is significant, it is not recommended to use coated and fatigue-strained components above 370 MPa. If the stress values are between 350 MPa and 370 MPa, the damage to the coating material is reduced, and, for medium durability, the components can be used within this range of stresses without affecting the base material and coating assembly.

- At fatigue stress levels below 340 MPa, no damage occurred in the tested base and the coating over 5 million cycles. Therefore, it is concluded that parts made of AISI 4340 alloy steel and coated with WIP-C1 (Ni/CrC) powder using CS can be expected to operate with high durability if the applied fatigue stresses do not exceed 340 MPa, even considering the presence of the stress concentrators.
