Interdisciplinary Research on Medieval Fresco Subjected to Degradation Processes in the Corbii de Piatră Cave Church

Abstract: This paper presents research on the degradation processes of the fresco painting in the cave church of Corbii de Piatră Hermitage under the influence of meteoric infiltration water and environmental factors. The medieval fresco dates from the end of the 13th century and the beginning of the 14th century, being painted on a sandstone wall. The infiltration of meteoric water through this wall, the temperature variations, the environment and the repeated wetting/drying processes determined the degradation of the fresco, resulting in its detachment from large surfaces. This research established correlations between the processes that take place, the structural transformations, the changes in composition and the adhesion of the fresco to the sandstone wall. The results have been made available to conservation and restoration specialists, in order to choose appropriate materials and technologies. This paper presents findings regarding the pictorial material and introduces new analysis techniques in research on the degradation processes of the fresco painting in

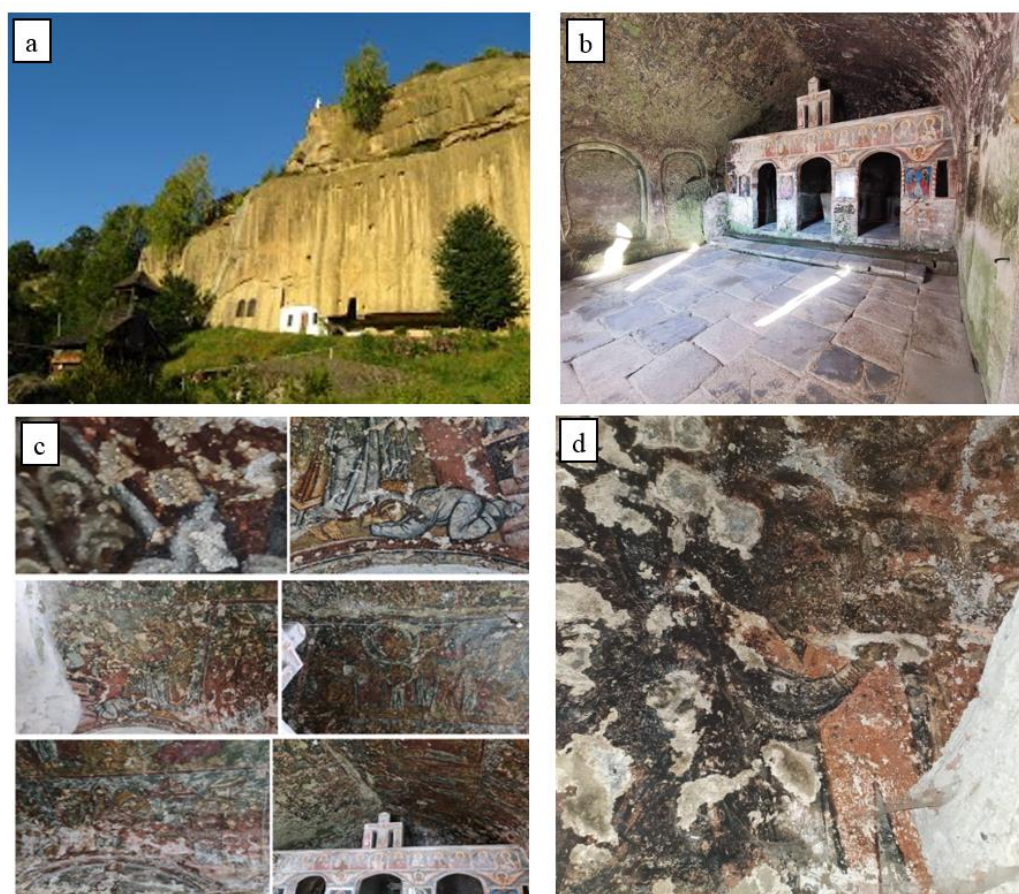
The al fresco painting was made at the beginning of the 14th century. Since the enclosure was excavated in the sandstone wall (Figure 1), the support on which the painting is applied has a relatively a uniform appearance, the roughness required for the application of the mortar layers for the fresco being provided by carving the sandstone. The support layers of the fresco are made on a lime base with straw inserts. Water infiltrations through the sandstone wall, temperature variations and biodegradation processes determined the advanced deterioration of the frescoes (Figure 1b–d).

Figure 1. Corbii de Piatra cave church: (a) exterior view, tiled wall; (b) interior view [3–5]; (c) layout of the paintings in 2019; (d) sampling area (2022).

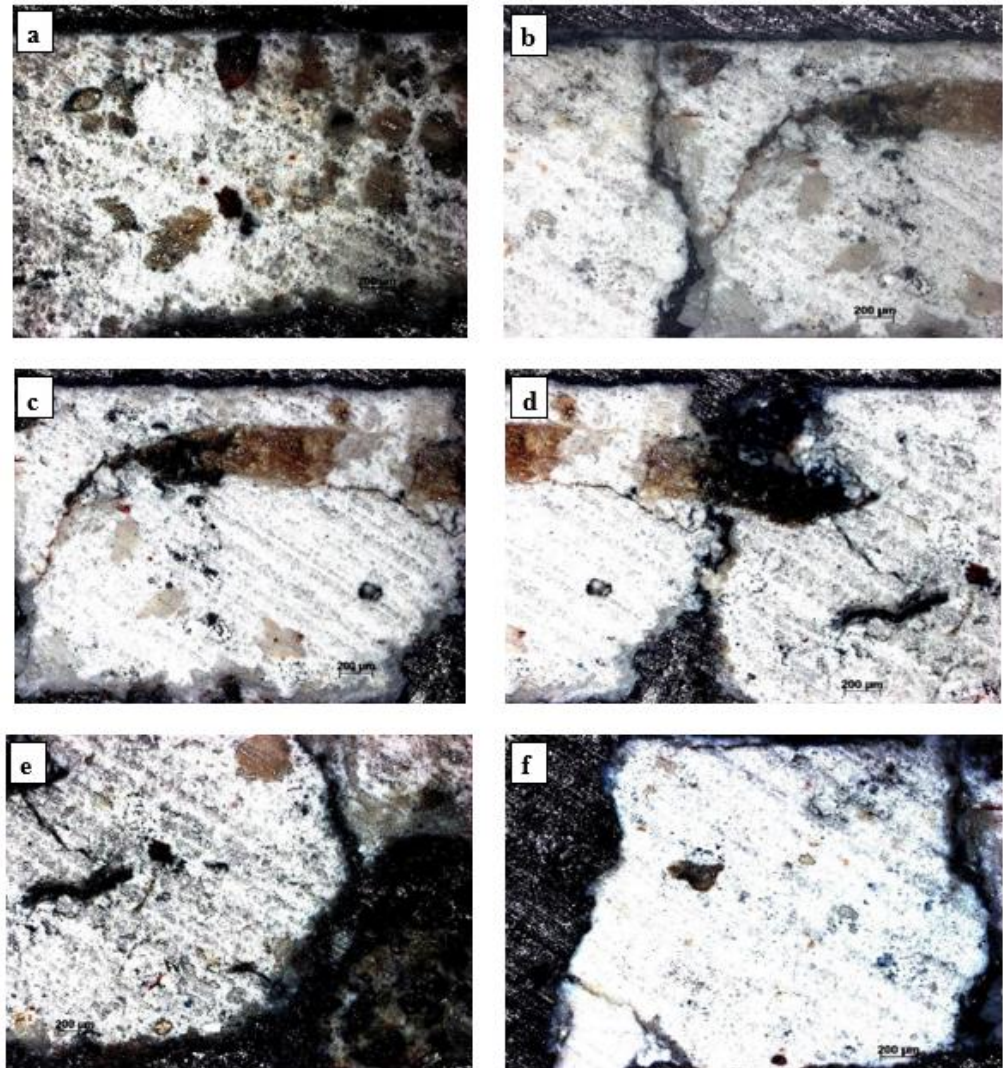
The sample analyzed in polarized light (Figure 2) shows a pictorial layer of a dark color, very thick and of uneven thickness. Inserts, inclusion particles, pores, cracks and

even voids were identified in the mortar matrix. The particles present in the mortar matrix have different shapes and sizes and have higher hardness than the mortar matrix mostly, a fact highlighted by the shading effect on the matrix (Figure 2a,c,d,f). The areas where there were straw inserts used in the preparation of the mortar matrix contain decomposition compounds with carbon from straw inserts and inclusions (Figure 2b–d). Cracks developed from the tip of the straw inserts, showing that these areas acted as stress concentrators (Figure 2b,c). Cracks appeared at the mortar insert–matrix interface that propagated into the matrix (Figure 2c,d). The cracks are long; they propagate from one boundary to another (Figure 2c–e), and the form of propagation is typical of brittle fracture (Figure 2b,d).

Figure 2. Mortar microstructure by microscopy in polarized light (OMPL): (a) hard inclusions in the mortar; (b) propagation of the crack from the top of the row and of the contraction crack in the vertical plane; (c,d) degradation by cracking; (e,f) inclusions, compactness defects.

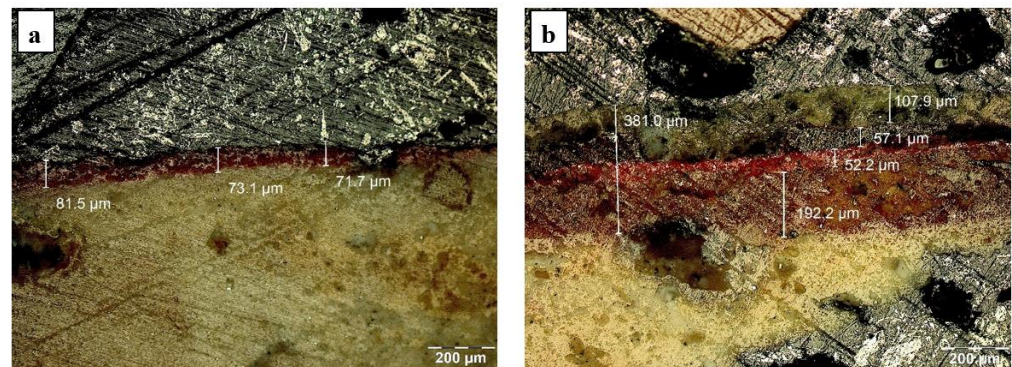
The optical microscopic analysis of the painting layer revealed two situations: an area with a relatively clean outer layer, red in color, with a thickness of approximately 50 µm (Figure 3a), and an area with a thick layer, consisting of deposits, with a thickness greater than 100 µm, under which there is a layer of red pigment with a thickness of approximately 50 µm. Under the pigment layer there is a light red area, with a thickness greater than 150 µm, the intensity of the color decreases from the pigment layer towards the interior of the mortar, which shows that the pigment has diffused into the mortar (Figure 3b). The phenomenon is typical for a fresco painting on a wet support.

Figure 3. Microstructure in section of the pictorial layer: (a) clean layer, (b) layer covered with a thick crust.

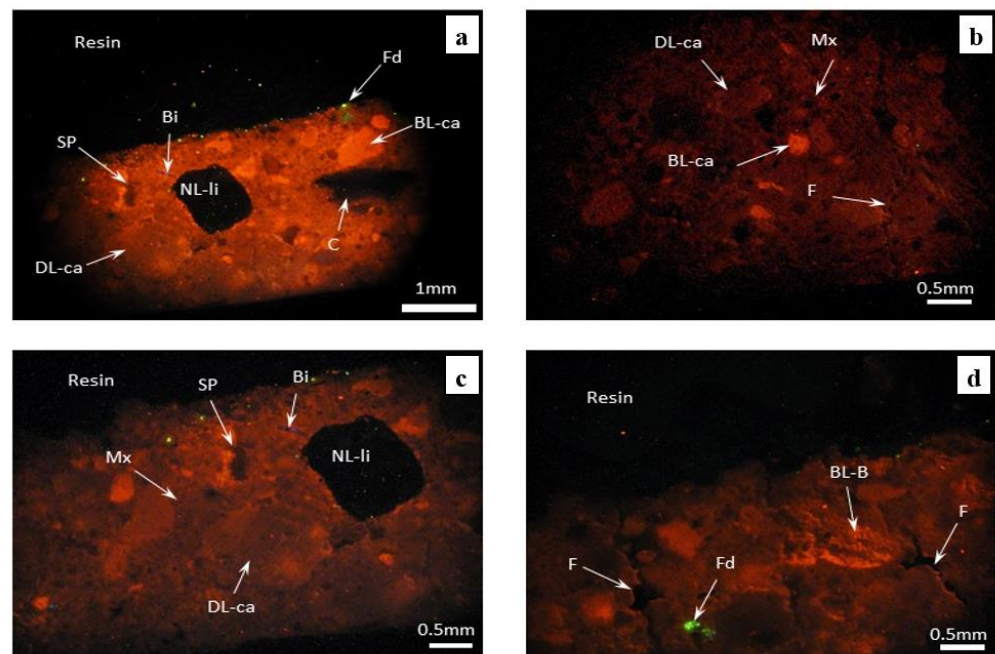
Characterization by cathodoluminescence of fresco fragment (Figure 4) revealed small fragments of carbonate and non-carbonate sedimentary grains (sand) embedded in a relatively homogeneous matrix. The sedimentary particles (fine sand) are represented by small fragments of limestone, feldspar, quartz, micas (mainly biotite) and carbonate bioclasts (shell debris). The matrix is the hardened slaked lime, added to the mixture at the point of the mortar preparation process.

Figure 4. (a–d) Fragment of fresco under cathodoluminescence microscopy. BL-ca—carbonate lithoclast with bright orange luminescence; DL-ca—carbonate lithoclast with dull luminescence; NL-li—non luminescent uncertain lithoclasts; Fd—feldspar grain with green bright luminescence; Bi—biotite with dull blue luminescence; BL-B—bioclasts with bright orange luminescence; C—carbonized plant fragments; Mx—dull luminescent matrix; SP—secondary porosity resulting from selective dissolution; F—irregular fissures.

In the analyzed mass, an incipient secondary porosity is observed, with the appearance of small and irregular pores in low concentration. The secondary porosity resulting from selective dissolution was generated by the interaction of both the sedimentary particles and mortar with meteoric waters, which have a slightly acidic character ($\text{pH} = 5.5\text{--}6.5$), and allow the fractional and selective dissolution of the particles involved [20]. Fine, irregular cracks also be observed, with approximately perpendicular development on the external surface of the fresco, due to the seasonal repetitive processes of drying and wetting.

The cathodoluminescence analysis highlighted the degradation process of the mortar layer throughout its thickness, with many pores and irregular cracks, which explains its friable character and low adhesion to the tiles, as well as the easy detachment of the fresco from the wall on large portions.

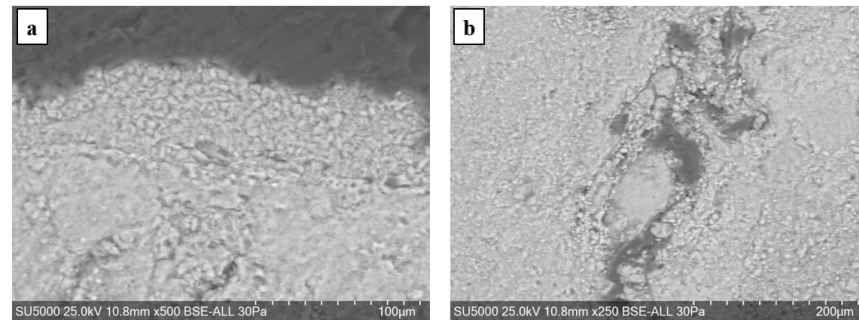
The SEM analysis of the fresco element shows that the pictorial layer is very thin, barely visible. The intonaco layer shows important degradations and a low compactness, towards a granular structure (Figures 7 and 8). The granular structure, with uneven areas, does not allow a delimitation of the intonaco and arriccio layers. Inside the mortar layer, areas of advanced degradation were highlighted, with large compaction defects (Figure 7b).

Figure 7. The microstructure of the fresco sample in cross-section: (a) the intonaco layer ($\times 500$ mag.); (b) advanced degradation zone ($\times 250$ mag.).

For the area of the mortar layer showing advanced internal degradation (Figure 7b), the elementary SEM-EDS analysis highlighted the correlation between the high sulfur content and the area of advanced degradation of the mortar layer (Figure 11).

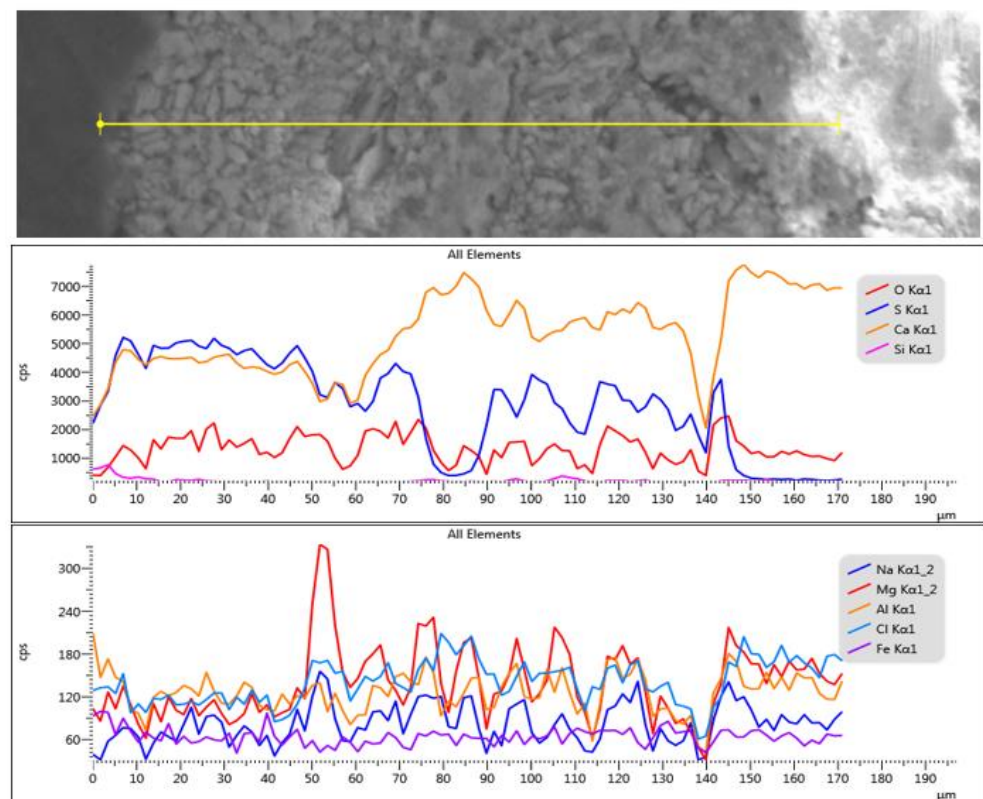
Figure 8. SEM-EDS line-scan analysis on the thickness of the mortar layer.

The line-scan analysis, on the thickness of the mortar layer, is presented in Figure 8. From the point of view of the composition, the presence of magnesium and calcium is noted throughout the thickness of the mortar. The superimposed spectra of the composition determined at different points located from the surface to the interior, in an area without pronounced degradation of the mortar layer (Figure 9), show high concentrations of sulfur

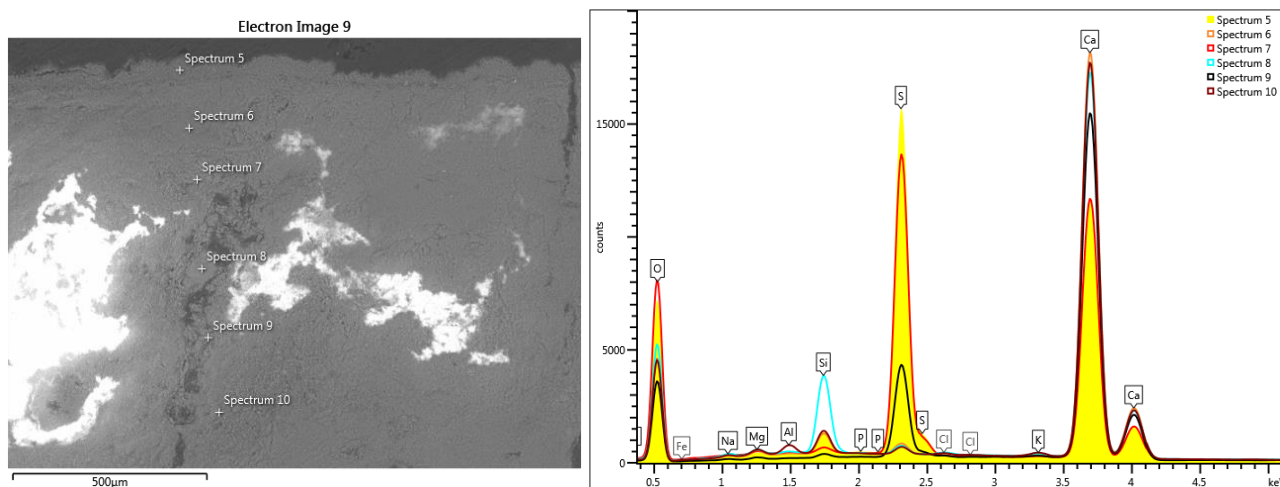
near the surface (spectra 5,6), and a decrease of sulfur concentration at the surface of the layer towards its interior (spectra 9,10).

Figure 9. Superimposed spectra regarding the evolution of the composition on the depth of the fresco: superficial layer with advanced pollution and Fe traces; the specific elements of the mortar composition.

The variation of the chemical composition on the thickness of the pictorial layer sample towards the interior of the mortar, without an advanced internal degradation, shows us the composition of the pictorial layer of the sample surface and the evolution of the mortar composition (Figure 9 and Table 1).

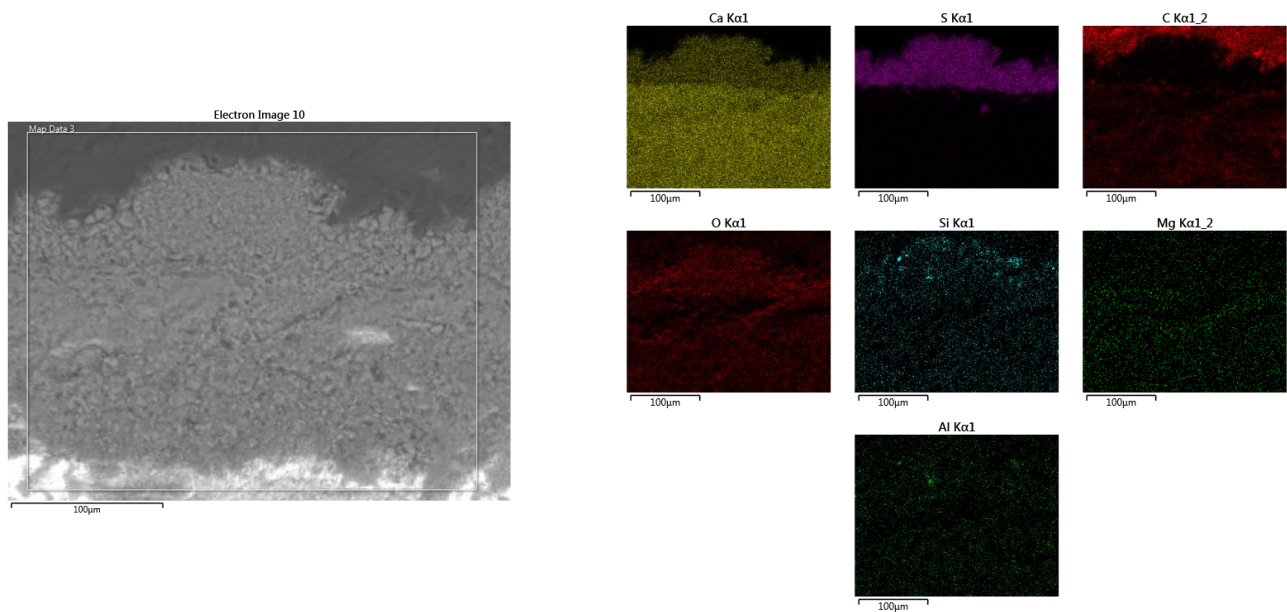
EDS-mapping drawn in the area without loosening on the thickness of the fresco layer (Figure 10) shows the presence of sulfur on the surface, which can be explained by the infiltration of meteoric water, which causes degradation of the fresco.

Figure 10. SEM-EDS mapping of the elemental composition in an area where the mortar layer does not show advanced degradation inside, with high sulfur content on the surface.

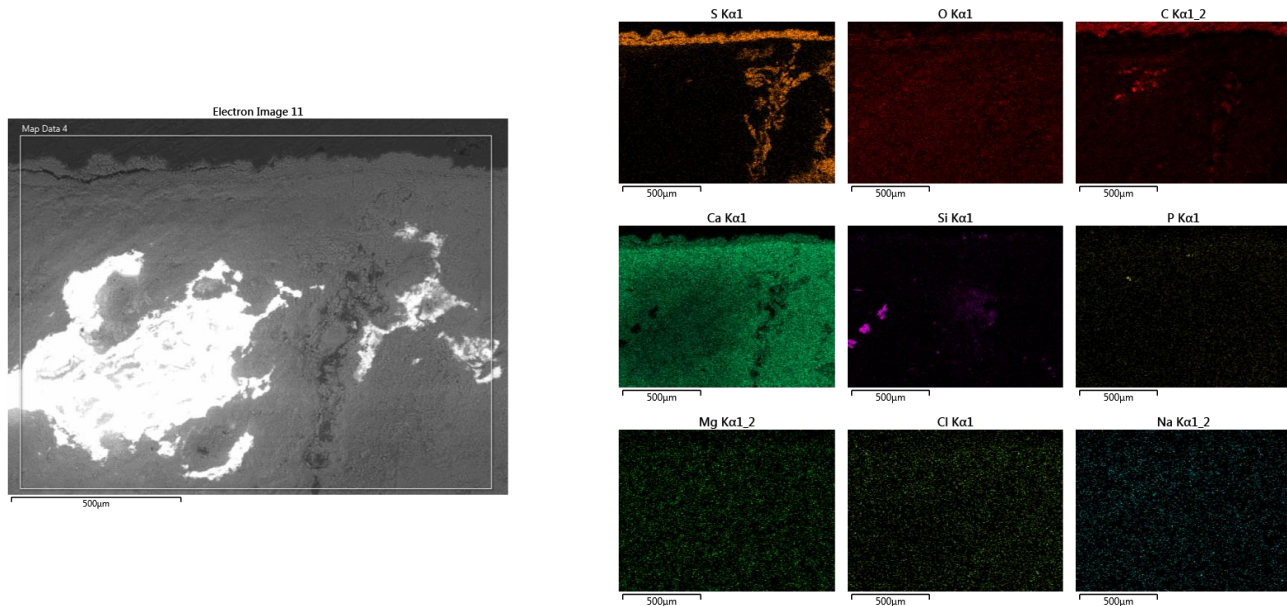
Figure 11. SEM-EDS mapping of the elemental composition in the mortar degradation zone through the infiltration of meteoric waters, with high sulfur content on the surface and in the advanced degradation zone.

The processes of internal degradation of the mortar layer through the action of meteoric water are correlated with the presence of sulfur in the strongly degraded area.

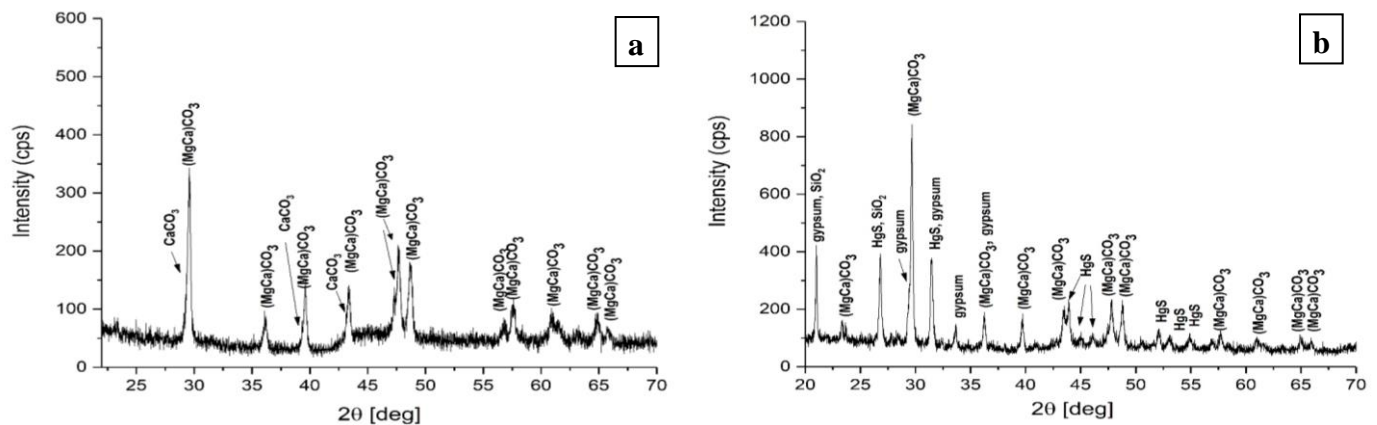
The XRD qualitative phase analysis (Figure 16) highlighted the presence of the following polycrystalline phases:

Figure 16. Qualitative phase analysis by X-ray diffraction of the fresco element with low adhesion to the sandstone wall: (a) mortar; (b) pictorial layer.

The gypsum comes from the infiltration water that carries it through the sandstone to the fresco; the waters that infiltrate the sandstone rock pass through clay-limestone rocks that contain gypsum [20]. Plaster can be found in the compactness defects of the support mortar, where it recrystallizes, or on the surface of the fresco in the pictorial layer. It has an important role in the degradation of the fresco. This type of degradation is marked by the presence of sulfur and is linked to defects in the sandstone walls that allow the transport of a large volume of water.
