Operational and Material Causes of High-Pressure Turbine Disc Damage in the RD-33 Engine

Abstract: This paper presents an analysis of the causes of damage and fragmentation to the high-pressure turbine (HPT) disc of the RD-33 engine mounted in the MiG-29 aircraft. The authors have carried out an analysis of the changes to the structure of the disc material, both in the areas containing cracks and in the undamaged areas. The impact of structural changes on the alterations in the analysed strength properties along the disc radius was assessed. Material tests were correlated with the analysis of the recorded engine parameters, indicating potential causes of the HPT disc fragmentation.

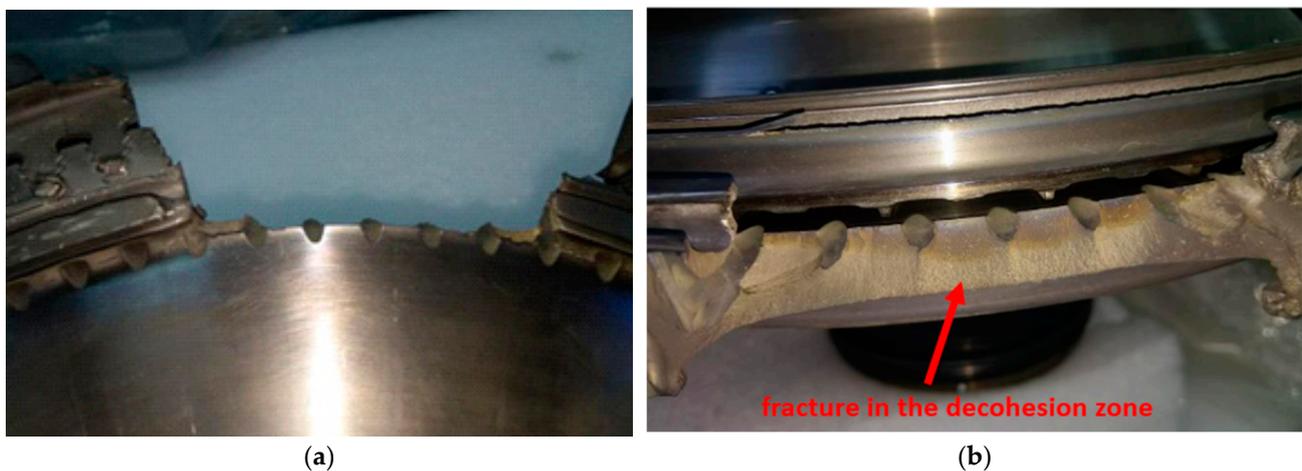
Failure to meet the above material and strength conditions may lead to exceeding the permissible level of stress, leading to decohesion of the turbine disc material, resulting in its defragmentation and, therefore, the destruction of the engine (Figure 1).

Figure 1. Area where a fragment of the HCP turbine disc of the RD-33 engine has been torn out (a), with a view of the resulting fracture in the material decohesion zone (b).

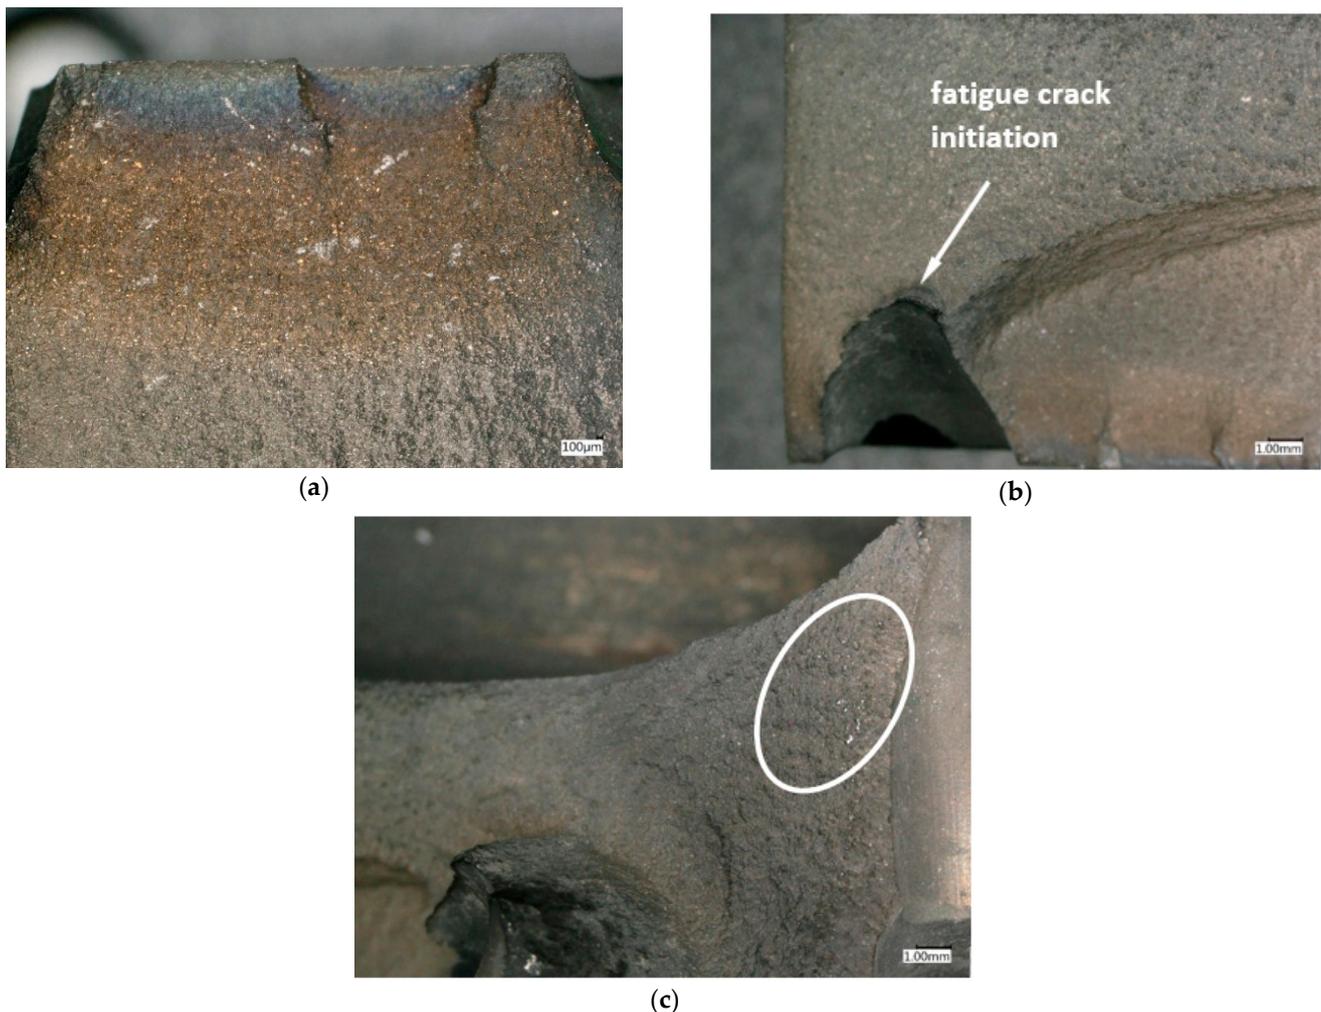
Macro examinations (Figure 4) carried out with the use of a Keyence VHX-950F digital microscope in the area of disc rim damage allow the conclusion that the damage to this element of the engine was progressing over a long period of time and was not of a temporary nature. This is evidenced by the surface of the analysed fractures without zones of obvious plastic deformation and by the areas which, despite strong oxidation, are characterised by the occurrence of local sites typical of material fatigue damage. Additional evidence confirming this thesis is the observation of discolourations on the surfaces of the analysed fractures, with the darkest shade near the disc surface and decreasing discolouration intensity with increasing distance from the surface. The strongest discolouration starts in the zones where the holes supplying cooling air to the blade interior penetrate the front surface of the turbine disc (Figure 4a). These areas contain morphological changes typical of fatigue sites, where fatigue damage of the material is initiated and crack propagation develops (Figure 4b). A characteristic feature of the analysed fractures is also the occurrence of clusters of bright spots of precipitation, which may constitute non-metallic inclusions in the material structure of the analysed disc (Figure 4c).

Figure 4. Macroscopic image of the fracture with visible traces of gaseous corrosion (sample 7) (a) and the site of fatigue cracking (sample 9) (b) in the area of the cooling holes, with a view of bright non-metallic precipitates (sample 9) (c).

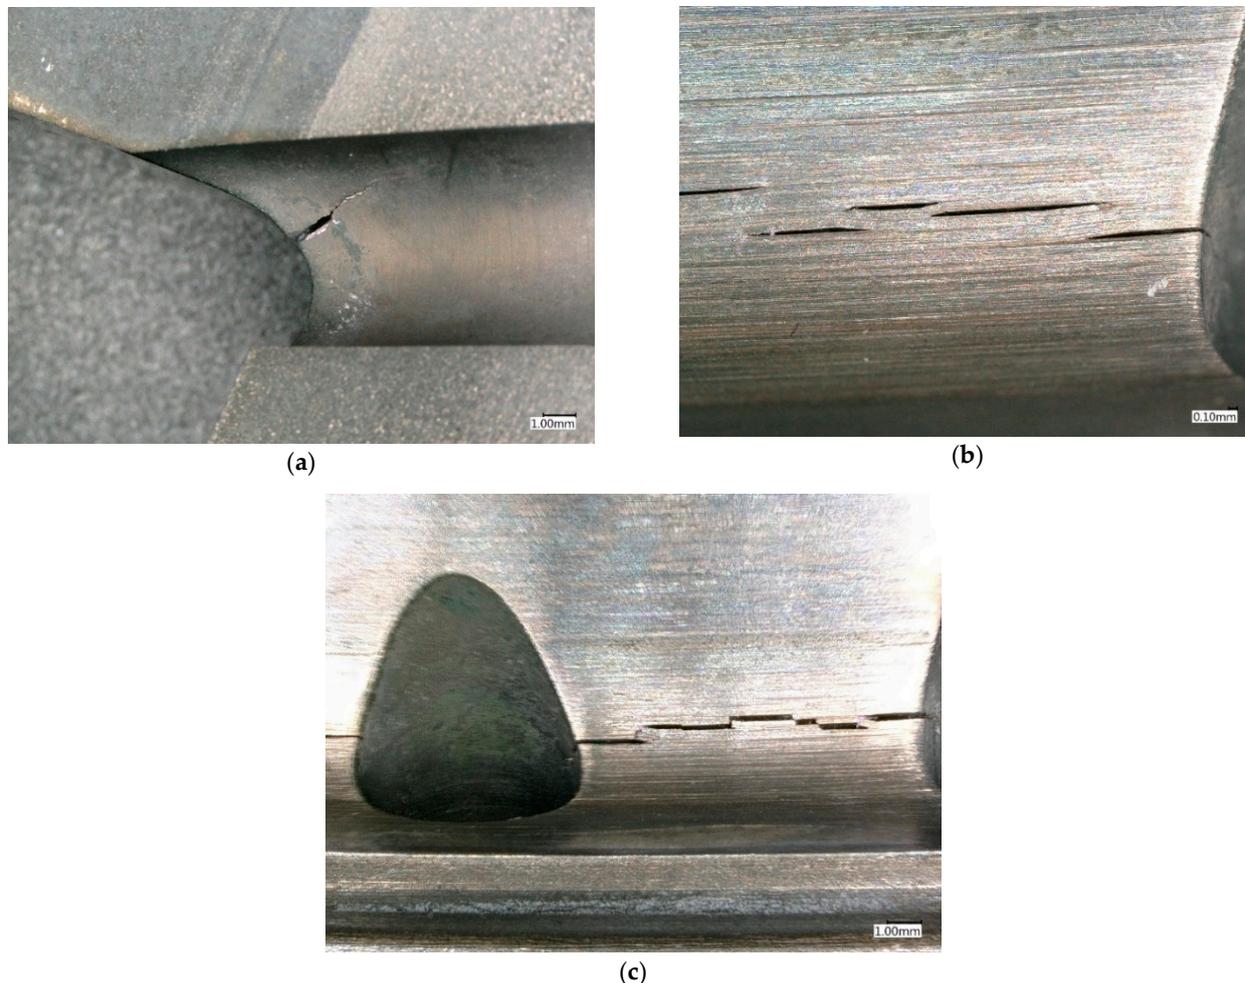
Macroscopic observation of the disc in the undamaged zone has confirmed the above assumptions. It was found that cracks initiated on the surface of the cooling channels at the front surface of the disc progressed around the periphery in the areas between the holes and then combined in this area, leading to complete decohesion of the disc material (Figure 5).

Figure 5. Crack initiated on the surface of the cooling hole in the “undamaged” area of the disc (sample 9) (a) with visible propagation in the zone between the holes (b), leading to crack joining and material decohesion (c).

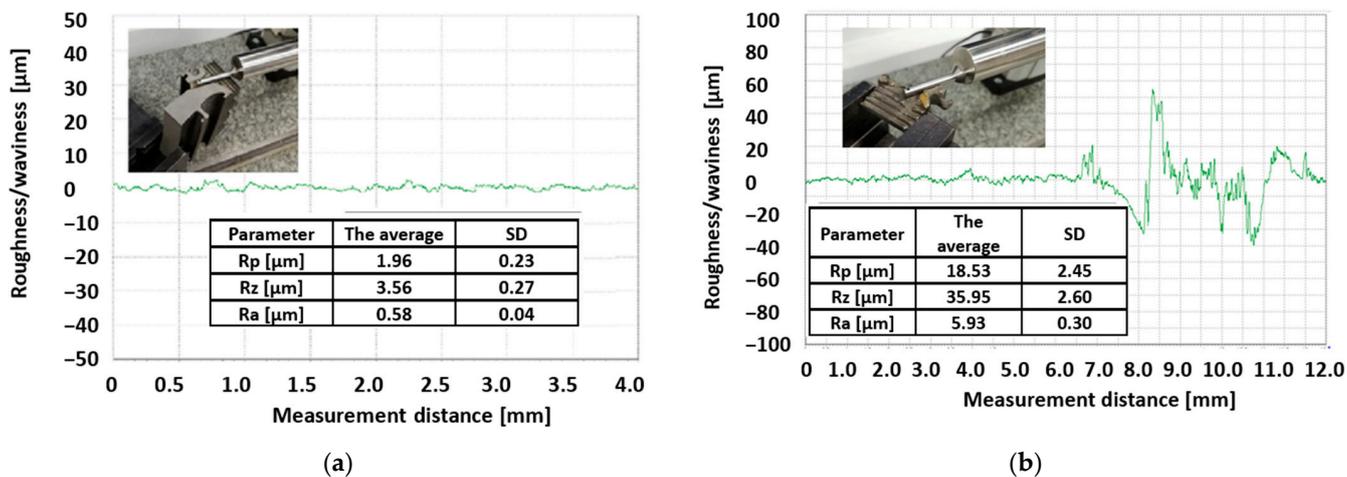
The conclusion regarding the long-term fatigue damage of the turbine disc material in the area of the cooling channels in the turbine disc rim area is confirmed by the analysis of the geometric structure of the channels' surface using the TOPO-01 profilographometer (IOS, Krakow, Poland). The visible effects of the material removal processing on the surface of the channels in the undamaged areas of the disc are characterised by roughness parameters at a level of $Rz = 3\text{--}7\ \mu\text{m}$ and $Ra = 0.3\text{--}0.7\ \mu\text{m}$ (Figure 6a). On the other hand, in the fracture developing on the surface of the channel in sample six, these parameters reached the values of $Rz = 39.95\ \mu\text{m}$ and $Ra = 5.93\ \mu\text{m}$ (Figure 6b).

Figure 6. Roughness measurement route in the “undamaged disc” area (a) and in the fracture zone formed in the cooling hole area (b) with sample results.

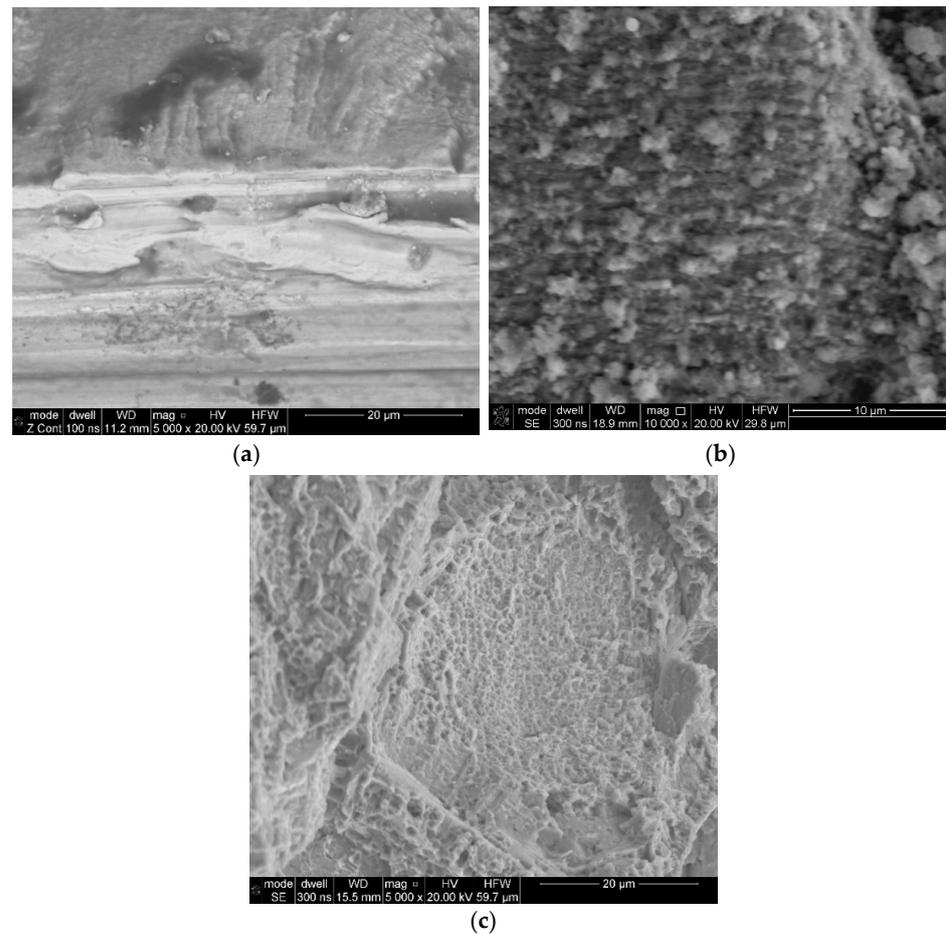
Fractographic studies of the surfaces were carried out using samples collected from the “damaged” area of the turbine before and after cleaning the analysed surface in an ultrasonic cleaner with the use of acetone. Based on these observations, it was found that the analysed fragments demonstrated characteristic features of a fatigue fracture. Numerous fatigue crack origin sites were observed by the fracture surface (Figure 7a). Each time, fatigue bands (Figure 7b) and a residual fracture zone (Figure 7c) were observed in the fatigue area above the fatigue sites.

Figure 7. Localised fatigue site in the cooling channel area (a), fatigue crack propagation zone with characteristic fatigue bands (b), and fracture area with visible traces of a plastic fracture (c).

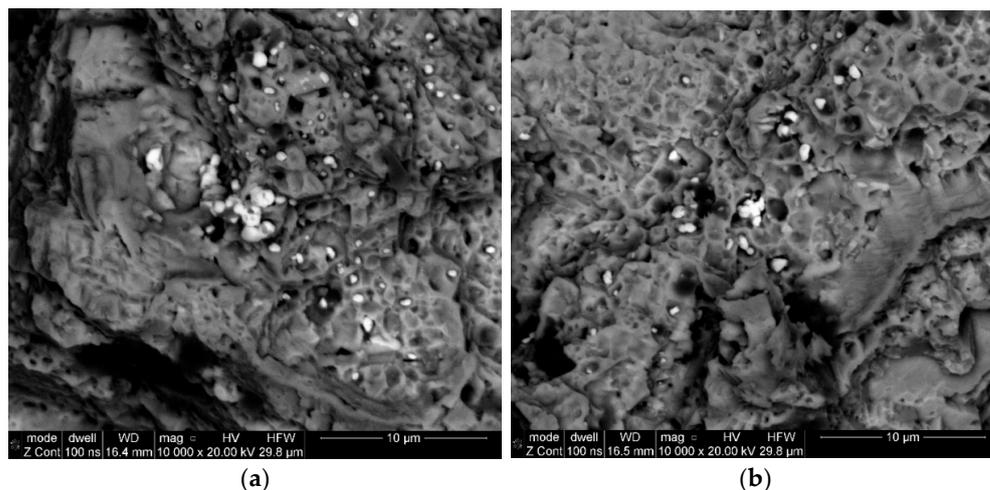
In addition, observations of fractures in the crack fracture zone revealed the presence of numerous clusters of fine non-metallic precipitates (Figure 8a). The point analyses of the chemical composition of samples collected from specific areas demonstrated that they were hafnium oxides (Figure 9). The confirmation of this observation is the surface distribution of elements shown in Figure 10, which, apart from identifying hafnium oxides, also allows for observation of the occurrence of aluminium oxide spots.

Figure 8. Concentrations of non-metallic precipitates in the area of residual fracture, sample 6 (a) and sample 7 (b).

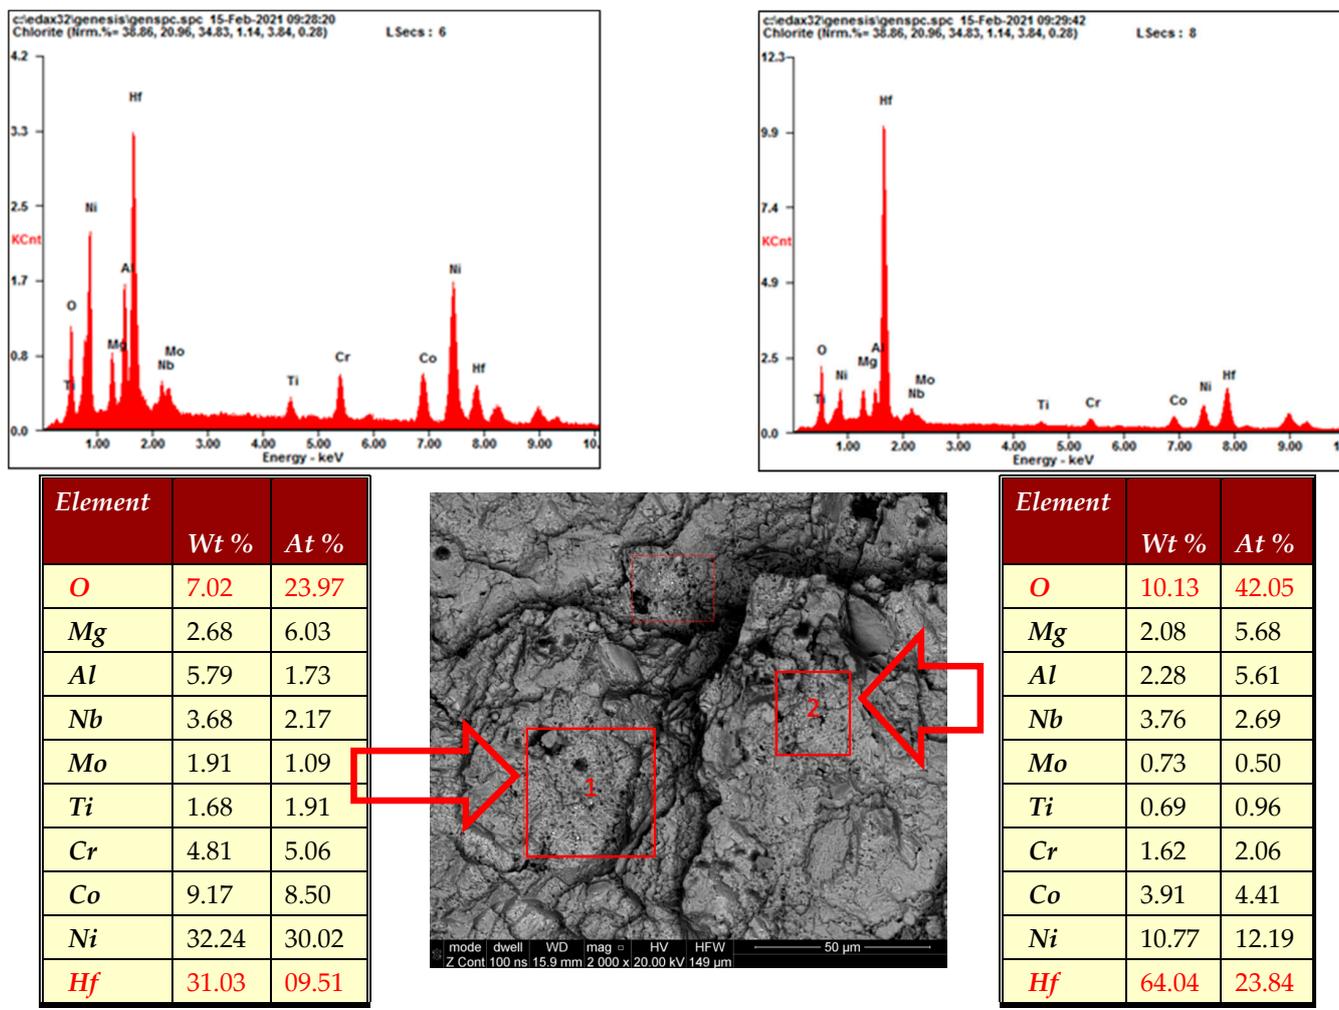
Figure 9. Spectrum EDS and qualitative analysis of non-metallic precipitates identified in the fracture zone. “1” and “2”—areas subjected to analysis of chemical composition using the WDS method.

When analysing the observations of the tested alloy microstructure, it is impossible to ignore the identified hafnium oxide precipitates (Figures 9 and 10). According to literature reports, this element was added to the EP741NP alloy to form hafnium carbides, limiting the growth of other $M_{23}C_6$ and MC carbides within the grain boundaries and thus improving the resistance to high-temperature creep [20,21]. However, according to the results presented in [22], failure to maintain the technological process regime at the alloy production stage may lead to the formation of hafnium oxide (HfO_2) precipitates

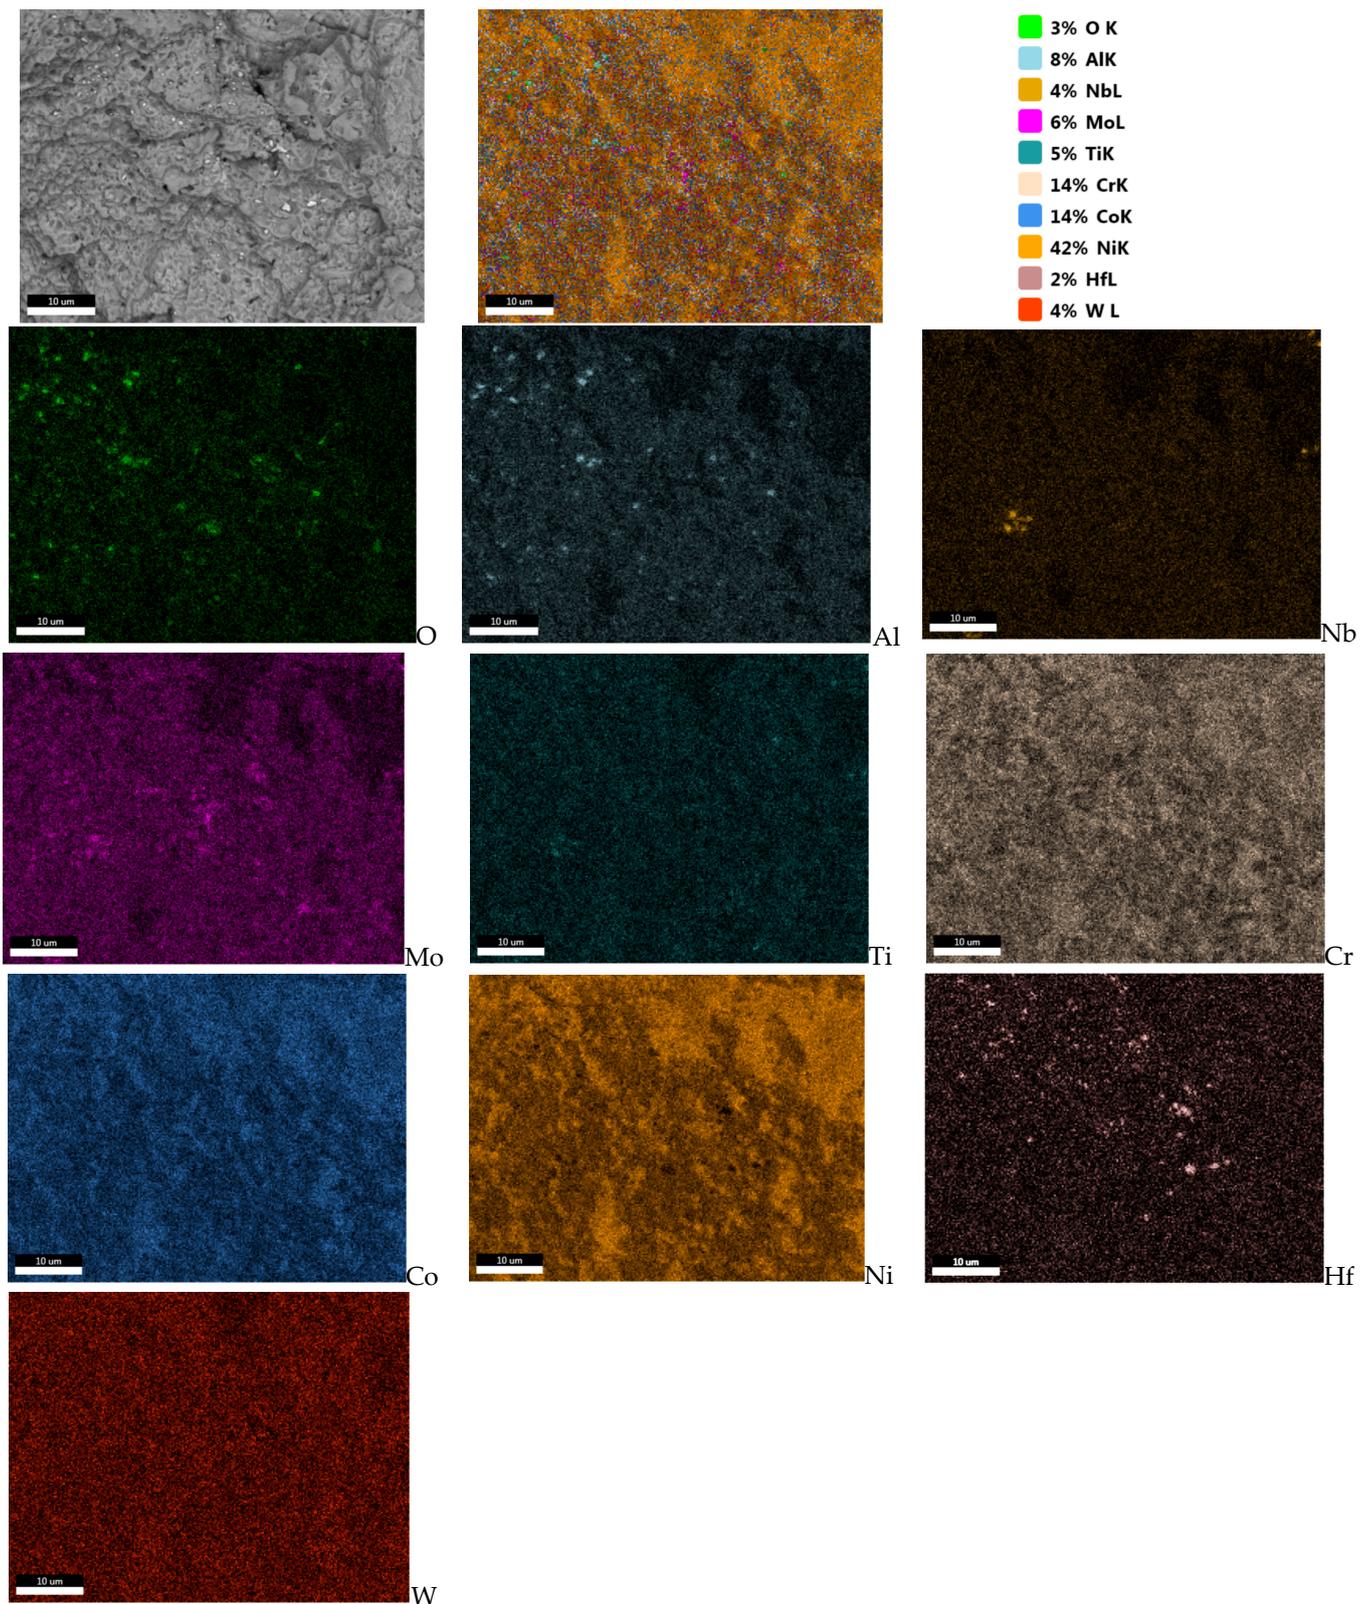
Figure 10. Surface distribution of elements in the residual fracture zone, showing clusters of hafnium and aluminium oxides.

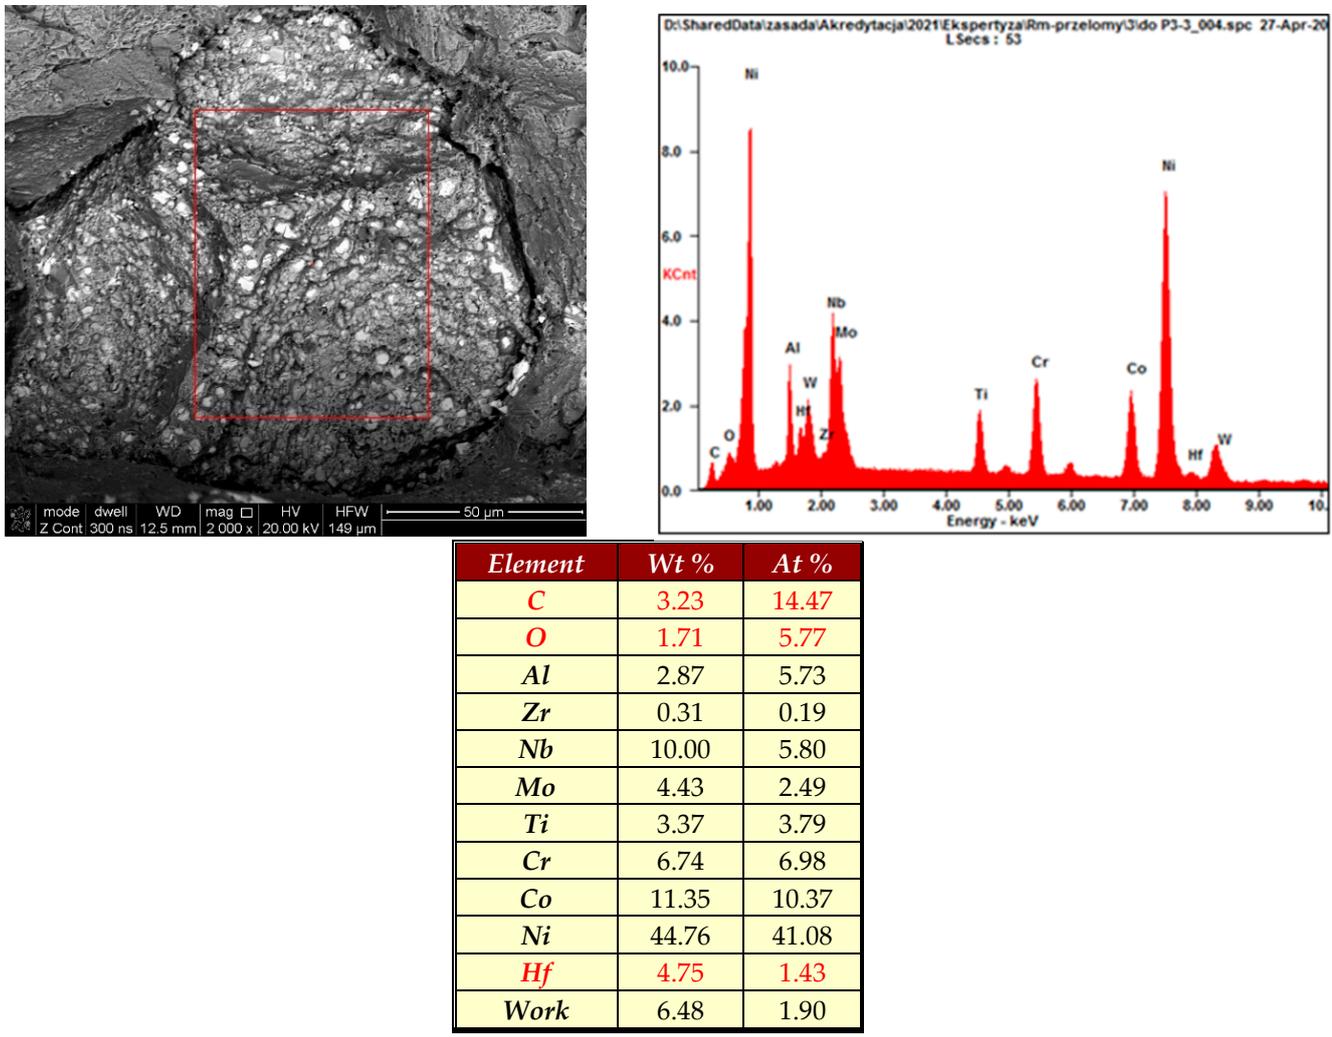
In addition, in the fatigue fracture zones, we identified areas of about 50 µm made of complex oxide carbide structures (Figure 11), which were undoubtedly structural notches in the analysed alloy volume. These undesirable precipitates could not have formed during

thermal processing or exploitation, which suggests that they were formed in the structure of the material during the metallurgical process of alloy production.

Figure 11. Spectrum and results of the qualitative analysis of the chemical composition in the area marked with a red square, containing complex carbide-oxide inclusions identified in the fatigue cracking zone.

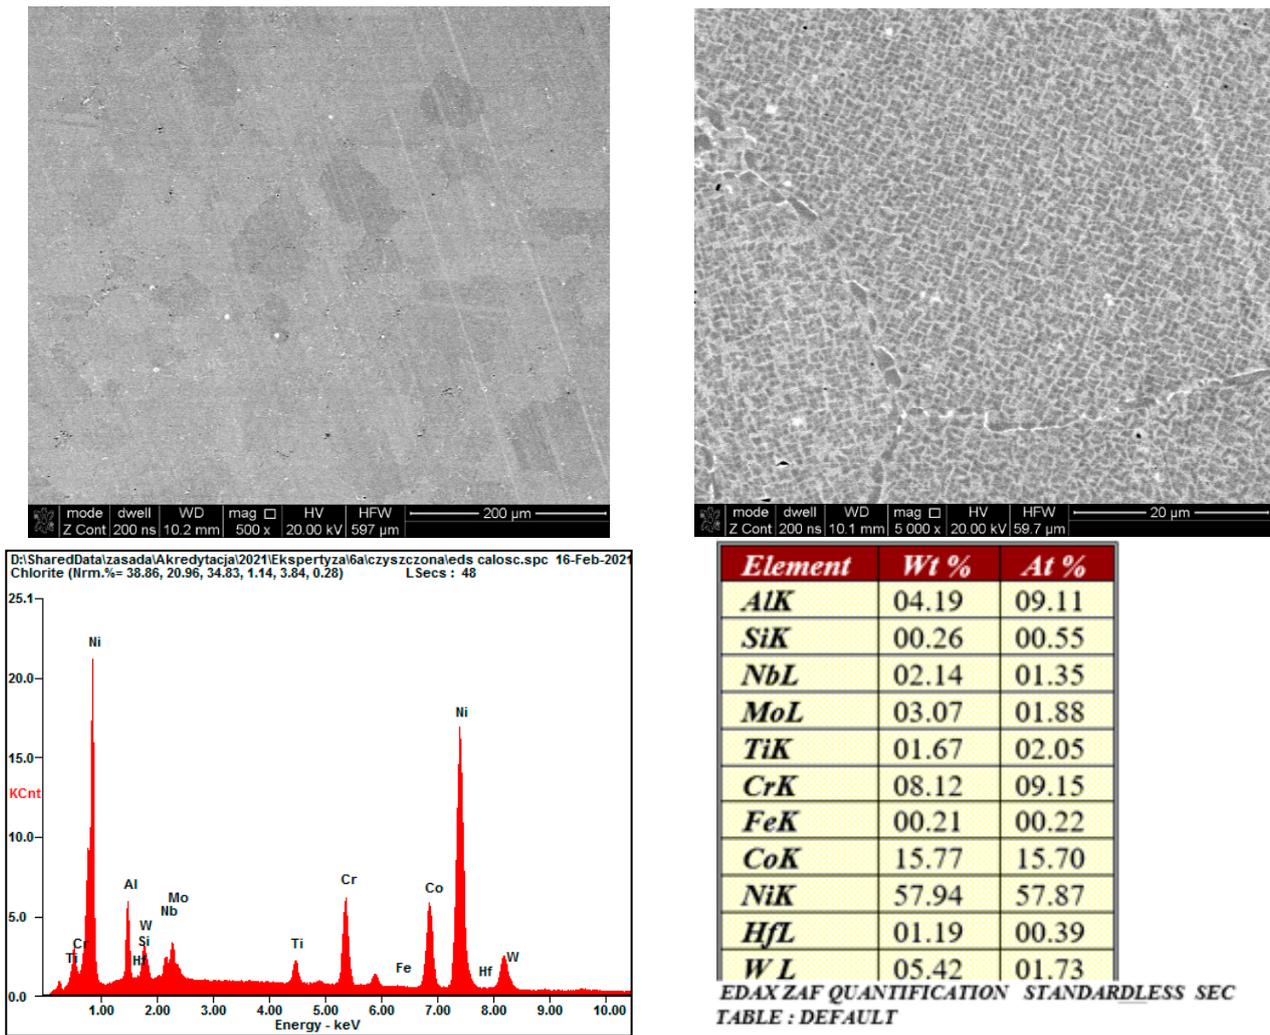
Figure 12. Two-phase $\gamma + \gamma'$ structure of the tested alloy with carbide precipitations within grain boundaries, with an analysis of the chemical composition and literature data [13,14] regarding the composition of the EP741NP alloy.

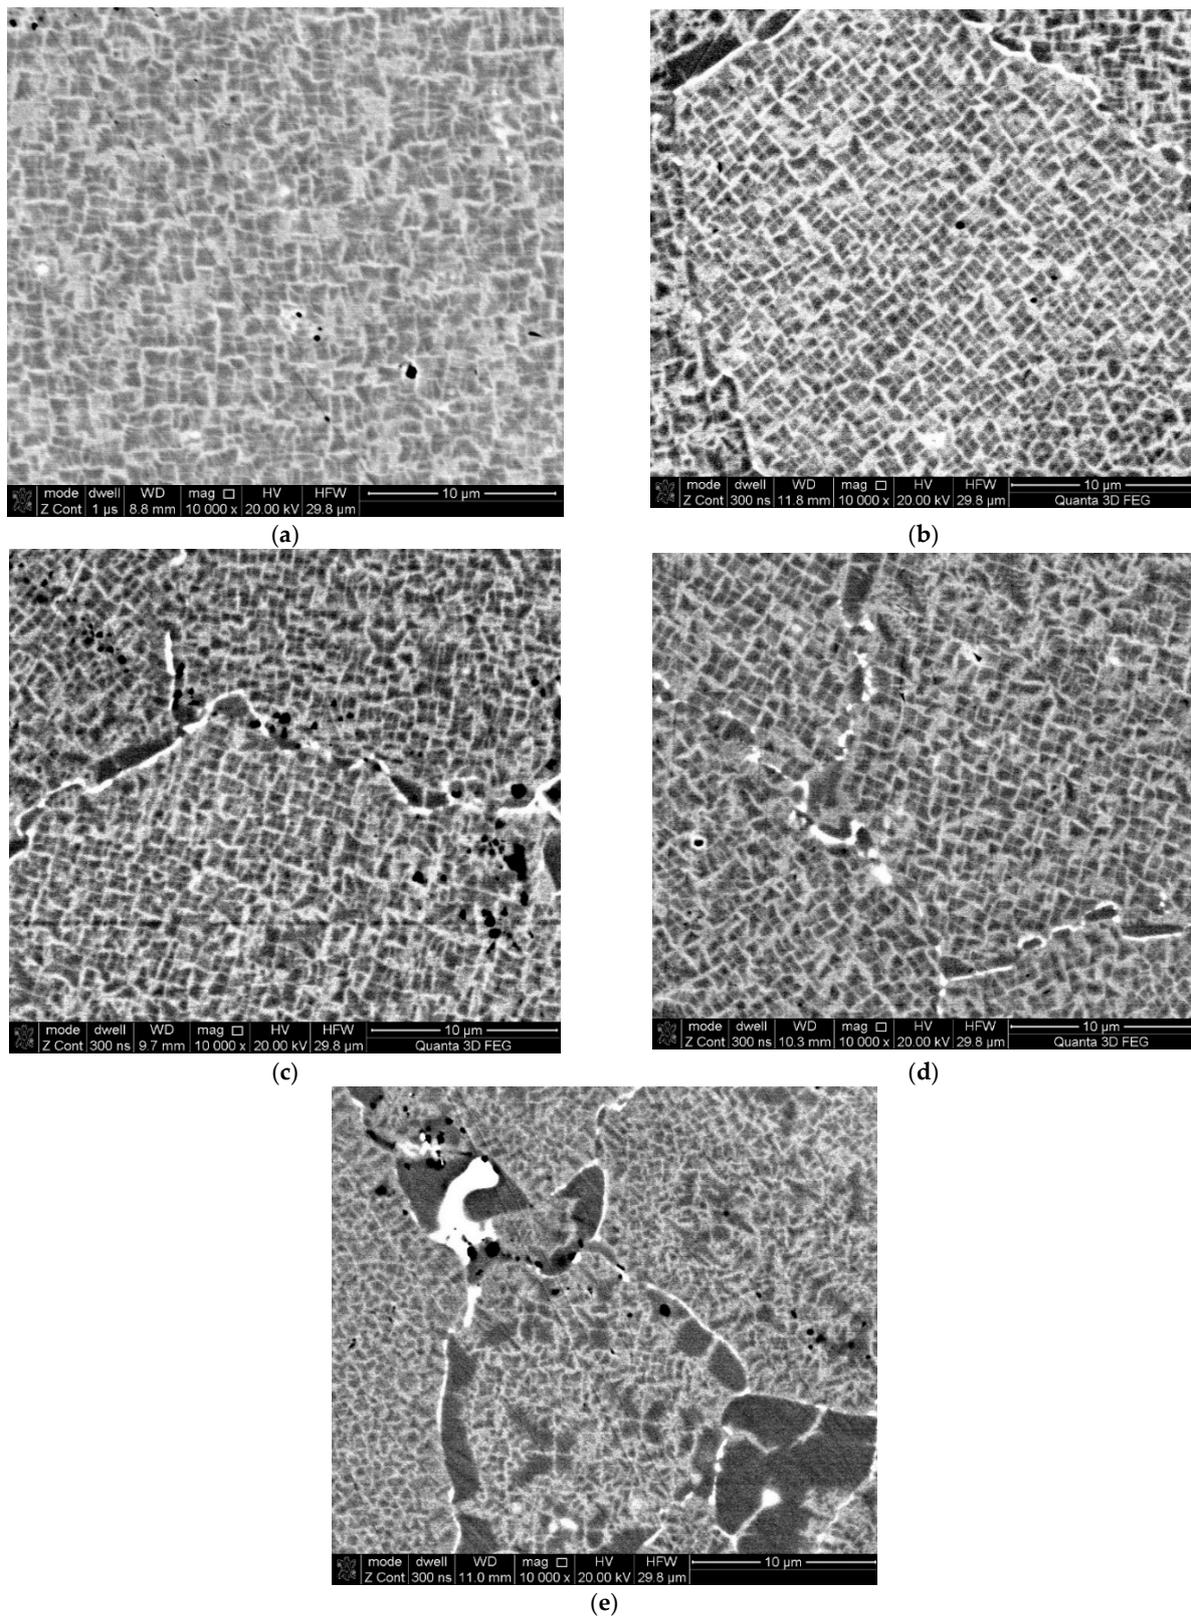
Figure 13. Changes in the cubic grains of the γ' phase in the alloy matrix and the growth of γ' and carbide precipitates within the boundaries of the original γ grains of the examined EP741NP alloy in the areas of samples collected for strength tests along the disc radius; distance from the foot plate of the disc: 23 mm (a), 63 mm (b), 85 mm (c), 128 mm (d), and 175 mm (e).

Based on the microscopic observations, it was found that the grain structure of the alloy in the area of the turbine disc rim (Figure 13a), i.e., in the zone of maximum thermal impact of hot exhaust gases, revealed clear differences in the morphology of the grain structure compared to the areas located below the rim (Figure 13b–e). A clear, selective growth of cuboidal grains of the γ' phase can be observed, leading to strong disorientation within the primary grains of the solid γ solution. In addition, within the original boundaries, the effects of anomalous growth of the γ' superstructure and carbide precipitates were observed. Such a morphological alteration is conducive to the development of cracks in the material between disoriented, expanded precipitates of the γ' phase, both along the primary grain boundaries and transcrystalline [15,16].

The cause of these structural changes is the long-term impact of high temperatures on the alloy structure. Literature reports on temperature changes in the structure of the EP741NP alloy and their impact on changes in mechanical properties, including mainly high-temperature creep resistance, clearly indicate that exceeding the total operating time of more than 200 h at a temperature of 750 °C causes structural changes, which were also observed in our study, leading to a decrease in strength properties [16–19]. Due to the observed structural component alterations, the structure in the crack areas was assessed. Sample six, from the damaged area of the disc, confirmed the literature reports that the fatigue cracks originated in overheated areas of primary grain boundaries of γ solid solution characterised by overgrown grains of the γ' phase and carbide precipitates (Figure 14a) and propagating between the grains of the γ' phase (Figure 14b), which confirms the cracking mechanism described in the works [15,16].

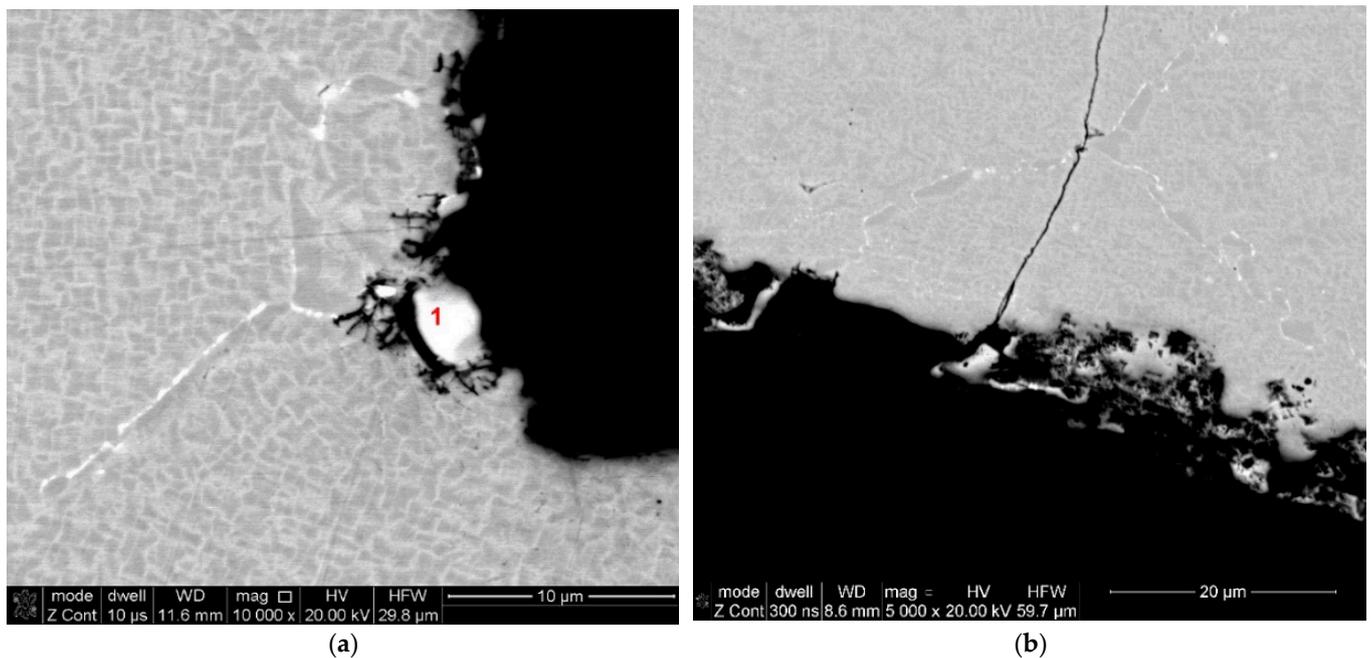
Figure 14. Crack origin in the primary grain boundaries of γ solid solution in the area of γ' phase grains and carbide precipitates marked with the number 1 (a) and crack propagation between γ' phase grains (b).

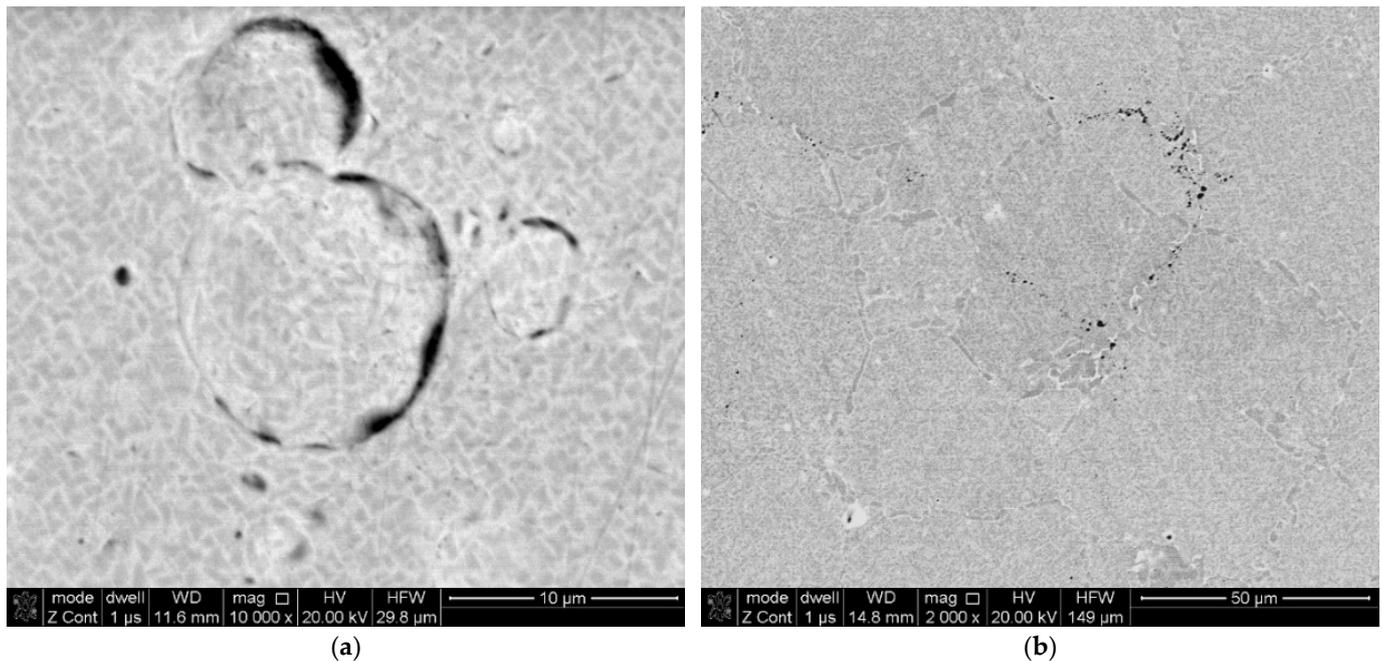
with a monoclinic structure, significantly contributing to the development of fatigue cracks, which was also confirmed in the case of the examined disc material. It should also be noted that, in addition to the previously found and described material defects in the structure of the analysed alloy, in the area of fatigue crack origin, primary particles of the powder used in the disc material sintering process were observed, which were covered with oxide impurities, which prevented the proper occurrence of the diffusion processes and obtention of a homogeneous sinter (Figure 15a). In addition, numerous oxides and nitrides were identified in the areas of the primary grain boundaries of the solid γ solution, weakening the cohesion and strength of the boundaries (Figure 15b).

Figure 15. Oxidised, primary powder particles unreacted during the sintering process (a) and numerous ceramic precipitates within the primary grains of the matrix (b).

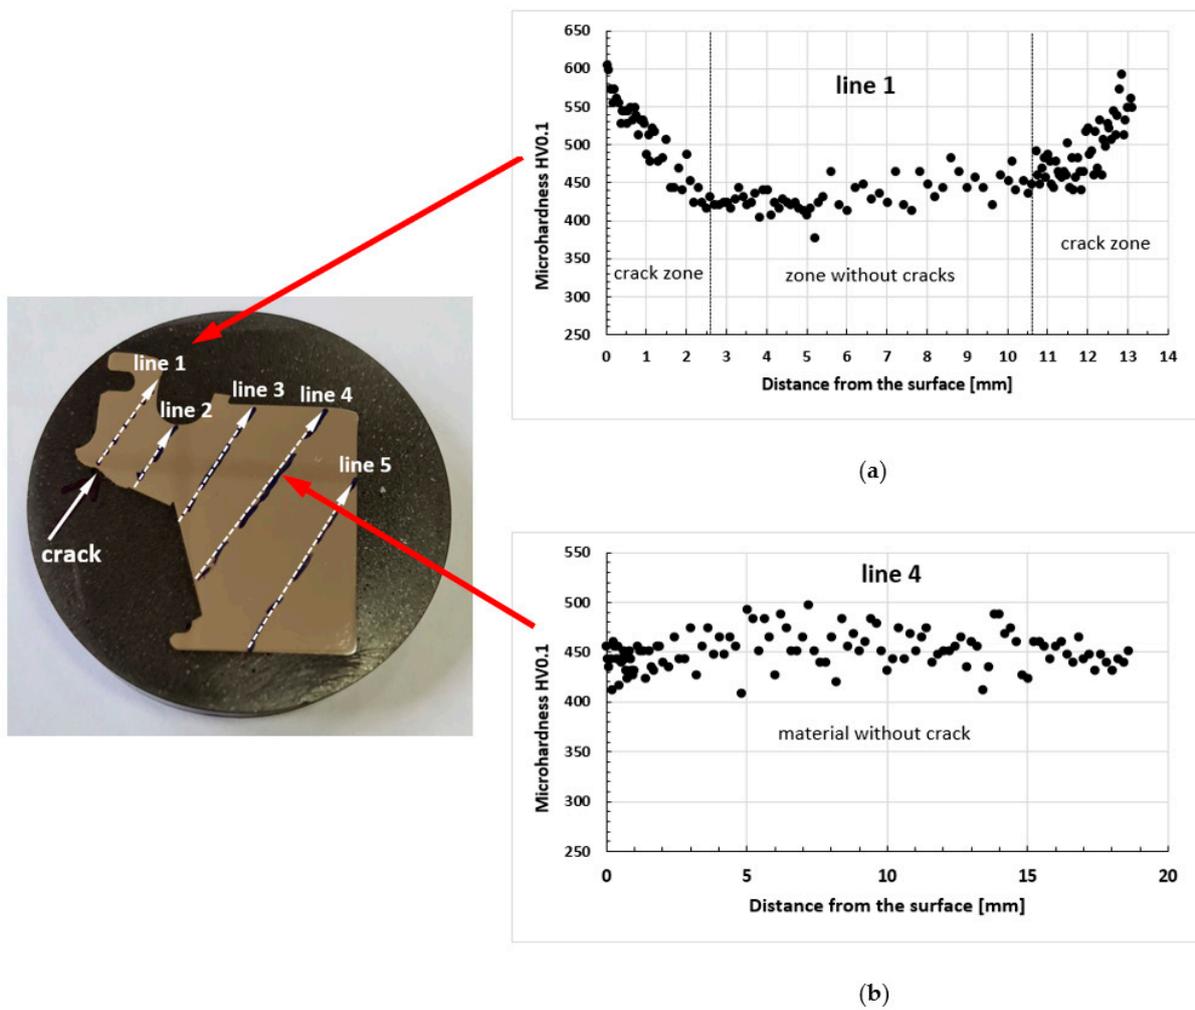
The growth of carbide phases, which are the direct cause of the initiation and propagation of fatigue cracks (see Figures 13e and 14a), was also confirmed by the microhardness measurements (Figure 16). They demonstrated homogeneous distribution of this parameter value at the level of 450HV0.1 in all undamaged areas (Figure 16b), regardless of their location as a function of the disc radius, indicating the macroscopic homogeneity of the material. On the other hand, a noticeable increase in microhardness, to the level of 600HV0.1, was observed in the area of fatigue crack propagation (Figure 16a).

Figure 16. Microhardness distribution along line 1 in the area of crack propagation (a) and along line 4 in the zone of homogeneous material (b).

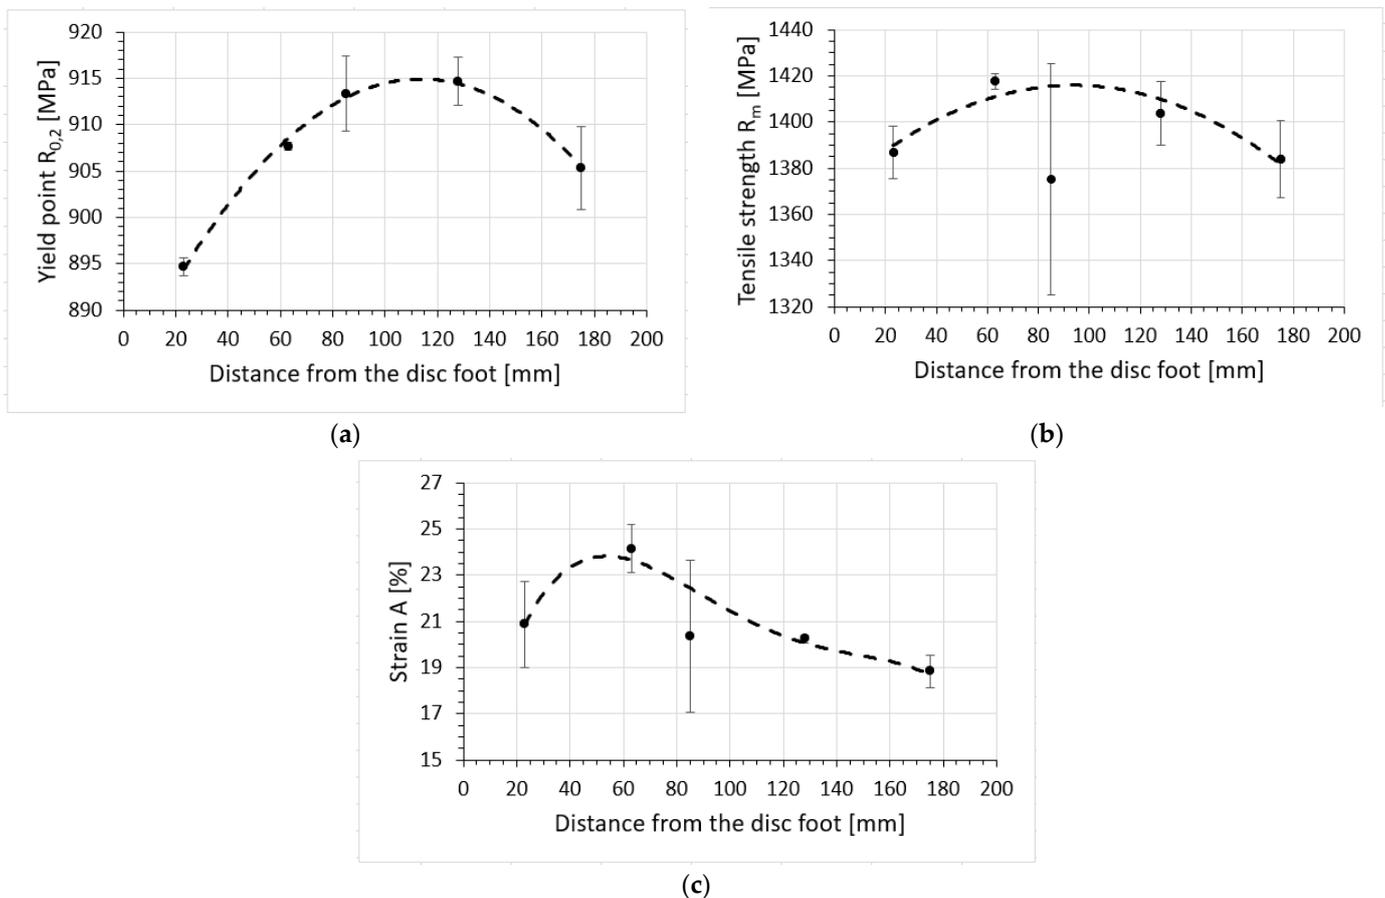
Figure 19. Changing the yield point $R_{0.2}$ (a), tensile strength R_m (b) and strain A (c) of the turbine material as a function of the distance from the disc base.

The strength properties of the turbine disc material, determined by means of a static tensile test, show a non-monotonic change in the strength properties along the disc radius, with the maximum value of $R_{0.2}$ and R_m for the distance from the disc foot plate in the range of 60–130 mm, i.e., in the zone of maximum cooling, with a noticeable decrease in plasticity in the rim area, i.e., the maximum temperature impact area. In addition, it should be noted that the values of strength and plastic properties determined at ambient temperature are lower than those reported in the literature [16,24] for the EP741NP alloy of the 1995 generation, while meeting the requirements for the EP741NP alloy of the 1981 generation (Table 3).

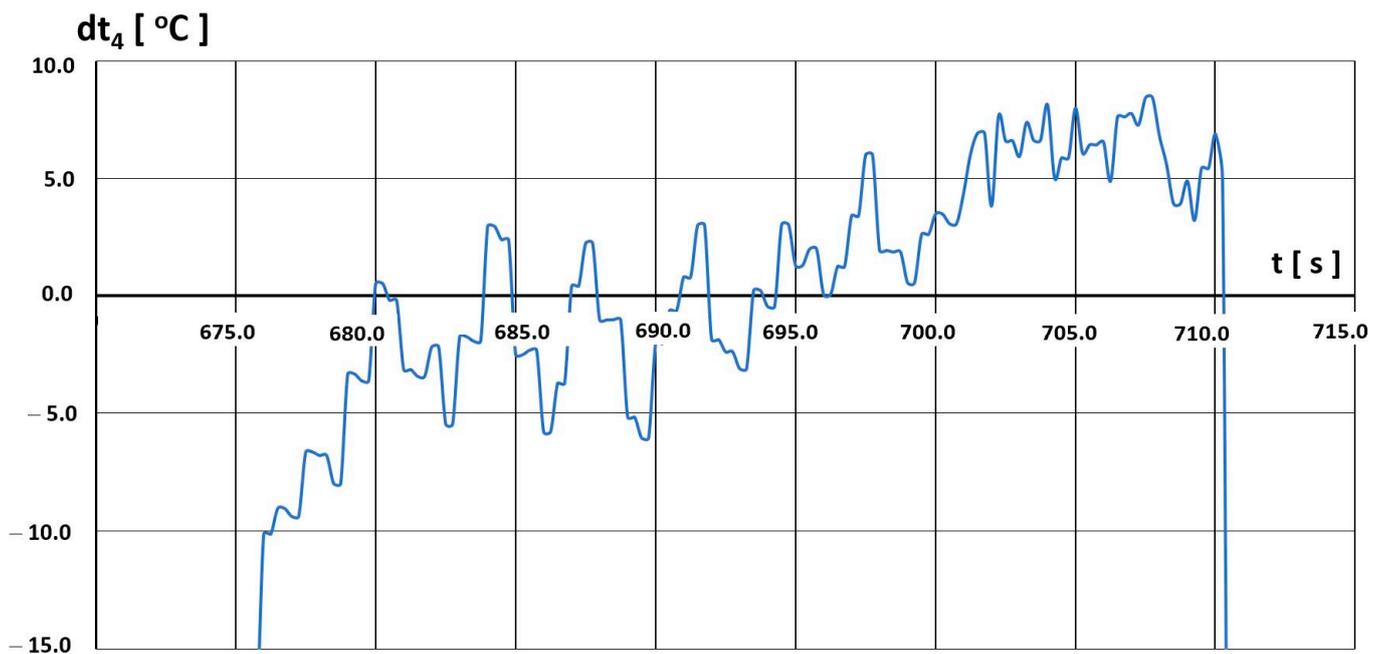
In the first interval (Figure 21), we observed excess temperature values of even up to $dt_4 = 8\text{ }^\circ\text{C}$. In the initial period, from 680 s, the exceedance was of a temporary nature, maintaining more or less the same value in the order of $3\text{ }^\circ\text{C}$. After 15 s, they assumed the character of a continuous exceedance, with the value increasing for 16 s. Temperature exceedance subsided at 711 s.

Figure 21. Temperature t_4 deviations from engine characteristics in the time interval (680–710) s.
