Operational and Material Causes of High-Pressure Turbine Disc Damage in the RD-33 Engine

Abstract: This paper presents an analysis of the causes of damage and fragmentation to the high-pressure turbine (HPT) disc of the RD-33 engine mounted in the MiG-29 aircraft. The authors have carried out an analysis of the changes to the structure of the disc material, both in the areas containing cracks and in the undamaged areas. The impact of structural changes on the alterations in the analysed strength properties along the disc radius was assessed. Material tests were correlated with the analysis of the recorded engine parameters, indicating potential causes of the HPT disc fragmentation.

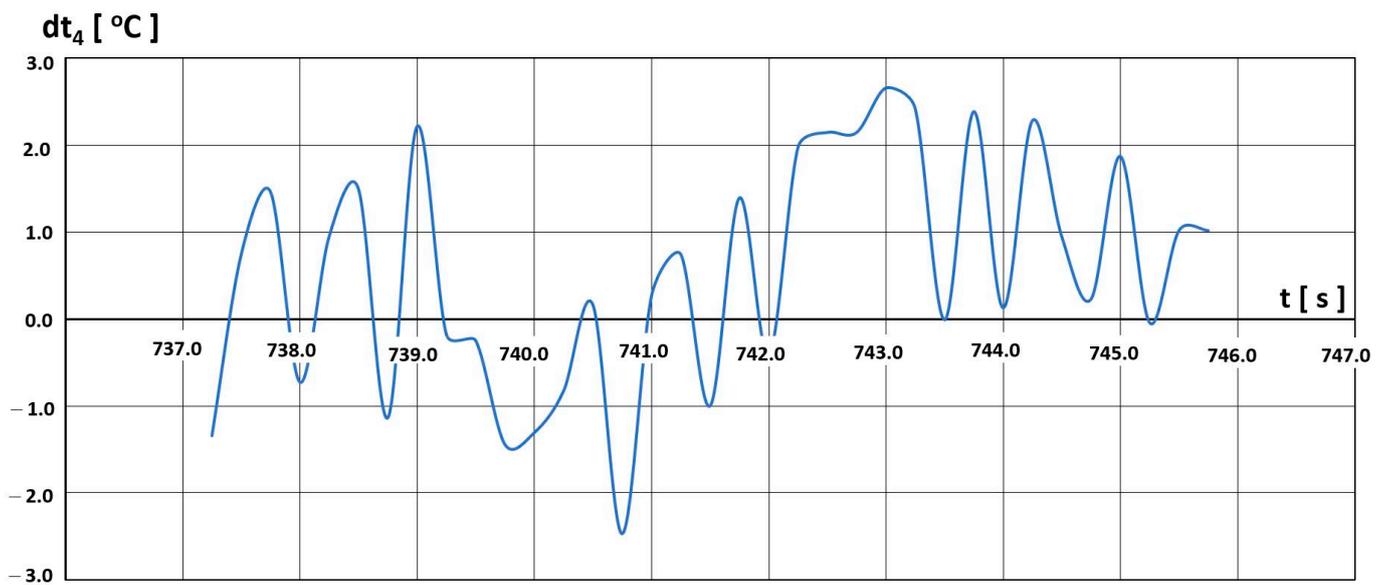
Figure 22. Temperature t_4 deviations from engine characteristics in the time interval (737–746) s.

The second interval (Figure 22) is characterised by a different course of the temperature exceedance dt_4 compared to the first one. The event was not continuous and had an oscillatory character. Exceedances of 2.5 °C are achieved, and the time of the entire interval lasted about 8 s.

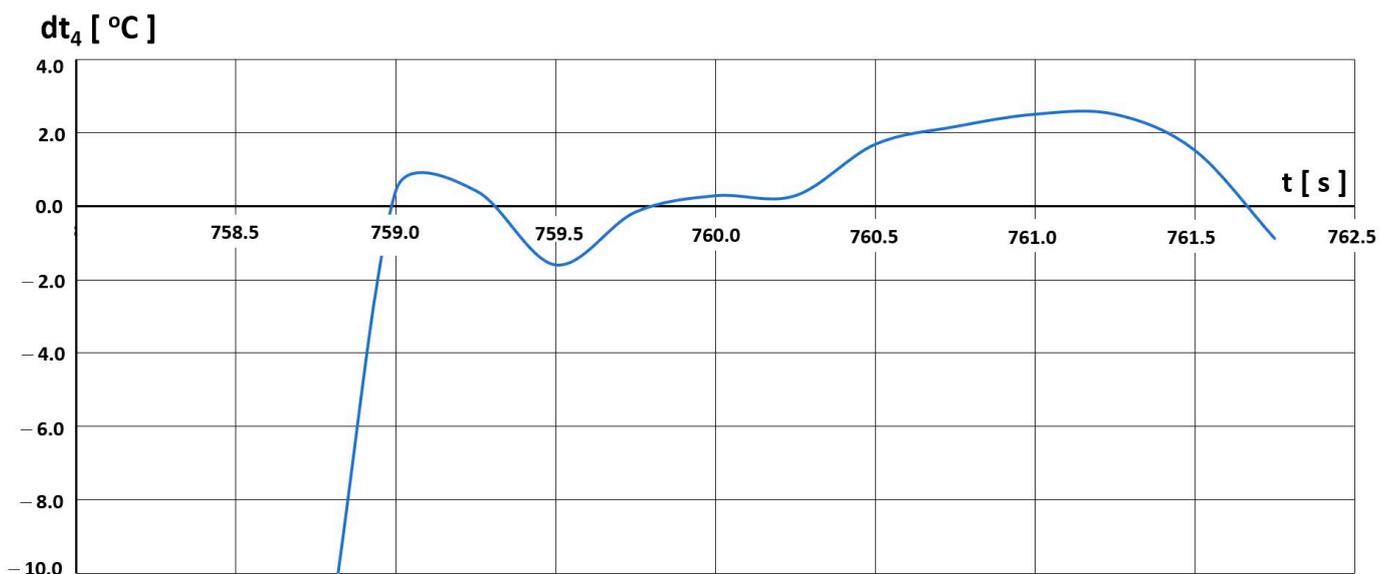
Figure 23. Temperature t_4 deviations from engine characteristics in the time interval (758–762) s.

The third interval (Figure 23) had a completely different course of temperature exceedance. At 759 s, there was a slight exceeding of the permitted limit temperature, which then became continuous in nature, lasting about 12 s, and then reaching a value of up to 3 °C.

This type of exceeding the permitted limit temperature, due to its cyclical nature, may cause turbine strength reduction by increasing the load of this assembly in terms of the thermal stress and low-cycle fatigue. These types of loads are important in the long term because of their cumulative effect, which, in the analysed case, led to the destruction of the tested engine subassembly, the high-pressure turbine disc.
