# Failure Analysis of Cracked P110 Repaired Tubing Used for Gas Transmission

**Abstract:** With green and low-carbon developments in oil fields, an increasing amount of repaired oil tubing is being used as oil and gas transmission pipelines in China. However, due to differences in manufacturing standards between oil tubing and transmission pipelines, there are inevitably some issues during their use. This paper investigates a case of cracking failure in repaired oil tubing used as a gathering and transportation pipeline. The failure occurred after eight months of operation and was characterized by a circumferential crack at the male thread end of the tubing joint. To determine the root cause of the failure, a series of experiments were conducted on the oil tubing. The experiments included visual inspection, chemical composition analysis, mechanical properties testing, hardness testing, metallographic examination, and microstructure analysis. The results revealed that the thread of the cracked tubing was not tightened to the specified position; the connection between the tubing and the coupling was welded in a circumferential direction; and cracks occurred in the heat-affected zone

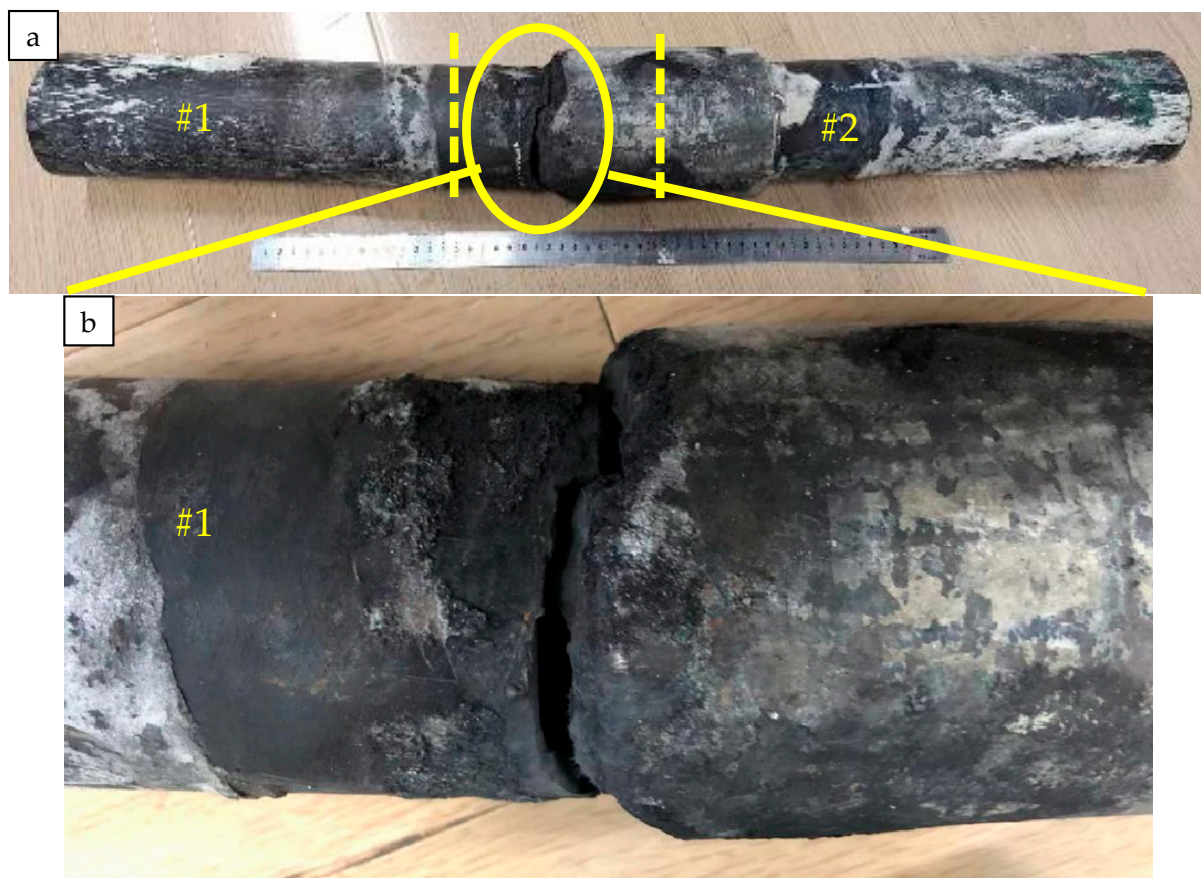
The studied repaired oil tubing used as a gathering and transportation pipeline leaked after being put into operation for eight months. The oil tubing specification is  $\Phi 88.9 \text{ mm} \times 6.45 \text{ mm}$ . The material is P110 or C110 according to API 5CT, and the transmission medium is natural gas; the gas transmission volume is about 100,000 cubic meters per day; the service temperature is  $15 \text{ }^\circ\text{C}$ ; the operating pressure is 5 MPa. According to the transmission medium composition test results, the medium contains 0.7669%  $\text{H}_2\text{S}$  and 2.387%  $\text{CO}_2$ . The leakage region of the oil tubing is the joint, and a circumferential crack occurred at the male thread end, as shown in Figure 1. To find the root cause of the failure, a series of experiments were carried out on the oil tubing.

**Figure 1.** Macroscopic morphology of failed pipe section. (a) The whole pipe (b) The cracked section.

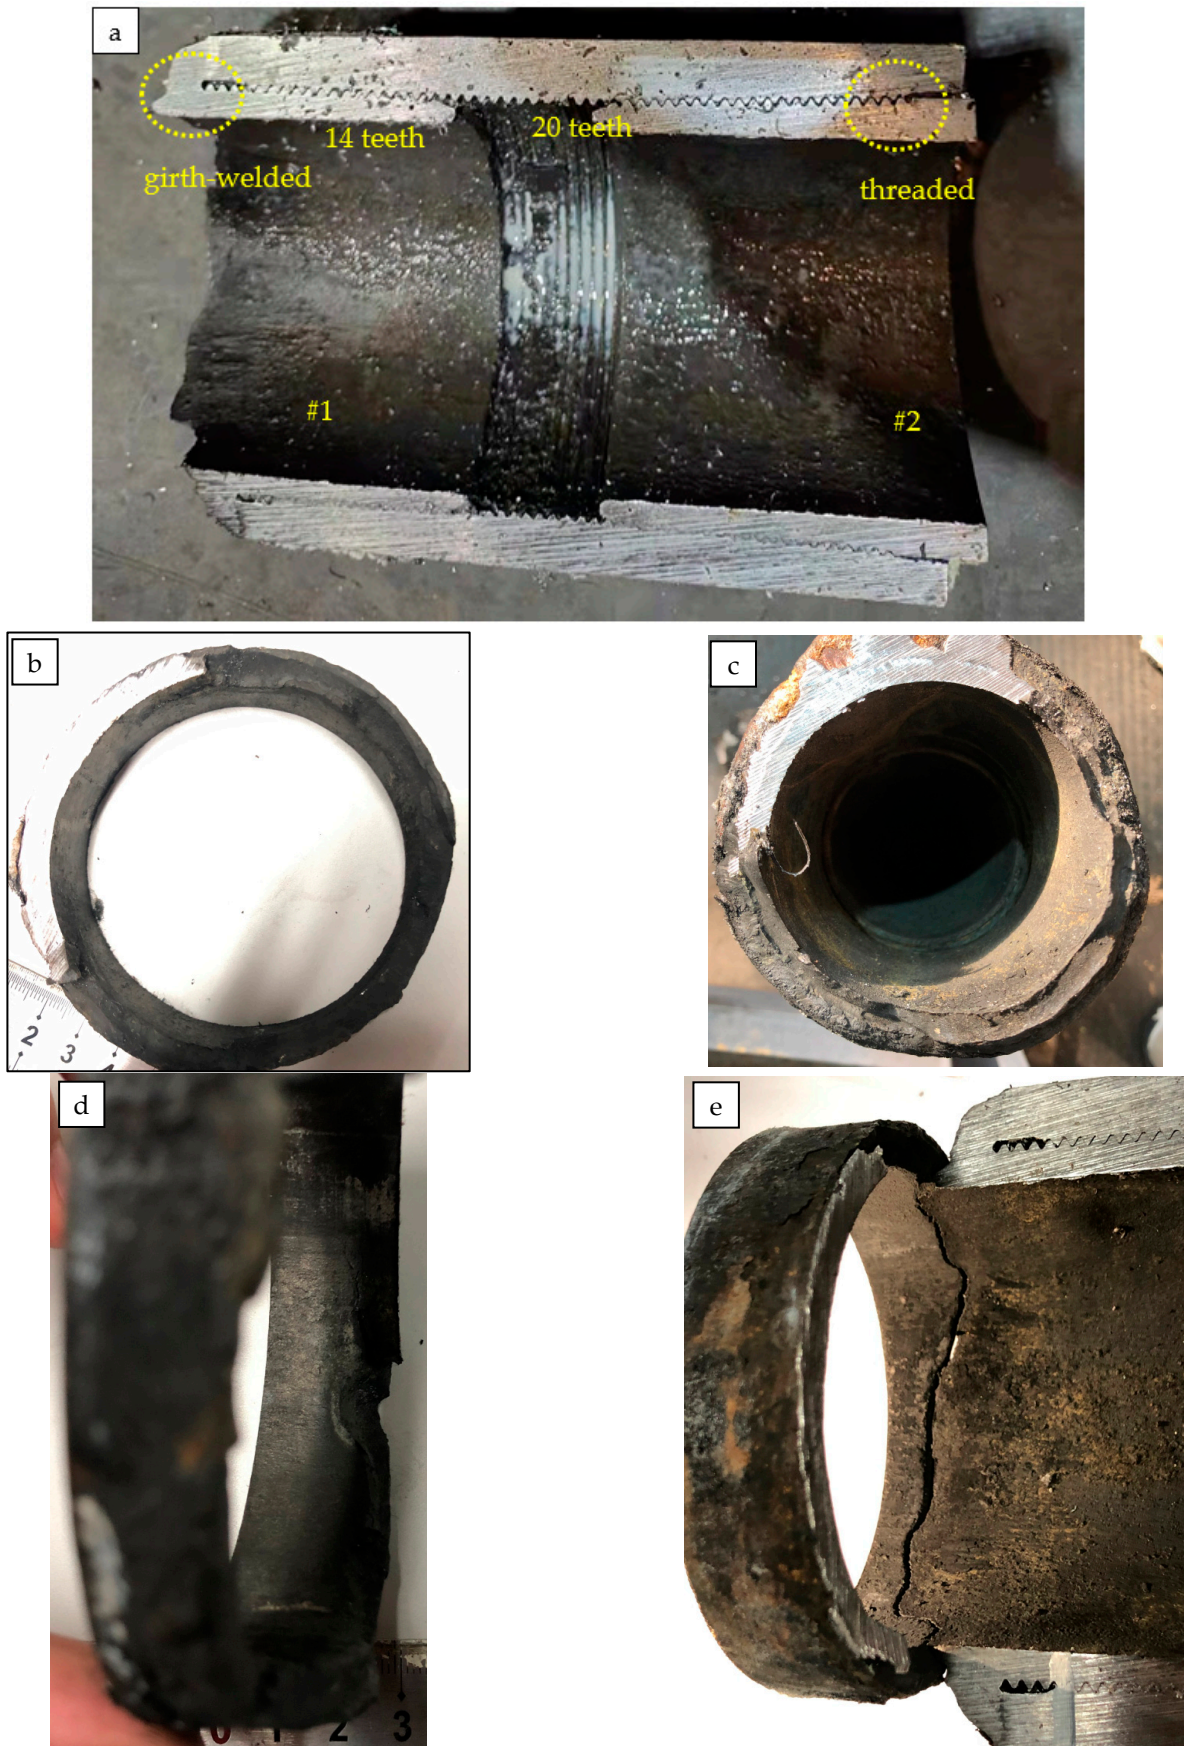
The failed repaired tubing at the coupling was cut in half, as shown in Figure 2; the #1 repaired tubing and the coupling were girth seal-welded at the connection region, while the #2 repaired tubing and the coupling were threaded.

The circumferential crack is located near the girth weld of the #1 tubing; the inner surface of the coupling joint is covered with black oil; and there is no obvious corrosion on the coupling and the #1 and #2 tubing. From the cross-section view, there are 20 teeth in total for the #2 male thread tubing, and about 14 teeth for the #1 male thread tubing. Therefore, it can be inferred that the male thread end of the #1 tubing has not been threaded to the specified position. The surface of the fracture is covered with black matter (Figure 2b,c). Observed from the side view, there is no obvious plastic deformation at the crack of the #1 tubing.

Figure 2. Macroscopic morphology of fracture.

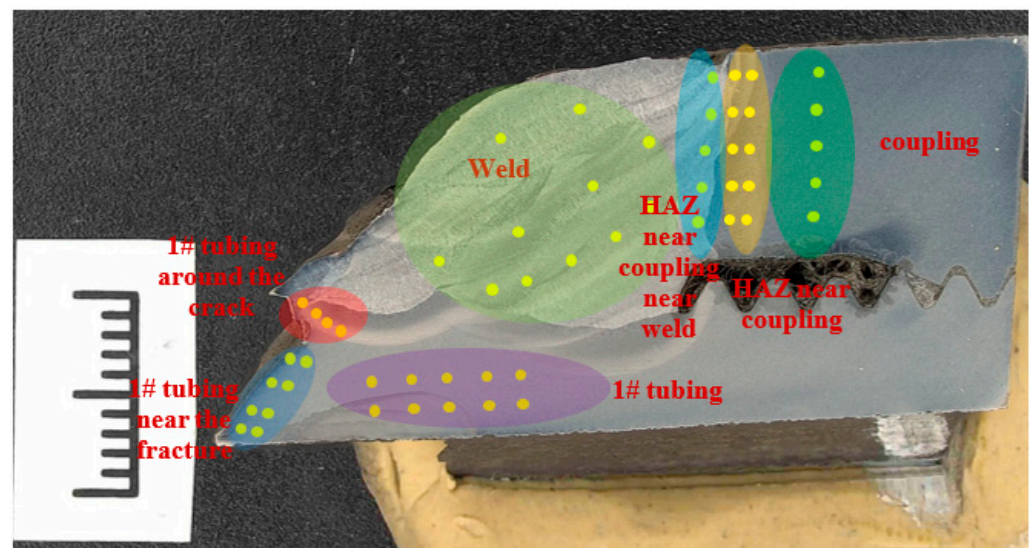
The microhardness of the longitudinal section of the crack region was tested with a DuraScan 70G5 micro-Vickers hardness tester (Emcotest, Kuchl, Austria) according to the ASTM E384-17 standard (Figure 5). The results are shown in Table 5. The hardness of the coupling is between 279 and 334 HV10, and the local hardness of the heat-affected zone of the coupling increases, reaching a maximum of 391 HV10. The hardness of the welding zone is lower than that of the coupling and the tubing, which is about 220 HV10. The hardness of the #1 tubing is about 320 HV10. At the crack of the welding toe of the #1 tubing, the hardness value reaches 476 HV10.

**Figure 5.** Schematic diagram of hardness test at cracked region.

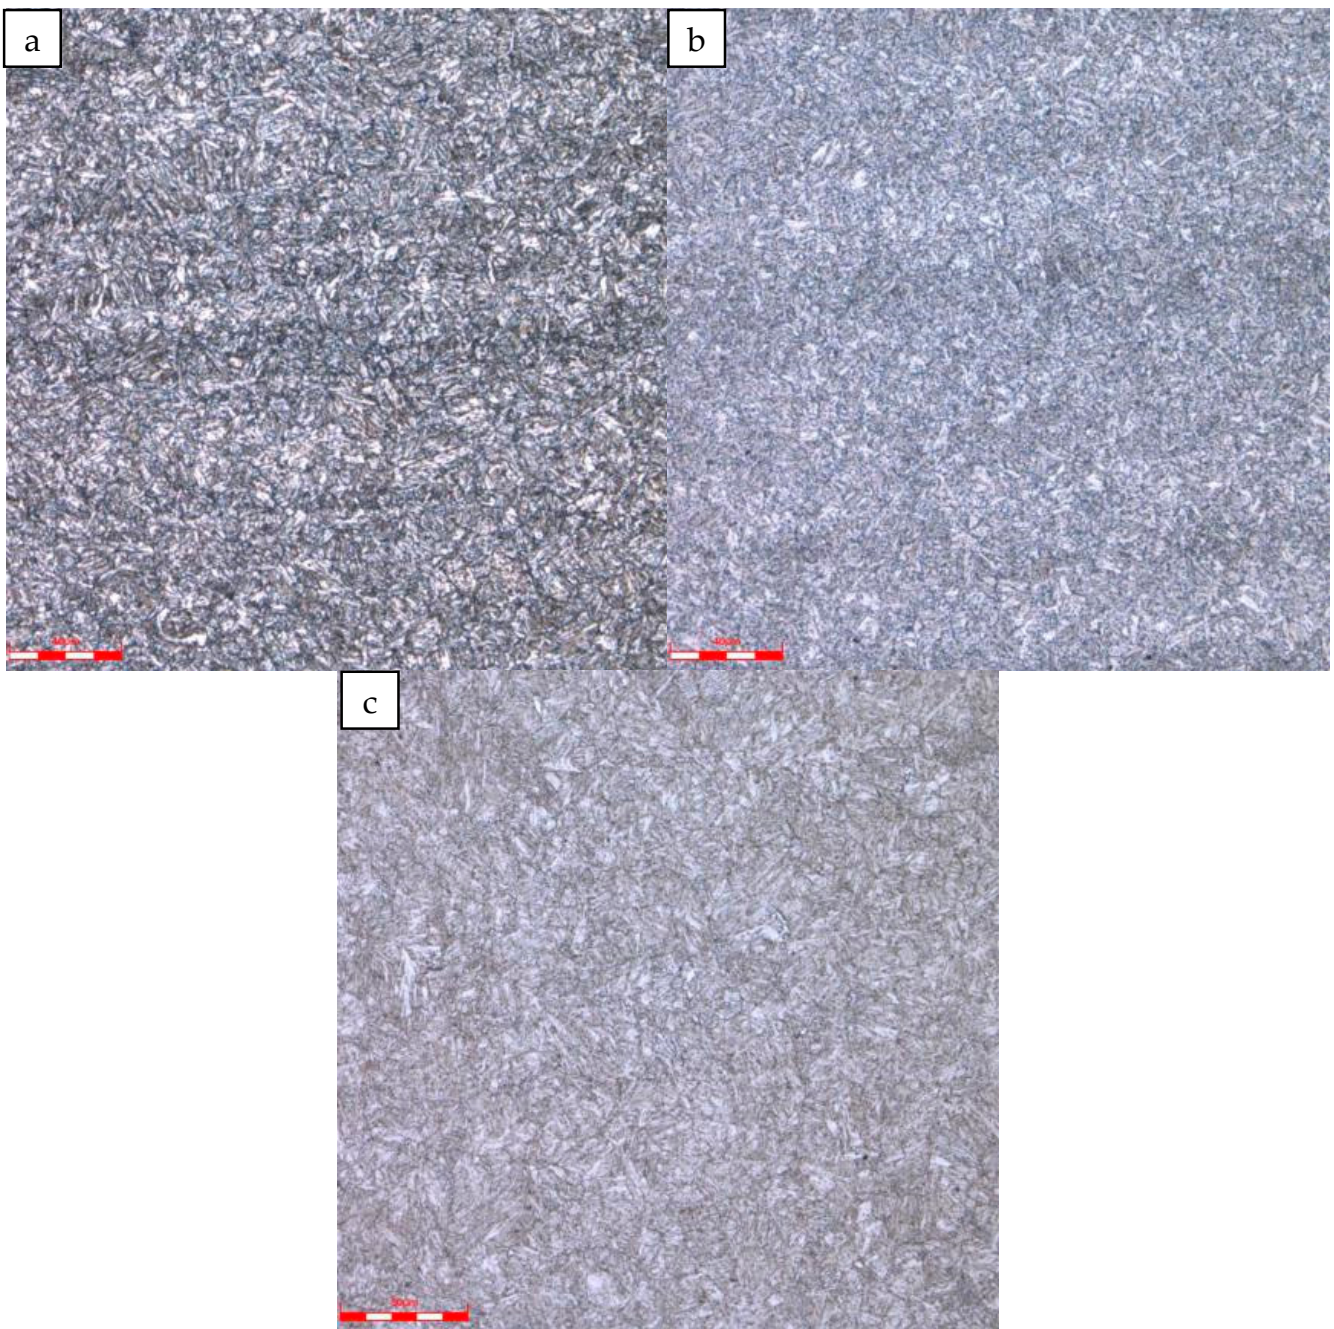
The metallographic structure of the sample was observed under a metallographic microscope. The microstructure of the repaired tubing and coupling was tempered sorbite, and the grain size was 9.5. The microstructure morphology is shown in Figure 6.

**Figure 6.** Microstructure of tubing and coupling: (a) #1 repaired tubing, (b) #2 repaired tubing, (c) coupling.

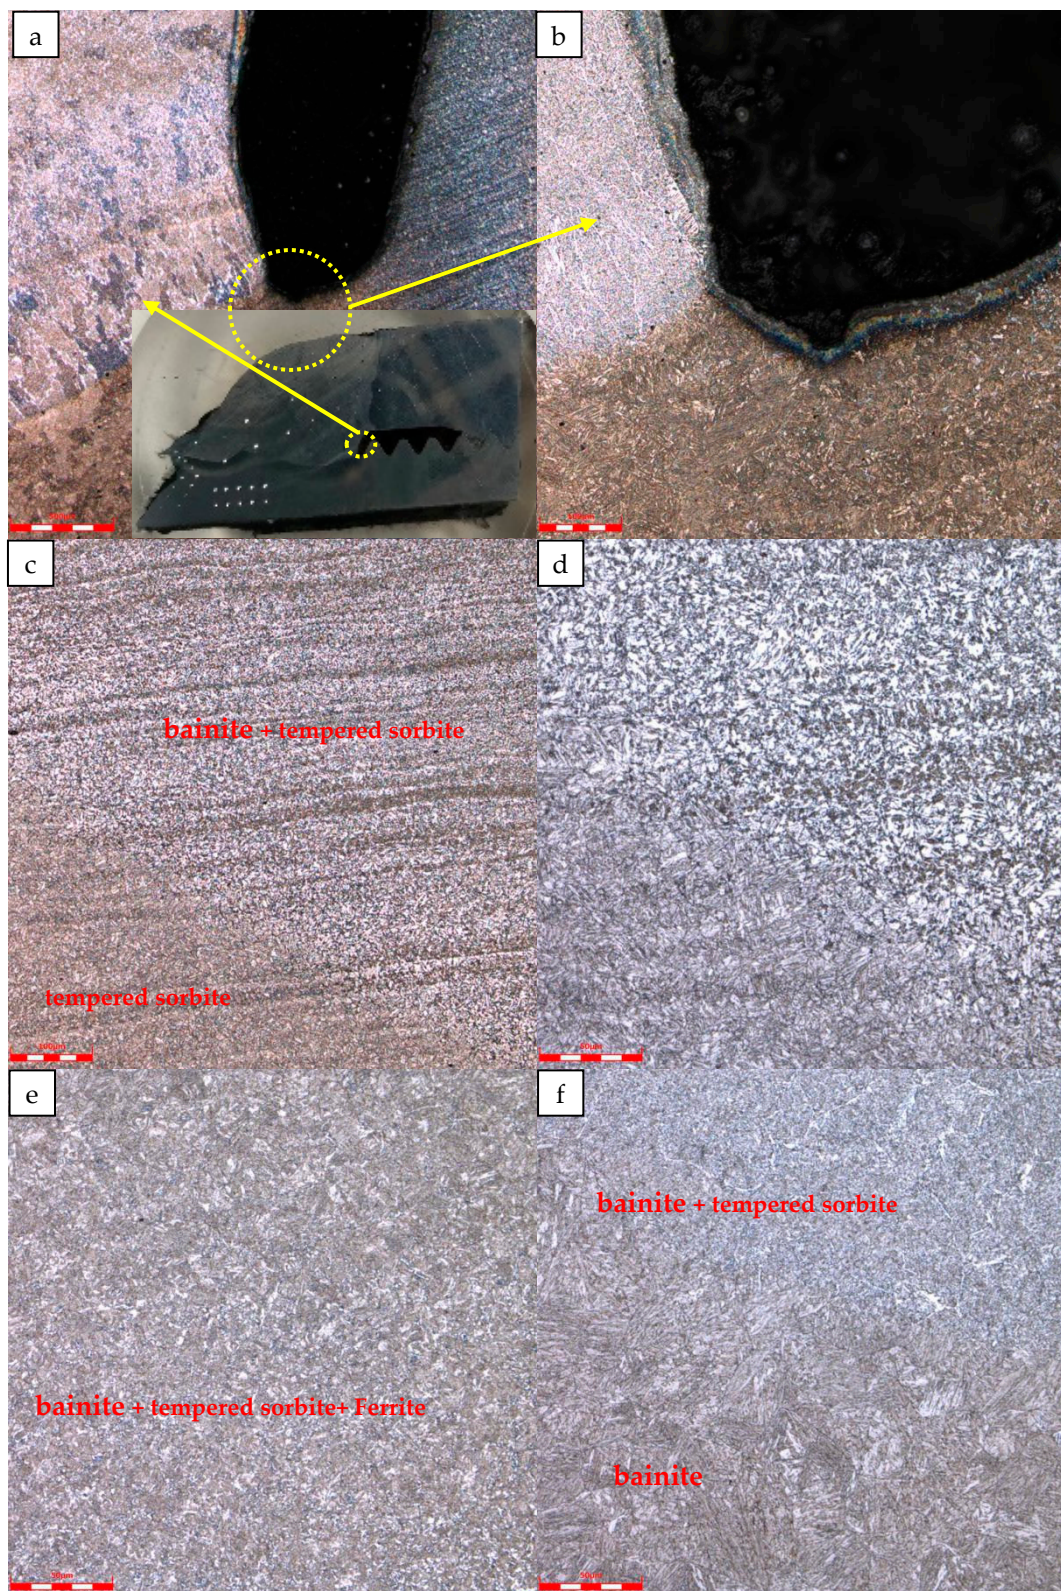
Figure 7 shows the microstructure of the weld and fracture region. The tubing cracked at the heat-affected zone. Flux microstructure in the thread root welding zone of the fracture section is columnar grain, and the thread microstructure is tempered sorbite. The structure of the heat-affected zone of the tubing is tempered sorbite and bainite with a small amount of ferrite. The fusion zone is bainite. No abnormal microstructures were found.

**Figure 7.** Metallographic structure of weld and fracture region: (a) Low magnification of welding microstructure of thread root of fracture; (b) The high magnification of the thread root welding microstructure of the fracture; (c) The low magnification of the heat-affected zone of the tubing; (d) High magnification of the heat-affected zone of the tubing; (e) Microstructure of the heat-affected zone of the tubing; (f) Weld and fusion zone structure of the heat-affected zone of the tubing.

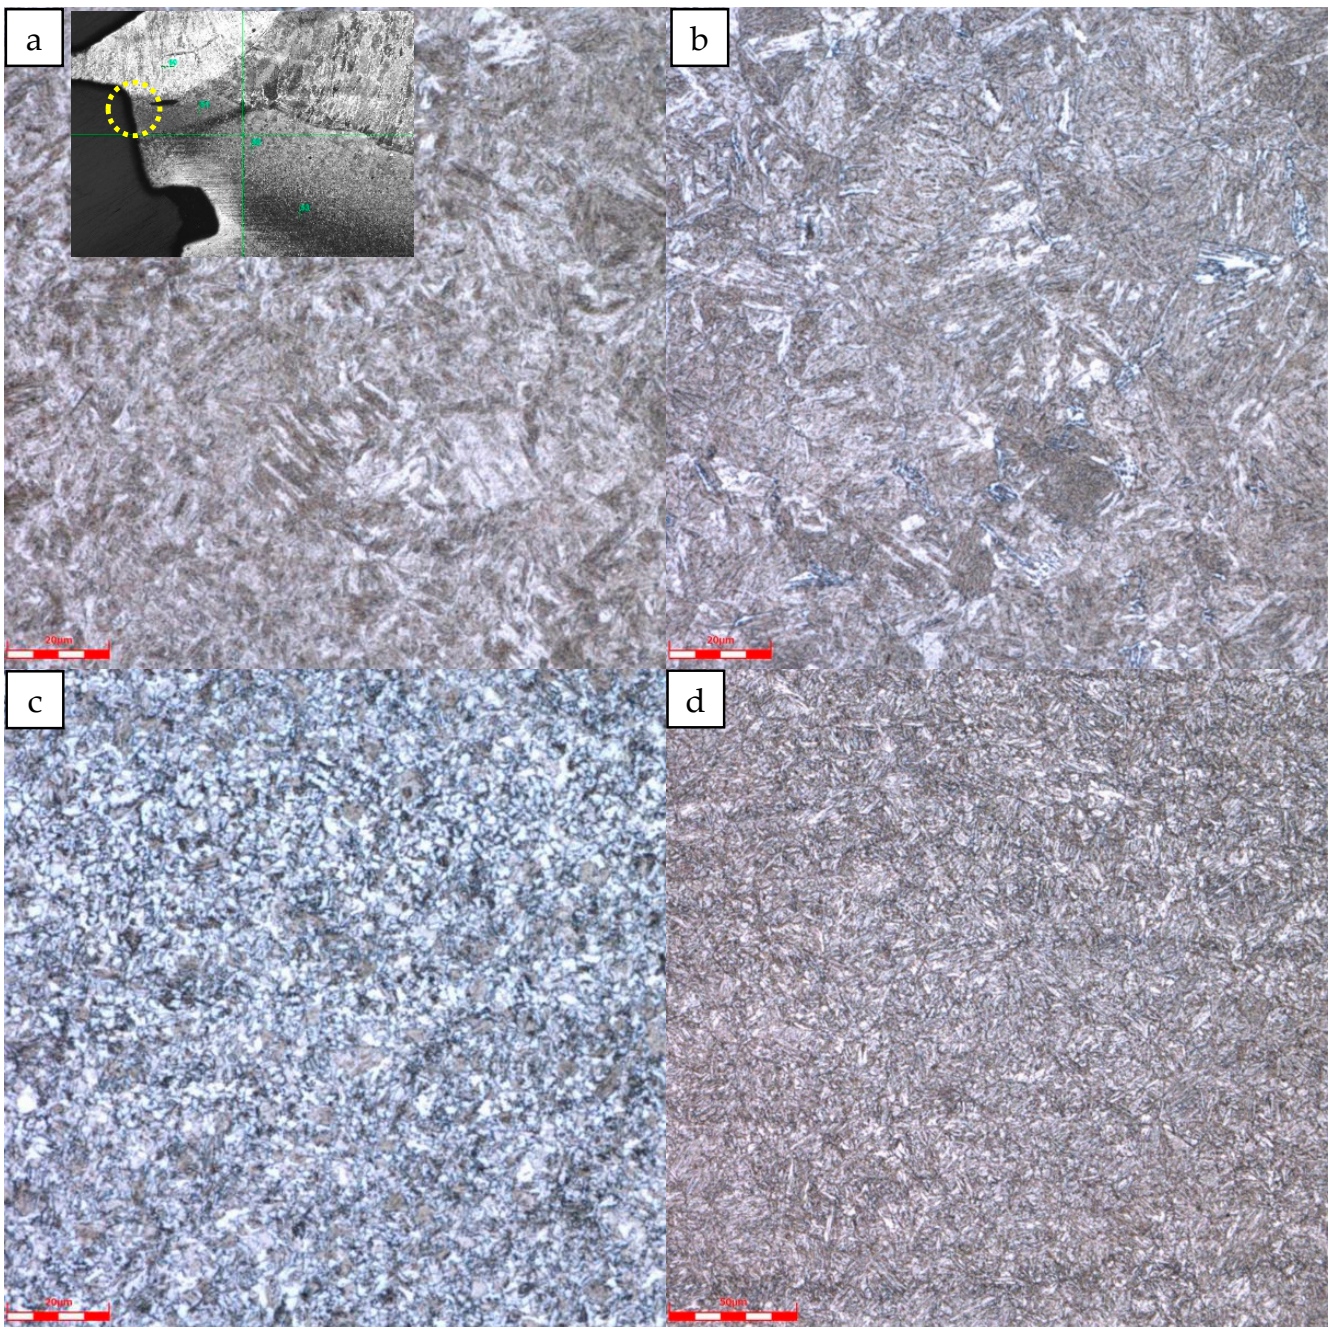
The microstructure near the fracture and the base metal was further analyzed, as shown in Figure 8. At the weld toe of the fracture, the position with the highest micro-Vickers hardness of 476 HV10, the microstructure is martensite; the microstructure in the heat-affected zone of the tubing near the weld is granular bainite; and the microstructure in the heat-affected zone near the tubing is polygonal ferrite with a Martensite/Austenite island; the tubing base metal structure is tempered sorbite.

**Figure 8.** Metallographic structure near the fracture: (a) Microstructure at the weld toe; (b) Microstructure of heat-affected zone near the weld; (c) Microstructure of heat-affected zone near tubing; (d) The microstructure of the tubing base metal.

According to the metallographic and hardness results of the fracture section, the microstructure at the weld toe is martensite with a hardness of 476 HV10. Near the weld in the heat-affected zone of the tubing is granular bainite with a hardness of 361 HV10. The microstructure of the base material is tempered sorbite, with a hardness of about 320 HV10. During the welding process, the cooling speed at different positions is different; the microstructure formed is different; and the volume of the microstructure changes differently, so internal stress will be formed. The lath-like martensite structure at the weld toe is a typical hard and brittle structure of carbon steel, which seriously reduces the toughness of the welded joint, leading to cold cracks [23,24] in the heat-affected zone, resulting in failure. To prevent cold cracks, the welding consumables could be dried; the base metal and welding consumables could be degreased and cleaned; and the residual stress could be eliminated by heat treatment after welding.

- (1) It is not suitable to use repaired tubing for medium transportation under the conditions of high-pressure gas transmission.
- (2) When repaired tubing is used for gathering and transportation construction, special measures should be taken to ensure that the thread is screwed up to the designated position.
- (3) To weld the repair tubing, the welding consumables could be dried; the base metal and welding consumables could be degreased and cleaned; and the residual stress could be eliminated by heat treatment after welding.

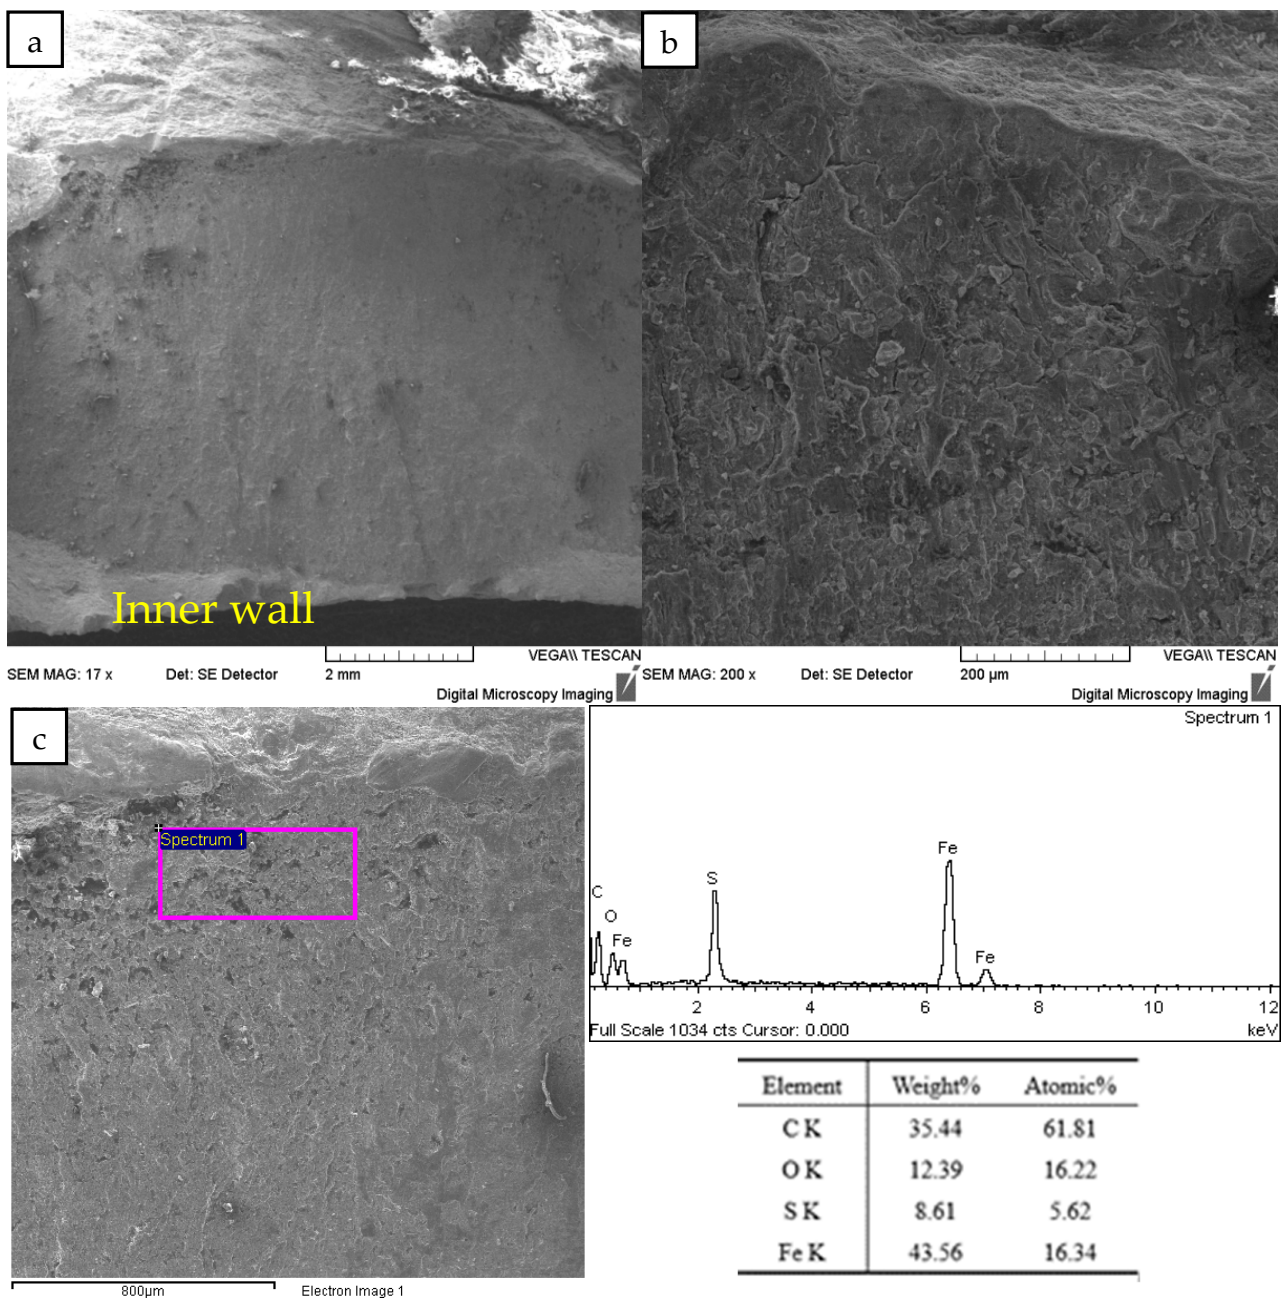
The cross-sectional morphology of the fracture was observed under a scanning electron microscope, as shown in Figure 9. The fracture is flat with radial patterns on the cross section converging on the outer wall. There is a shear lip on the inner wall, which is the characteristic of the arrest area of the fracture, so it is inferred that the outer wall is the origin of the crack. Observed under high magnification, the fracture surface is covered with corrosion products, and no dimple ductile fracture characteristics are found. The surface corrosion product was characterized by an energy disperse spectrum, and the corrosion product contained C, O, S, and Fe elements, which was consistent with the H<sub>2</sub>S and CO<sub>2</sub> contained in the medium, indicating that the crack was corroded by H<sub>2</sub>S and CO<sub>2</sub>.

**Figure 9.** Cross-section morphology and energy dispersive spectrum results: (a) Low magnification of crack source region; (b) High magnification of crack source region; (c) Schematic diagram and results of EDS.

According to the fracture analysis, the crack of the #1 repaired tubing originated from the outer wall, so the failure caused by internal corrosion of H<sub>2</sub>S and CO<sub>2</sub> can be ruled out. From the cross-sectional metallographic view, the crack propagates along the heat-affected zone, so it is inferred that the root cause of the cracking is related to welding.

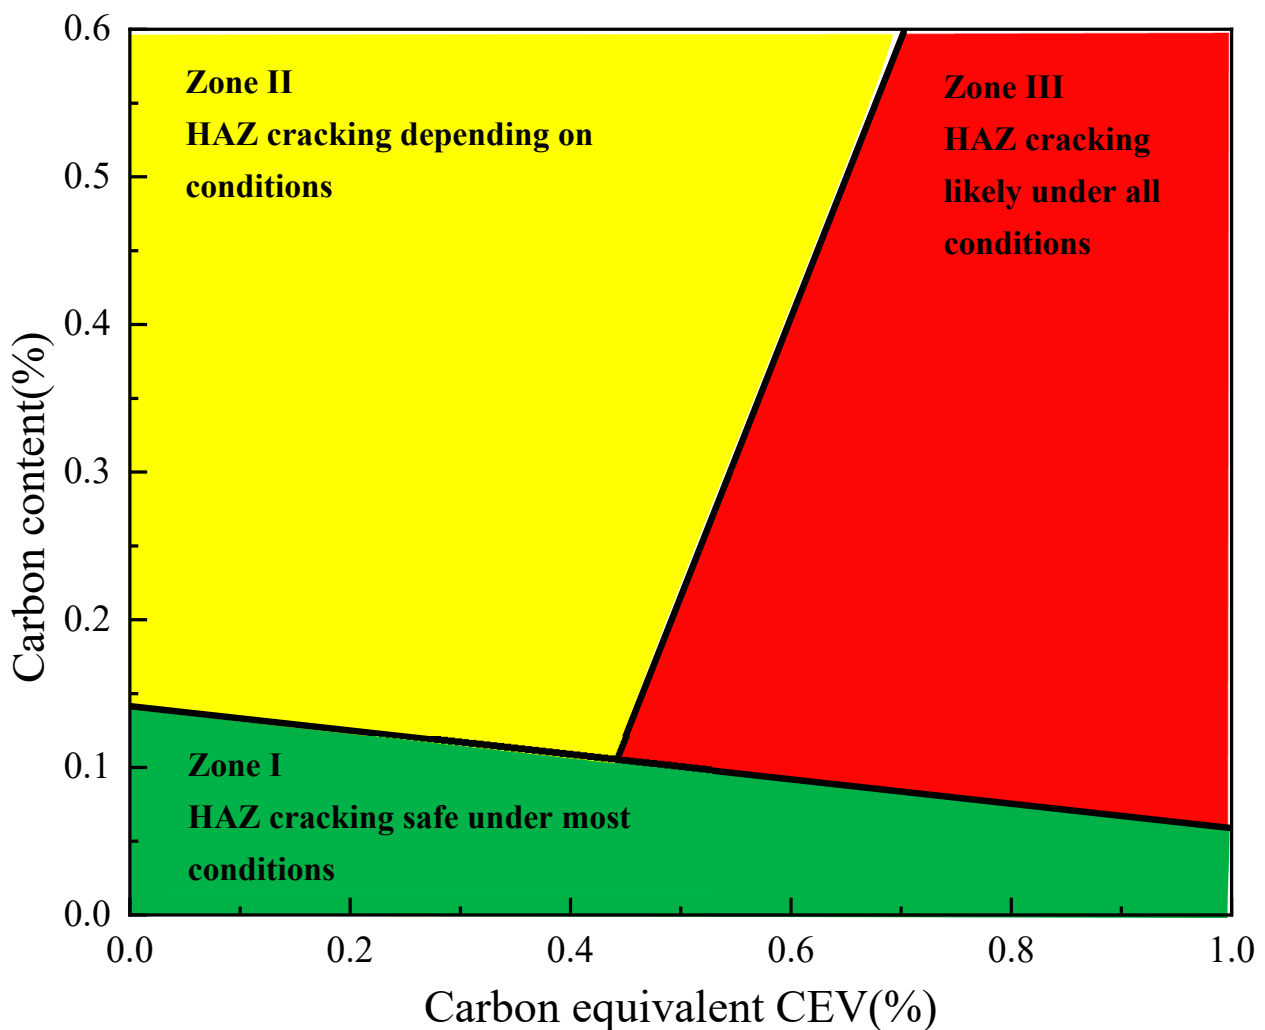
According to Equation (1), the carbon equivalent value of the #1 repaired tubing is calculated as 0.5369%, which indicates that the #1 repaired tubing has poor weldability and is a difficult-to-weld material. According to the cracking tendency Graville diagram [15,16] of the welding heat-affected zone as shown in Figure 10, the #1 repaired tubing material is located in the cracking zone II of the heat-affected zone, close to zone III, and is a possible cracking material.

**Figure 10.** Cracking tendency—Graville diagram of welding. Black square indicated cracking tendency of #1 repaired tubing.

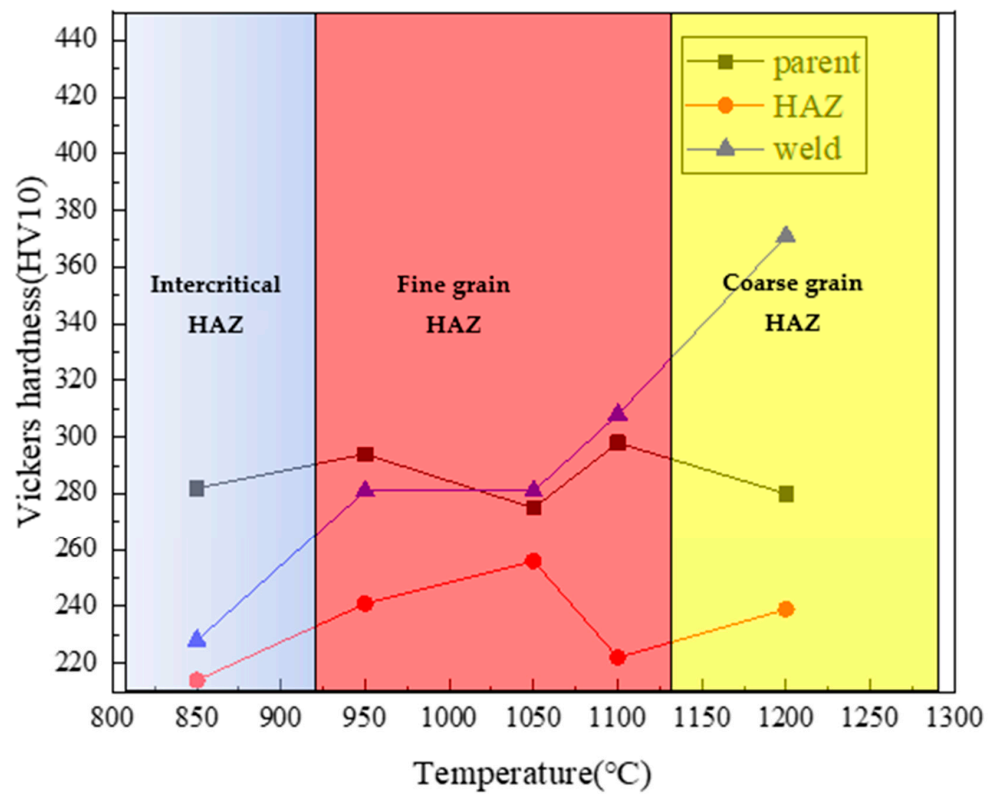
The hardness and microstructure of the tubing base metal at different simulated peak temperatures after thermal simulation are shown in Figures 13 and 14. The results show that when cooling from 850 °C, the tempered sorbite of the parent metal of the tubing transforms into ferrite, pearlite, and bainite, which exhibit a low hardness value, 228HV10. When cooling from 950, 1050, and 1100 °C, the tempered sorbite transforms into bainite, ferrite, and pearlite, exhibiting relative high hardness values, 281~308 HV10. When cooling from 1200 °C, the base metal transforms into martensite with a little granular bainite, exhibiting the highest hardness value of 371HV10.

Figure 13. Microhardness value of thermally simulated samples at different peak temperatures.

According to the International Institute of Welding, the maximum Vickers hardness in the heat-affected zone (HAZ) should not exceed 350HV10, and the presence of martensitic structure should be avoided [21,22]. From the thermal simulation results, it is observed that martensitic structure appears in the coarse-grained heat-affected zone (CGHAZ) with a maximum hardness of 371HV10, which is higher than the specified limit of 350HV10. This indicates poor weldability of the material and an increased susceptibility to cold cracking.

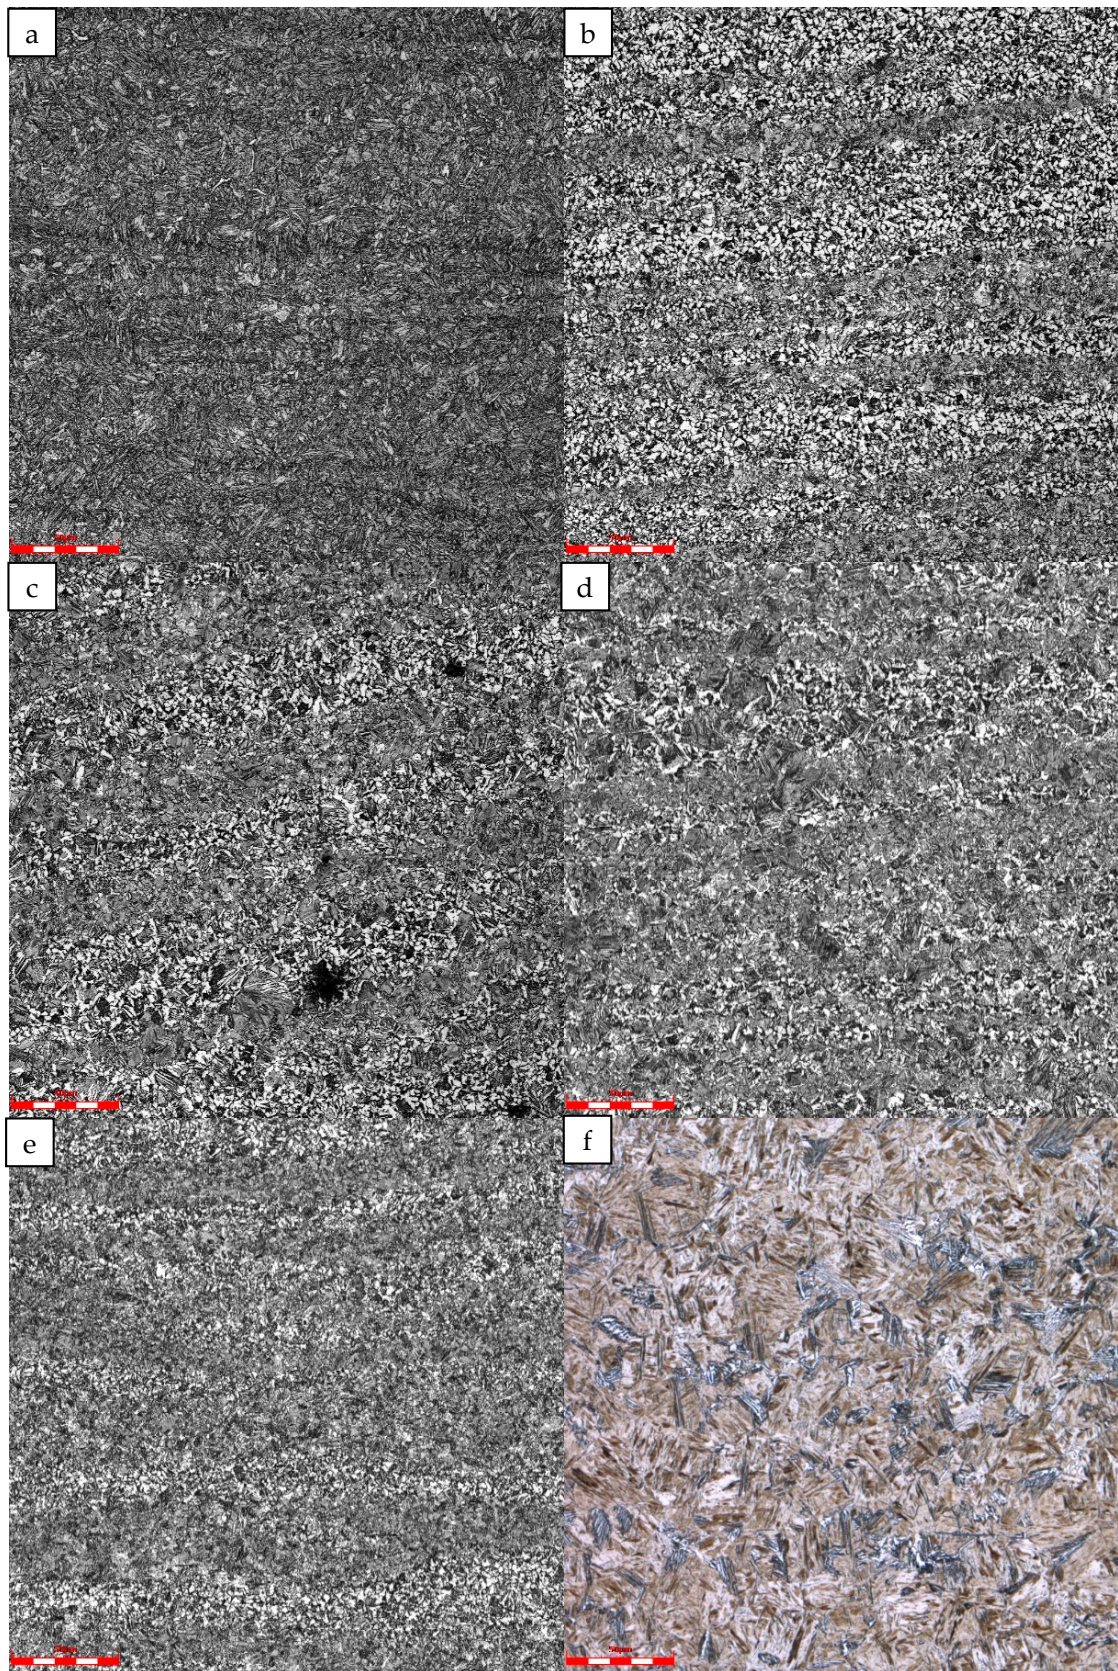
**Figure 14.** Optical microstructure of #1 repaired tubing base material at different simulated peak temperatures: (a) base material, (b) 850 °C, (c) 950 °C, (d) 1050 °C, (e) 1100 °C, and (f) 1200 °C.
