Research on 18th-Century Building Structures in Terms of Static Scheme Changes

Monika Mackiewicz ^{1,*}

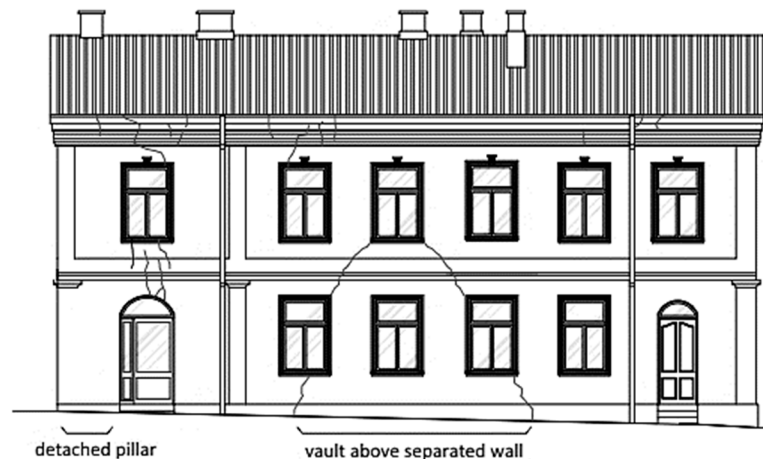
Figure 1. Separation of the wall fragments, due to scratches and cracks, into smaller parts that work independently.

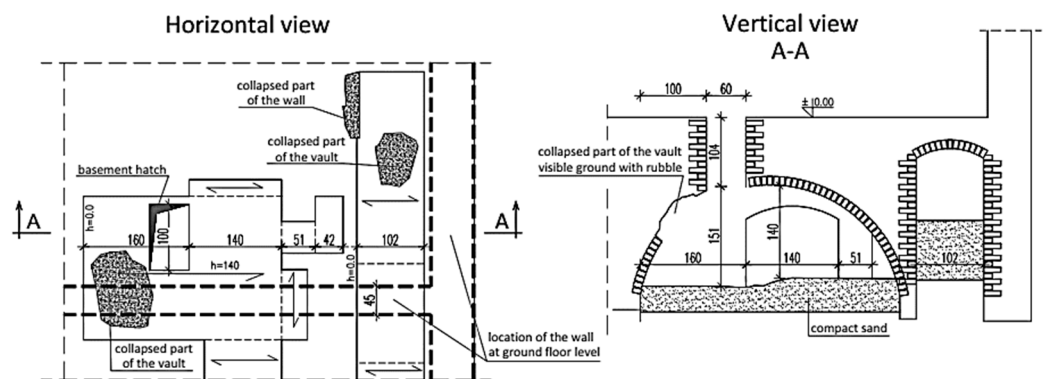
Figure 2. The structural arrangement of a basement vault from the turn of the 18th and 19th centuries.

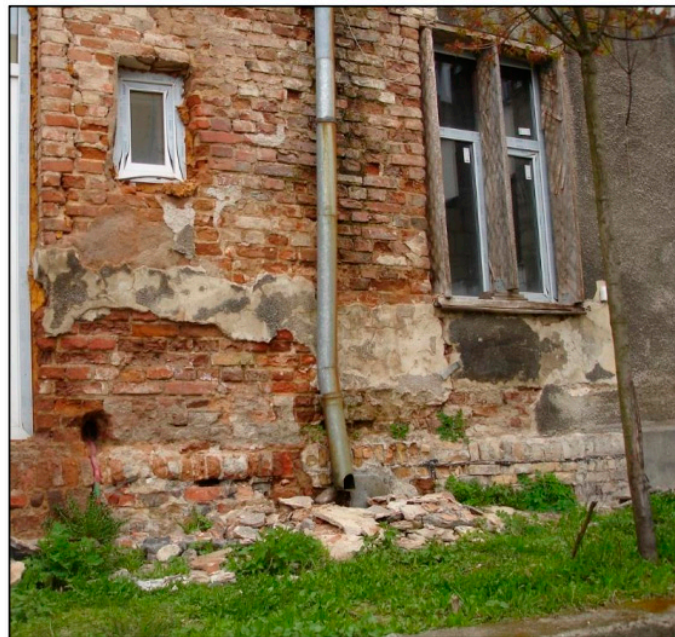
Figure 3. Damage to a plaster and brick wall due to leaking drainpipes.

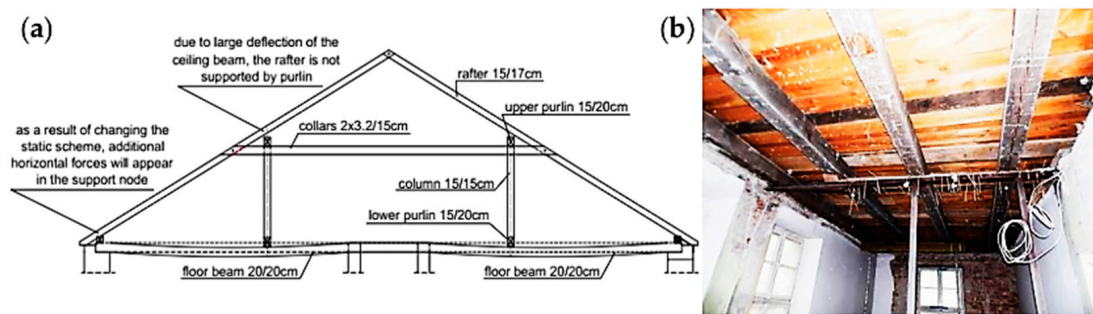
Figure 4. Deformation of a ceiling with wooden beams: (a) roof truss structure supported on the deformed ceiling and (b) view of the ceiling temporarily supported in order to limit the deflection.

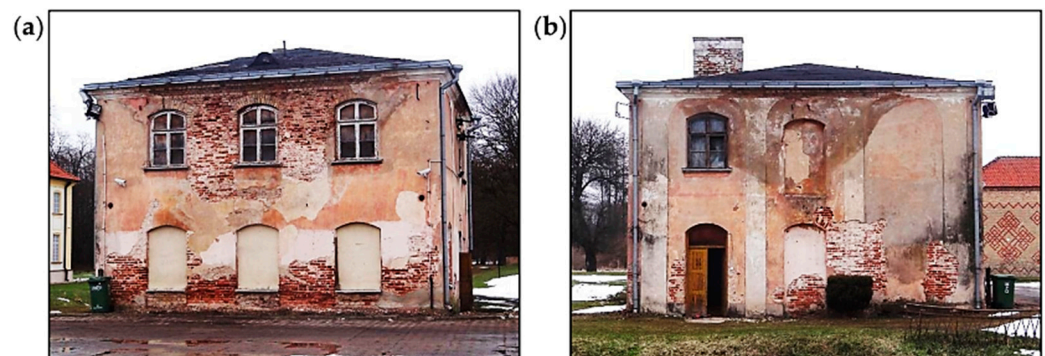
Figure 5. Pavilion building: (a) front elevation and (b) side elevation.

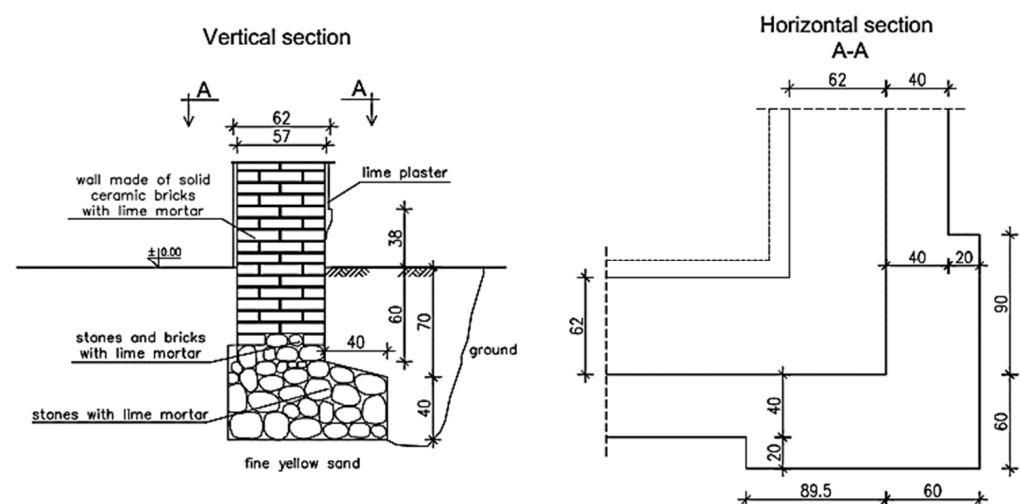
Figure 6. Vertical and horizontal sections of the foundation extension in the building corner.

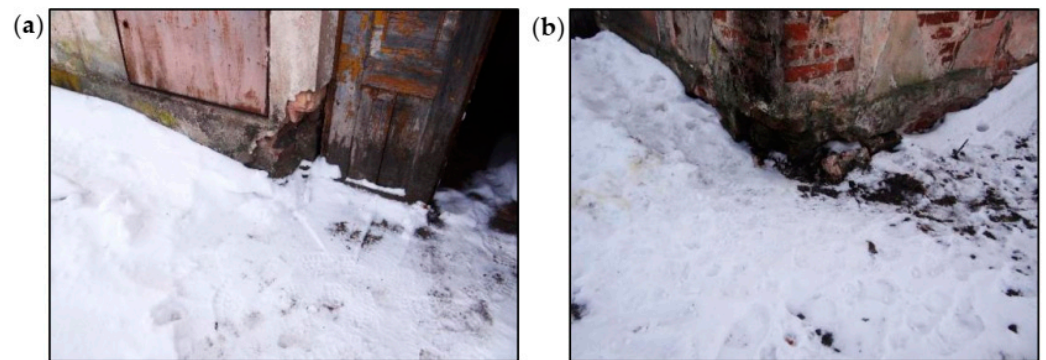
Figure 7. View of defects in external brick walls: (a) near a door opening and (b) in the corner of the building.

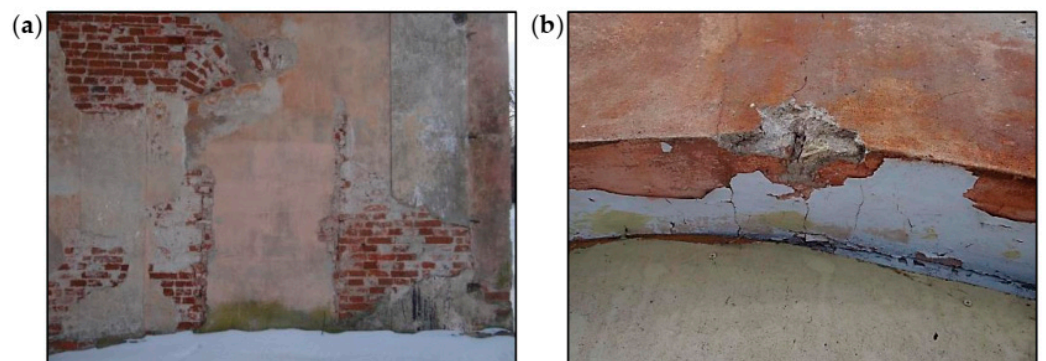
Figure 8. Damage to external walls: (a) plaster losses and bricked-up door opening and (b) crack in the arch above the window.

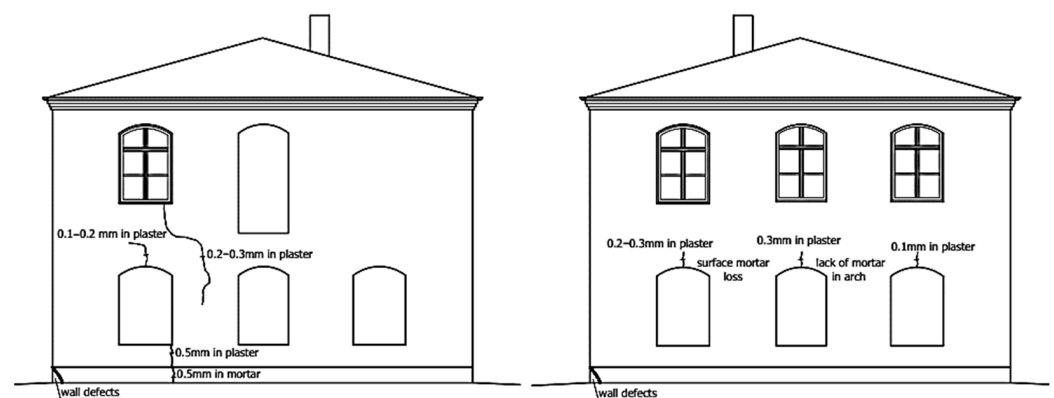
Figure 9. Inventory of scratches on two external walls.

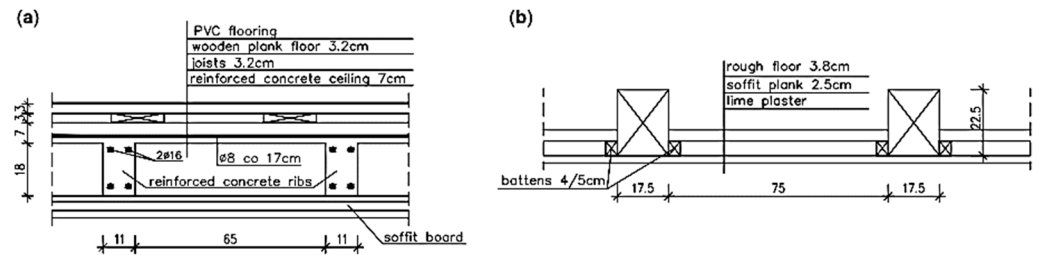
Figure 10. Ceiling sections: (a) concrete ceiling above the ground floor and (b) wooden ceiling above the first floor.

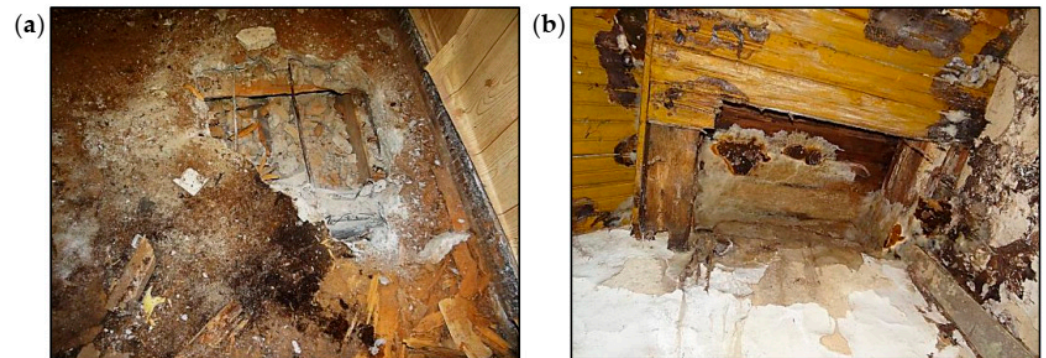
Figure 11. Ceiling opencasts: (a) from the top of the reinforcement concrete ceiling and (b) from the bottom of the wooden ceiling.

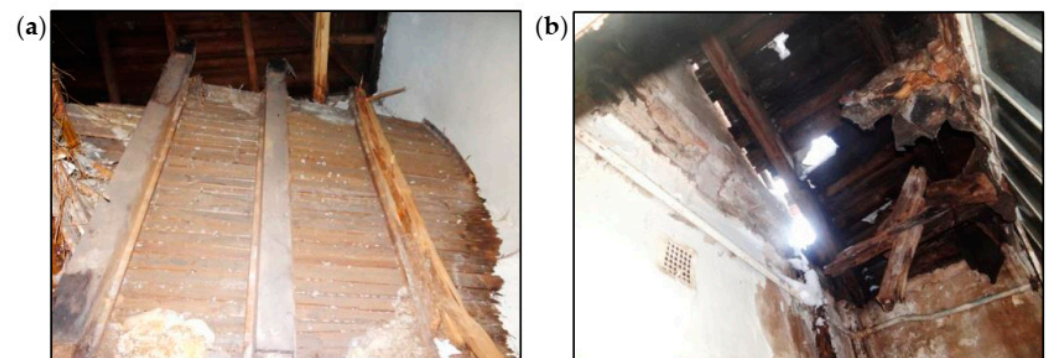
Leaks in the roof covering caused dampness in the wooden elements of the roof truss, and the biological corrosion developed. Wooden elements close to the chimney eaves and a leaky roof covering were significantly damaged. Some of the rafters were damaged in the places where they rested on the roofing wall plates. The collapse of the wooden ceiling above the first floor caused the pillar walls of the roof truss to be supported only on the brick walls and fragments of the remaining ceiling. The pillar walls above the staircase and the room on the southeast side had no support.

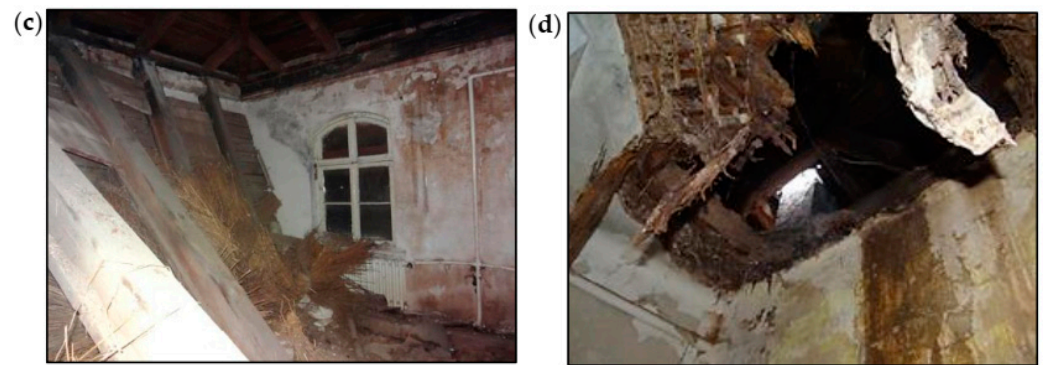
Figure 12. View of the collapsed wooden ceiling: (a,b) above the staircase and (c,d) above a room on the first floor.

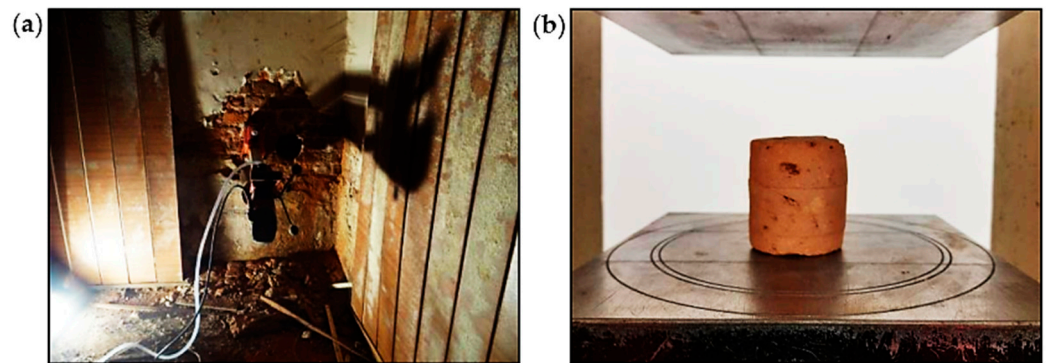
Figure 13. Destructive testing: (a) cutting out brick samples from the wall and (b) the strength test of a brick.

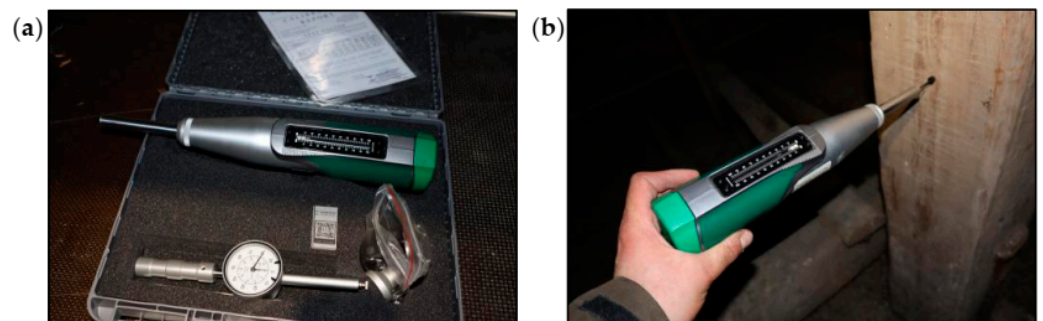
Figure 14. Woodtester: (a) view of the device and accessories and (b) during the test.

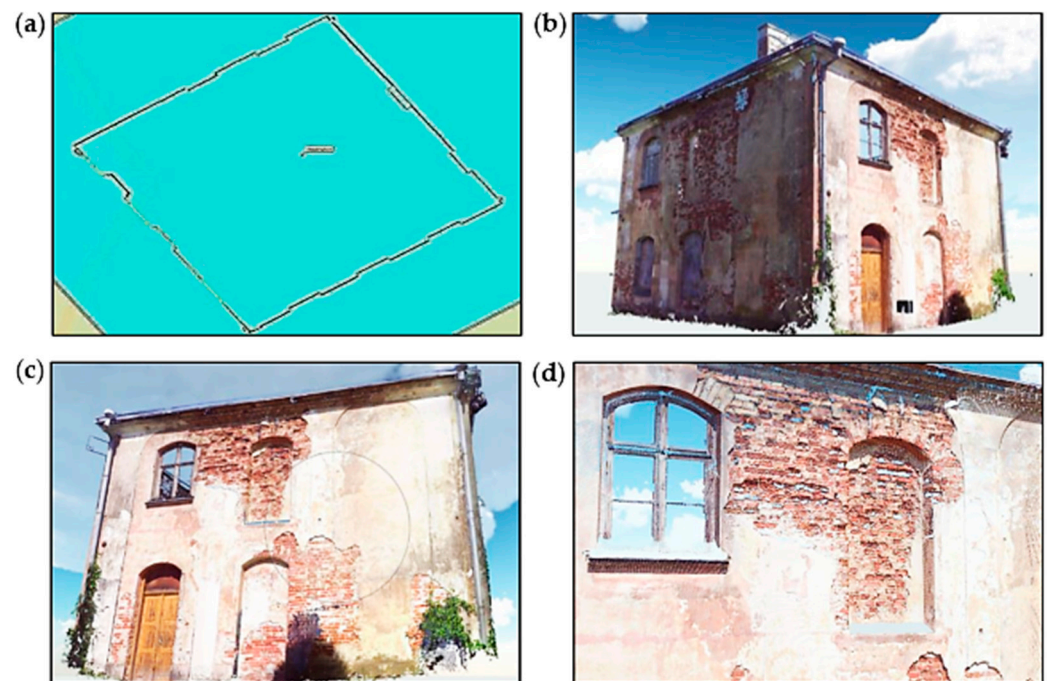
Figure 15. Images obtained based on the point cloud: (a) horizontal projection with building dimensions; (b,c) a view of the external walls and (d) a view of defects in the brick wall.

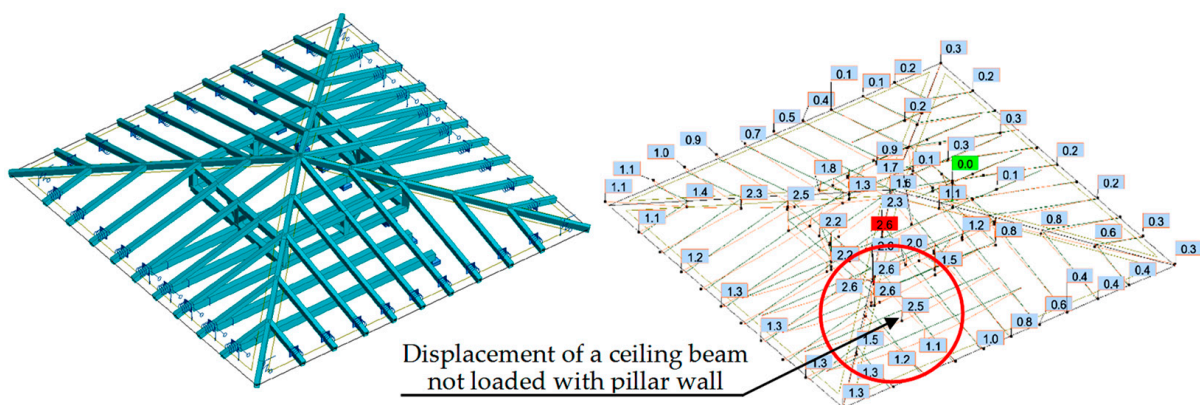
Figure 17. Variant I—model and displacements due to permanent loads.

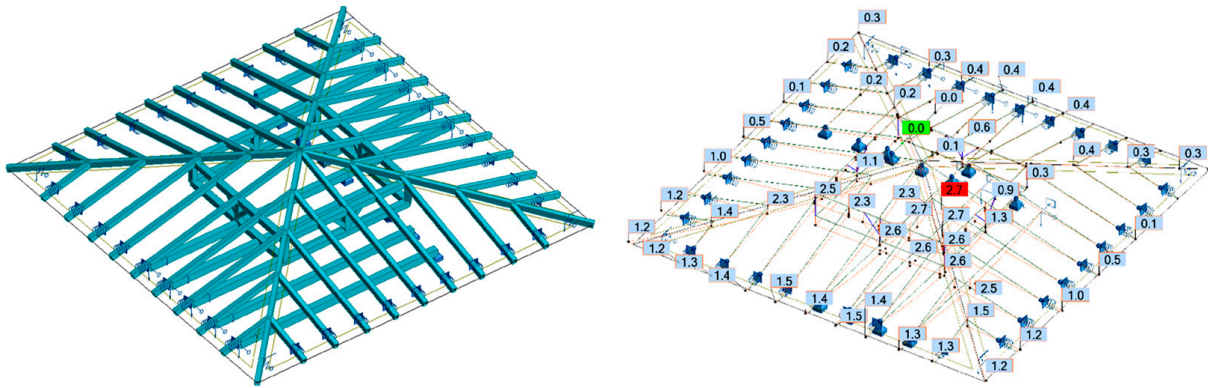
Figure 18. Variant II—model and displacements due to permanent loads; the pillars and swords can transfer only compressive forces.

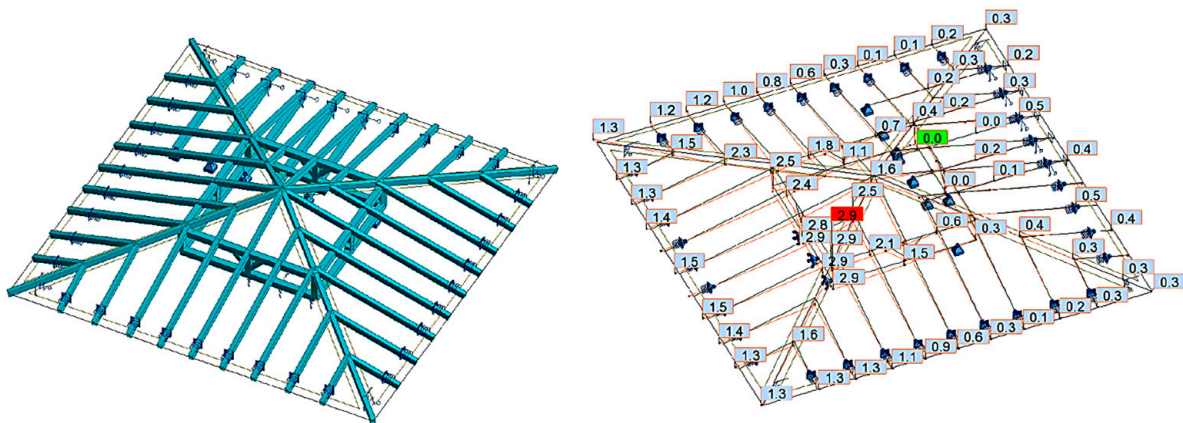
Figure 19. Variant III—model and displacements due to permanent loads; the pillars and swords can transfer only compressive forces; and flexible supports with the initial deflection of the ceiling beams.
