# Rain-Driven Failure Risk on Forest Roads around Catchment Landforms in Mountainous Areas of Japan

**Citation:** Watanabe, M.; Saito, M.; Toda, K.; Shirasawa, H. Rain-Driven Failure Risk on Forest Roads around Catchment Landforms in Mountainous Areas of Japan. *Forests* **2023**, *14*, 537. <https://doi.org/10.3390/f14030537>

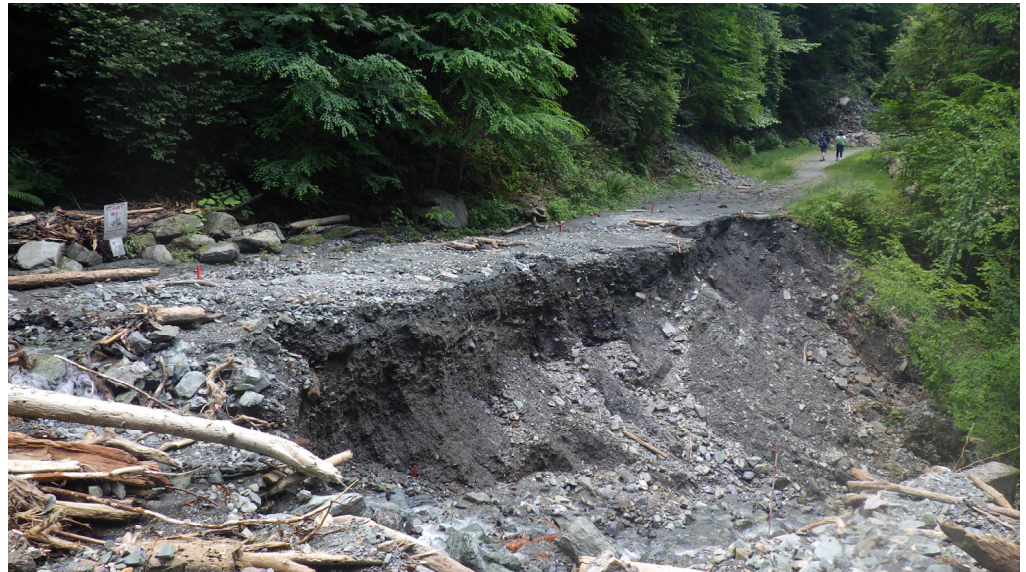
**Figure 1.** Image of forest road failure. A culvert at a stream crossing was destroyed by heavy rain, and the road body was eroded by stream water, making it inaccessible to vehicles.
