# Post-Earthquake Damage Assessment—Case Study of the Educational Building after the Zagreb Earthquake

**Abstract:** In the wake of recent strong earthquakes in Croatia, there is a need for a detailed and more comprehensive post-earthquake damage assessment. Given that masonry structures are highly vulnerable to horizontal actions caused by earthquakes and a majority of the Croatian building stock is made of masonry, this field is particularly important for Croatia. In this paper, a complete assessment of an educational building in Zagreb Lower Town is reported. An extensive program of visual inspection and geometrical surveys has been planned and performed. Additionally, an in situ shear strength test is presented. After extensive fieldwork, collected data and results were input in *3Muri* software for structural modeling. Moreover, a non-linear static (pushover) analysis was performed to individuate the possible failure mechanisms and to compare real-life damage to software results.

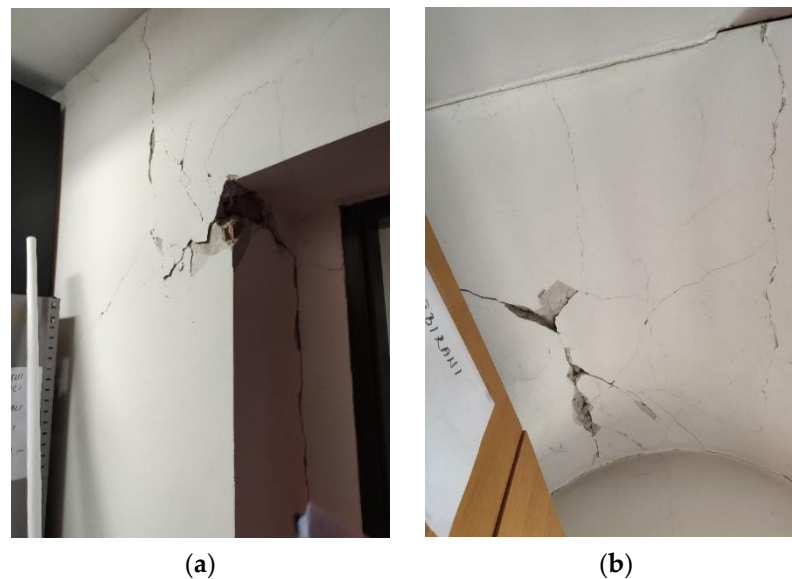
- There is visible damage in the form of cracks on the wall coverings, arches (Figure 11a), vaults and ceilings (Figure 11b) on all floors;
- Separation and local decay of plaster;
- Minor local damage is visible on structural elements (walls, columns, arches);
- In the eastern part of the building, diagonal cracks are visible on the load-bearing walls.

Figure 11. Cracks on the 1st floor: wall, lintel (a) and ceiling (b) (photo credit: I. Hafner).

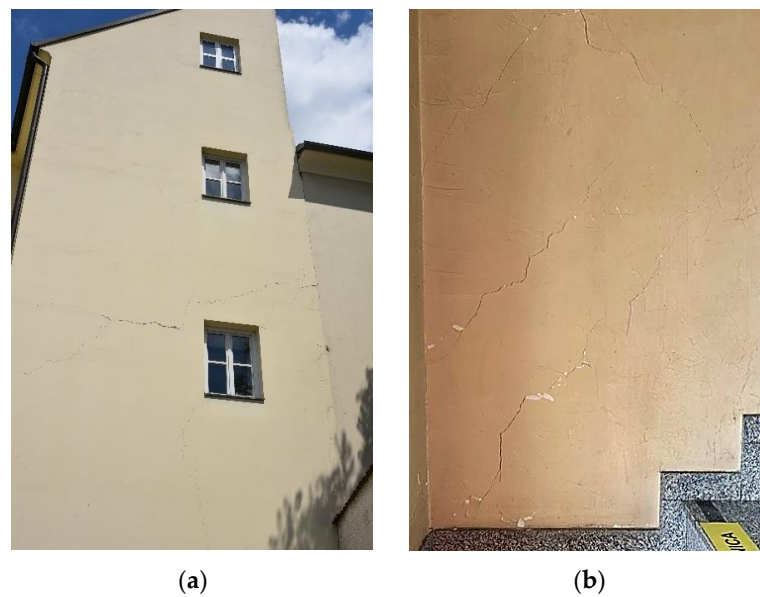
The second floor and attic suffered minor damage, while the most severe damage is found on the eastern (Figure 12a,b) and central staircase wings (Figure 13a,b). Recommendations were given that the building can be used with a restriction in the zones where there is a danger of plaster falling. Additionally, the eastern and western staircase can be used with a restriction in the number of people, while the central staircase is not to be used until a detailed assessment is conducted.

**Figure 12.** Cracks on the eastern staircase: exterior (a) and interior (b) (photo credit: I. Hafner).

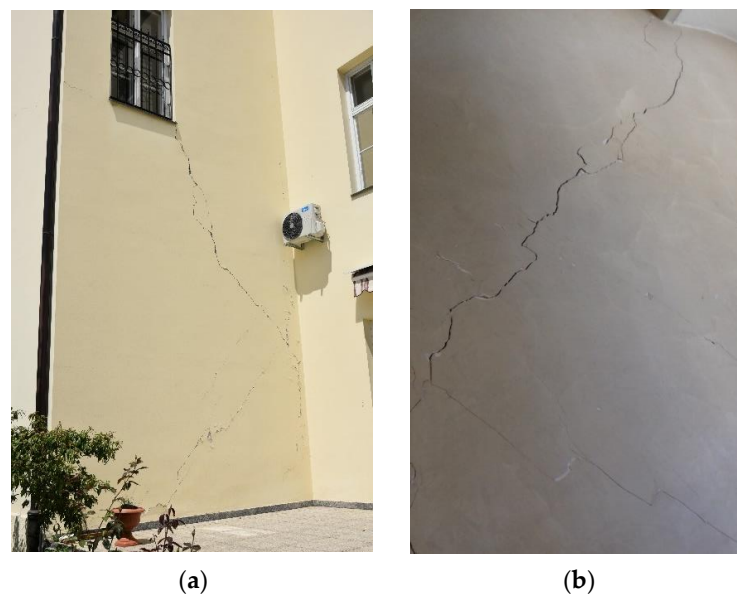
**Figure 13.** Diagonal cracks on the central staircase: exterior (a) and interior (b) (photo credit: I. Hafner).

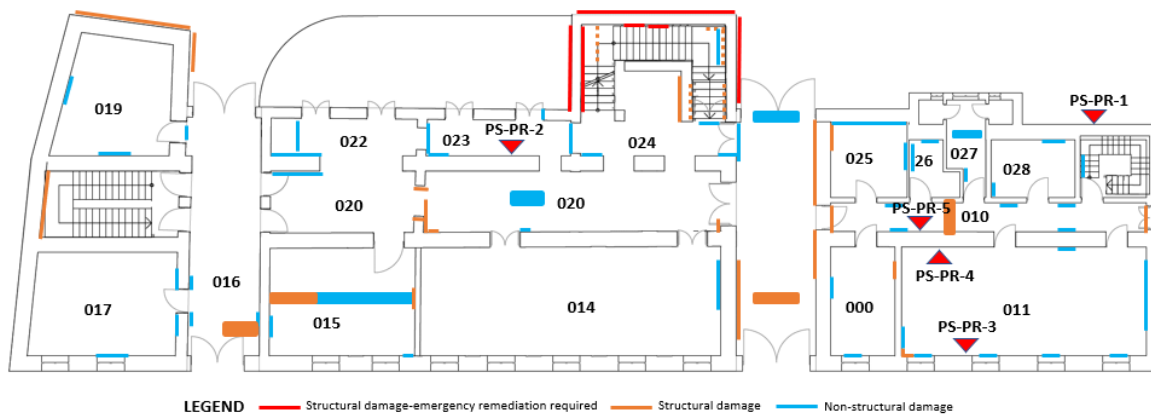
Figure 14. Ground floor of the building—damage scheme and shear strength testing positions.

A detailed inspection of the building revealed the following damage: at the ground floor, the damage is visible in the form of cracks on the wall coverings, arches, vaults and ceilings, as well as separation and local decay of plaster. Cracks in the barrel vaults are mostly parallel to the supporting joints, probably due to lateral movements during the earthquake. They are the result of the occurrence of tensile stresses perpendicular to the supporting joint. Such cracks can cause hinge formation and consequent loss of stability if they propagate deep enough. Fortunately, the cracks in the assessed building are narrow and mostly found in the plaster. Minor local damage to structural elements (walls, columns, arches) is also visible. In the central core of the building where the main staircase is located and in the eastern part of the building, diagonal cracks are visible on the load-bearing walls, which can also be seen on the north side of the building. Damage is visible on all floors in the form of cracks and falling plaster on the walls. Minor local damage to the walls on the 1st floor is also visible, and cracks at the joints of partition walls and ceilings are locally visible. In the central wing of the building where the main staircase is located and in the eastern wing of the building, diagonal cracks are visible on the load-bearing walls, which can also be seen on the north side of the building.

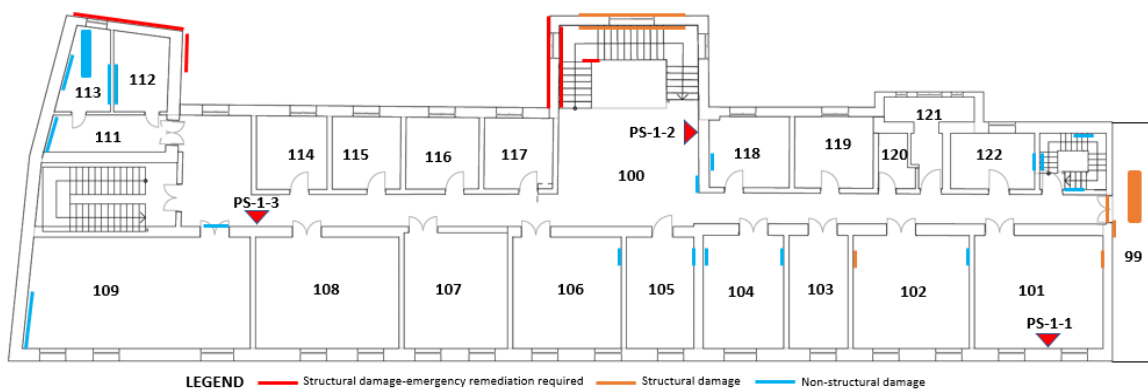
Figure 15. 1st floor of the building—damage scheme and shear strength testing positions.

The east wing was also damaged at the ground floor and 1st floor level. The cracks that appeared propagated were through the entire wall of the south facade of the wing. It is unfavorable that the cracks are joined and continue to the transversely-joined walls and lintels. The cause of such cracks can be the slight contribution of a torsional response of the building as a whole, where the boundary elements are the most loaded ones, and their failure occurs. Additionally, that part with the building is connected to the neighboring building. Although this can generally have a positive effect on the whole building, in the case of walls on the east wing, such a boundary condition can cause additional forces. If the walls are not well connected to the diaphragms by a tensile compression connection, this can cause them to fail. Since there has been no displacement of the wall out-of-plane, it is not in danger of collapsing, but it should be strengthened soon, and further damage propagation should be prevented. Minor damage in the form of cracks on the walls can be seen on the west and east staircases.

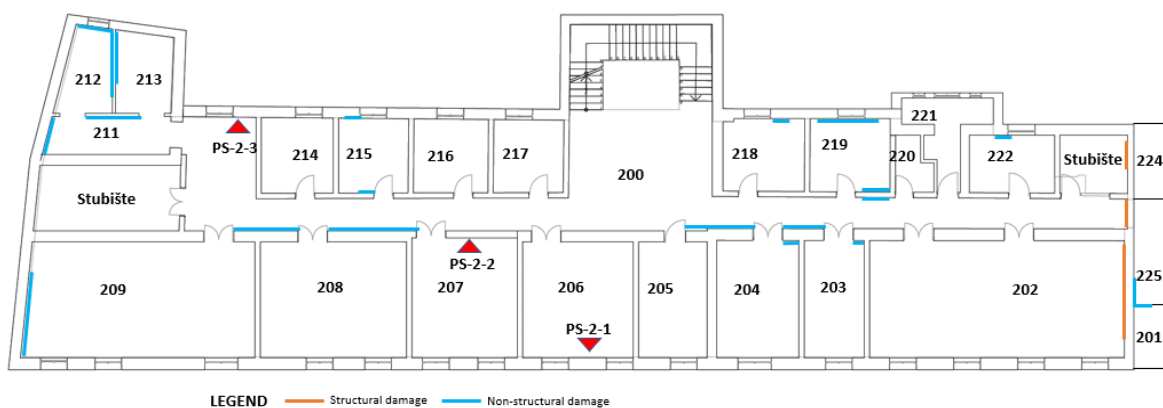
Figure 16. 2nd floor of the building—damage scheme and shear strength testing positions.

The 2nd floor and attic suffered minor damage. Particular attention should be paid to the central part of the building, occupying the wing with the staircase. The formation of cracks on the central wing transverse walls is clearly visible, indicating a possible failure mechanism out-of-plane of the entire wing. A wedge was made, and the cracks were interconnected and propagated inside the building (they also appear in the stair beams). There was no displacement of the walls out-of-plane, but the preconditions for its failure were met. The central wing needs to be strengthened as soon as possible as part of the entire building's renovation.

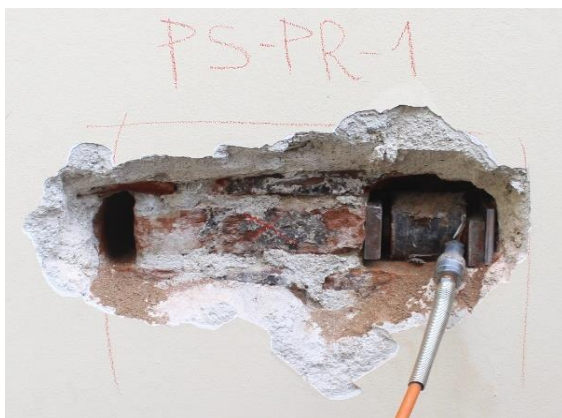
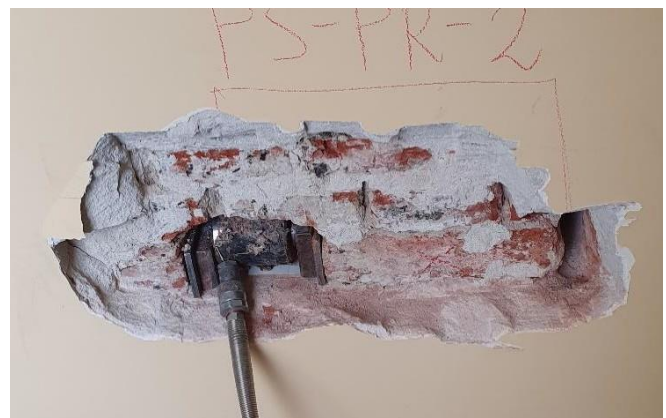
Figure 18. Masonry shear strength tests at measuring positions PS-PR-1 (a) and PS-PR-2 (b) on the ground floor (photo credit: L. Lulić).

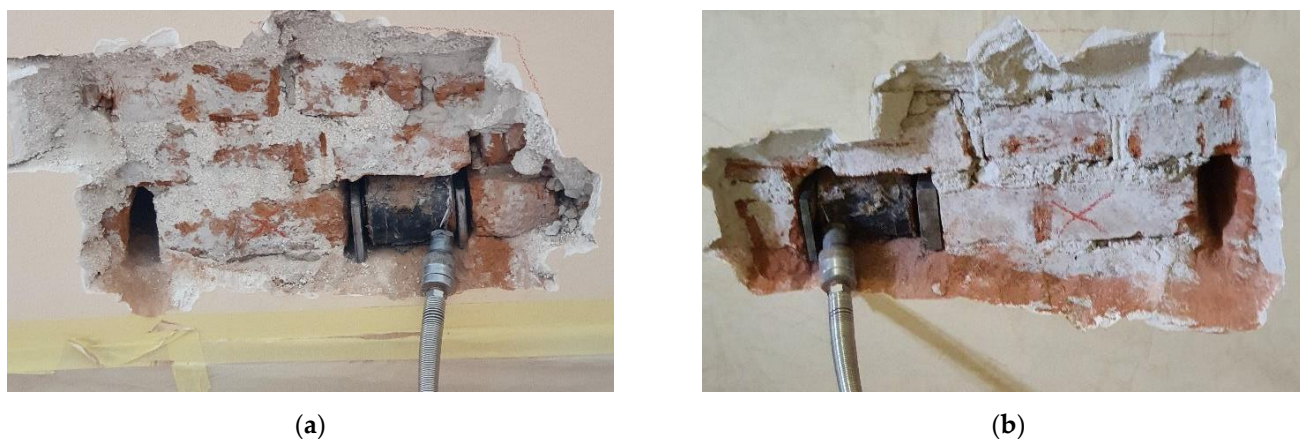
Figure 19. Masonry shear strength tests at measuring positions PS-1-1 (a) and PS-1-3 (b) on the 1st floor (photo credit: L. Lulić).

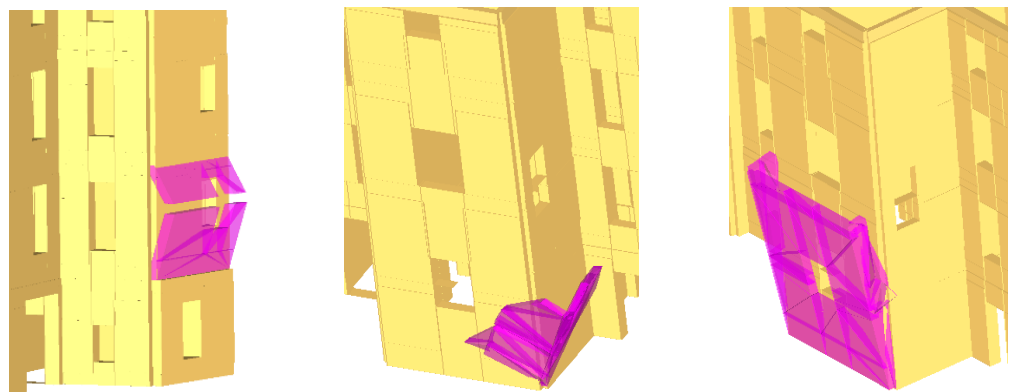
Figure 32. Local mechanism LM1 (east wing), LM2 and LM3 (central wing).

Local Mechanism	$\alpha$
LM1	4.93
LM2	2.10
LM3	0.53

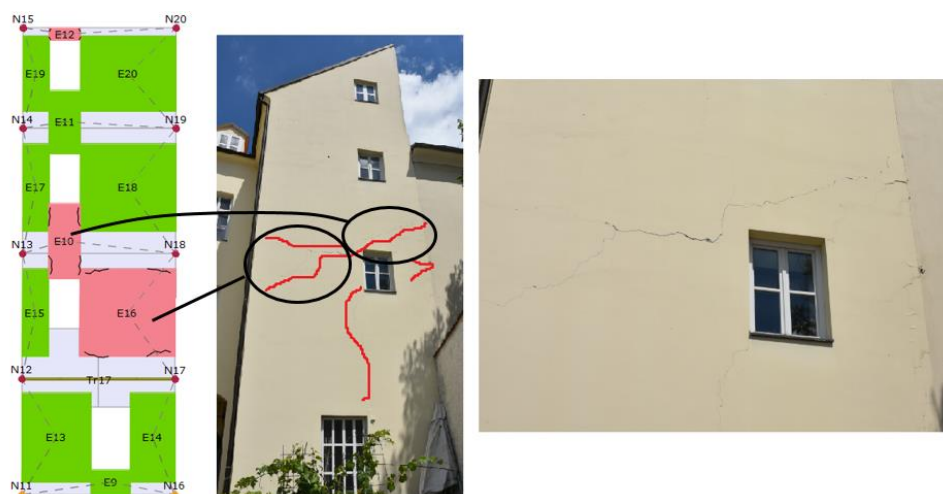
Figure 33. First comparison (photo credit: T. Kišiček).

After the performed analyses, the real damage was compared with the damage distribution previewed in 3Muri (Figures 33–36). Description of building's capacity through displacement rather than forces allows us to better understand and accurately predict a building's response in the form of a damage initiation and propagation throughout all phases of analysis all the way until the formation of failure mechanism and collapse. That is possible, thanks to incremental non-linear static pushover analysis that shows us damage patterns for every macro-element in every step of the analysis. Compared results are very similar to real damage, which implies good accuracy of the used analysis and software.
