Multipurpose Retrofitting of a Tower Building in Brescia

Abstract: The paper aims to report a proper low-impact integrated study approach for the energy and seismic retrofitting of a tower building located in the city centre of Brescia (Italy). The building consists of a group of aggregate buildings built in the 1950s, from which emerged an 11-storey tower. It was built with the technology of the time by means of a perimeter and spine framed structure in reinforced concrete, double perimeter infill with a hollow brick air chamber, external cladding on the main fronts with small Botticino marble tiles. The building is registered by the Ministry of Cultural Heritage for its facade and is located in a seismic zone of category two. When work began, the construction was in a class three; thus, the whole project was updated to obtain the new seismic authorisation. The coating showed progressive decay, with dangerous structural instability of the heavy coating. The design team decided to adopt wider corrective action compared to the observed phenomenon, integrating it with a local seismic and global energy improvement through the insertion of a ventilated wall in the building and the rea

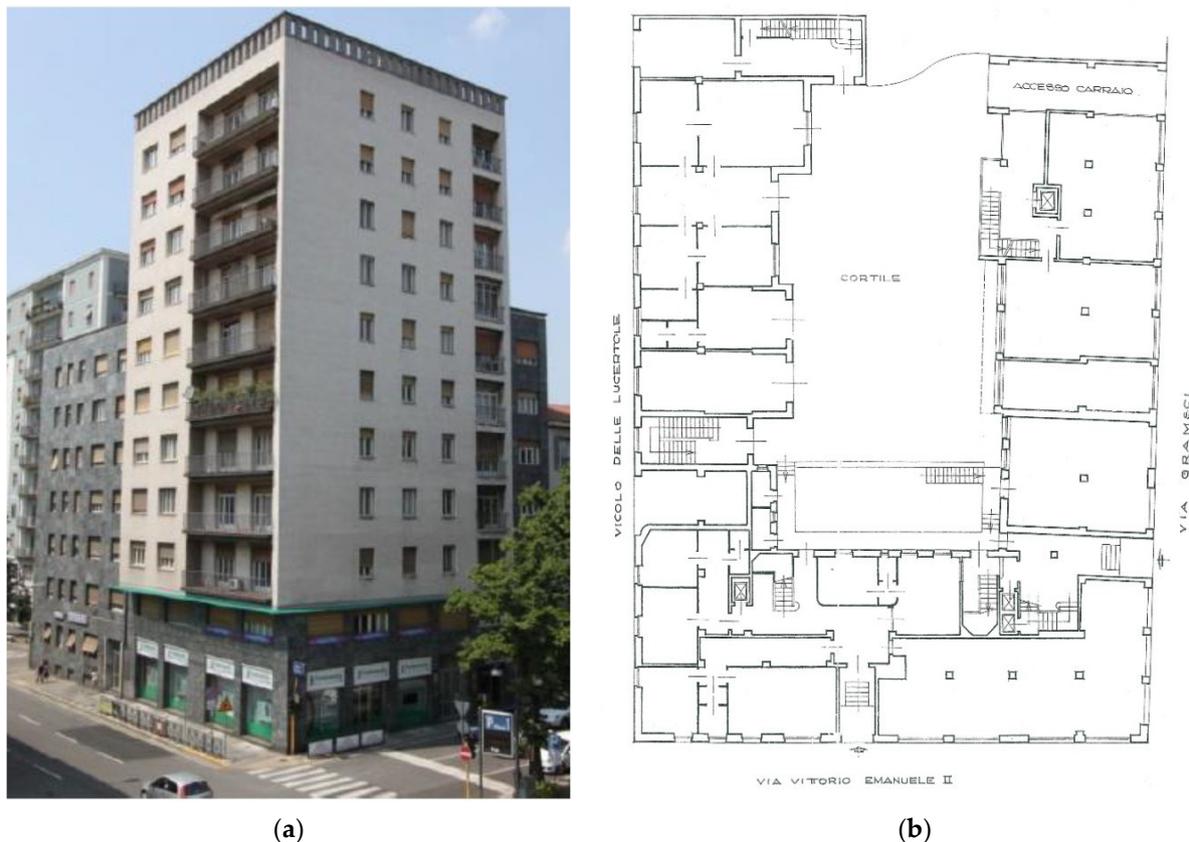
Initially, the problem was due to the obvious signs of decay on the facade cladding, which had been damaged in several places by the weather and smog. The areas that showed swelling and no longer bonded to the wall had caused some of the wall tiles to detach, causing great concern to the owners of the property that they might fall off. Since the building is located in the town centre of Brescia, in a busy area of high traffic, and is also subject to the restrictions of the local supervisors of the Ministry of Cultural Heritage, the resolution of this initial problem was necessary, and the study was started to avoid risks to passers-by and to guarantee their safety. The initial study then identified certain corrective actions that were more substantial and remedial than the observed phenomenon, integrating this with possible local seismic and global energy improvement through the insertion of a ventilated wall in the building and the implementation of accurate thermal and energy insulation systems.

Figure 1. The 1950s tower building in Brescia: (a) before the intervention and (b) original plan of the complex. The bottom-right corner is the 11-storey tower.

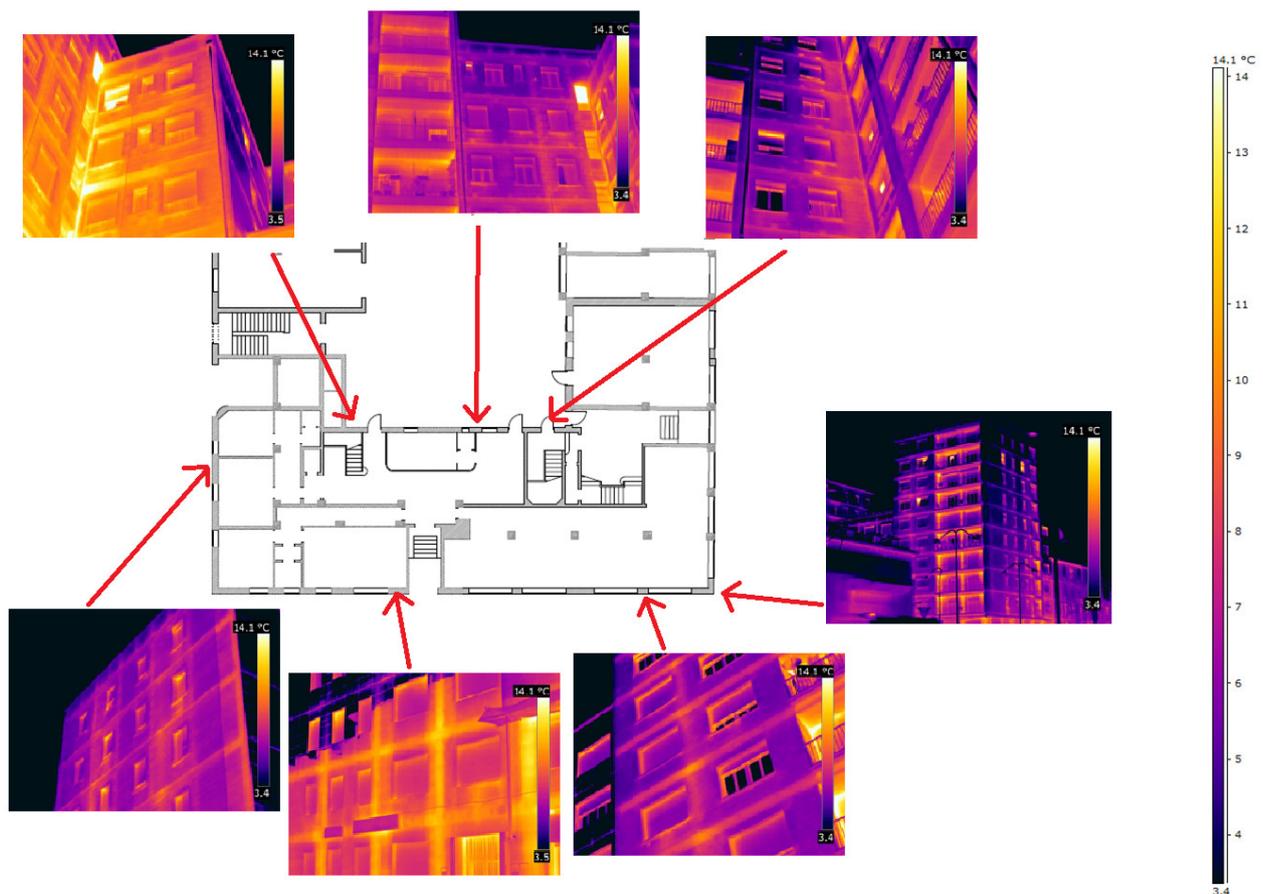
As part of the initial survey, in order to assess the state of the sites and obtain the necessary data for the preliminary study of the design proposals, a detailed inspection of the opaque surfaces of the structures was carried out using infrared thermography to survey the surface characteristics of the walls (Figure 5). This investigation was carried out by personnel qualified to the second level in non-destructive testing (NDT) and conducted according to the reference standards, UNI EN ISO 9712:2012 [13]. As is well known, thermography is a diagnostic technique that measures the infrared radiation emitted by bodies, and then returns a two-dimensional representation of the surface temperature distribution. This provides highly significant data on which to base corrections and implementations.

Figure 5. Plan of the building Block 1 and some reference thermograms.

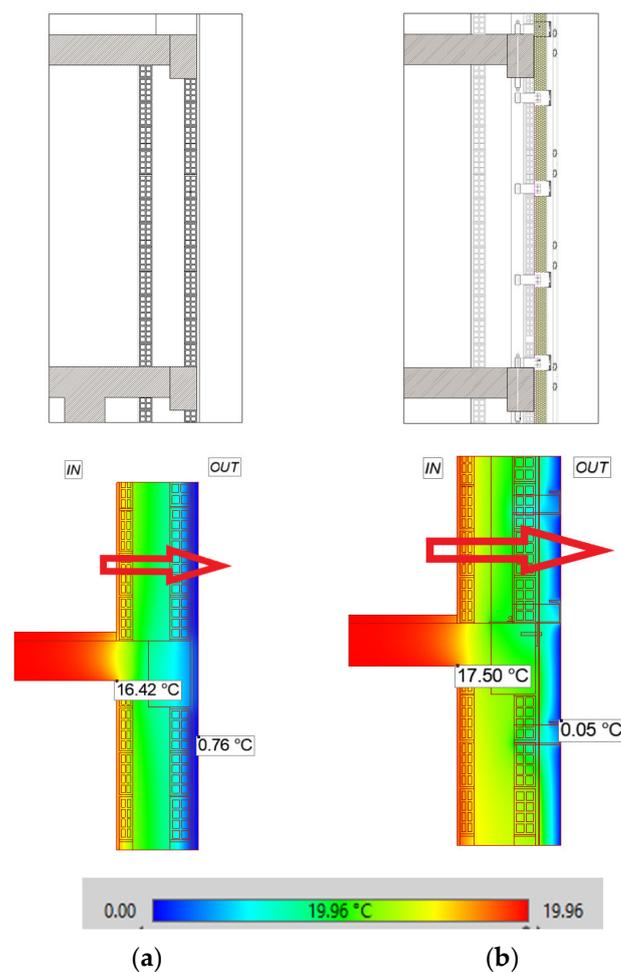
The simulation of the thermal flows shown in the diagram in Figure 6a represents the surface temperature trend in the actual state. It will be noted that the presence of the reinforced concrete slab and the high transmittance of the internal wall contribute to lowering the surface temperature, a problem encountered above all at the corners between the wall and the floor. It is well known that surface temperatures below 16 °C lead to thermal discomfort and the risk of mould and condensation forming.

Figure 6. (a) On the left, detail of the hollow core masonry, typical of the construction period; on the right the finite element heat flow simulation. (b) On the left, detail of the hollow core masonry after thermal insulation and ventilated façade and, on the right, the finite element heat flow simulation.

The application of rock wool insulation under the ventilated façade, with a density of 70 kg/m³ and a thickness of 12 cm, which is highly breathable, allows surface temperatures of over 18 °C to be reached and guarantees good hygrometric behaviour of the masonry, as shown in Figure 6b.

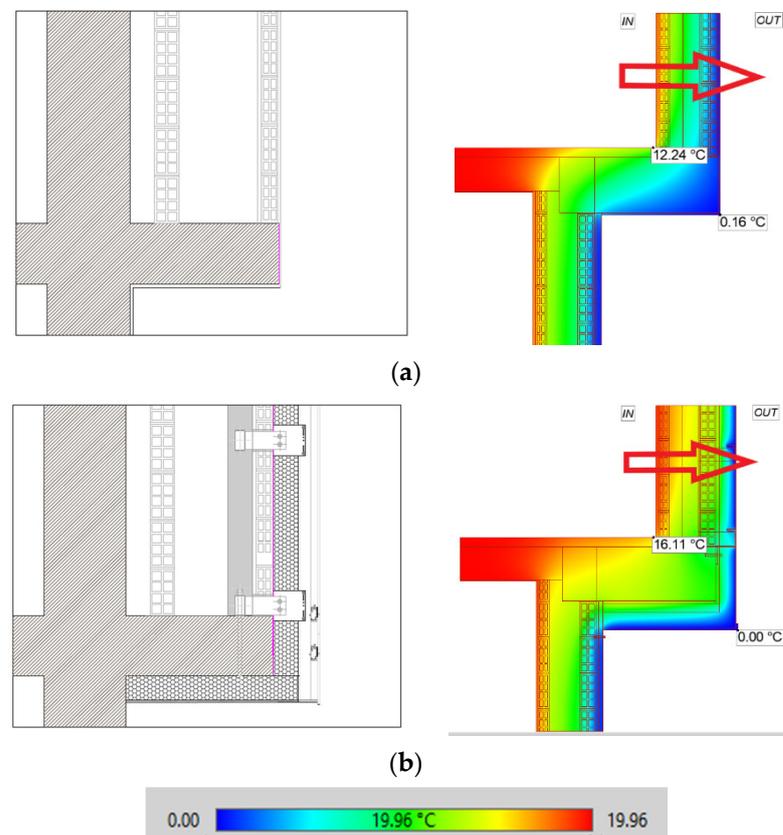
In the examination at the façade overhang point, extremely low internal surface temperatures were found at the outermost corner (Figure 7a). The design study identified

Figure 7. (a) On the left, detail of the façade overhang, typical of the construction period, and, on the right, the finite element heat flow simulation. (b) On the left, detail of the overhang after thermal insulation and ventilated facade work and, on the right, its finite element heat flow simulation.

the correct product to raise the temperature of this critical node, contributing to a significant improvement in the comfort of the rooms affected by limiting heat loss (Figure 7a,b).

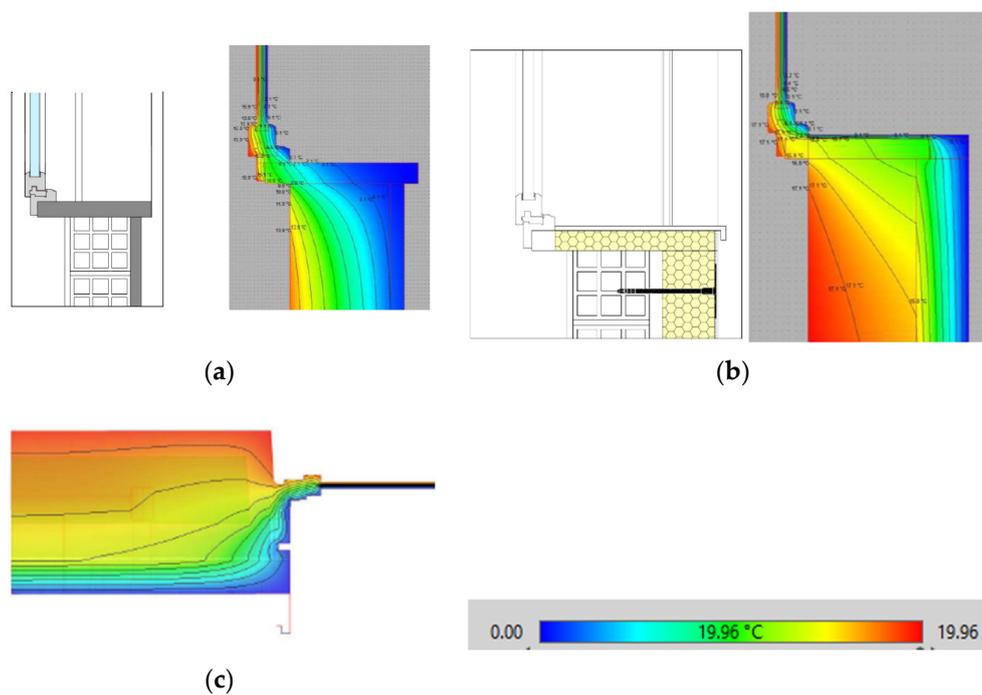
Another critical point was the insulation of the lower pier (Figure 8). As the detail in Figure 8a shows, the window and doorframe rests on a stone sill. This type of fixing prevents the stone from being removed or cut during the execution of the works. The thermal analyses carried out indicate that the surface temperatures at these points are extremely low (around 10 °C). The design solution identified was to cover the existing sill with an ultra-thin, hydrophobic, nano-porous aerogel-based insulation panel (high thermal characteristics $\lambda = 0.015 \text{ W/mK}$) of low thickness, in order not to interfere with the condensation drain of the existing window frame. This intervention allows raising the internal surface temperature of the edge of the existing dock by about 6/7 °C (Figure 8b). Some positive results are reported in Table 2.

Figure 8. (a) Detail of windowsill node, typical of the construction period, on the left; finite element heat flow simulation on the right. (b) Detail of windowsill joint after intervention on the left; finite heat flow simulation on the right, as well in (c).

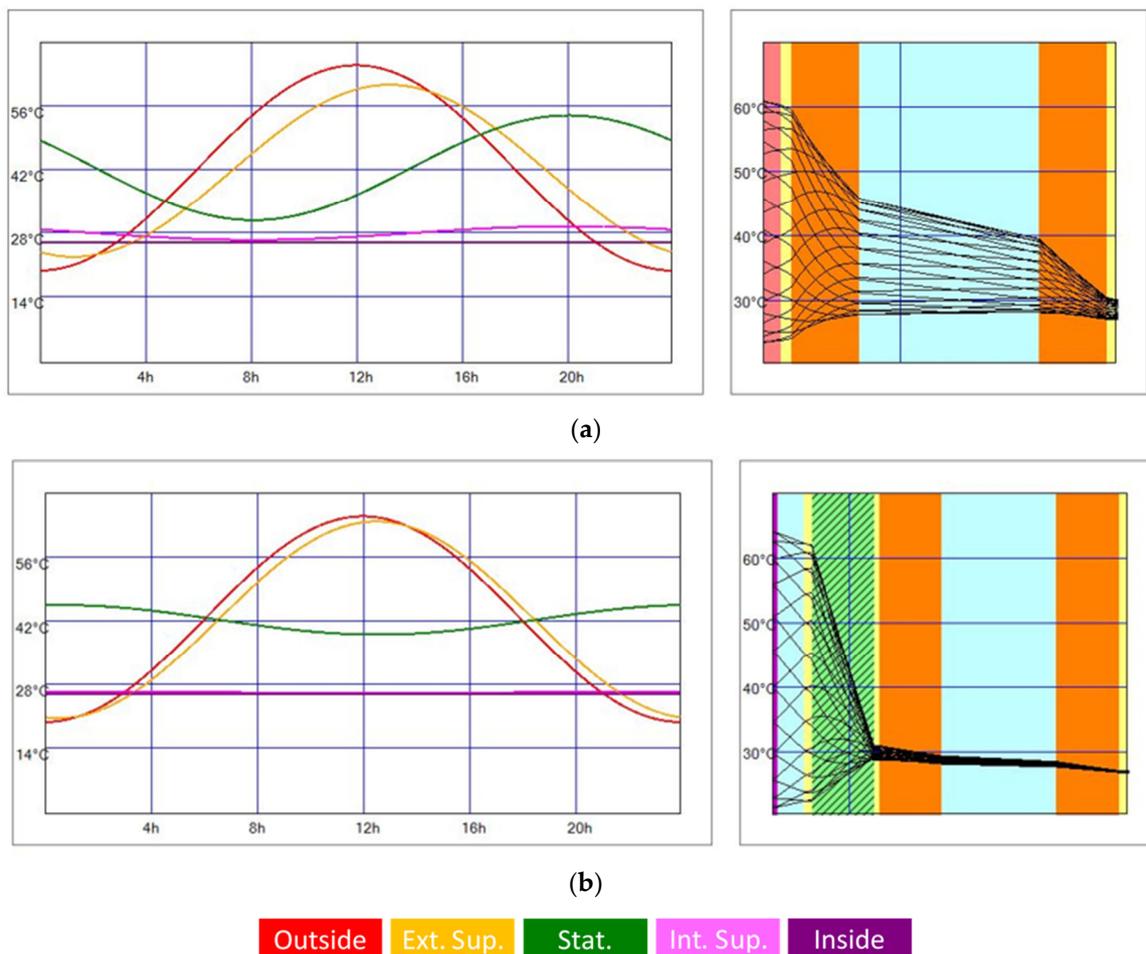
As it can be observed from the diagram (Figure 9b), the application of the ventilated façade and the insulating material leads to a decrease in the surface temperature on the inner side of the masonry, with undoubted advantages to the quality of thermal comfort in hot weather.

Figure 9. Analysis of the summer condition of the wall: (a) before intervention and (b) after intervention.

Considering both the existing wall and the design wall in a dynamic regime, the application of thermal insulation (medium–high density materials), with a ventilated façade above, proved to be advantageous in terms of lowering the internal surface temperature. In the diagram below, in the image on the right, it results that the internal surface temperature before the intervention was higher than 30 °C (Figure 9a). Figure 9b shows the dynamic simulation of the design hypothesis: insulation of the existing hollow core masonry and the application of the ventilated wall.

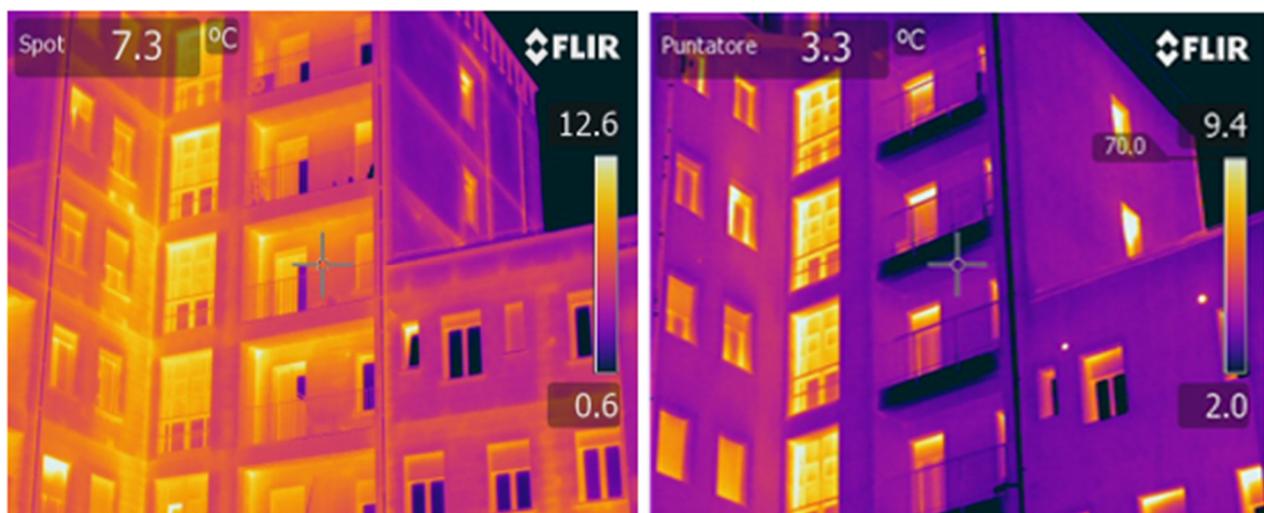
The thermograms in Figure 11 demonstrate the effectiveness of the thermal insulation work carried out: the heat losses of the opaque structures have been practically eliminated. The APE Energy Performance Certificates of the single building units, drawn up at the end of the works, were made with the CENED procedure currently in force in the Lombardy Region, according to Decree 30.7.15 N°6480 [16]. The energy class achieved after the intervention was A.

Figure 11. Thermogram: (a) before work; (b) after work.

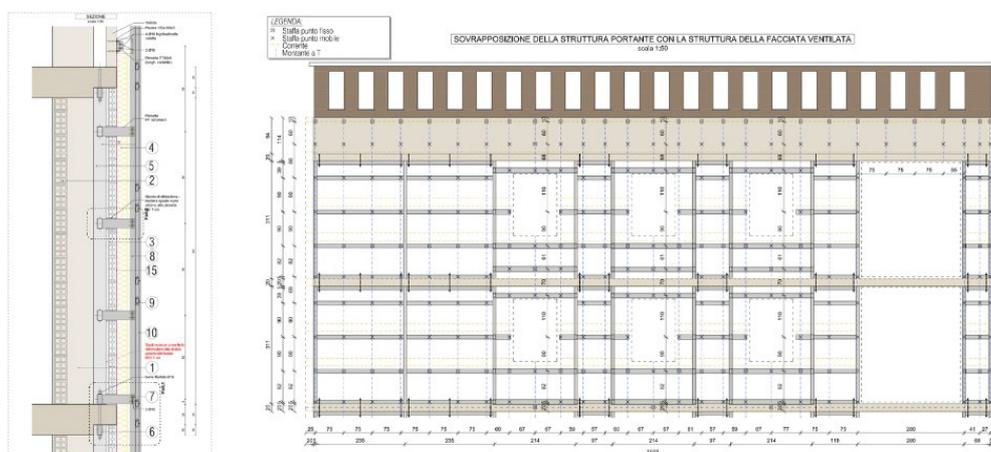
Figure 13. Tubular steel structure for the ventilated façade.

Of the two brick planks that make up the perimeter curtain walling, the inner one was left untouched, while the outer one, covered with tiles, was demolished, creating a structure with steel tubes hinged to the frame beams only, which was then curtain walled, leaving only the steel brackets (“little fins”) bearing the hanging ventilated façade. The steel structure is deliberately not tied to the pillars (Figures 13 and 14).

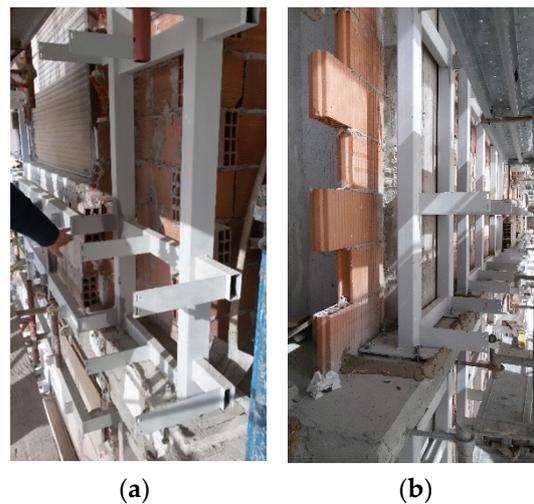
Figure 14. (a,b) Application of the tubular steel structure for the ventilated façade, where the “little fins” are visible.

Additional technological assemblies were placed in the cavity for the subsequent integration of systems and rock wool for thermal and acoustic insulation and fire protection (Figure 14). The previously removed infills were then reconstructed, consequently encapsulating the metal structure, with external application on the new planks of fibred anti-overtum systems, with local ante- and post-operam verification, rustic finishing and subsequent construction of the hanging ventilated wall.

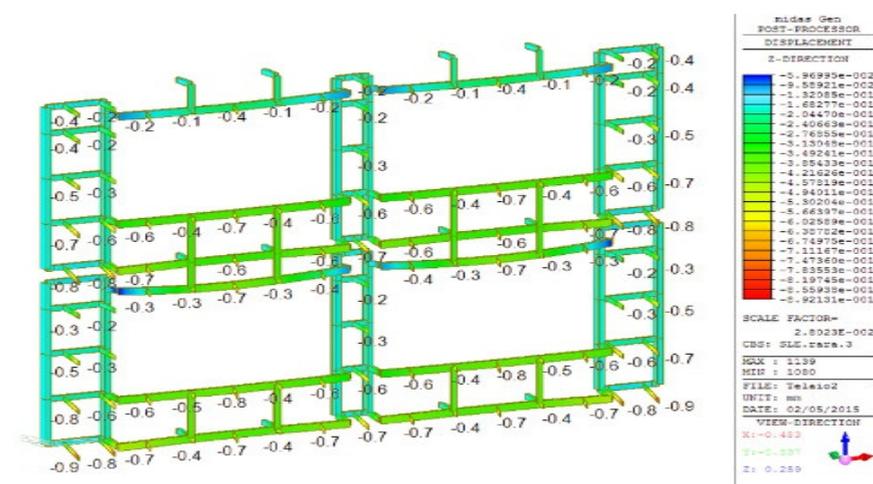
From the results of the analyses carried out on the design model (Table 4), it can be seen that at both SLV and SLD, all combinations have safety coefficients greater than one and, although slightly reduced, can be defined as substantially unchanged if compared to the actual state. This resulted in an intervention of local seismic improvement only. The deformable metal structure hinged with brackets to hang the ventilated façade does not induce angular distortions to the building, increasing local safety without any significant global effects, transmitting only vertical loads, which are in fact reduced and generally less than 10% due to the careful choice of materials and application techniques. An important aspect of the new metal façade support structure was to keep deformation under control to ensure compatibility between the support system and the new façade (Figure 17).

Figure 17. Analysis results—deformation in mm related to vertical displacements (D_z) of the new metal structure supporting the façade in the SLE–Rara3 combination.
