Analysis of Water and Mud Inrush in Tunnel Fault Fracture Zone—A Case Study of Yonglian Tunnel

In this paper, water and mud inrush in the F2 fault of Yonglian Tunnel in the Jiangxi Province of China is taken as a typical case project. The process of water and mud inrush in the left and right tunnels during the tunnel's construction is introduced in detail, from aspects of time, scale and the consequences of inrush. Based on this, generation conditions and the evolution mechanism of water and mud inrush in tunnel faults are revealed.

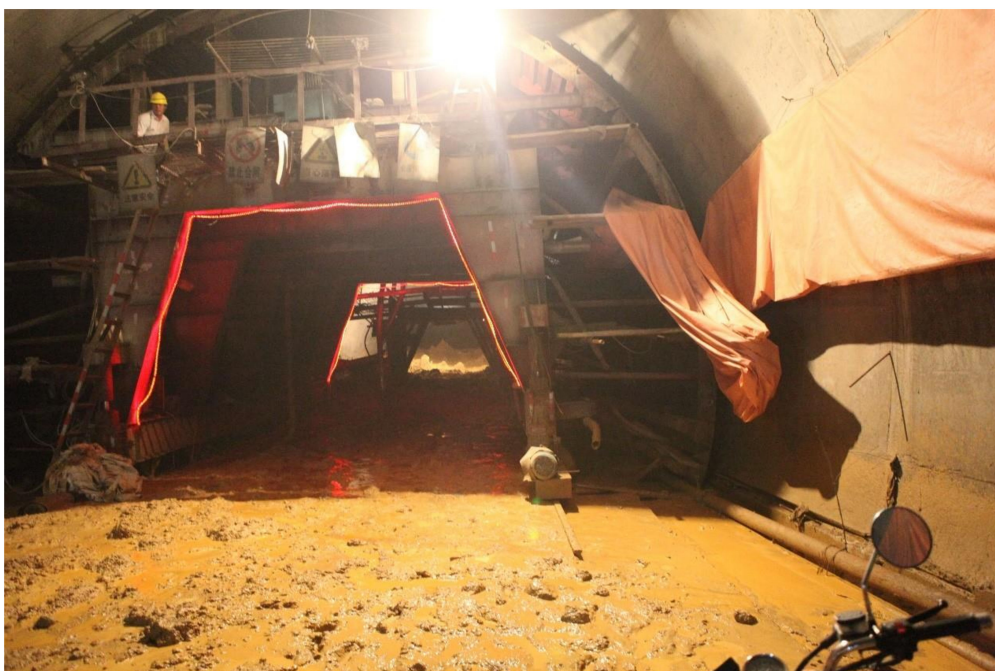
Second water and mud inrush: at 4:20 a.m. on 3 July, the second water and mud inrush occurred at the same location as the first inrush (Figure 3). The volume of outburst water reached around 3800 m³ and the cumulative mud volume reached around 1200 m³.

**Figure 3.** Water and mud inrush in the left tunnel for the second time.

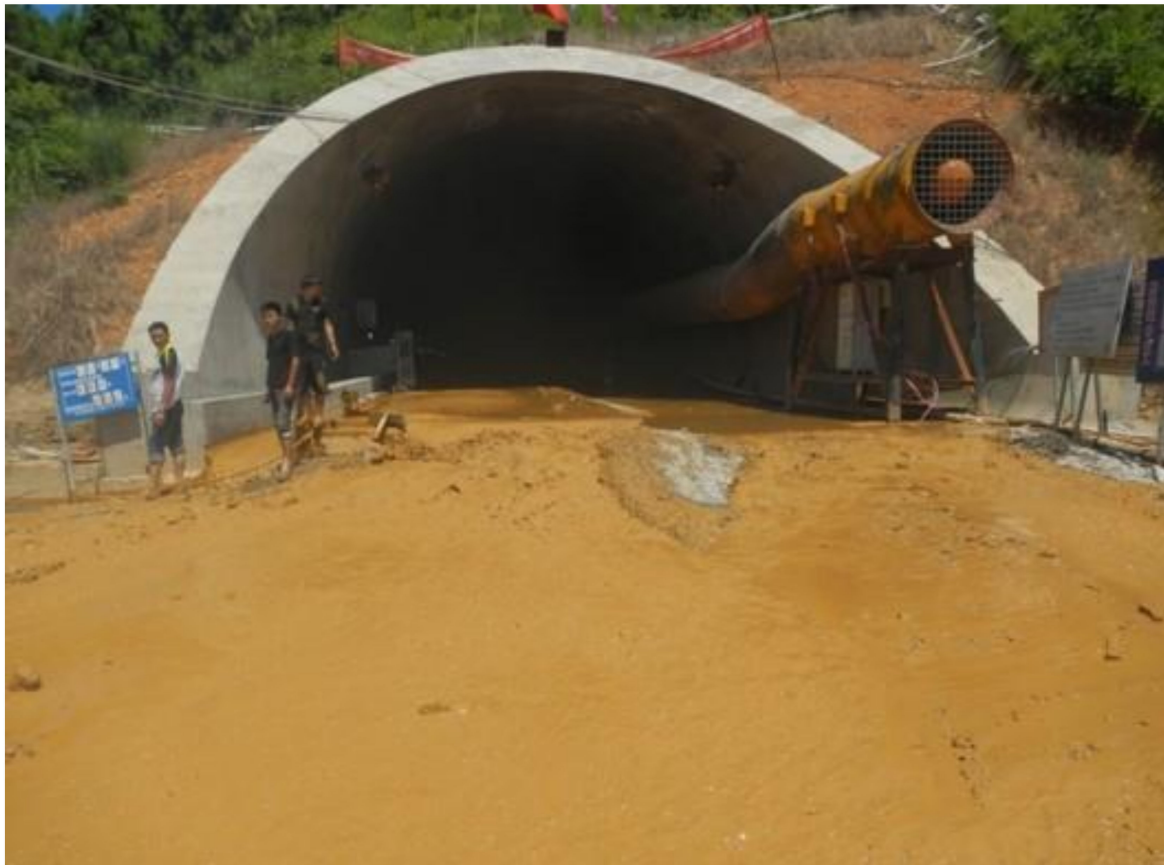
Third water and mud inrush: at 10:50 a.m. on 3 July, yellow mud water mixed with sand and gravel spewed out of the original water and mud inrush position (Figure 4), rushing straight toward people nearby. An off-road vehicle, which was about 30 m away from the tunnel face and yet to evacuate, was washed away by muddy water for about 20 m and fell into the ditch. During 10 mins of the third water and mud inrush, a total of around 27,000 m³ of mud water gushed out, and about 3000 m³ of mud was deposited near the tunnel face.

Figure 4. Water and mud inrush in left tunnel at third time.

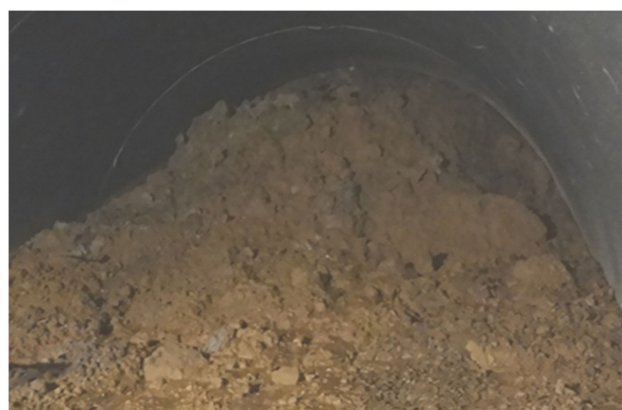
Second water and mud inrush: on 18 September, the flow of muddy water gushing from the vault at YK91 + 376 increased rapidly, showing a jet shape, and the beyond-limit value of initial supports at the replacement position was further developed. On 19 September, the left side of the new replacement position (YK91 + 370~376) collapsed and mud began to burst at 11:00 a.m. (shown in Figure 5). Around 900 m³ of water and 2100 m³ of silt burst from the hole.

Figure 5. Inrush in right tunnel for the second time.

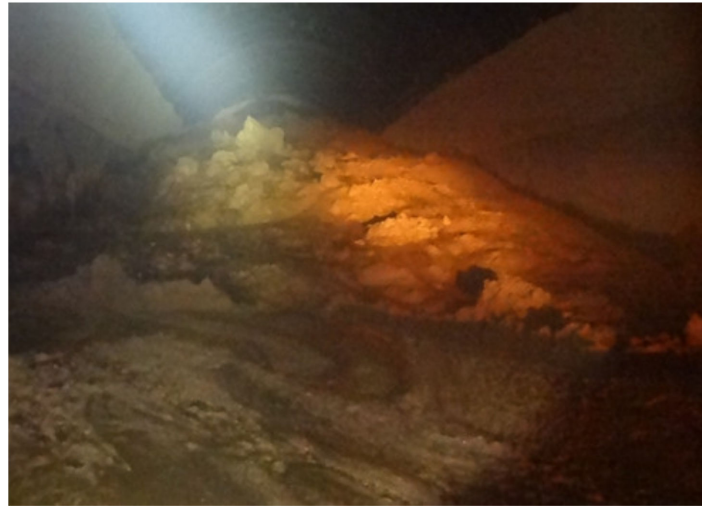
Third water and mud inrush: recorded from 3:50 p.m. to 4:10 p.m. on 23 September near YK91 + 374 with sound of rumbling (shown in Figure 6). Accumulated mud gushing from the hole approached 4200 m³, with the farthest edge located about 140 m away from the tunnel face. This water and mud inrush pushed the lining trolley (located 25 m away from the tunnel face) back to about 70 m.

Figure 6. Inrush in right tunnel for the third time.

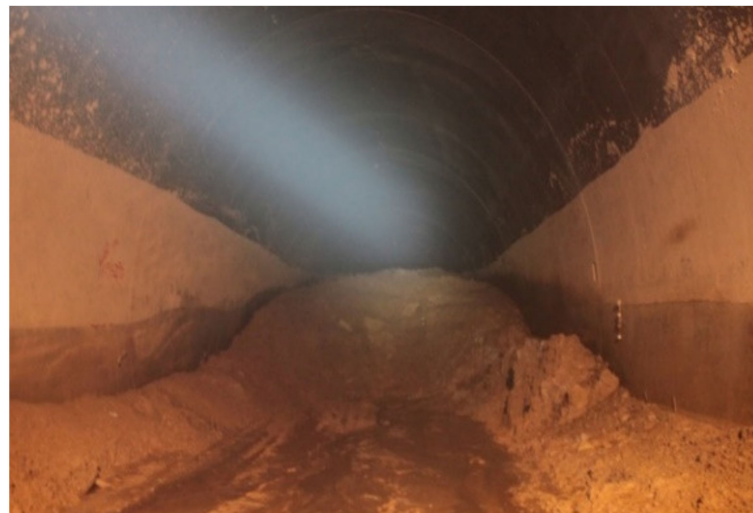
The sixth water and mud inrush was recorded at 7:30 a.m. on 7 October. When the mud was cleaned up near YK91+374, the sixth water and mud inrush occurred at the collapse hole (shown in Figure 7), causing mud to gush back to YK91 + 255. The accumulated silt was around 4900 m³.

Figure 7. Inrush in right tunnel at sixth time.

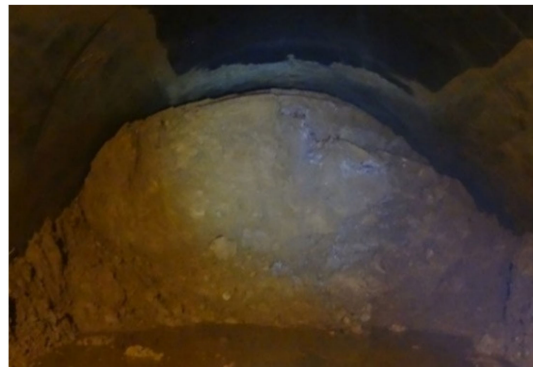
The seventh water and mud inrush was recorded at 1:30 a.m. on 25 October. When the mud in the entrance to the right tunnel was cleaned, a large-scale water and mud inrush occurred again in the right tunnel (shown in Figure 8). About 8500 m³ of mud gushed to YK91 + 255 and the cross-section 80 m behind the collapse hole was completely filled with silt.

Figure 8. Inrush in right tunnel at seventh time.

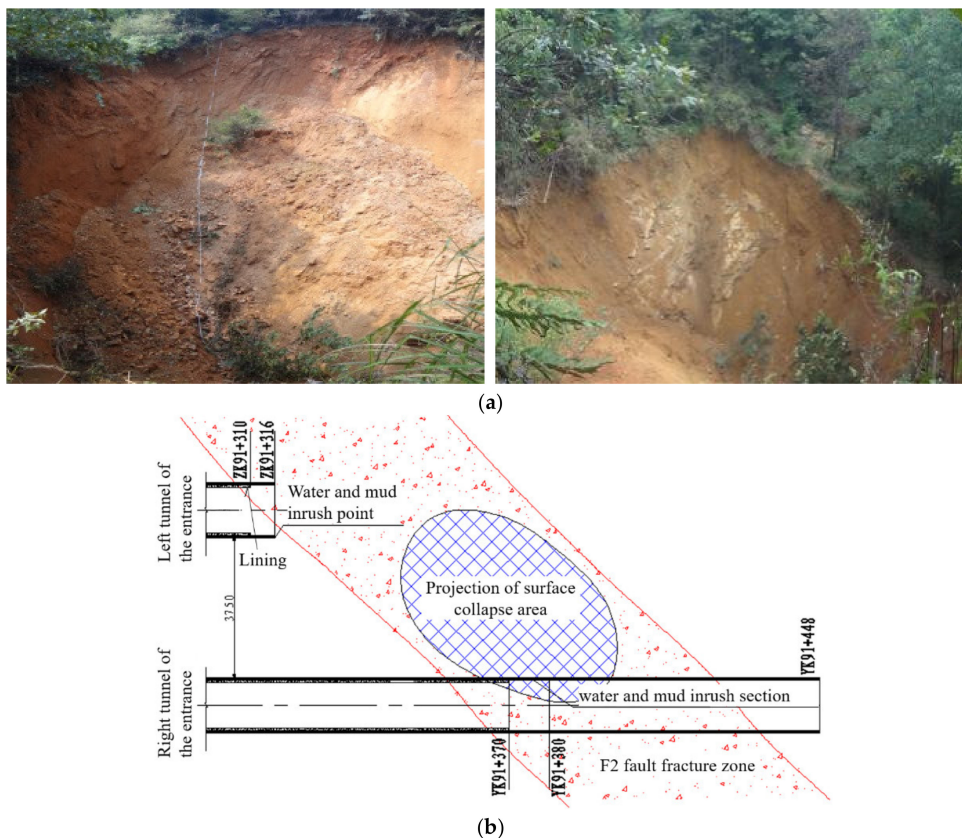
After first and second large-scale water and mud inrushes in the entrance to the right tunnel, there was no obvious anomaly at the top of the entrance hilltop. After the third water and mud inrush occurred on 23 September 2012, an obvious subsidence collapse of the surface could be found about 20 m away from YK91 + 371~389 on the inner side of the right tunnel (in the F2 fault, next to the ZK5 drill hole) (shown in Figure 9). The elevation difference between the hilltop and tunnel design line was about 190 m. The ground subsidence plan was irregular and round, with a diameter of about 25 m, an area of about 500 m² and a depth of about 8 m to 15 m. The area and depth of the collapsed ground further expanded due to the occurrence of water and mud inrushes. During a survey on November 11th, the subsidence plane at the hilltop represented an irregular oval, with a major and minor axis of about 62 m and 46 m, an area of about 1800 m² and a depth of about 15 m to 32 m.

Figure 9. Subsidence collapse after water and mud inrush. (a) Pictures of the surface collapse; (b) The relative positions of surface collapse area and F2 fault.

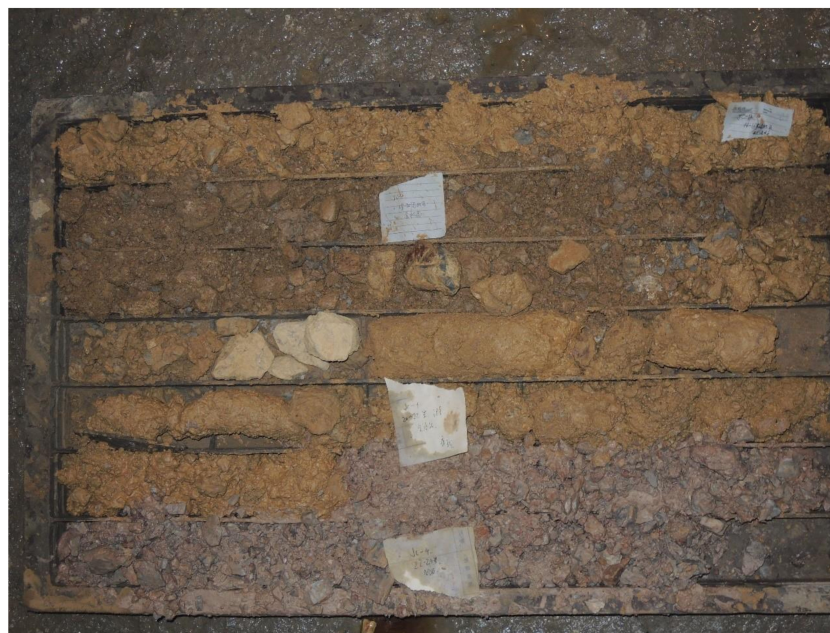
The F2 fault of the tunnel is located in an interbedded area of shale and sandstone, with extremely broken surrounding rock, high porosity, high mud content and extremely low mechanical strength. The rock mass exposed in the excavation process can even be crushed by hand. Containing minerals like montmorillonite, the shale in rock mass belongs to weakly expansive surrounding rock. The rock mass in the fault zone is loose and easy to disintegrate through contact with water, and becomes soft and muddy and is able to flow like water. It can be seen that the F2 fault rock mass is fragile in structure, rich in loose broken materials and very weathered, which provides good material conditions for the formation of a water and mud inrush in the tunnel. Lithology revealed rock cores in the F2 fault during tunnel investigation, and excavation is shown in Figure 10.

Figure 10. Rock cores in F2 fault zone.

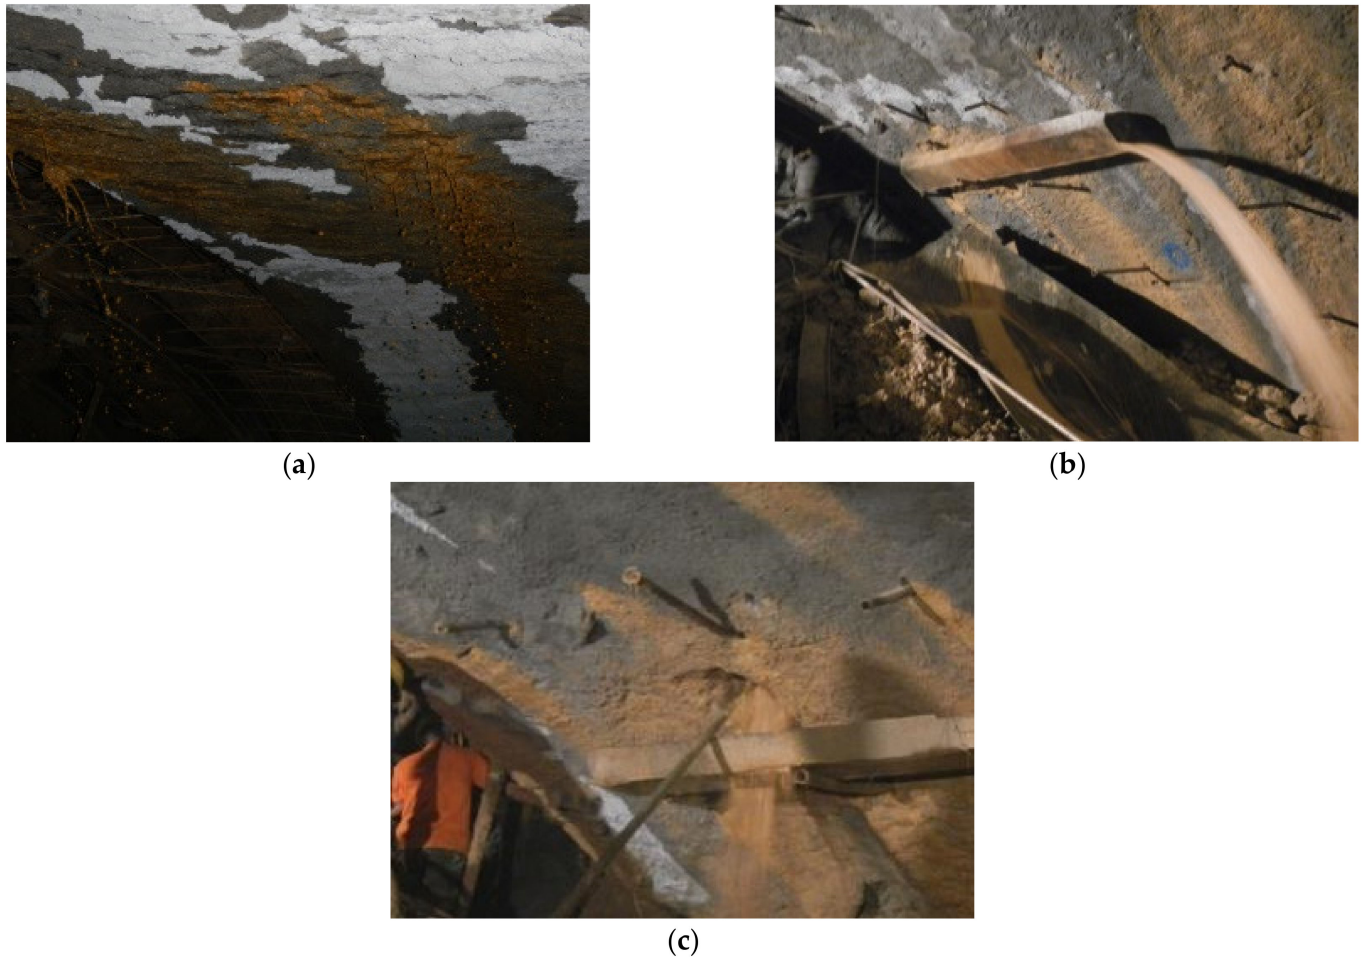
The construction team began to excavate the collapsed body and replace the grid steel frame from station ZK91 + 303 m on 25 June 2012. At 8:00 a.m., excavation reached the mileage of ZK91 + 312, and the grid steel frame was replaced to ZK91 + 311 (entering the F2 fault fracture zone). At about 9:00 a.m., a small amount of water seeped out from arch foot of the right wall at ZK91 + 308 mileage, and gradually water flow and the amount of water outlet points increased and extended to the vault. By 10:00 a.m., there were many water flows dripping along the system bolts and grouting holes of the arch shoulder and vault at a mileage of ZK91 + 308. According to statistics of field data, the total water flow rate was about 0.7 m³/h. By 12:00 p.m., the total water flow rate at the shoulder and vault at a mileage of ZK91 + 308 increased to 2.9 m³/h.

Figure 12. Circumstance of water inflow in tunnel. (a) Water dropping from the arch at first; (b) water flow increasing at the outlet; and (c) a large channel formed.
