Study on the Dip Angle Effect of Asymmetric Deformation and Failure of the Gob-Side Coal–Rock Roadway in Gently Inclined Coal Seam

Citation: Gao, L.; Zhan, X.; Zhang, P.; Wen, Z.; Ma, Z.; Kong, D.; Kang, X.; Han, S. Study on the Dip Angle Effect of Asymmetric Deformation and Failure of the Gob-Side Coal–Rock Roadway in Gently Inclined Coal Seam. *Sustainability* **2022**, *14*, 7299. <https://doi.org/10.3390/su14127299>

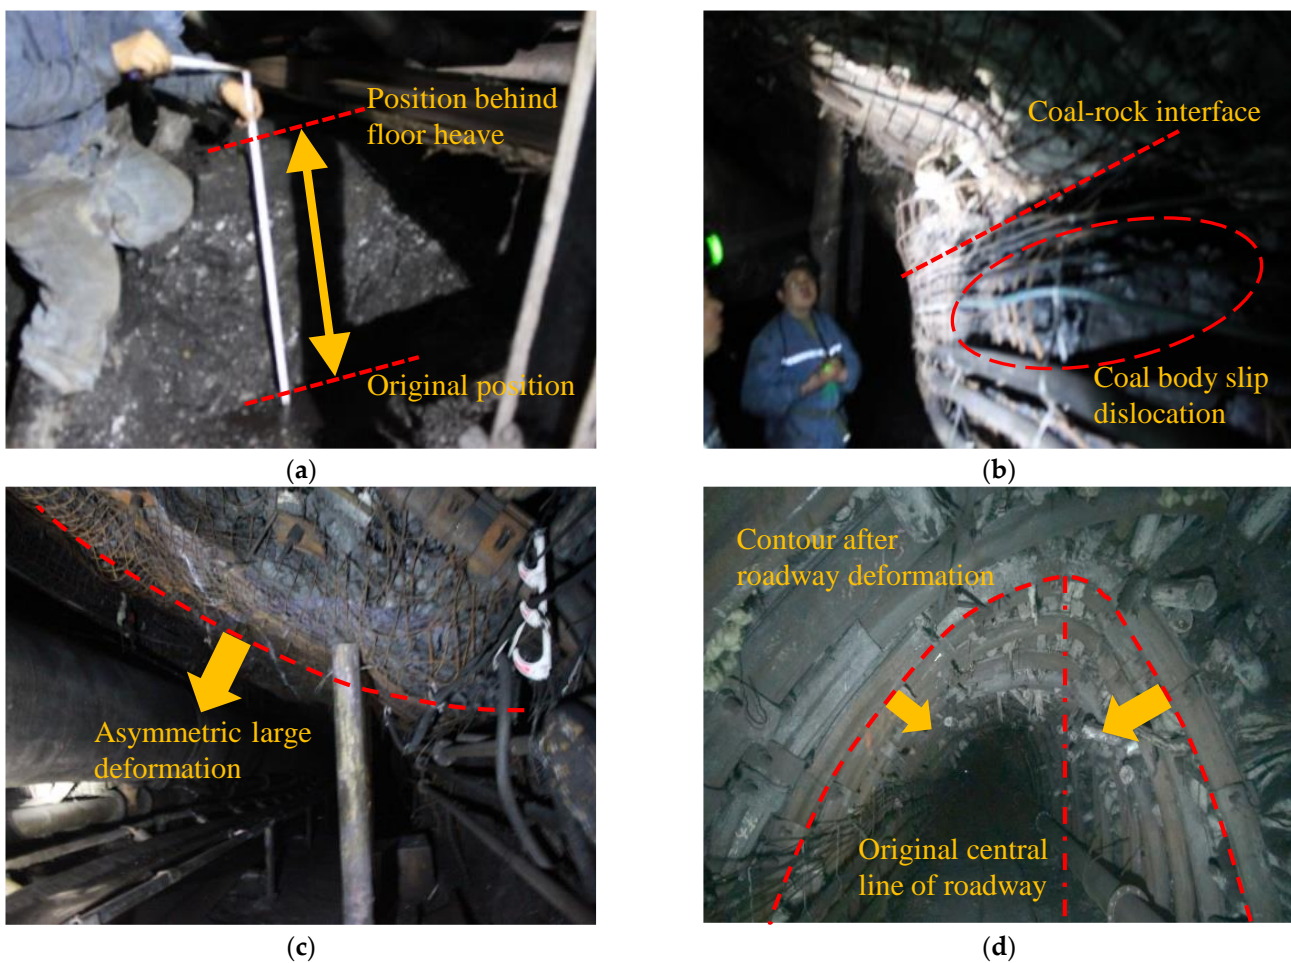
- (1) Continuous floor heave. Due to the infiltration of fissure water in the surrounding rock and the influx of water from the neighboring mining, the floor was seriously flooded after roof watering, and floor heave deformation was continuously produced, as shown in Figure 1a.

- (2) Coal–rock interface slip dislocation. The coal–rock body at the coal–rock interface on the side of the roadway, especially at the side of the narrow coal pillar, produced an obvious slip dislocation deformation along the coal–rock interface. When it was serious, it presented the phenomenon of stepped bulging, as shown in Figure 1b.

- (3) The two sides showed asymmetric deformation characteristics. It was found in the investigation that, under the existing support model, the deformation of the coal pillar side of the roadway was generally greater than that of the solid coal side, as shown in Figure 1c,d. According to the results of the field investigation, the sketch of asymmetric deformation characteristics of the roadway was drawn in Figure 2.

Figure 1. Pictures of roadway deformation characteristics. (a) Continuous floor heave; (b) coal–rock interface slip dislocation; (c) asymmetrical failure of bolt–mesh–anchor support; (d) asymmetrical failure of U-shaped steel support.

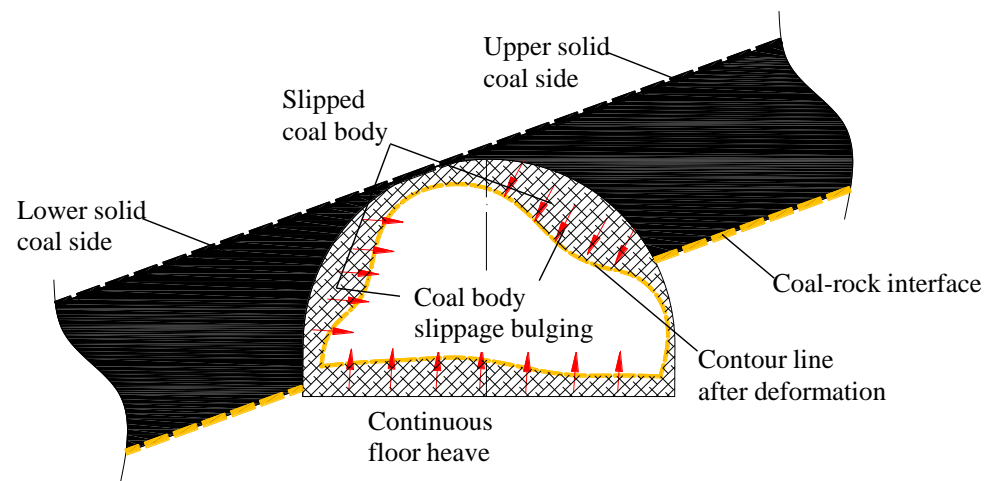
Figure 2. Sketch of asymmetric deformation characteristics of roadway.
