Watch Out for the Tailings Pond, a Sharp Edge Hanging over Our Heads: Lessons Learned and Perceptions from the Brumadinho Tailings Dam Failure Disaster

Deqiang Cheng ¹, Yifei Cui ^{2,*}, Zhenhong Li ^{3,4,5} and Javed Iqbal ^{6,7,8}

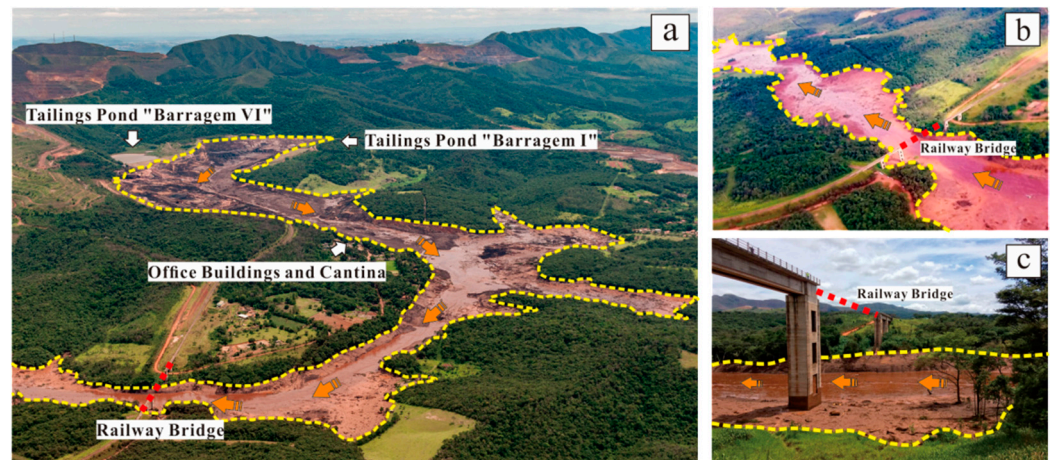
Figure 3. Disaster pictures. (a) Aerial view of Brumadinho dam disaster taken at 11:46 on 27 January 2019 [19]; (b) video screenshot of the destroyed railway bridge, 3 km downstream from the collapsed dam, on 26 January 2019 from YouTube [20]; (c) picture of iron ore railway bridge destroyed by mudflow taken on 26 January 2019 [21]. Note that the yellow line represents the extents of the areas affected by the mudflow, the red line represents the railway bridge which was damaged, and the brown arrow indicates the movement direction of the mudflow.

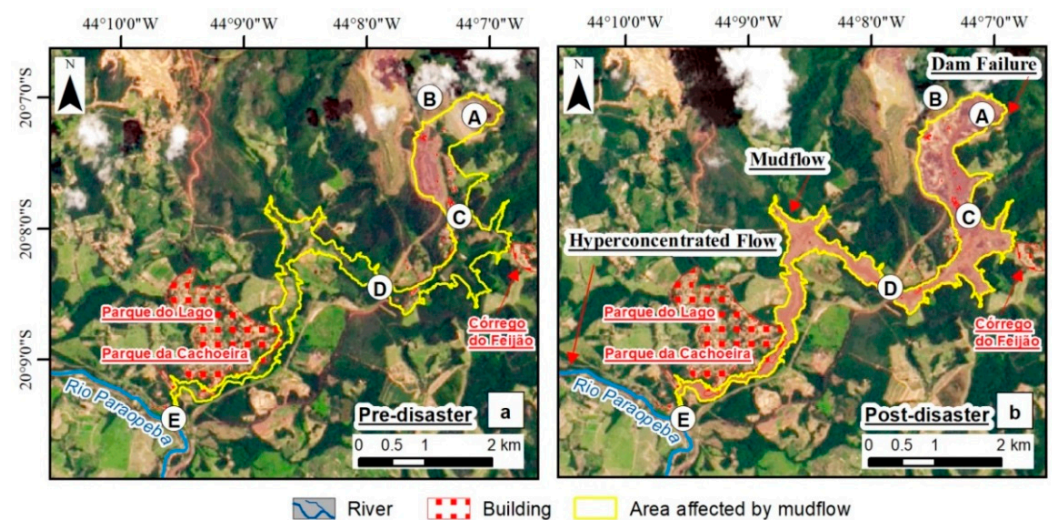
Hazard chains are the hot topic in the broader realm of natural hazards [57] (e.g., earthquake-induced chains [58], glacial-outburst-induced chains [59], and volcano-eruption-induced chains [60]). In this disaster, the dam released a mudflow of tailings after the dam failure (Figure 7b-A). The high-speed mudflow struck the mine's administrative area (Figure 7b-C) [61], destroyed the railway bridge (Figure 3b,c and Figure 7b-D), and continued to move downstream. At about 3:50 pm on 25 January 2019, the mud reached and came into the Paraopeba River (Figure 7b-E). On 27 January 2019, around 5:30 am, sirens

were sounded for the stability of the mine's adjacent Dam VI [16] (Figure 7b-B), where increased water levels were observed.

This hazard chain contained three stages including dam failure, mudflow, and hyperconcentrated flow with tailings waste (Figure 7b). The occurrence of this hazard chain is the result of a combination of many factors. Since the tailings contained a certain amount of water, it created conditions for the mudflow after the tailings dam failure. The tailings waste entered the river following the original branch channel, which in turn enlarged the impact of this disaster with extremely high turbidity and metal concentrations, lower dissolved oxygen, and change of microbial communities which would impact the growth and reproduction of aquatic creatures [62,63].

Figure 7. Comparison of pre- and post-disaster Landsat 8 images [64]. (a) Pre-disaster remote sensing image (14 January 2019) [27]; (b) post-disaster remote sensing image (30 January 2019) [28]. A = location of the destroyed tailings dam and the tailings pond “Barragem I” on 25 January 2019. B = location of tailings pond “Barragem VI” which appeared as an early warning of stability on 27 January 2019. C = location of the destroyed cantina and office buildings. D = location of the destroyed railway bridge (Figure 3b,c). E = location of the entry point of the mudflow into the Paraopeba River.

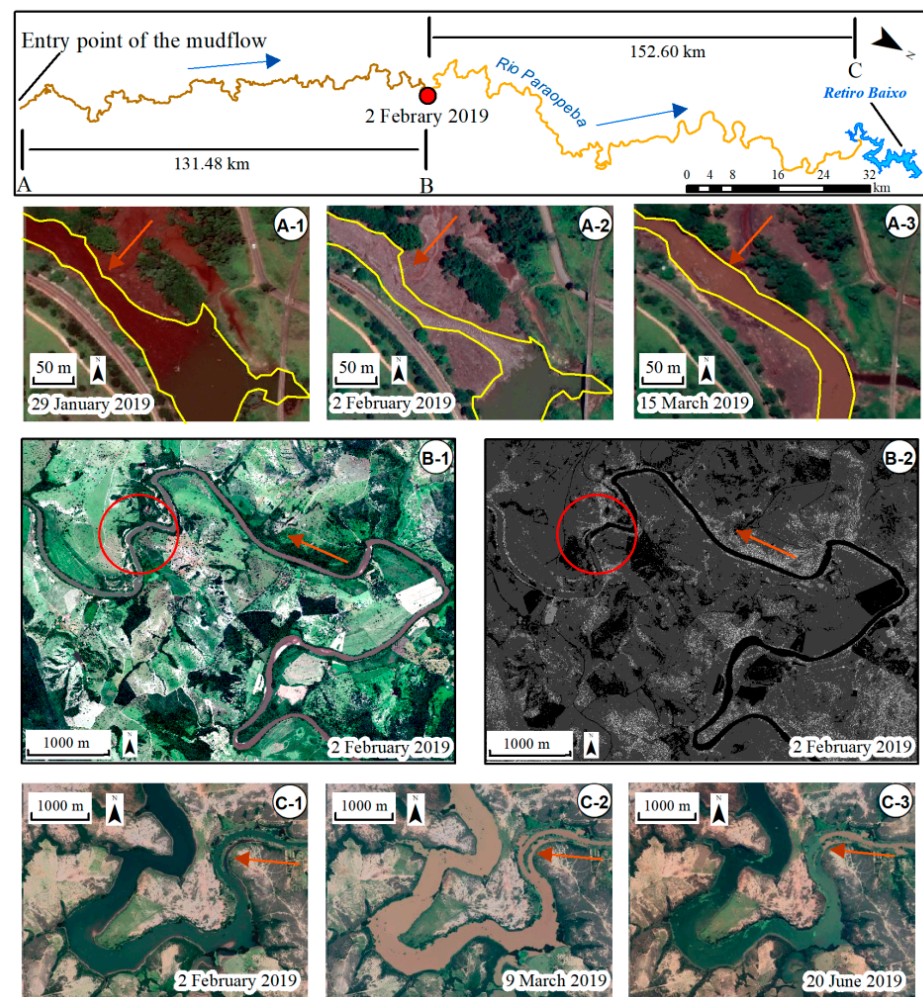
Through the examination of multi-temporal Google Earth images, the transport process of waste in the Paraopeba River can be observed (Figure 8). Comparing Figure 8A-1 with 8A-2, a large amount of waste entered the river several days after the failure, which might block the river for a certain period. Figure 8A-3 shows that due to the increase of precipitation in the later period (Figure 13), the water level of the river increased and eroded a new channel.

Figure 8B-1 shows the location of the waste as of 2 February 2019. It can be observed that the color of the right river section is vermeil, compared with the left section (red circle). The length of AB reach is 131.48 km with a height difference of about 60 m. It took less than a week for the waste to transport from A to B. After the waste entered the Paraopeba River, the transport speed of waste in the water was affected by many factors, such as concentration and stream gradients [65,66]. In addition, according to remote sensing images of Google Earth, it appears that the barrier of some small river dams in the Paraopeba River might also slow down the movement of the waste. Figure 8B-1 is a true-color image of tailings in rivers, and the change of water color in the circle position can be observed. In order to make the watercolor contrast more obvious, considering that the green and red bands are sensitive to the sediment [67], the ratio between these bands were calculated. As can be seen in Figure 8B-2, there is an obvious change in water color at the red circle.

Figure 8. Transport process of waste in the Paraopeba River. A—1, 2, 3 = images of the entry point of the mudflow into the Paraopeba River, the yellow lines are used to mark the river boundary; B—1, 2 = images on 2 February 2019 around point B in the Paraopeba River, the watercolor change can be seen; C—1, 2, 3 = images of the entry point into the Retiro Baixo.

Comparing Figure 8C-1 with 8C-2, the influence of waste on the water body was obvious after it entered the reservoir of hydropower station—Retiro Baixo. A few months later, the watercolor recovered due to the deposition of sediments. Based on the analysis of Figure 8 and multi-temporal Google Earth images, a table of sediment transport time node was generated (Table 4) in order to make the interpretation of sediment transport clear.

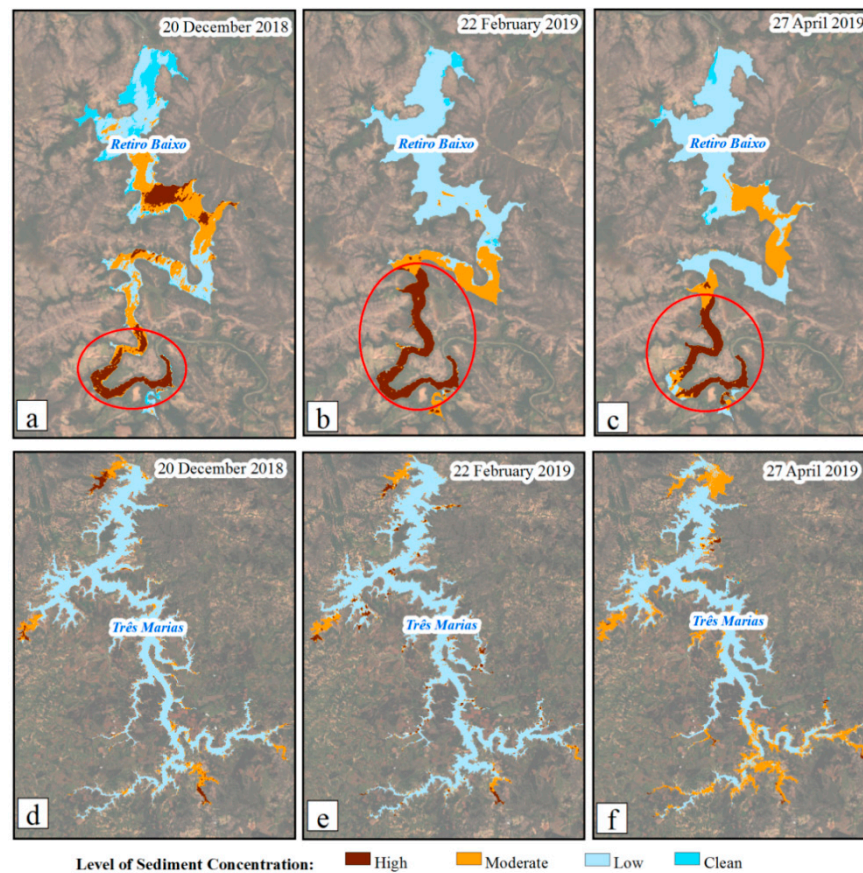
The sediment index was obtained using the SI calculating method. Figure 10 shows the pre- and post-disaster sediment concentrations. Contrasting the area of high sediment concentration where the river enters into the Retiro Baixo reservoir (Figure 10a–c), it had a larger area of 3.66 km² compared with 1.89 km² on 20 December 2018 and 2.49 km² on 27 April 2019 with a 2-month interval spanning this disaster. It can be observed that the sediment plume had a great impact on the reservoir of the Retiro Baixo Plant, over 300 km from the failure location, while less impact on the reservoir of the Retiro Baixo Plant. This result is consistent with Vale’s evaluation [73]. It appeared that small river gradients and obstruction of the reservoir barriers played an important role in slowing down the tailings waste moving into the São Francisco River. It is not hard to find out that this disaster event had little impact on the Três Marias reservoir (Figure 10d–f).

Figure 10. Level of sediment concentration of Retiro Baixo and Três Marias. (a) Level of sediment concentration of Retiro Baixo on 20 December 2018; (b) level of sediment concentration of Retiro Baixo on 22 February 2019; (c) level of sediment concentration of Retiro Baixo on 27 April 2019; (d) level of sediment concentration of Três Marias on 20 December 2018; (e) level of sediment concentration of Três Marias on 22 February 2019; (f) level of sediment concentration of Três Marias on 27 April 2019.

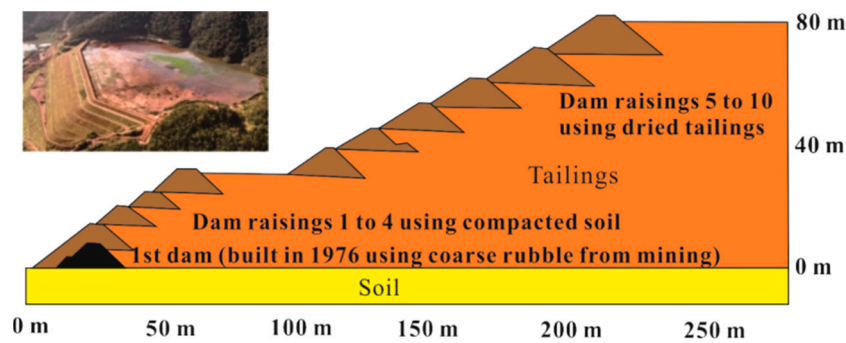
Figure 12. Cross section of Brumadinho dam “Barragem I” from the west to the east [88,89].

Some experts believed that Brazil's weak regulatory structures and regulatory gaps allowed the dam's failure [86]. This dam was built in 1976 using the "upstream" method, in which coarse rubble, compacted soil, and dried tailings were used to build the dam (Figure 12). This is similar to the Fundão dam which failed in November 2015, killing 19 people and causing an environmental catastrophe, compared with a more expensive and strong method using solid rocks to contain the waste. The water leak was first observed near its base in July 2018, and then repairs were carried out [87]. José de Gouveia, the worker of Vale, said that the dam exhibited a small leak soon after the rainy season, and leaking water was observed in several places at the bottom [87]. The possible pore pressure build-up would have resulted in a decrease in effective stress and initiated a failure.

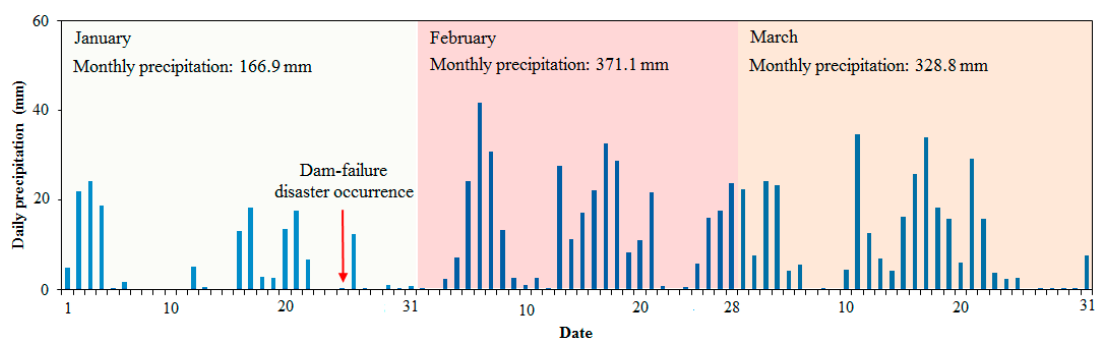
In this section, weather effects are examined. Daily precipitation data in Brumadinho were obtained from the World Weather Online website [90]. It appeared that precipitation increased the water content of the tailings pond before the dam failure event, increased the pore pressure, and thus induced failure initiation, which could be an important triggering factor for the tailings dam collapse (Figure 13). Although there was less rainfall in January than in February and March 2019, the rainfall in January 2019 sometimes reached the peak of monthly rainfall in some years from the perspective of multi-year rainfalls (Figure 14).

Figure 13. Daily precipitation in Brumadinho during the period from January to March 2019 [90].

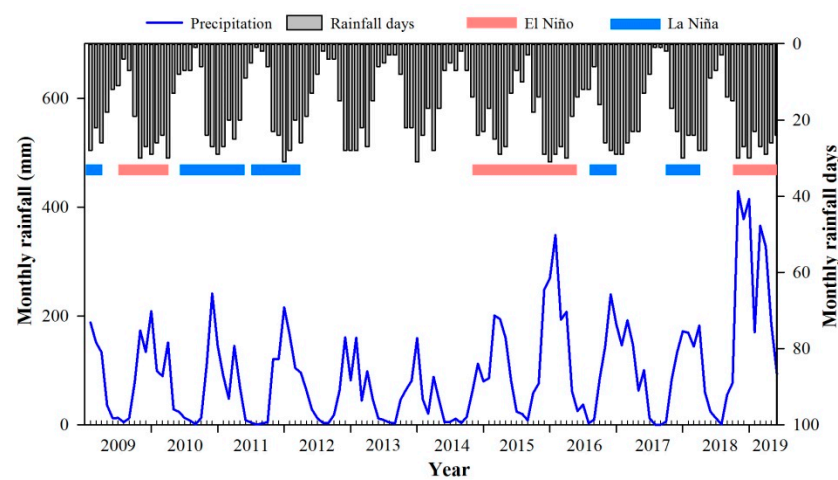
Figure 14. Monthly precipitation in Brumadinho during the period from 2009 to 2019 [90].

Extreme weathers in Brumadinho are linked to El Niño conditions from September to January typically [93]. A major El Niño event has been recorded since October 2018, and there were unusual rainfalls before the disaster (Figure 14) [94]. The increase of soil water content created conditions for the dam instability.
