Assessment of Complex Masonry Structures with GPR Compared to Other Non-Destructive Testing Studies

Sonia Santos-Assunção ¹, Vega Perez-Gracia ^{1,*}, Oriol Caselles ², Jaume Clapes ² and Victor Salinas ²

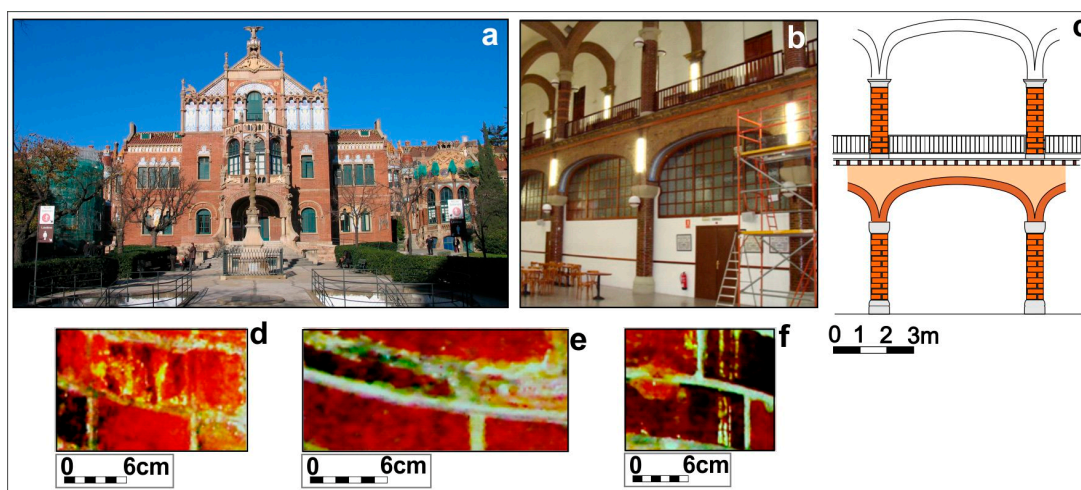
The Hospital of Sant Pau i la Santa Creu is considered one of the most important “Modernista” monuments in Barcelona. This huge complex was designed by the architect, Lluís Domènech i Muntaner, in 1905, and it is composed of numerous buildings communicated by underground tunnels. The buildings are supported by masonry columns. During the last few years, several intensive restoration tasks were performed as a consequence of the failure of one dome. The evaluation paid attention to the columns, which appear deteriorated in many parts of the complex. Fissures and dampness seem to be some of the most common pathologies observed on a preliminary visual inspection of those columns. Figure 1 shows the main entrance of the complex, the interior of one of the buildings and some images of the pathologies observed in the columns. Damages caused by corrosion also appear in several of the

columns, indicating the existence of some metallic element embedded into the column. Other columns present visible humidity effects, even in the case of members in internal rooms. In several members, fissures and cracks appear on the surface, and some of the columns present ancient restorations.

Figure 1. Hospital de Sant Pau i la Santa Creu. (a) View of the main façade; (b) internal view of one pavilion; (c) scheme of the supporting structures in the internal pavilion; (d) damage in columns caused by corrosion; (e) fissures in masonry columns; (f) moisture affecting the exterior of the columns.

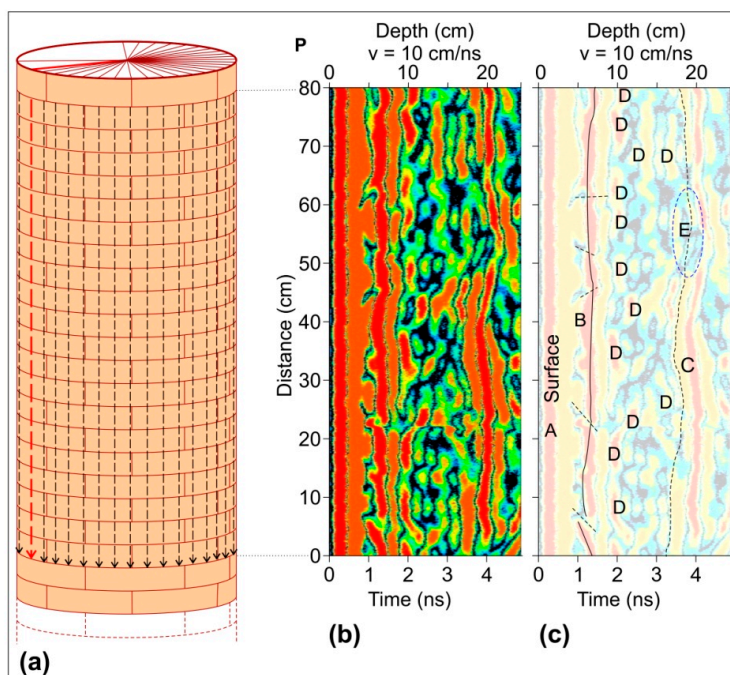
Figure 5. Distribution of the vertical radar lines on the column (a) and one of the radar images obtained in the profile (P) (b); four main detected anomalies are marked on the radar data interpretation, shown in (c): A: reflection on the surface of the column; B: reflection on the contact between the external bricks and other inner materials; the non-regular reflection seems to indicate that the bricks are not disposed in a uniform layer. C: Reflection on an internal element, uniform along the entire column; D: reflections on irregular targets inside of the column; E: the anomaly is weaker or even disappears in some parts of the profile.

In neither circular (Figures 6 and 7) nor longitudinal (Figure 5) radar images did anomalies seem to indicate that supporting metallic structures do not exist inside the column. All anomalies are discontinuous and not strong enough to be caused by metallic targets, with the exception of the strong reflection that appears between 3.5 ns and 4 ns. This anomaly is visible in all of the circular profiles, at similar two-way travel times, indicating a possible depth of about 20 cm or 26 cm, corresponding to velocities of 10 cm/ns and 13 cm/ns. The radius of the column is 32 cm. Hence, this anomaly could be caused by the reflection on a metallic tube in the center of the column, with a diameter of about 10 cm. It is noticeable that this anomaly is strong and continuous in some parts of the column, while in other parts, the anomaly becomes weaker or even disappears. A possible interpretation is the existence of a damaged metallic rain drain pipe inside the column. This drainage pipe was later revealed when the sample was broken. Damages in this tube could explain the moisture pathologies observed in the external part of the column.

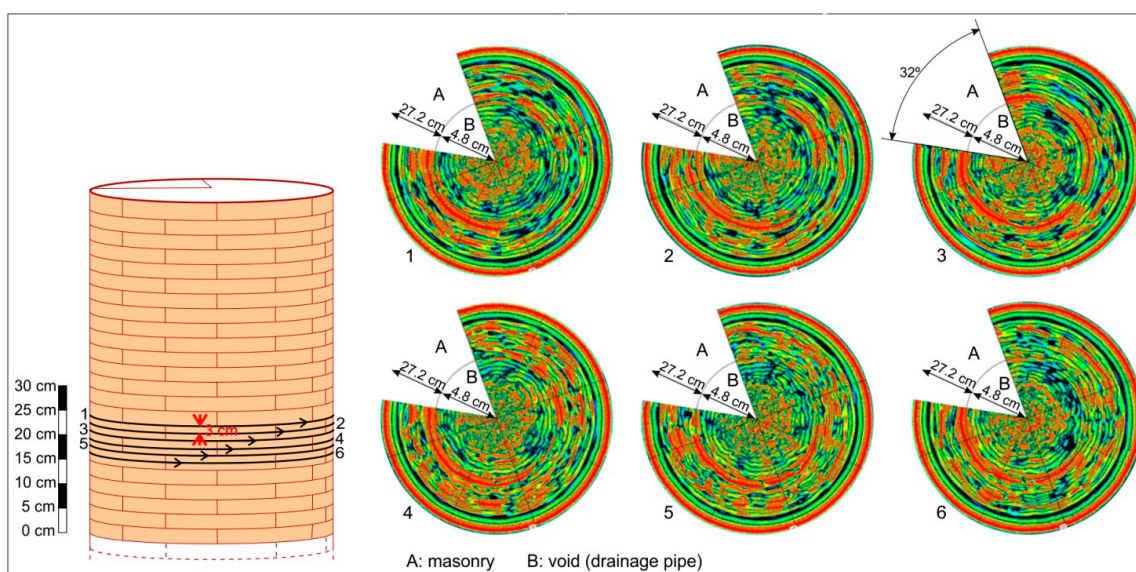
Figure 6. Radar images from six of the adjacent circular profiles.

circular radar lines, along 328° , separated 3 cm. Figure 6 presents the position of six of those horizontal radar lines on the column surface and the six radar images associated with these profiles.

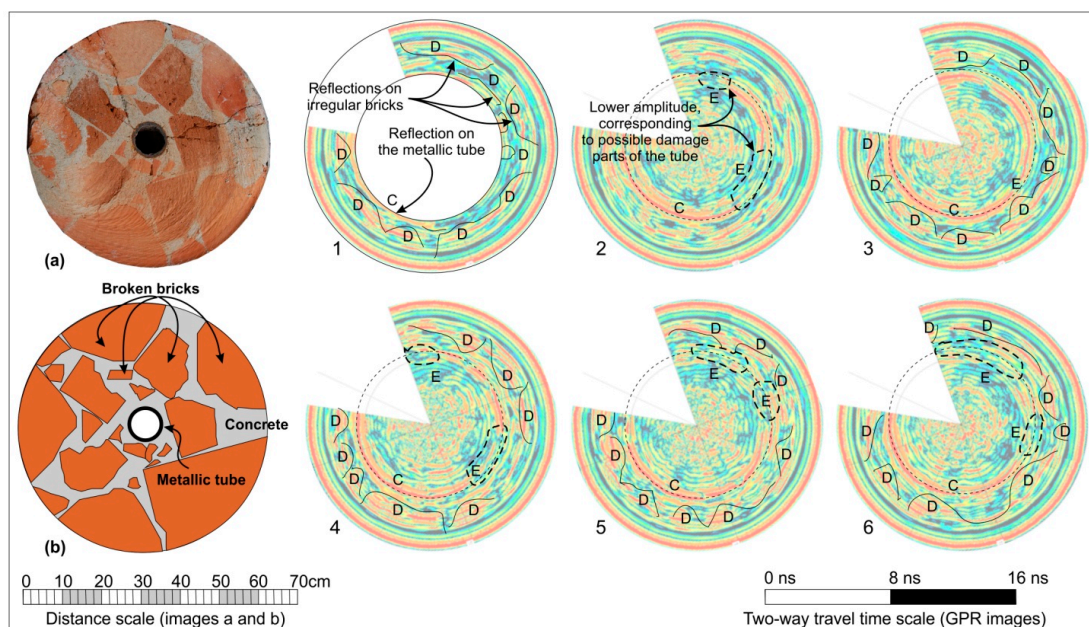
Interpretation of the anomalies observed in circular profiles is shown in Figure 7. Some of the anomalies along the entire profile confirm an irregular pattern most likely associated with the internal arrangement of bricks or perhaps broken bricks. The specimen was cut after the radar exploration, and the section showed the irregular masonry arrangement.

Figure 7. Section of the column (a); photograph of one section; (b) schematic drawing, showing the different inner elements and possible interpretation of the circular profiles (1 to 6). C: anomaly caused by the internal metallic tube. D: irregular pattern as a consequence of the irregular bricks arrangement. E: the amplitude of the reflection on the tube becomes weaker in some parts.

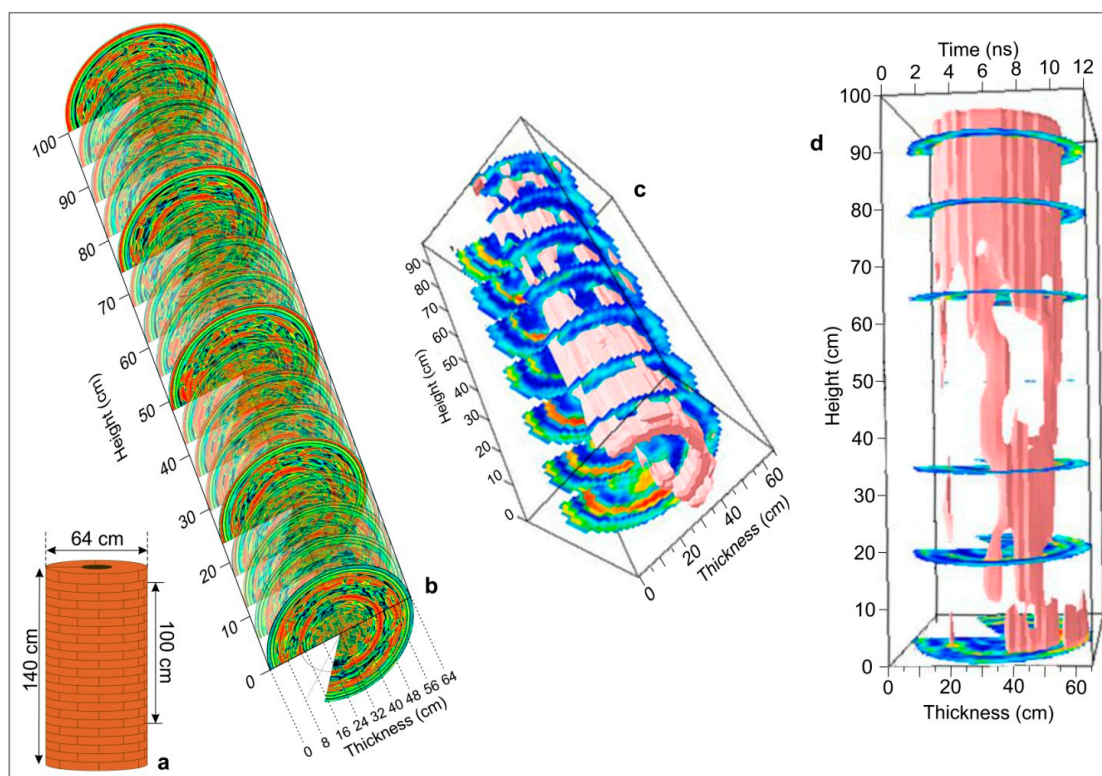
could be crucial to determine the possible areas where dampness may become an important pathology. Nevertheless, the extension of the pipe damage is difficult to evaluate by using only B-scans. Consequently, three-dimensional images were obtained in order to achieve a more complete visualization of the inner tube and other possible internal and important targets. 3D images were extracted by using the square of the amplitude in each A-scan and by interpolation in cylindrical coordinates. Rendered images with amplitudes higher than 75% provide proper images of the pipe (Figure 8). Results underscore the existence of the longitudinal body along the column, but evidencing the existence of some parts where the image disappears. Discontinuities are approximated to damaged parts of the pipe. Nevertheless, it is not possible to associate absolutely the discontinuities in the isoamplitude images with the parts of the tube that are completely broken, because small cracks in the pipe, voids in the masonry near the pipe or changes in the materials of the masonry column could also affect the amplitude of the wave. These amplitudes could be smaller than the 75% cut-off value considered in the rendered isoamplitude image. The use of small cut-off amplitudes did not improve the resolution in this particular case study, because of the complexity of the structure. The heterogeneous materials produce numerous reflections, obtaining confused images in the rendered isoamplitude for smaller cut-off values.

Figure 8. Three-dimensional images of the column. (a) Scheme of the tested specimen. One hundred meters were tested by means of circular GPR profiles. (b) The 3D composition of some circular radargrams. (c) The isosurface render generated with GPRSlice software, showing the anomaly that probably corresponds to the inner pipe and other smaller targets. (d) Image of the isosurface corresponding to amplitudes higher than 75% of the maximum amplitude. Changes in the amplitude could reveal the existence of possible damages corresponding to void areas in the rendered isosurface.

Other possible causes of the changes in the amplitude could be the corrosion of parts of the tube. The effects on the GPR signals as a consequence of the corrosion of metallic bars embedded in concrete had been proposed in 2009 by [24], and some tests were presented in 2013 by [25], concluding that bar corrosion increases the average wave velocity, the amplitude and the frequency of the bar reflection. However, in the study of the masonry column, the inhomogeneous and irregular medium impedes the possibility of detecting or identifying changes in the radar data that could be related to corrosion effects.

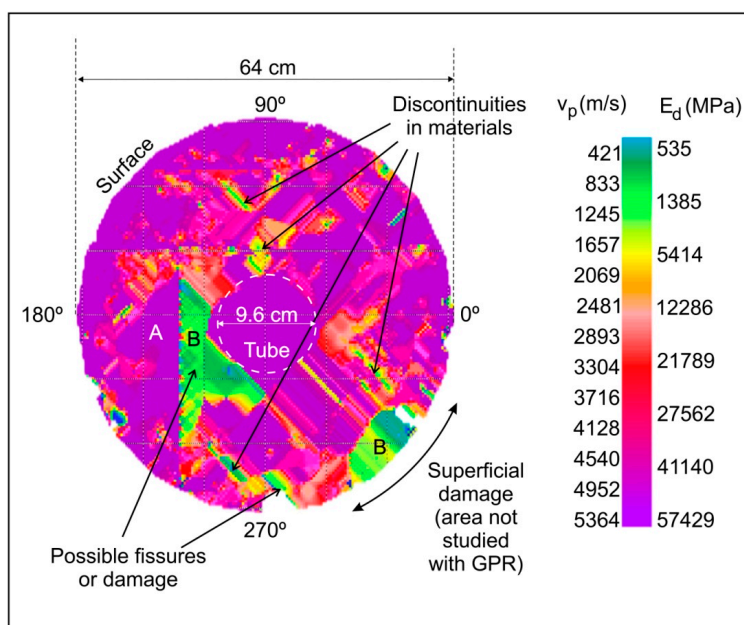
Seismic tomography seems to confirm the existence of the pipe in the center of the column. In this zone, a circular area presents high seismic propagation velocity (Figure 9). Several zones of the section presenting lower velocities could be associated with cracks or more damaged parts of the column. In some cases, it could be caused by the elements used in the further restoration of the column. These low-velocity zones are usually placed close to the pipe or in the shallowest part of the column. Irregular and small changes on the velocity are most likely caused by the irregular arrangement of materials inside the structure. However, it is noticeable that the column exhibits high homogeneity, with the stronger changes happening only in two small areas. The outer low-velocity area corresponds to an area of the column with visible damages. Seismic results underscore the interpretation of the GPR data. It is also remarkable that the high velocity of the inner part of the possible tube is an artifact of the software used. The low velocity of seismic waves in air caused no rays to cross this section, producing an incorrect and artificial interpolation.

Figure 9. Seismic tomography results. Changes in seismic velocity indicate the existence of different zones and irregular materials.

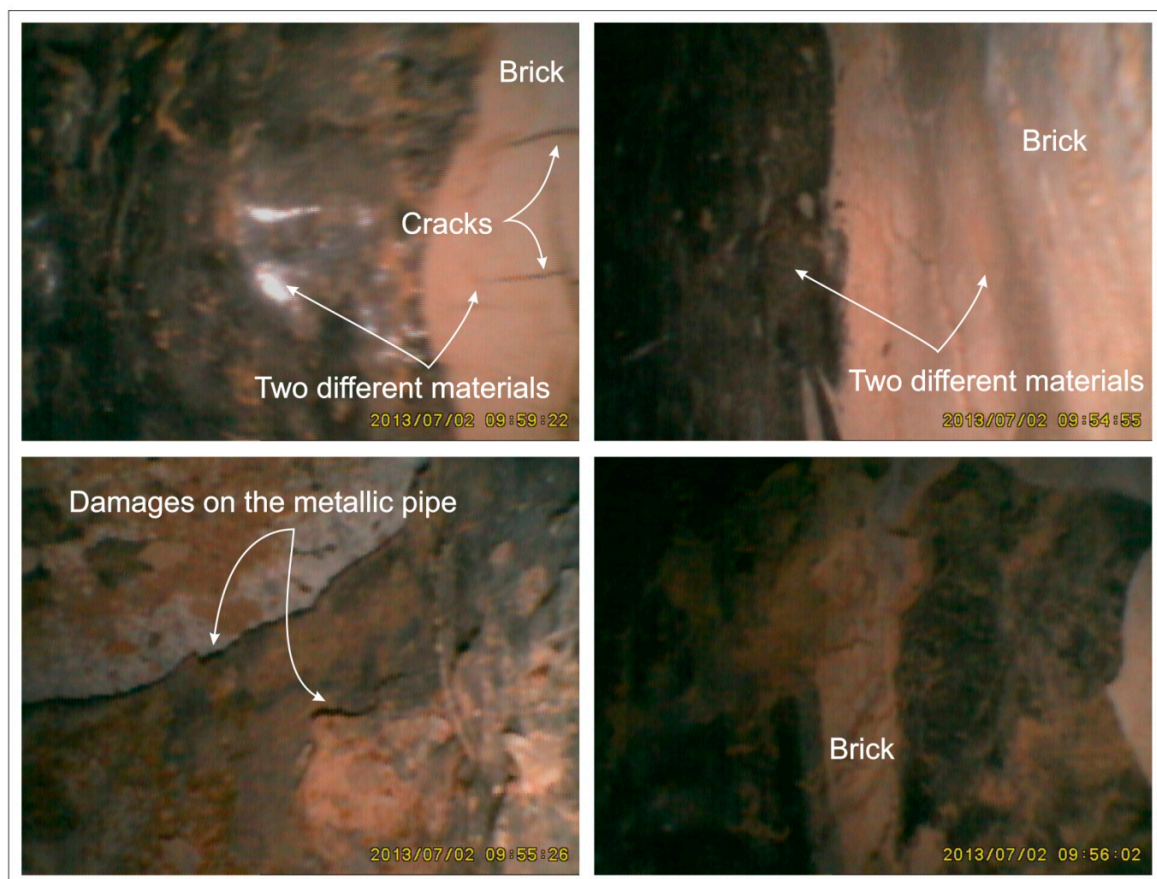
Images obtained from the interior of the column (Figure 10) confirm the existence of different materials and a damaged metallic element. In some cases, cracks appear on the images associated with bricks, highlighting some of the pathologies affecting the interior of the column.

Figure 10. Some endoscopy images, highlighting different parts and damages inside the column.

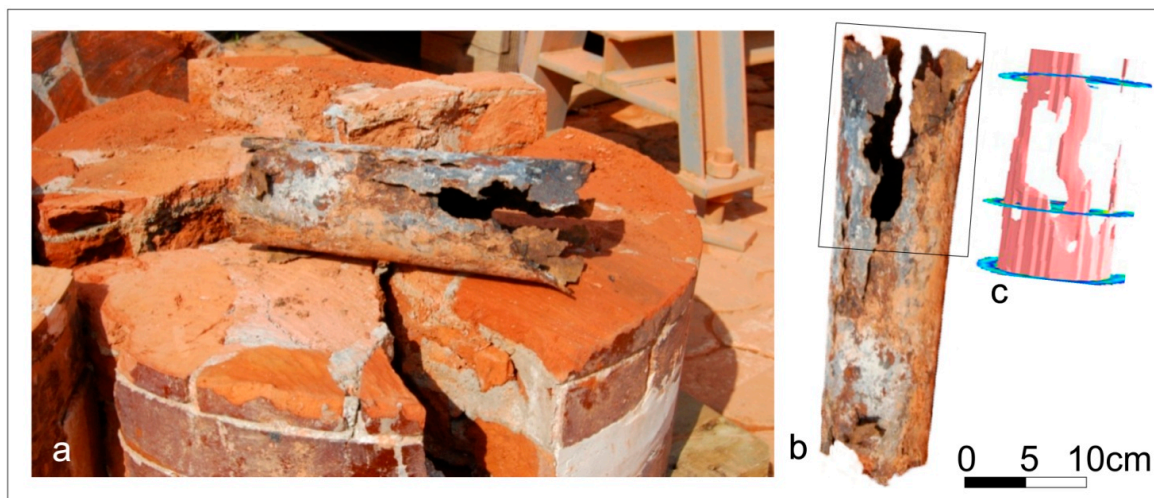
Finally, after the non-destructive surveys, a compression test was applied to the column. Hence, the column was broken, and the different elements became visible. The inner metallic pipe was extracted, and the direct visual inspection allowed for observing the damages as a consequence of corrosion. Figure 11 presents a photograph of the broken column and part of the extracted tube. This image is in concordance with the GPR and seismic images, showing the irregular arrangement of the bricks, disposed in triangular sections. The photograph of the drainage pipe section is also compared to the 3D radar render imaging, confirming the initial hypothesis about the damages.

Figure 11. (a) Section of the column after the compression test and (b) the metallic tube extracted, compared to (c) 3D radar imaging from isoamplitudes after a cylindrical interpolation.
