# A Comprehensive Investigation on Abnormal Impoundment of Reservoirs—A Case Study of Qionglin Reservoir in Kinmen Island

**Abstract:** Leakage is the most serious problem in reservoir operation, because heavy leakage influences reservoir impoundment efficiency and even leads to a complete loss of reservoir functions. Since its completion in 1982, Qionglin Reservoir has never been fully filled with water except in the spring of 1983 when there was heavy rain. The reservoir management unit suspected that its side slopes, bottom or dam might leak and carried out a number of leakage prevention and improvement works, but all of them failed to fulfill the impoundment function of the reservoir. Hence, this study attempts to find out the reasons why the reservoir cannot impound water. A series of tests and investigations are carried out in this study, including electrical resistivity tomography of dam, tracer test, geological drilling test, reservoir water level observation, investigation of reservoir catchment area and field investigation of dam. The test results and investigation results show that no leakage path and leakage are found. According to the analysis, there is no serious lea

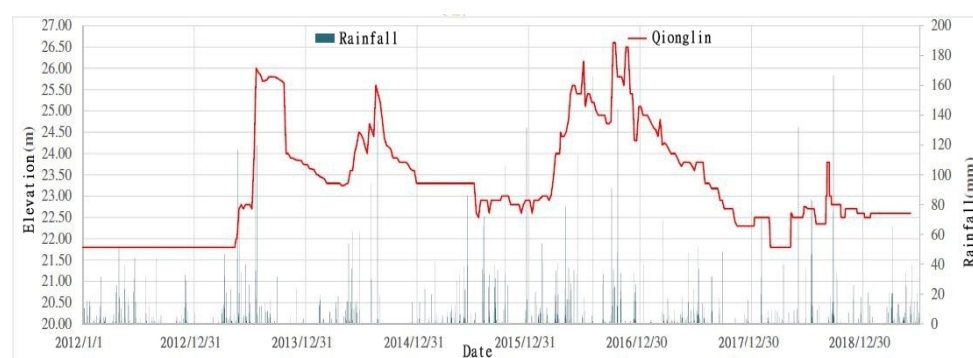
Figure 6 is the comparison between water levels and rainfall of Qionglin Reservoir from 19 December 2011 to 4 June 2019. From the observation of the above water level changes, Qionglin Reservoir was at the dead water level before May 2013; its water level changed significantly from May 2013 to 2017 with the rainfall; the water level changes slightly after dropping to the dead water level in March 2018; and the water level was around EL.22.5–23 m, despite the heavy rain in May and August 2018.

**Figure 6.** Comparison between water levels and rainfall of Qionglin Reservoir.

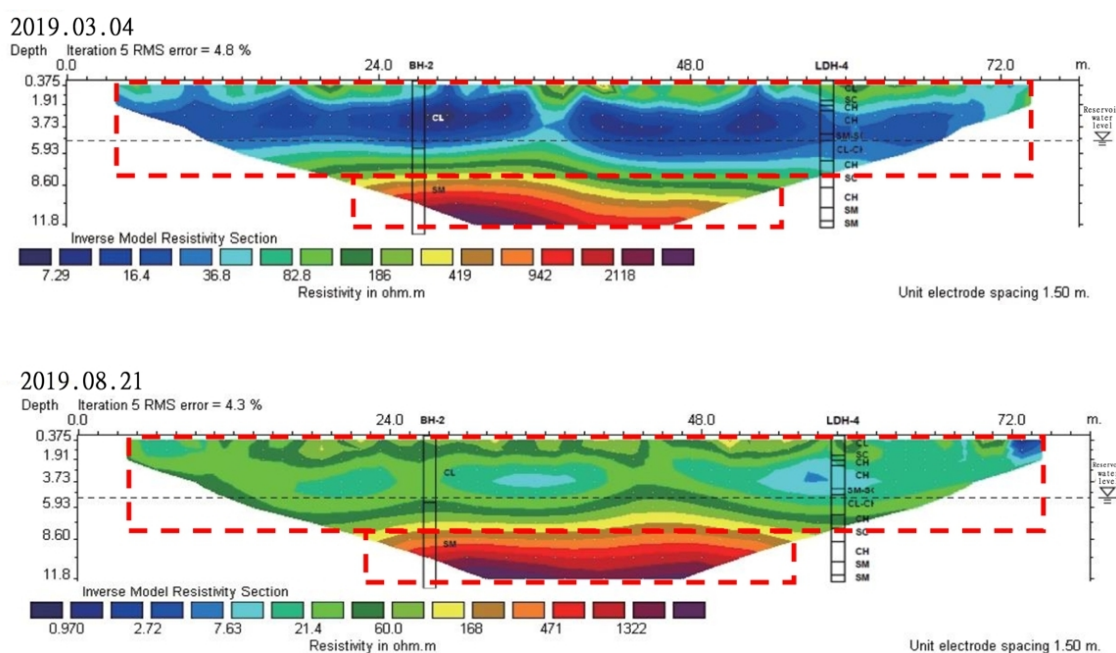
Figure 7. Results of line L1.

The electrical resistivity tomography results of L1 are shown in Figure 7. The resistivity distribution was roughly two-layered, showing a low–high pattern from shallow to deep. In the first layer, the resistivity was relatively low, and the depth was less than 8.6 m; in the second layer, the resistivity was relatively high, and the thickness was about 3 m. The first test was carried out a few days after rain, and it was wet below the surface; therefore, the resistivity was very low, within 6 m below the surface. By comparing the results of the two tests, the overall results tended to be the same with clear distinction under the depth of 6 m, except for the variables caused by rainy days. With the drilling data and the reservoir water level of the day, it could be found that the boundary between the permeable layer and the impermeable layer was the same as the boundary of the earth resistance between the first layer and the second layer.

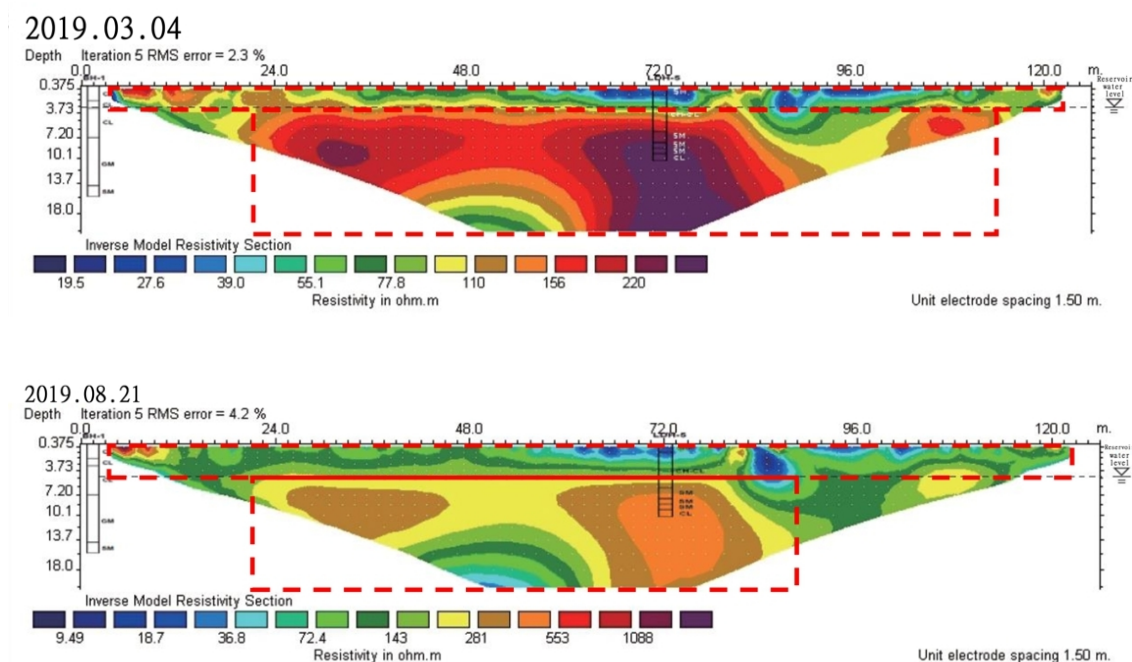
Figure 8. Results of line L2.

The electrical resistivity tomography results of L2 are shown in Figure 8. The resistivity distribution was roughly two-layered, showing a low–high pattern from shallow to deep. In the first layer, the resistivity was relatively low, and the depth was less than 4 m; in the second layer, the resistivity was relatively high, and the thickness was about 15 m. The overall results of the two tests tended to be the same. With the drilling data and the reservoir water level of the day, it could be found that the boundary between the permeable layer and the impermeable layer was the same as the boundary of the resistance between the first layer and the second layer.

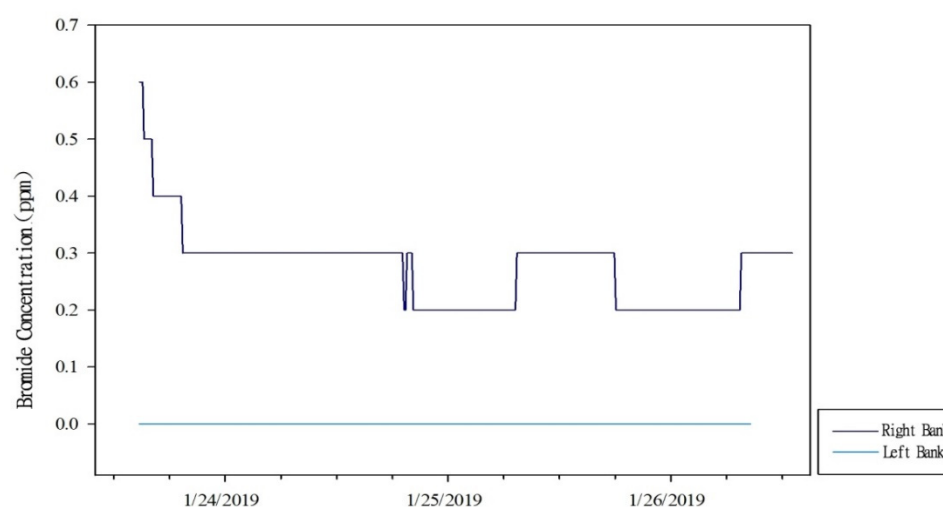
Figure 9 is the diachronic diagram of time-varying bromide ion concentration on the left bank (the stilling basin outside the reservoir) and the right bank (inside the reservoir area) measured by TempHion ISE. At the beginning, the background values of left bank and the right bank were 0 ppm and 0.6 ppm, respectively. As the bromide ion concentration was automatically received every 10 min, the diachronic diagram of the left bank shows that the artificial tracer put in has no influence; while the diachronic diagram of the right bank shows that the concentration decreases rapidly from 0.6 ppm to 0.3 ppm and then remains between 0.3 ppm and 0.2 ppm, indicating that the right bank was not influenced by the artificial tracer put in due to the background value of the right bank of 0.6. It indicates that the stilling basin did not receive any signal from the artificial tracer during the test period (from the afternoon of 23 January 2019 to the noon of 26 January 2019).

**Figure 9.** Diachronic diagram of bromide ion concentration on the left and right banks of the stilling basin by TempHion ISE.

In this study, water samples were respectively collected from the stilling basin on the left bank and the reservoir area on the right bank on 26 January 2019 and sent back to the laboratory for analysis. The results showed that the bromide ion concentration in the water of the reservoir on the right bank was about 0.3 ppm, while no bromide ion concentration was detected in the analysis of the water samples collected from the stilling basin on the left bank. Such results were same as the bromide ion concentration results measured on the left and right banks by TempHion ISE. Additionally, in this study, on 10 June 2019, water samples were collected again from the reservoir area on the right bank and the stilling basin on the left bank for testing. The results showed that the bromide ion concentration in the water of the reservoir on the right bank had significantly decreased to 0.03 ppm, while no bromide ion concentration was detected from the stilling basin on the left bank. Such results were similar to those of the first analysis, but after nearly 5 months, bromide ion concentration had significantly decreased. The tracer test results showed that no leakage was found in the dam spillway.

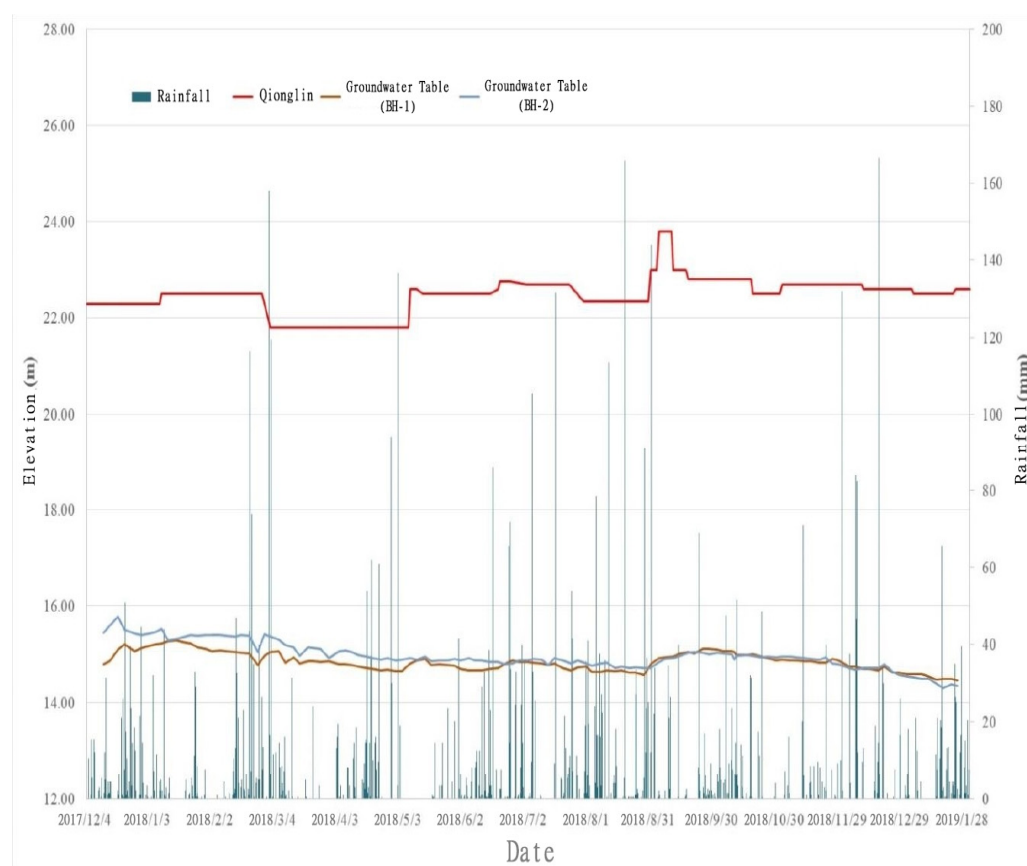
In order to understand the relationship among reservoir water level, rainfall and groundwater level, in this study, the two holes BH-1 and BH-2 were changed to be groundwater observation wells after drilling, to observe the changes of groundwater level around the reservoir. Figure 10 shows the groundwater level elevation changes. From December 2017 to January 2019, the groundwater level changed slightly, generally between EL 14.5 m and EL 15.5 m. The maximum and minimum groundwater levels of BH-1 were EL 15.28 m and EL 14.46 m, respectively. The maximum and minimum groundwater levels of BH-2 were EL 15.78 m and EL 14.30 m, respectively. According to Figure 10, the groundwater level did not immediately change with reservoir water level and rainfall, which only reflected the change trend.

**Figure 10.** Groundwater level elevation changes.

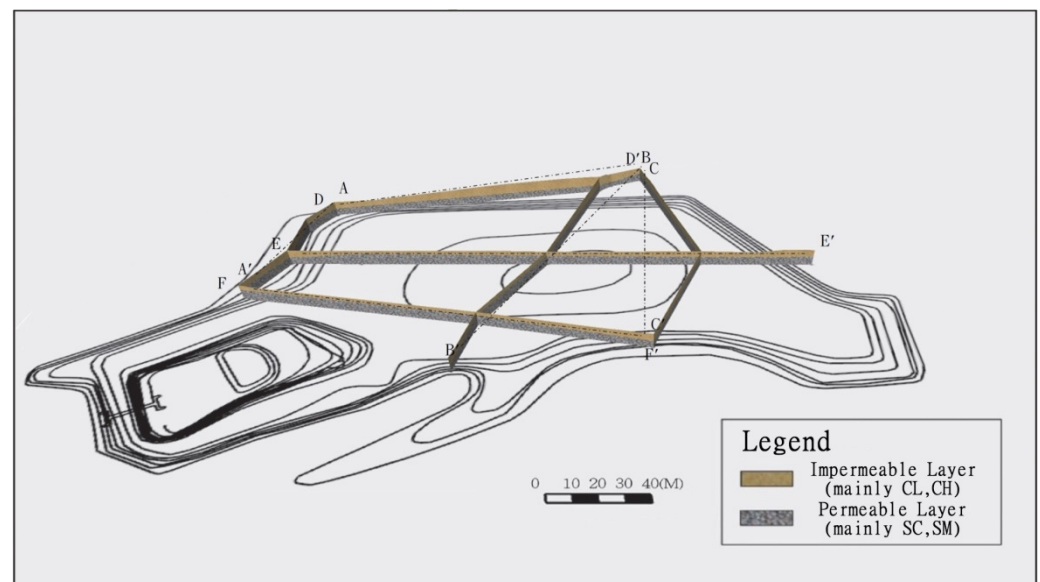
- (1) According to the results of the manual test pits, the Relative Compaction (RC) of the dam is 93%, and the Relative Compaction (RC) of the dam bottom is 89–92%, which proves that it did meet the compaction density requirements and effectively reduce the water permeability when the reservoir bottom was backfilled.

- (4) The sedimentary layers of the geological section A–A' are, from bottom to top, a permeable layer mainly comprised of SM and an impermeable layer mainly comprised of CL. The minimum elevation of the impermeable layer is 7 m, and the maximum elevation is 10 m.

- (5) The sedimentary layers of the geological section B–B' are, from bottom to top, a permeable layer mainly comprised of SM and an impermeable layer comprised of CL and small amounts of SC and SM. The minimum elevation of the impermeable layer is 4.5 m, and the maximum elevation is 10 m.

- (6) The sedimentary layers of the geological section C–C' are, from bottom to top, a permeable layer mainly comprised of SM and an impermeable layer mainly comprised of CL. The impermeable layer is about in a straight-line shape, with an elevation about 8 m.

- (7) The sedimentary layers of the geological section D–D' are, from bottom to top, a permeable layer mainly comprised of SM and SC and an impermeable layer comprised of CH, CL and small amounts of SC and SM. The minimum elevation of the impermeable layer is 5.5 m, and the maximum elevation is 8 m.

- (9) The sedimentary layers of the geological section F–F' are, from bottom to top, a permeable layer mainly comprised of SM and an impermeable layer comprised of CL and small amounts of SM. The minimum elevation of the impermeable layer is 8 m, and the maximum elevation is 10 m.

- (10) According to the geological drilling data and geological fence diagram, in the sedimentary layers inside and outside the dam and of the reservoir bottom, their impermeable layers cover their permeable layers. In addition, leakage improvement works have been carried out for the reservoir, and impermeable cloth has been laid throughout the reservoir area. Therefore, it is preliminarily concluded that Qionglin Reservoir shall have no serious leakage.

**Figure 11.** Geological fence diagram.

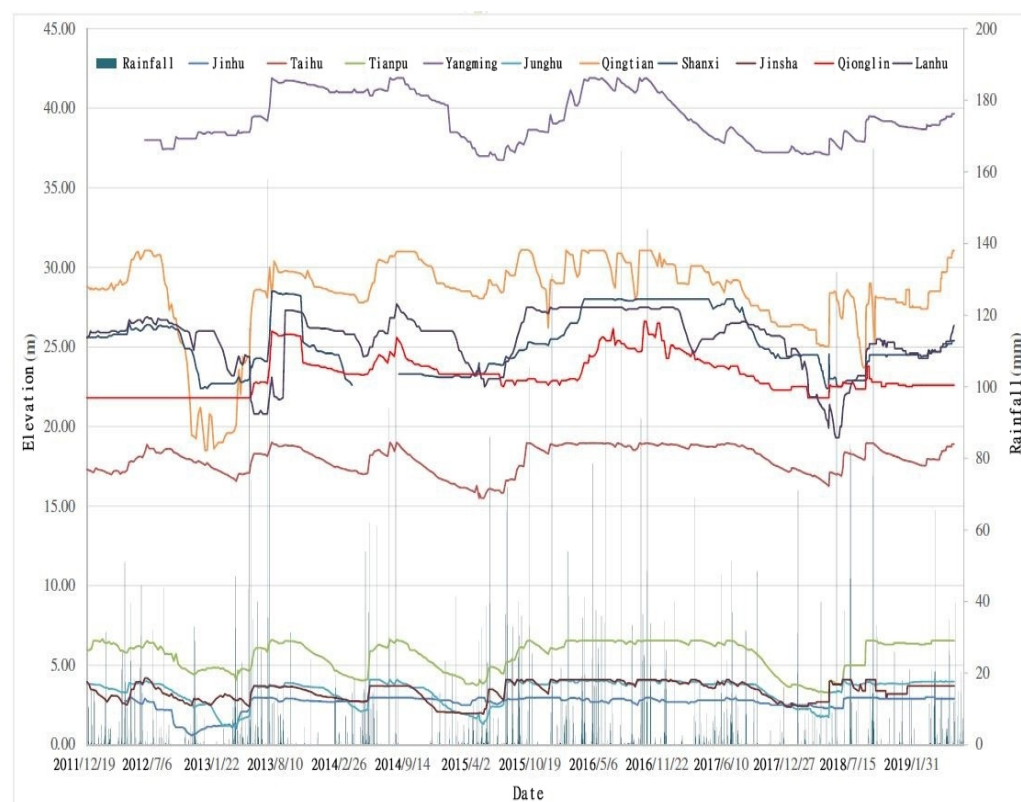
Figure 12 is the comparison between water levels and rainfall of 10 Reservoir in Kinmen Island from 19 December 2011 to 4 June 2019. The results showed that there was no abnormal change in the water level of Qionglin Reservoir, and the rate of decline from the high water level was not higher than that of other reservoirs (without considering the water intake from reservoirs). According to the data from the meteorological station of Kinmen County, the monthly evaporation of Kinmen is between 100 and 200 mm depending on the season, and the average daily evaporation is between 3 and 6 mm. Figure 12 showed that, from the end of October 2016 to the beginning of June 2017, the water level of Qionglin Reservoir steadily declined. After comparing the declining trend with the rainfall and

evaporation, it was proved that the declining trend of reservoir water level is within a reasonable range. Based on the analysis of the above reservoir water level changes, Qionglin Reservoir should have no serious leakage.

**Figure 12.** Comparison between water levels and rainfall of 10 reservoirs in Kinmen Island.

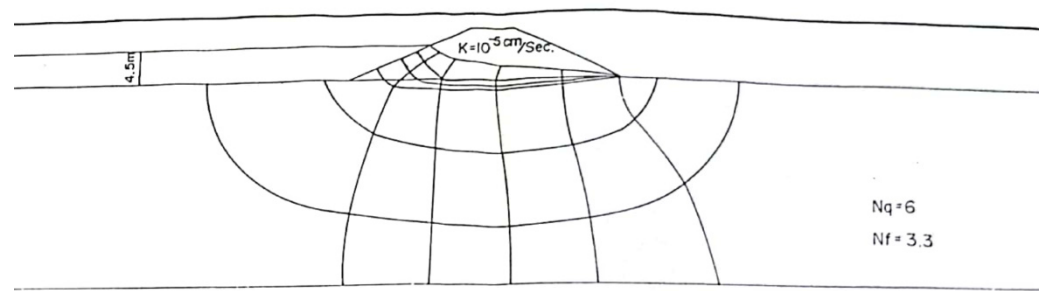
Case 1: Analysis of dam leakage: when the reservoir water level is full (EL = 26.5m), leakage will occur due to the hydraulic gradient, and at this time, the groundwater level will raise and maintain at the bottom of the reservoir (EL = 21.5m).

The leakage analysis of the dam is as follows: the basic assumptions are as follows, and the flow net is shown in Figure 13.

$$Q = 400 \times 2.475 \times 10^{-6} \times 86,400 \times 365 = 3.1 \times 10^4 \text{ m}^3/\text{year} = 31,000 \text{ m}^3/\text{year}$$

**Figure 13.** Seepage flow net diagram of dam and dam foundation of Qionglin Reservoir.

From the above calculation, it can be seen that when Qionglin Reservoir is full all year round, the annual leakage of the dam is 31,000 m<sup>3</sup>/year. However, when there is a small amount of water in the reservoir all the year round, leakage occurs due to the hydraulic gradient of groundwater, the annual leakage is 22,700 m<sup>3</sup>/year in the bottom of the reservoir. Although all the leakage is not large, the reservoir management unit must pay attention to this problem, such as by implementing the leakage prevention improvement project at the bottom of the reservoir.
