Examples of PlaceMarker Surveys

Supplementary Information 3 presents examples of PlaceMarker surveys undertaken in different settings with summary details of metrics, impression-based assessments, and key points: (a) Bradford-on-Avon, Wiltshire; (b) Deben, near Debenham, Suffolk; (c) Moat Road, Wood Brook, Loughborough; (d) River Tame, Bromford and Castle Vale, Birmingham.

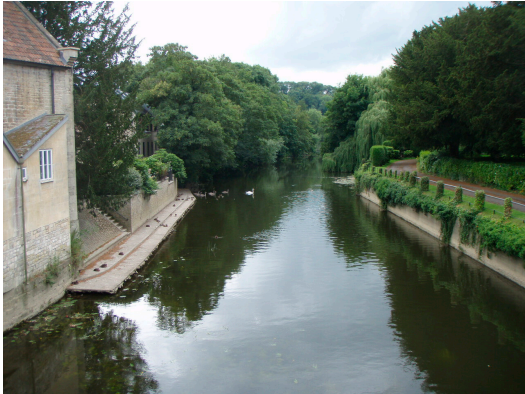
<p>(a) Bradford-on-Avon Flood Alleviation Scheme</p>	<p>Pre-project survey completed on 14.4.16</p>
<p>River Stretch Survey Grid references: Upstream ST 82670 60874; Downstream ST 82309 60642</p> <p>Stretch Habitat Quality Index (SHQI): 9 Average Materials class: Lightly engineered (LE) Physical habitat class: Stable (St) Vegetation class: Moderate tree cover, vegetated channel (MTV) Complexity class: High Stability class: Slightly Dynamic Channel condition class: Very Poor Connectivity class: High</p> <p><i>Stretches with varying levels of engineering, but displaying some level of either recovery or activity, with reduced riparian vegetation complexity or excessive macrophyte growth. The recommendation is, where possible, to reduce the levels of immobile substrates and bank materials and increase sinuosity. Tree cover and bank top and face vegetation should be managed to provide increased variety and complexity. These channels show moderate to high levels of activity and should be targeted for rehabilitation where opportunities arise.</i></p>

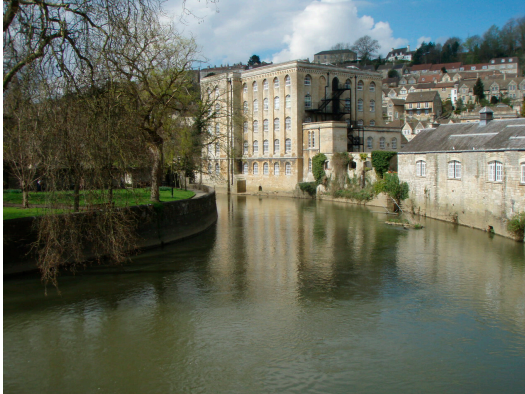
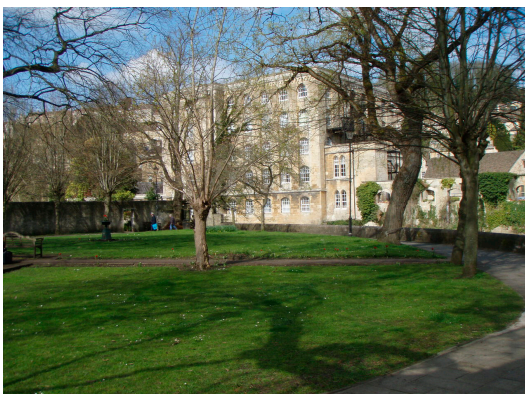
<p>Study Area Survey Impression-based assessments Habitat Quality Assessment (HaQA): 4 Poor Landscape Quality Assessment (LQA): 2 Good Amenity Quality Assessment (AQA): 2 Good Heritage Quality Assessment (HeQA): 1 Very Good</p> <p>Key Points: Habitat. River heavily constrained by buildings and walls along its banks, some large mature trees growing on the river margins and out of the river walls, little space for marginal vegetation, little evidence of in channel vegetation. Landscape. Area of high public use and visual appearance of any work will be scrutinised by local people and the visiting public. Vernacular Architecture, mature trees, and adjacent parkland play a significant role in the landscape are important in forming the setting for the site. A 'Landscape Visual Assessment' will be needed to support any Environment Agency scheme. Heritage. Architecture is a major feature of the Study Area and Visual Fringe. The road bridge across the river dating from the 13th Century is a major heritage feature. Amenity. Plentiful public access to the left bank, with good footpath connectivity although this could be improved but there is limited access on the right bank. Much of the Study Area is attractive, mainly formal gardens with plenty pf public seating. The Environment Agency should seek to retain and, if possible, improve the view of the river from the Study Area.</p>

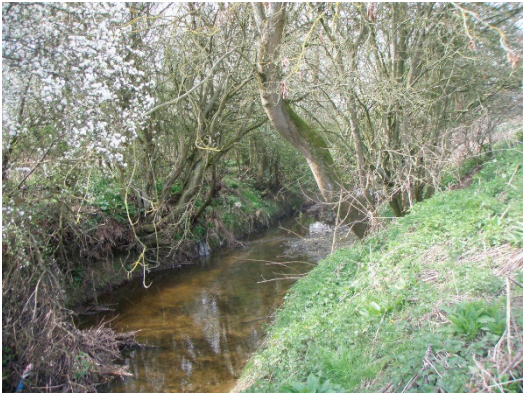
<p>(b) Deben, downstream of Debenham, Suffolk Proposed flood risk management scheme</p>	<p>Pre-project survey completed on 11.4.16</p>
<p>River Stretch Survey Grid references: Upstream TM 17661 62752; Downstream TM 18060 62571</p> <p>Stretch Habitat Quality Index (SHQI): 7 Average Materials class: Semi-natural (medium) (SNM) Physical habitat class: Semi-natural moderately active (SNMAct) Vegetation class: Moderate tree cover, vegetated channel (MTV) Complexity class: High Stability class: Dynamic Channel condition class: Average Connectivity class: Very High</p> <p><i>Stretches with varying levels of engineering, but displaying some level of either recovery or activity, with reduced riparian vegetation complexity or excessive macrophyte growth. The recommendation is, where possible, to reduce the levels of immobile substrates and bank materials and increase sinuosity. Tree cover and bank top and face vegetation should be managed to provide increased variety and complexity. These channels show moderate to high levels of activity and should be targeted for rehabilitation where opportunities arise.</i></p>

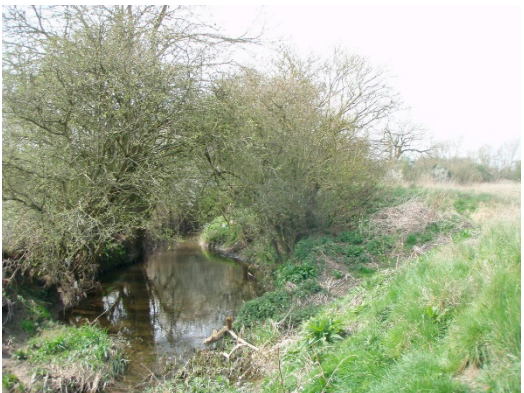
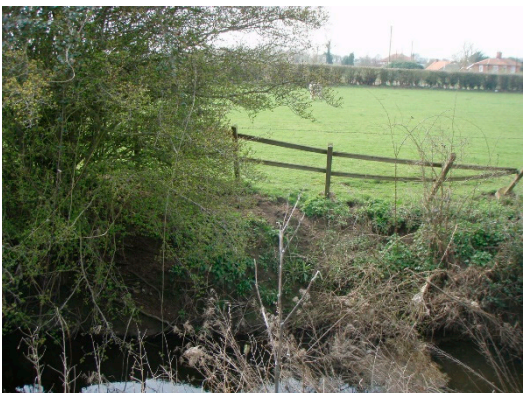
<p>Study Area Survey</p> <p>Impression-based assessments Habitat Quality Assessment (HaQA): 2 Good Landscape Quality Assessment (LQA): 3 Average Amenity Quality Assessment (AQA): 5 Very Poor Heritage Quality Assessment (HeQA): 5 Very Poor</p> <p>Key Points: Habitat. Study area comprises ungrazed rough grassland and horse pasture. River has good tree cover along its banks with some mature trees (Ash) and decaying trees mixed with scrub. Some evidence of past dredging and river adjustment. Consult with geomorphologist and Fisheries & Biodiversity Group about potential for habitat improvement including reconnection of an old meander loop. Landscape. Rural landscape village and church can be seen from the Study Area. River is incised and not easily visible so currently not a significant landscape feature. Heritage. No heritage features within the Study Area. Amenity. There is no public access to the Study Area but the conservation area of Debenham with its historic buildings is a 5-minute walk away so there might be an opportunity to create public access and a circular walk.</p>

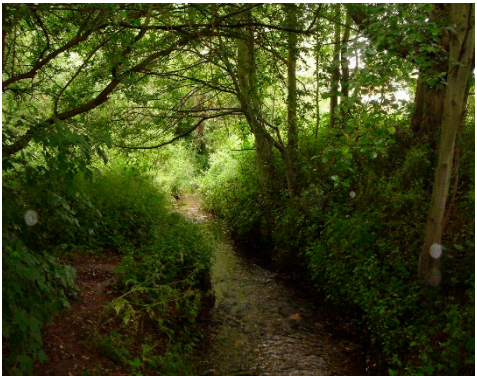
<p>(c) Loughborough Flood Alleviation Scheme (Moat Road, tributary of Wood Brook)</p>	<p>Pre-project survey completed on 29.6.16</p>
<p>River Stretch Survey Grid references: Upstream SK 52513 17111; Downstream SK 52359 17776 Stretch Habitat Quality Index (SHQI): 6 Good Materials class: Semi-natural (medium) (SNM) Physical habitat class: Semi-natural moderately active (SNMAct) Vegetation class: High tree cover with some connectivity, low channel vegetation (HTLV) Complexity class: Above Average Stability class: Dynamic Channel condition class: Average Connectivity class: High</p> <p><i>Semi-natural, recovering and a few uniform channels displaying some activity, with good vegetation complexity and tree cover. The recommendation is to remove any remaining reinforcement to allow the channel to recover more freely. These stretches should also be protected from further development.</i></p>

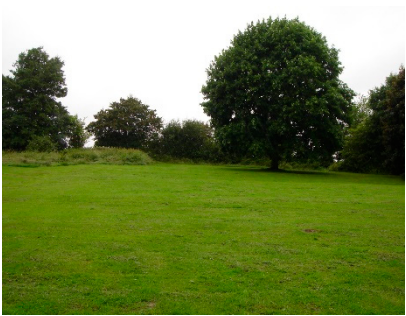
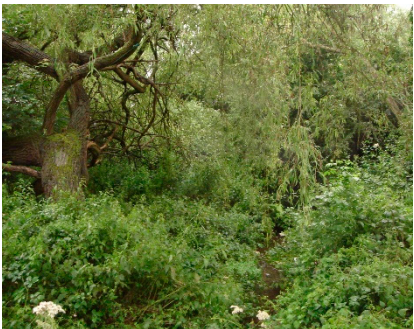
<p>Study Area Survey Impression-based assessments Habitat Quality Assessment (HaQA): 3 Average Landscape Quality Assessment (LQA): 3 Average Amenity Quality Assessment (AQA): 2 Good Heritage Quality Assessment (HeQA): 4 Poor</p> <p>Key Points: Habitat. Willow trees form a semi continuous buffer along the channel with tall ruderals and scrub. Two local wildlife sites are linked to the study area including Pignut Spinny LWS and a local designated hedgerow along track between Moat Road and Bramcote Road and leading off Craven Close. Moat Road LWS is a lowland wet grassland with a characteristic flora (Greater Burnett and Meadow Sweet). Landscape. Extensive areas of amenity grassland along right bank adjacent to residential areas with views across and to the tree and scrub watercourse corridor. Filtering the views are clumps of standard planted trees. More varied and active management of the watercourse corridor could seek to improve visual linkages. Heritage. Listed Moat House and associated overflow to the tributary. The building and garden are fenced with tall trees and shrubs boundary and have no visual connection to the study area. Amenity. Three footbridges along the river stretch provide linkages within and across the study area and to the wider area and the public rights of way network. The track and designated hedgerow offer a 'green lane' crossing the area and linking to the surrounding countryside. Area includes amenity grassland and a well-used children's playground with adjacent car park.</p>

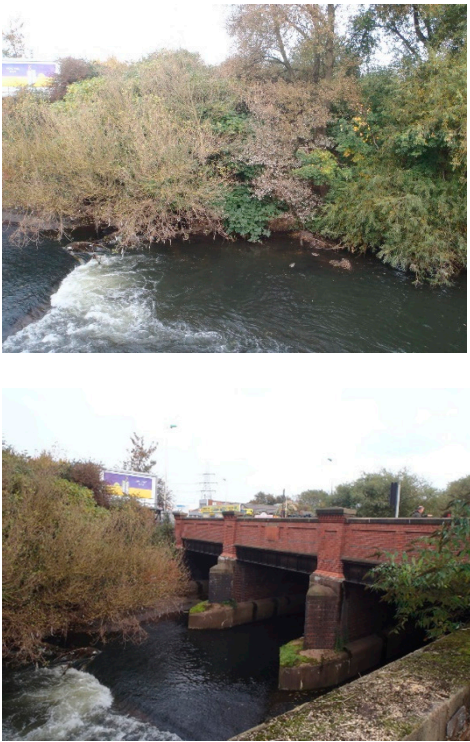
(d) River Tame, Bromford and Castle Vale Flood Risk Management Scheme	Pre-project survey completed on 21.10.16
<p>River Stretch Survey 1 Grid references: Upstream SP 11642 89473; Downstream SP 11867 89661</p> <p>Stretch Habitat Quality Index (SHQI): 7 Average Materials class: Lightly engineered (LE) Physical habitat class: Semi-natural stable (SNSt) Vegetation class: High tree cover with some connectivity, low channel vegetation (HTLV) Complexity class: Low Stability class: Slightly Dynamic Channel condition class: Very Poor Connectivity class: Poor</p> <p><i>Stretches with varying levels of engineering, but displaying some level of either recovery or activity, with reduced riparian vegetation complexity or excessive macrophyte growth. The recommendation is, where possible, to reduce the levels of immobile substrates and bank materials and increase sinuosity. Tree cover and bank top and face vegetation should be managed to provide increased variety and complexity. These channels show moderate to high levels of activity and should be targeted for rehabilitation where opportunities arise.</i></p>

<p>River Stretch Survey 2 Grid references: Upstream SP 12755 90008; Downstream SP 13219 90148</p> <p>Stretch Habitat Quality Index (SHQI): 14 Poor Materials class: Heavily engineered (HE) Physical habitat class: Uniform adjusting (UAdj) Vegetation class: Low tree cover, low channel vegetation (LTLV) Complexity class: Very Low Stability class: Slightly Dynamic Channel condition class: Average Connectivity class: Moderate</p> <p><i>Moderate to heavily engineered channels with low to moderate levels of activity, low complexity of bank vegetation and often algal dominated channels. The recommendation is to assess the water quality for improvement of in-channel vegetation diversity and undertake a detailed assessment of the level of rehabilitation required to improve the physical condition of the channel. Where possible, a reduction of reinforcement level and/or type and an increase in sinuosity of the channel is desirable.</i></p>

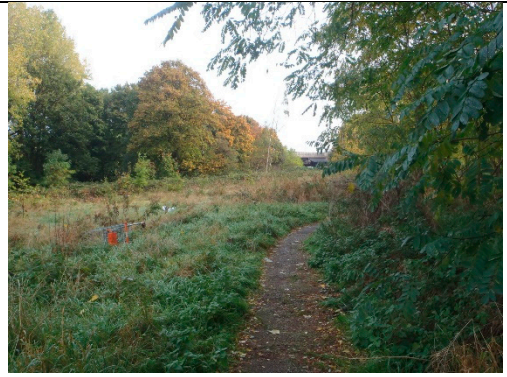
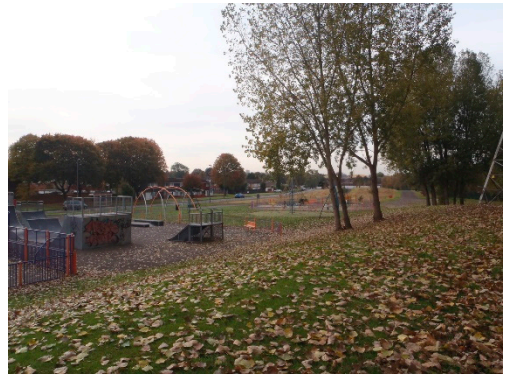
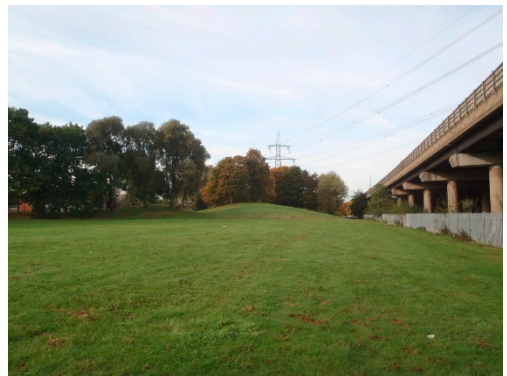
<p>Study Area Survey</p> <p>Impression-based assessments Habitat Quality Assessment (HaQA): 4 Poor Landscape Quality Assessment (LQA): 4 Poor</p>

Amenity Quality Assessment (AQA): 3 Average
Heritage Quality Assessment (HeQA): 5 Very Poor

Habitat. Area of unmanaged scrub and woodland at the downstream end of the study area.

Landscape. Line of trees providing screening of elevated M6 from residential properties.

Heritage. No heritage features.

Amenity. Amenity grassland and new recreational facilities at upstream end of study area adjacent to Bromford Drive comprising children's play equipment, skateboard ramps, basketball court, and outdoor gym equipment and seating benches.
