Tracking Deformation Processes at the Legnica Glogow Copper District (Poland) by Satellite InSAR—II: Żelazny Most Tailings Dam

Keywords: A-DInSAR; tailings dam stability; Żelazny Most; remote sensing monitoring; ground deformation

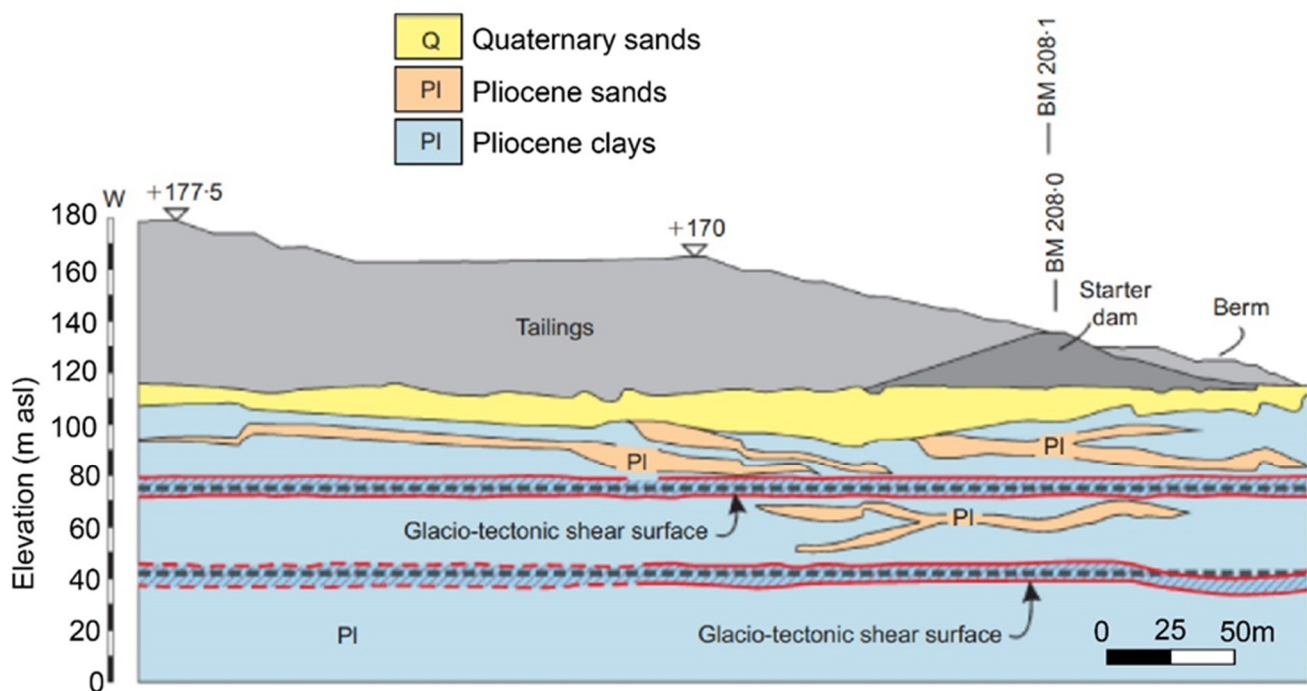
Figure 2. Section XVIIE of the Želazný Most Tailings dam (eastern part of the dam; modified form [1], reprinted with permission from [1]. 2014, ICE Publishing). Glacio-tectonic shear surfaces are represented in red.

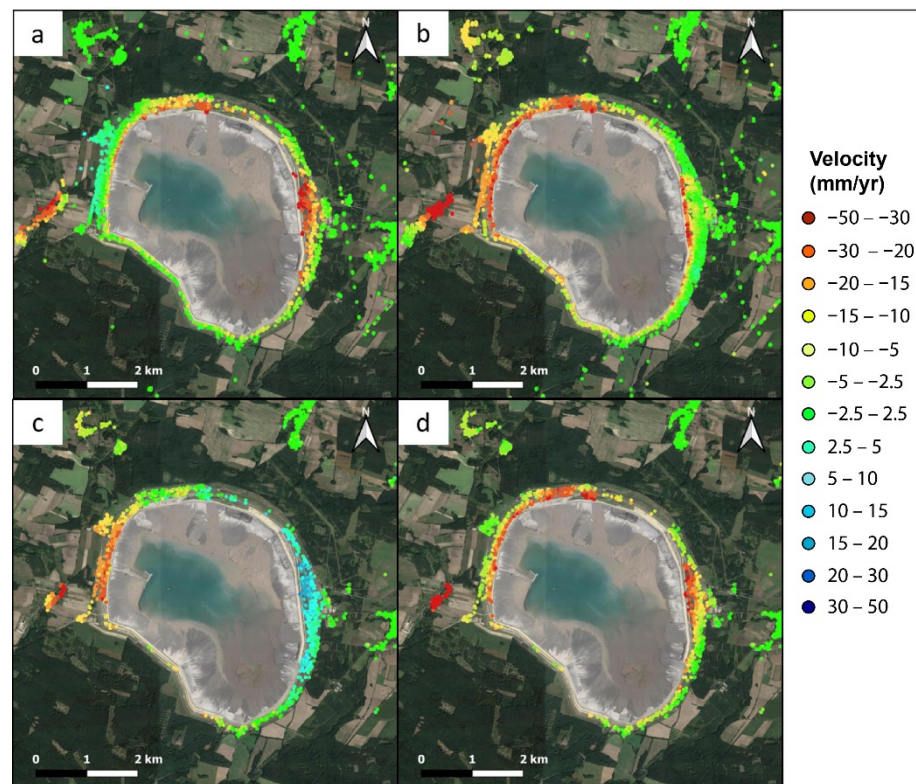
The A-DInSAR velocity maps of the Želazny Most TSF, for the period October 2014–April 2019, are shown in Figure 4. The panels a and b show the LOS velocity, in ascending and descending orbital geometry respectively, while c and d the east-west and up-down velocity maps, respectively. For the LOS velocity maps, the used convention for the color bar is as follows: green PSs represent the velocity range between -2.5 and 2.5 mm/yr, which has been considered no deformation; PSs moving away from the satellite are in yellow, orange, and red, while PSs moving toward the satellite are from cyan to blue. For the east-west and up-down velocity maps, the green PSs represent no displacement; yellow to red PSs are moving westwards or downward, respectively, while cyan to blue PSs are moving eastward or upwards, respectively.

As regards the horizontal displacements (east-west direction in Figure 4c), it is worth noting that, along the eastern embankment of the dam, PSs are moving eastwards with velocity up to 30 mm/yr, while along the western embankment, PSs are moving westwards, with similar maximum rate of displacement (up to -30 mm/yr). Therefore, in these sectors of the dam, the embankment is deforming outwards, i.e., the velocity vectors are radial with respect to the center of the basin. Along the northern sector of the dam, instead, the east-west deformation rates are very small, with values ranging between 5 and -5 mm/yr. The horizontal rates in the north-south direction, as mentioned in the previous paragraph, cannot be properly measured by InSAR [49,50].

As regards the vertical displacements (Figure 4d), PSs moving downwards (subsidence) are in yellow to red colors, while there are no areas with PSs moving upwards (uplift). The velocity values measured along the vertical direction show that several parts of the dam ring are affected by subsidence or settlement (hereinafter considered as synonyms). The southern part of the dam shows lower subsidence (from -5 to -15 mm/yr), while in all other sectors of the dam, subsidence is more intense, especially in the innermost and higher rings. In the eastern sector, the subsidence rate is up to -30 mm/yr in the innermost part of the tailings dam ring, with peak values of -50 mm/yr in the central part of the eastern sector. Subsidence decreases up to values of -5 mm/yr towards the base of the dam structure, i.e., in the so-called starter dam. In the western sector of the tailings dam a similar pattern of deformation can be observed: in the innermost rings the subsidence is up to -30 mm/yr, while in the starter dam the settlements are in the order of -6 mm/yr. In the northern sector of the dam, the maximum velocity is about -35 mm/yr in the inner portion of the dam and decreases in the starter dam.

Figure 4. A-DInSAR velocity of displacement maps (mm/yr) of the Želazný Most tailings dam for the period October 2014–April 2019; (a,b) velocity in LOS ascending and descending orbital geometry respectively; green PSs are considered as stable; yellow-red PSs are moving away from the satellite; cyan-blue PSs are moving toward the satellite; (c) velocity in east-west direction; cyan-blue PSs are moving eastwards; yellow-red PSs are moving westwards; (d) velocity in up-down direction; yellow-red PSs are moving downward.

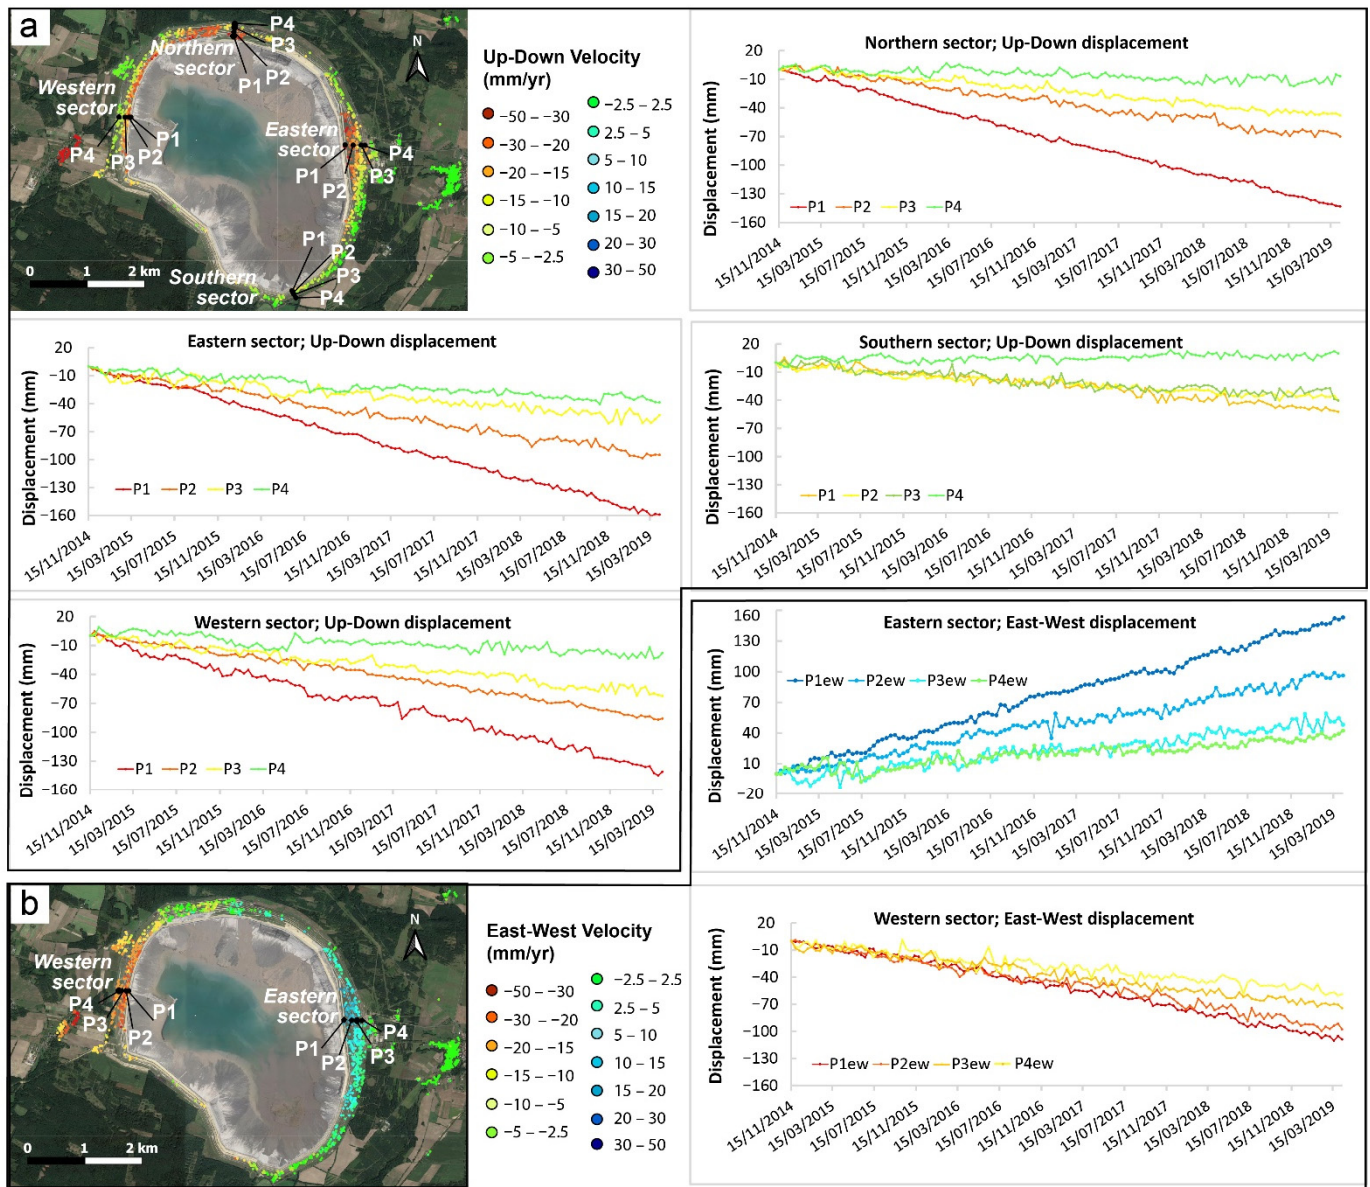
In order to analyze the trend of horizontal and vertical displacement over time, the time series of displacement has been computed for each measurement point. Some interesting examples are shown in Figure 5: for each sector of the dam, four time series selected at different highs of the dam body are represented (location of the selected points is also given in the map panels). For each dam sector, Points P1 are located near the beach and the ponds, in a higher position; points P2 and P3 are selected in the middle highs, and P4 are located on the starter dam. The time series of vertical displacements (Figure 5a) highlights that the points P1 show steep trends, as they are affected by intense deformation. The deformation pattern increases quite steadily over time (from October 2014 to April 2019), with a linear trend. The displacements become more and more moderate, going down in altitude at points P2, P3, and P4 (less steep time series).

Figure 5. Time series of displacement for the Želazny Most TSF; (a) time series of up-down displacements for the northern, southern, eastern and western sectors of the dam; downward displacements are in red; (b) time series of east-west displacements for the eastern and western sectors of the dam; eastward displacements are in blue, westward displacement are in red. The location of the PSs selected for processing the time series is also shown in the map panels.

As regards the time series of east-west displacements (Figure 5b), the eastward displacements are shown in blue, and westward displacements are in red. Also in this case, the trend of the time series shows larger cumulative displacements values for points located near the beach and the ponds (P1ew and P2ew) compared to the points at the foot of the dam (P3ew and P4ew). However, such difference in the horizontal deformation patterns is very weak in the western sector of the dam, where the displacement towards the west (or towards the outside), seems to take place as an en bloc movement.

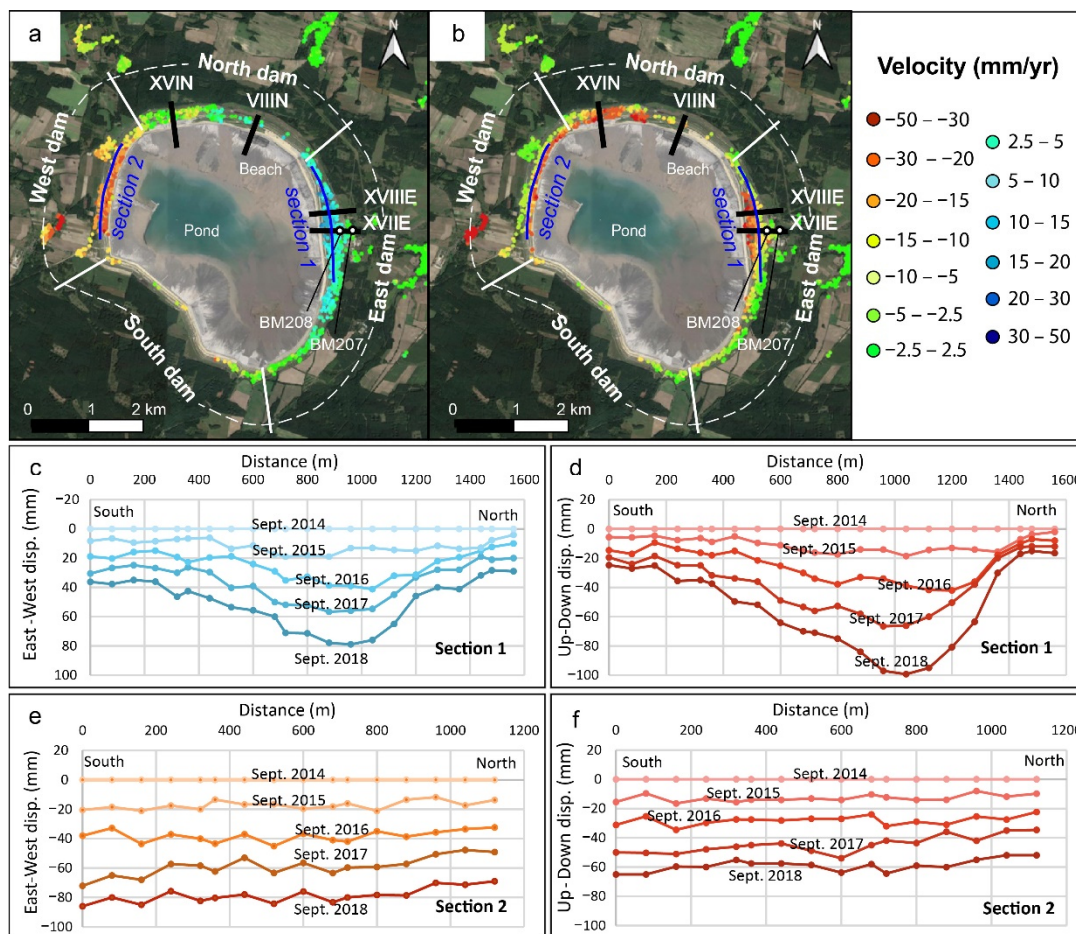
The displacement pattern in space has been investigated through two cross sections parallel to the dam body, along the eastern and western embankments (Sections 1 and 2, located in Figure 6a,b). The cross sections run at a middling altitude of the dam body. Each curve of the section graphs (Figure 6c–f) represents the A-DInSAR displacement profile of the dam at that height, for each analyzed year. In particular, the curves of the graphs show the cumulative deformation that affected those sectors of the dam up to September of each

Figure 6. Longitudinal sections of cumulative displacement along the eastern dam (Section 1) and the western dam (Section 2); sections and dam sectors location are overlaid on (a) the east-west velocity map and (b) the up-down velocity map; (c) east-west displacement along the Section 1; (d) up-down displacement along the Section 1; (e) east-west displacement along the Section 2; (f) up-down displacement along the Section 2.

Section 1, which concerns the eastern dam, shows that the eastern perimeter of the dam does not deform uniformly, but the central zone of the section shows more intense displacement, both in the horizontal (Figure 6c) and vertical directions of movement (Figure 6d), with maximum cumulative displacement of 80 mm eastwards and 100 mm downward, in about four years. As discussed above, higher deformation values are expected at higher altitudes of the dam, and lower values are expected at the base of the dam.

Section 2, along the western dam, instead shows a uniform pattern of deformation both in the horizontal (Figure 6e) and vertical directions (Figure 6f), with maximum horizontal cumulative displacements similar with respect to the eastern sector (about 80 mm), but in the opposite direction (i.e., westwards), and the cumulative subsidence is around 60 mm in about four years.

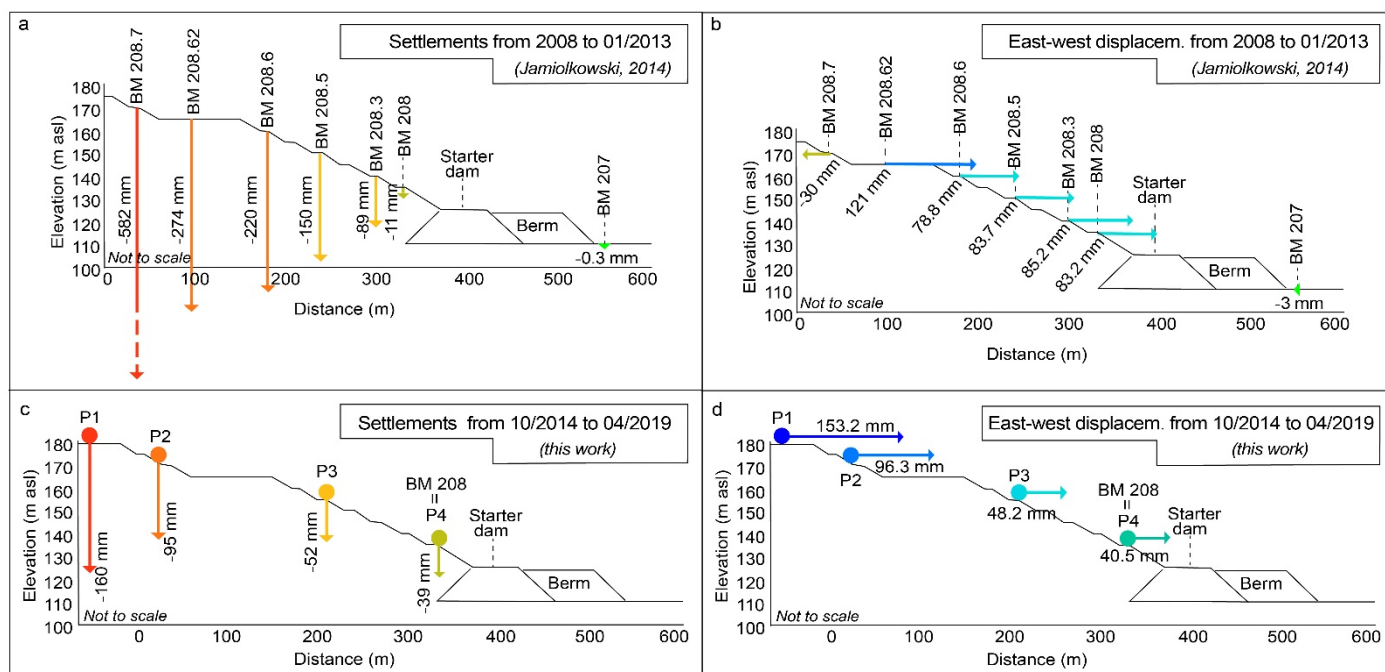
The Želazny Most dam structure is affected by a complex deformation pattern that involves both the vertical and horizontal directions. As regards the vertical displacements, the deformation corresponds to subsidence (or settlements) occurring on the dam ring with different intensity depending on the position and altitude along the dam body: higher in the

upper part and lower at the base of the dam ring. Such differential movement also concerns horizontal displacements for the eastern sector. This pattern of deformation is represented on a schematic cross section (cross-section XVII of Jamiolkowski [1] located in Figure 6a,b) in Figure 7, where both settlements and horizontal displacement are represented for two time intervals: from 2008 to 2013, with values deduced from Jamiolkowski [1] and from 2014 to April 2019, with data measured by A-DInSAR technique. The original values of cumulated displacements provided by Jamiolkowski [1] covered different time frames for each benchmark represented on Figure 7 a,b, as each benchmark was monitored since different dates: for example, the benchmark BM-208 located at the starter dam (location in Figure 6a,b), was monitored from 1981 until 2013, while BM-208.7, on top of the dam, was added later and was monitored from 2007 until 2013. To make these displacement values comparable to each other and roughly comparable also with those retrieved by the A-DInSAR four-year analysis, the average annual velocity for each benchmark has been calculated, and the related displacement value has been obtained for a time interval of four years.

Figure 7. Schematic cross-section XVII (location in Figure 6a,b) on the eastern dam; vectors represent the cumulative settlement (mm) at different heights of the dam body; (a,b) settlements and east-west displacements, respectively, from 2008 to January 2013 at 7 benchmarks (deduced from [1]); (c,d) settlements and east-west displacements respectively, from October 2014 to April 2019, measured by A-DInSAR, at points P1, P2, P3, and P4 (located in Figure 5).

Figure 7c and d show the superficial deformation achieved by A-DInSAR technique from October 2014 to April 2019 at the points P1, P2, P3, and P4, located in Figure 5.

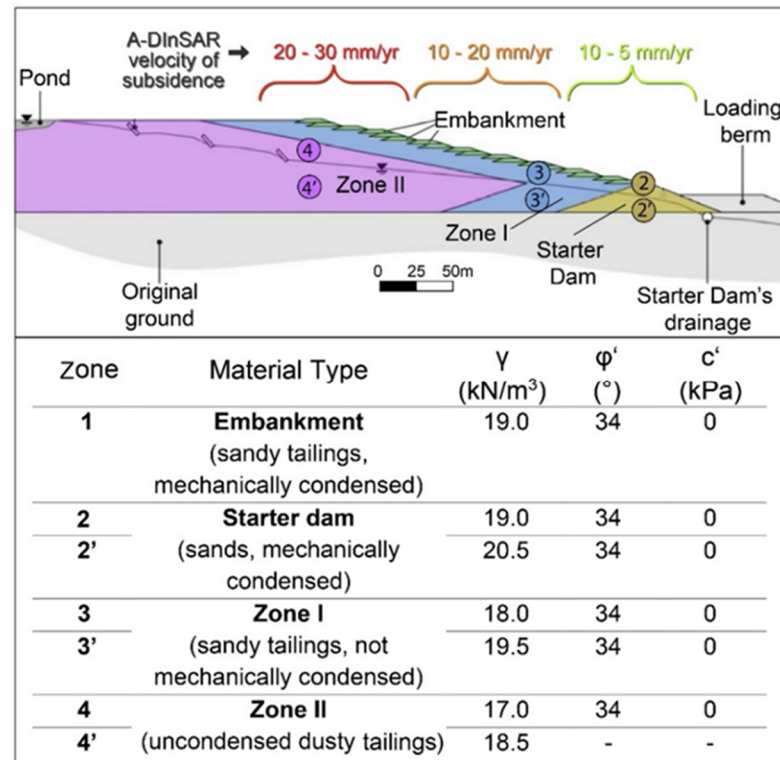
Figure 8. Scheme of tailings zoning in the site's embankment and selected geotechnical parameters of the soil form [30]; 2', 3' and 4' are for fully saturated material; γ : unit weight; ϕ' : internal friction angle; c' : effective cohesion; AD-InSAR subsidence velocities measured in this work are also reported above the profile.

According to Stefanek et al. [30], the material type that forms the starter dam is sand mechanically condensed (2 and 2' in Figure 8). In this basal part of the dam ring, the subsidence rate can range from 5 to 10 mm/yr. Zone I consists of sandy tailings, not mechanically condensed (3 and 3' in Figure 8) and Zone II, which is the most inner part of the dam structure (4 and 4' in Figure 8) is made of uncondensed dusty tailings. The parts of the embankment affected by more intense subsidence (20–30 mm/yr) are founded on greater thicknesses of sandy tailings not mechanically condensed or on uncondensed dusty tailings (note the thickness of the Zone II in Figure 8). Therefore, the more pronounced subsidence rates in the highest sectors of the dam could be linked both to the most recent age of construction and to the larger thickness of compressible materials in the inner part of the dam body.

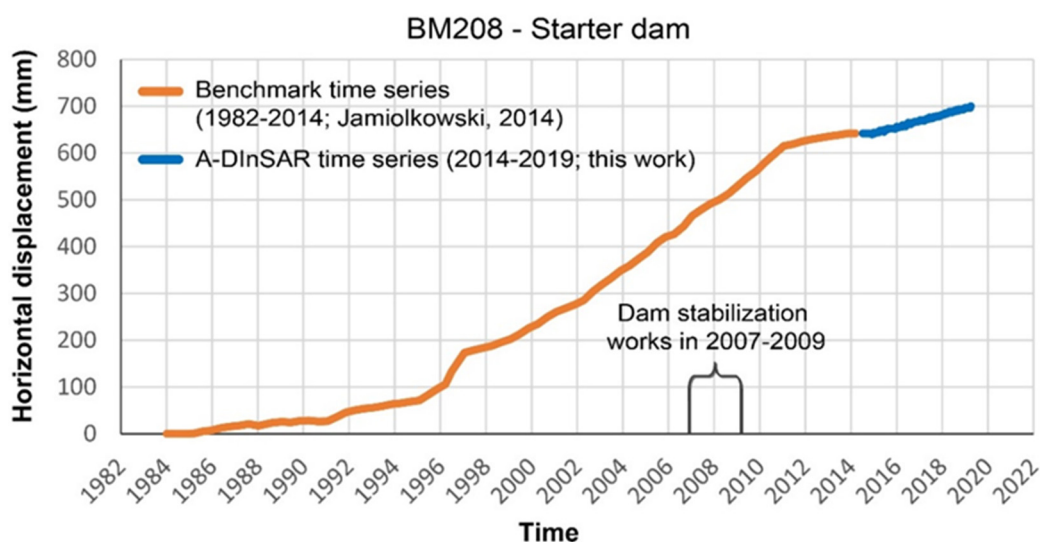
Table 2. Horizontal surface displacement rates of benchmark BM-208 located in the easter sector of the dam; the velocity is an averaged value for each analyzed year.

Figure 9. Time series of horizontal surface displacements of benchmarks BM-208; orange line: benchmark time series from [1]; blue line: A-DInSAR time series.

It is worth mentioning that the time series of the displacement of BM208 represents the behavior of the base of the dam structure (starter dam), while at higher altitudes of the dam, the intensity of horizontal displacements is considerably greater, as stated above (Figure 7b,d). As discussed in previous works, the geodetic and the inclinometer data show that the starter dam and the foundation soil above the shallower shear plane in clays

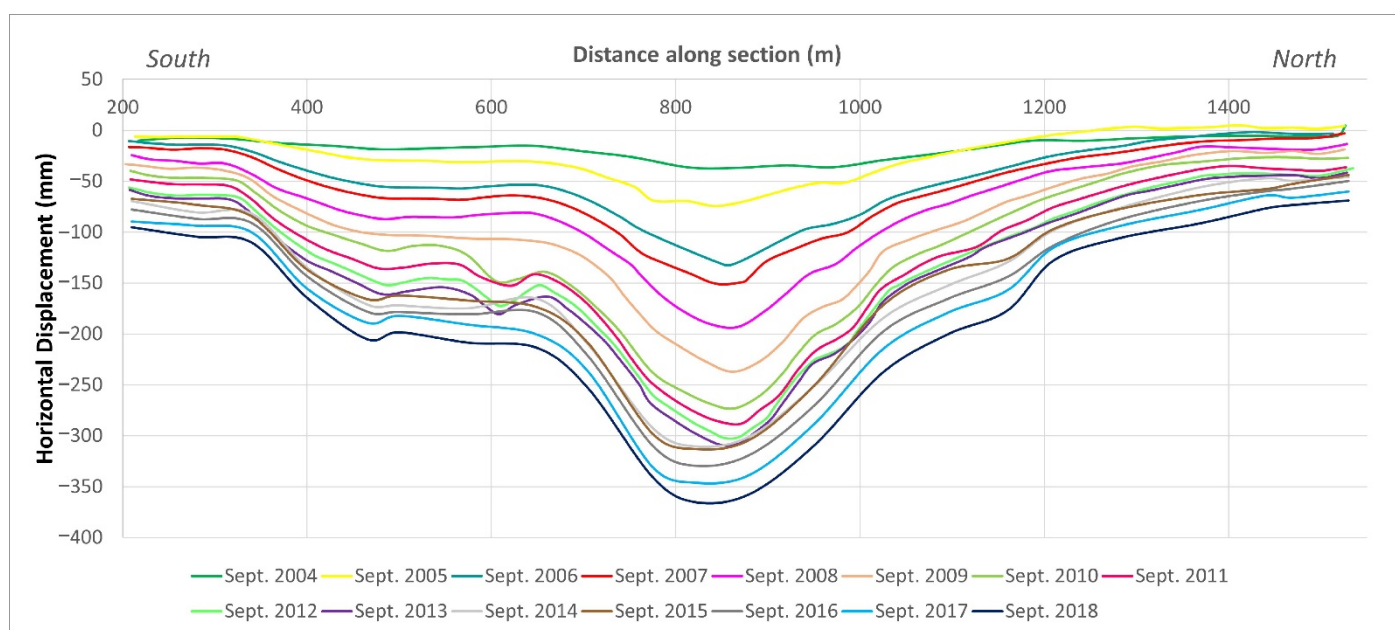
The longitudinal section along the eastern dam (Section 1 in Figure 6a,b) shows how cumulative displacement is distributed along the eastern perimeter and allows for the analysis of the spatial deformation pattern of the east side of the dam. Each curve of the graph shows the cumulative deformation that affected the dam up to September of each year. This timing was chosen in order to compare and combine this graph with the same longitudinal section of Jamiolkowski [1], which represents a plan view of horizontal cumulated displacements from 2004 to 2013. The latter has been extended with the measurements obtained by A-DInSAR for the years 2014–2018, along the longitudinal section at medium height of the dam (Figure 10). Despite some uncertainties about the exact location of the section of Jamiolkowski, the curves show a very similar trend: greater displacements occur in the central part of the eastern dam, and the rates of eastward displacement (that can be deduced by the distance between the curves) are similar. Two remarks can be made about the above mentioned discussion: the first one is that in the eastern sector of the TSF, the dam does not behave like a rigid body and shows areas of greater weakness in the central part; the second remark is that, although the horizontal deformation seems to have had a slowdown from 2010 to 2013, it continued in 2014 to 2018 with recovered intensity, up to almost 370 mm of displacement. It is possible that stabilization and prevention works performed to reduce the lateral sliding of the dam have not been effective.

Figure 10. Longitudinal section of cumulative horizontal displacement along the eastern dam (Section 1, location in Figure 6a); curves from 2004 to 2013 are from [1]; curves from 2014 to 2018 are from AD-InSAR measurements.
