Characterization of In Vivo Damage on Retrieved Total Shoulder Glenoid Liners

Abstract: An attempt was made to retrieve glenoid liners from revision surgery to undertake a retrospective study to measure the resulting in vivo damage. Since the glenoid liners are circumferential, the curvature changes at every point in the component, an “assisting arm” was designed to hold the liner firmly, thus allowing accurate microscopic measurements. We characterized the damage in terms of pitting, embedded debris, complete fracture, abrasion, deformation, delamination, burnishing, grooving, and scratching that took place mutually exclusively. This study of 26 liners showed embedded debris was the most underrated damage mode found on the liners, followed by pitting and abrasion, representing 65.2% and 52.2% of the liners, respectively. The prevalence of pitting in over half the samples examined is indicative of free-radical oxidation, resulting in a decrease in physical strength from morphological changes in the microstructure. These may initiate from different pathways, however, they may interact with other processes in which other damage initiates and grows, resulting in higher damage causing

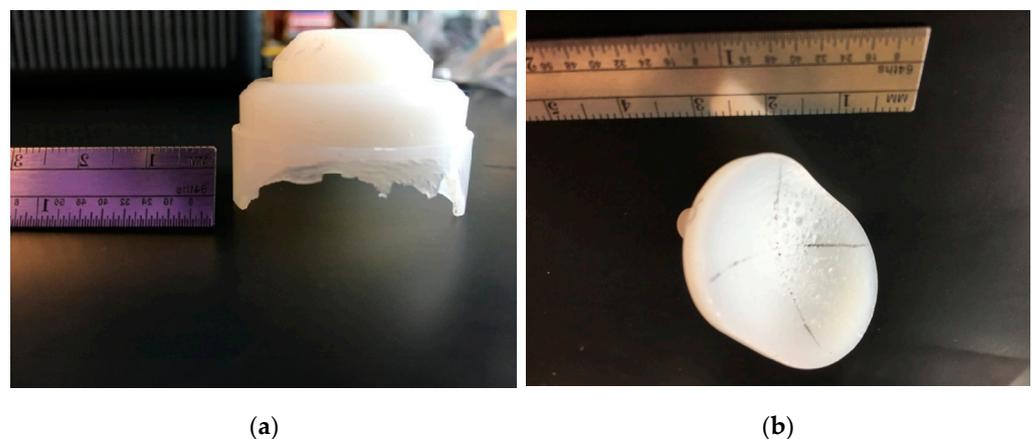
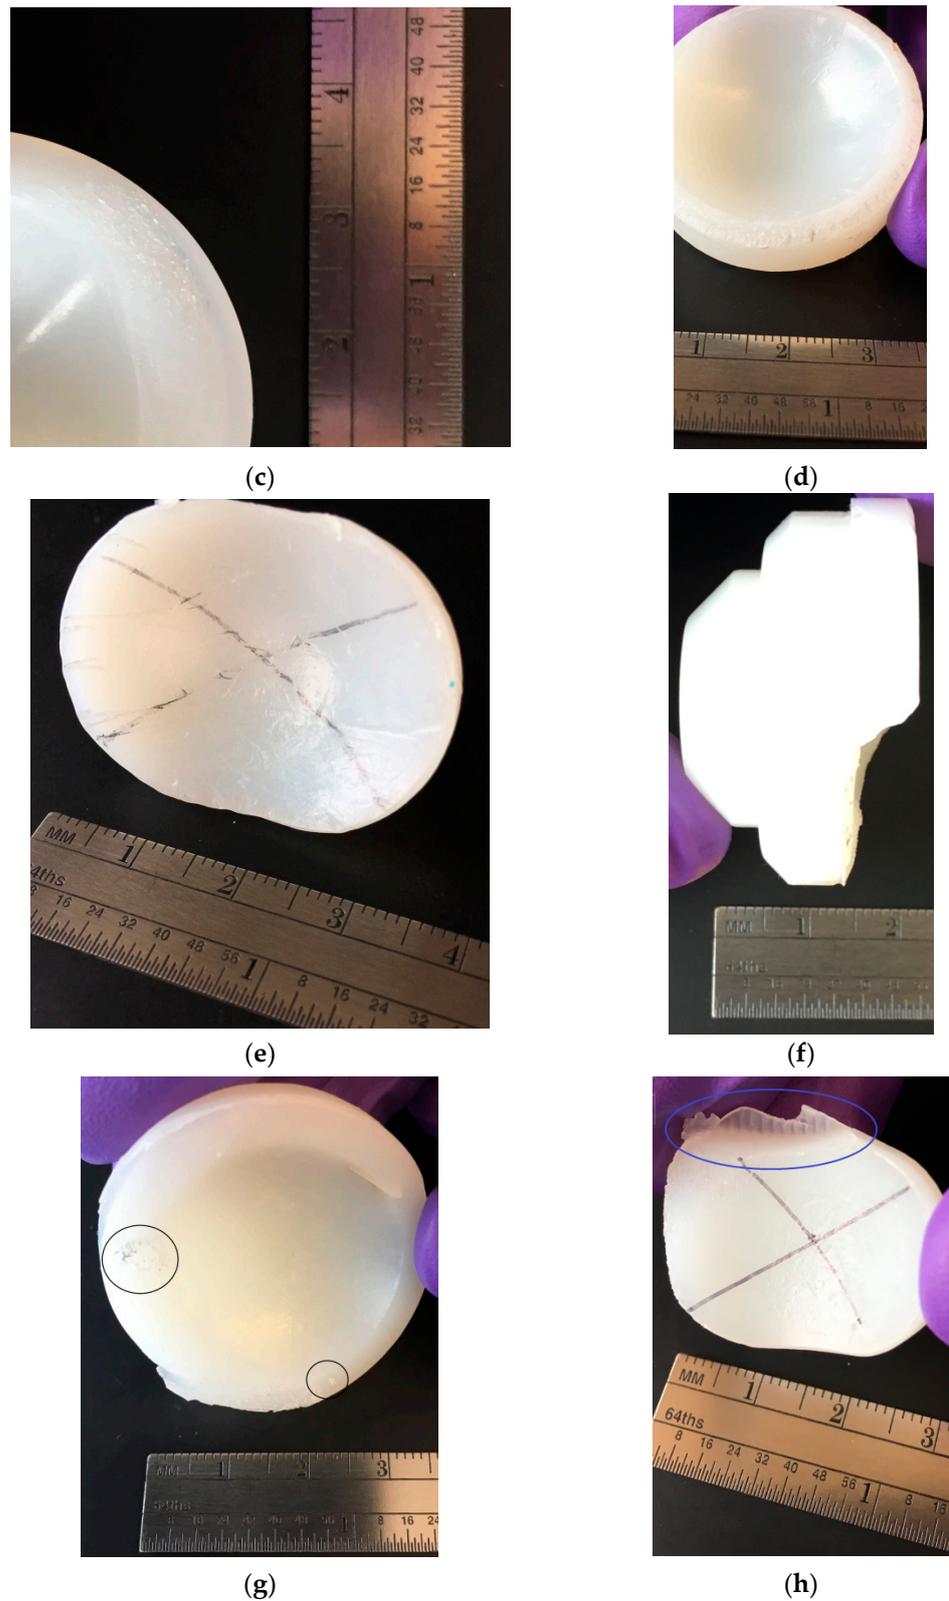
Delamination is the separating of layers of the UHMWPE due to cyclic fatigue loads. Repeated loading and unloading events cause intermolecular bonds within the liner to break, leading to the material separating into layers. Of the liners examined, 14 liners or 60.9% had delamination characteristics visible without magnification (Figure 1a). Even though we do not know the time when the devices were revised, it is quite possible that the devices replaced sooner than 5 years may have a limited amount of delamination.

Figure 1. Examination of liners for various types of wear damage. (a) Delamination of Liner B1B9. (b) Surface Pitting of Liner B2B8. (c) Mixture of Delamination with Surface Abrasion on Liner B1B1. (d) Surface Scratches Seen within the Cup of Liner B1B8. (e) Burnishing of Articulating Surface of Liner B2B1. (f) Deformation Caused by Delamination, Apparent Subluxation, and Cracking. (g) Embedded Debris in Liner B1B6. (h) Complete Fracture of liner B1B9.

Pitting refers to the craters that form in the UHMWPE caused by oxidation and crystallization of material, accelerated by environmental factors. Pitting corrosion was found in 13% of the liners during a visual examination. Figure 1b shows an example of surface pitting on an articulating surface.

Abrasions are defined as multiple surface scratches in the same orientation made by one surface rubbing on another. Due to excessive scratching in some instances, it is difficult to differentiate single scratch events from abrasions. Abrasions were found in 6 liners or 26.1% of the samples examined. Figure 1c shows an example of abrasion wear.

Scratching is a damage mode where the surface is permanently marked or scored by a foreign object. It is the most common mode of wear in UHMWPE liners due to unavoidable microscopic surface irregularities present in all materials. Scratching of the articulating surface was found in 100% of the samples examined. Figure 1d is an example of surface scratching on the liner articulating surface.

Burnishing is an apparent shininess of a surface due to plastic deformation caused by excessive loading and unloading in conjunction with fatigue and repeated loads/stresses. On the implants examined, burnishing was seen in localized areas with apparent high-stress points. Burnishing was present in 15 liners or 65.2% of the liners examined. Figure 1e shows an example of surface burnishing.

Deformation is defined as exaggerated wear changing the shape of the overall material. Although deformation can occur from a high-stress event, constant wear can cause material deformity and lead to absolute failure of a liner. Deformation was present in 8 liners or 34.7% of cases examined. Figure 1f shows deformation from excessive wear.

Embedded debris is described by any foreign material that becomes attached to the surface or lodged into the structure of the glenoid liner. These foreign materials have various origins, including metal fragments from respective replacement components, components of bone, or materials used during prosthesis implantation. Limited embedded material was visible without magnification. Some embedded debris was immediately apparent in regions with grooving and delamination due to the increased surface roughness, however, micro-debris on the articulating surface was rarely noted in the absence of optical magnification. Of the liners examined, 17.4% had embedded material seen within the UHMWPE. Figure 1g shows an example of embedded debris in the implant.

Complete fracture of the liner is caused by extensive propagation of wear transitioning to fatigue cracking propagating to critical size and unable to sustain the applied load. This may also occur due to overload due to high-stress events (from falls or terrain issues) in addition to malalignment secondary to aseptic loosening [6]. As damage infiltrates the inner layers of the UHMWPE, it eventually spans across the inner surface and spreads orthogonally in either direction. Continued loading and fatigue accelerate the fracture process and lead to the failure of the liner. One liner examined displayed complete fracture, causing separation into two pieces. This liner is detailed in Figure 1h. In total, complete fracture through the liner was noted in 17.4% of the liners.

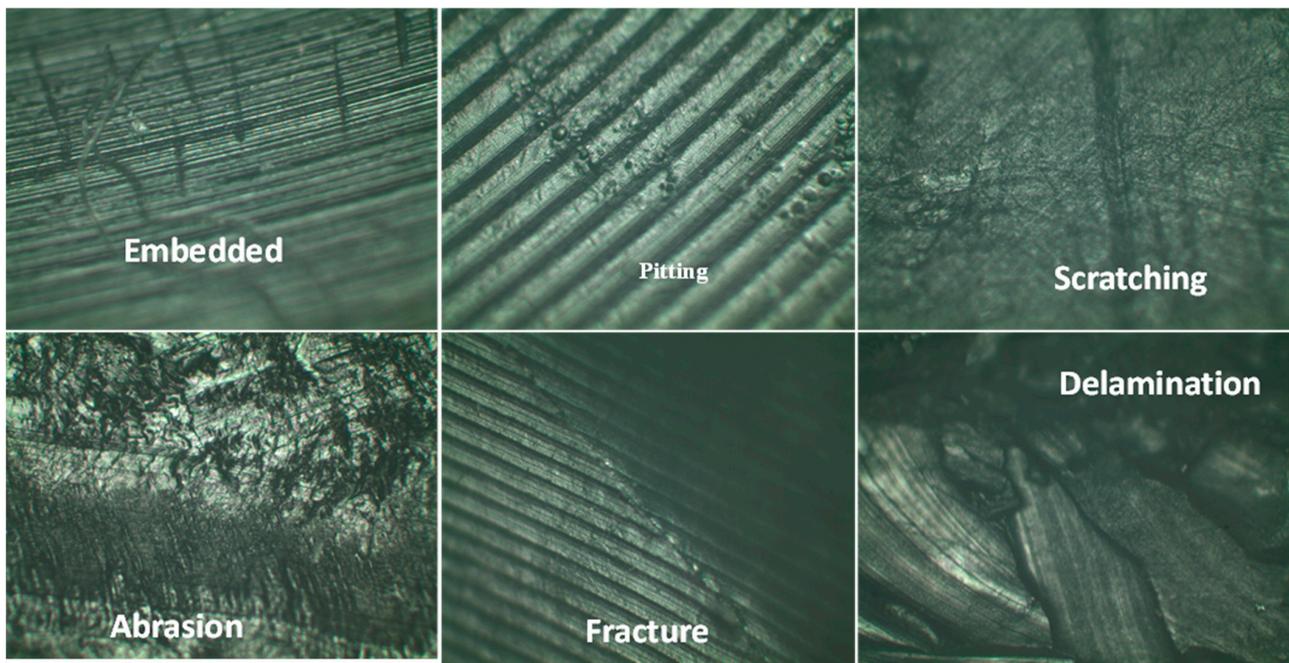
The initial goal of stereomicroscopy was to characterize and examine non-worn surfaces to distinguish the fundamental topography of the articular surfaces (Figure 4). The initial inspection of the liners showed microdamage in the form of scratches on all liners examined. On reverse TSA liners and select traditional TSA, machining ridges were present, spiraling out from the center of the articulating surface toward the edges (Figure 5a). At locations where scratching was present, the damage in many cases had propagated into the formation of a groove. Figure 5b shows a typical example of a machined surface with scratch and groove formation. Figures 4 and 5b also show grooves forming an abrasion of the edge of a liner articular surface.

Figure 4. Stereomicroscopy Using a Universal Arm to Hold the Liners shows different damage features on different glenoid liners documented in Figure 1.

Another type of wear examined in scrutiny during stereomicroscopy was pitting corrosion. Pitting (Figure 5d) in polymer components is often associated with free-radical oxidation [9,12]. In the visual examination process, pitting was observed on 26.1% of the liners. Stereomicroscopy revealed insolated regions of pitting on liners that had not been previously found. These results are indicative of free-radical oxidation of the liner, leading to corrosion from oxygen acting as an anode within the UHMWPE. See Figure 4 for an example of pitting found in the liners.

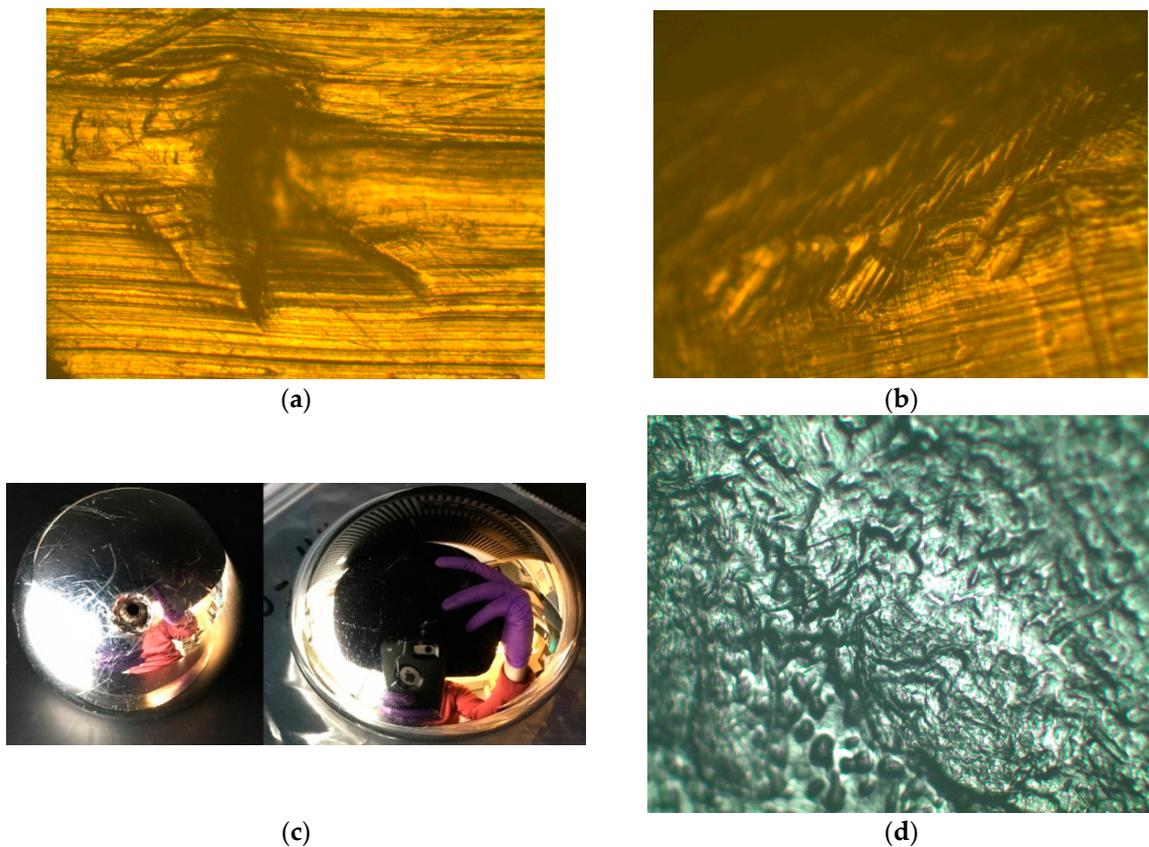
Figure 5. Stereomicrograph of damage features observed in the glenoid liners. (a) Machining Marks Surrounding the Formation of Groove with Scratching on the Perimeter. (b) Grooves Forming an Abrasion on Liner B2B3. (c) Example of damaged and B2B11 (left) and undamaged Humeral Head B2B8 (right). (d) Liner B1B9 showing pitting and baseline surface deformity.

Similar examples of damage were seen throughout other liners examined. In some instances, it was accompanied by third-body particles not immediately apparent in the visual examination. The origin of these grooves was not apparent, however, since many humeral heads accompanying the liners did not have obvious damage. For an example of some of the humeral heads associated with the liners, refer to Figure 5c.

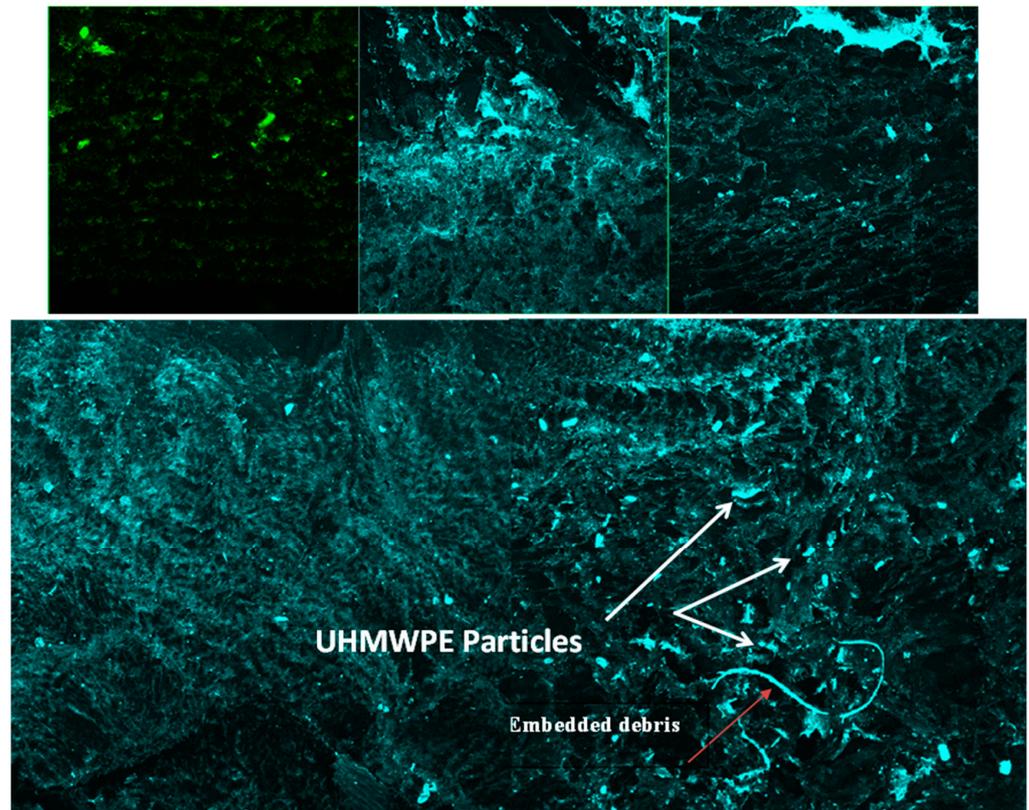
Figure 7. Pitting and delamination of liner B1B5, embedded debris, and UHMWPE particles in B1B8.

From the confocal microscopy performed on the liners, it was determined that the average depth of delamination was 567 μm . Furthermore, the average depth of the pit was found to be 116 μm . Additional analysis can be performed using these data in conjunction with oxidation index testing in order to better estimate depth propagation as it relates to the time of in vivo exposure.

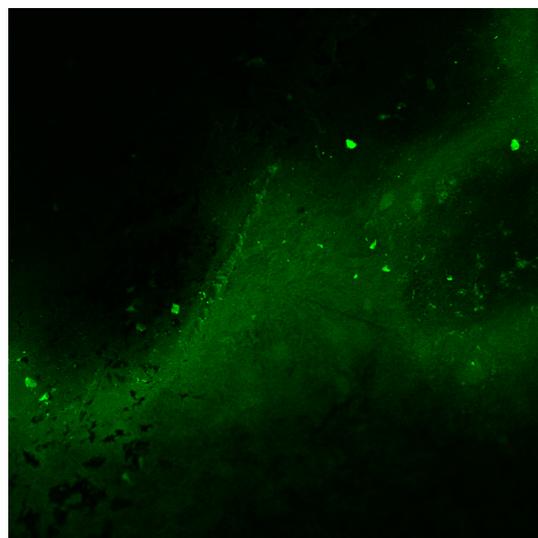
Figure 8. Pitting and Embedded Debris on Liner B2B8.
