Investigation on Multiphase Erosion–Corrosion of Elbow in LPG Desulfurization Unit

Abstract: Severe leakages of the elbow occur in the regeneration tower return pipeline of the LPG desulfurization unit, leading to the unplanned shutdown of the unit frequently over the period of four months. It is forced to apply additional steel plates to prevent the leakage. Elusively, it is found that the first wall contact with the fluid is fully eroded away in the vicinity of the bend, however, the walls of additional steel plates are intact. The clarification of this problem is required to ensure safe production. This strange phenomenon can be investigated by failure analysis and computational fluid dynamics (CFD) simulation. The failure analysis showed that the gas–liquid two-phase erosion–corrosion was the main cause of elbow leakage. The simulation shows that droplet erosion plays a dominant role in the erosion–corrosion process, and the elbow will leak in 4.3 months, which matches the actual situation very well. Furthermore, multiphase erosion–corrosion behavior was thoroughly investigated to expose the feature of the mentioned strange phenomenon. It was shown that when the corrosion hole

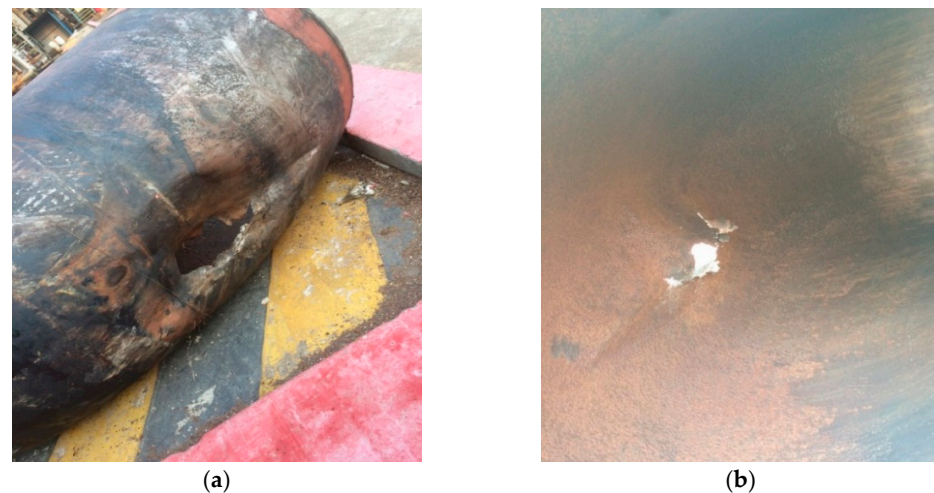
The elbow in the regeneration tower return line of the LPG desulfurization unit leaks frequently over the period of four months, which leads to unplanned shutdown, as shown in Figure 1. To guarantee production, the leakage is repaired by an additional steel plate, as shown in Figure 2. A strange phenomenon is found where the outer wall of the elbow is entirely eroded, however, the additional plates are intact, as shown in Figure 3.

Figure 1. Leakage occurring in the elbow: (a) outside view; (b) inside view.

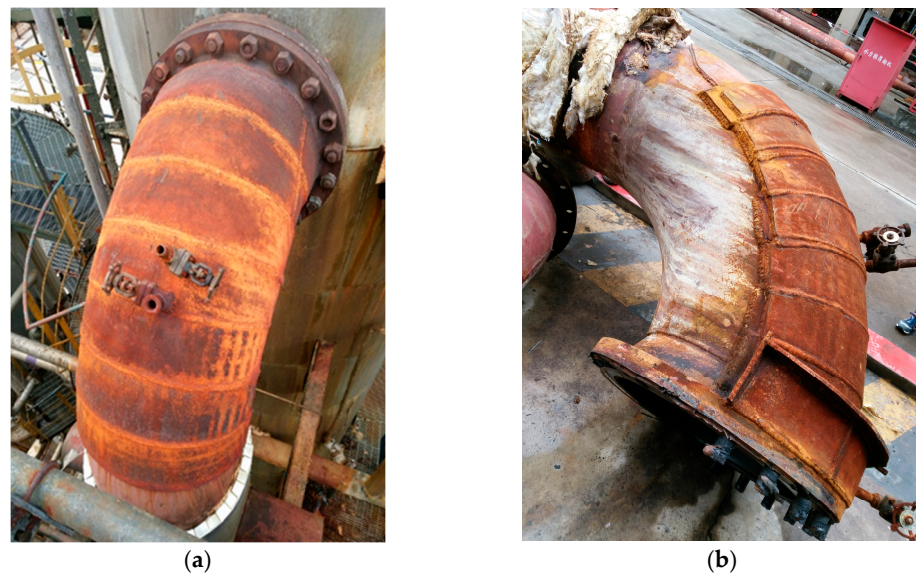
Figure 2. The elbow before and after repair: (a) elbow; (b) elbow with additional plates.

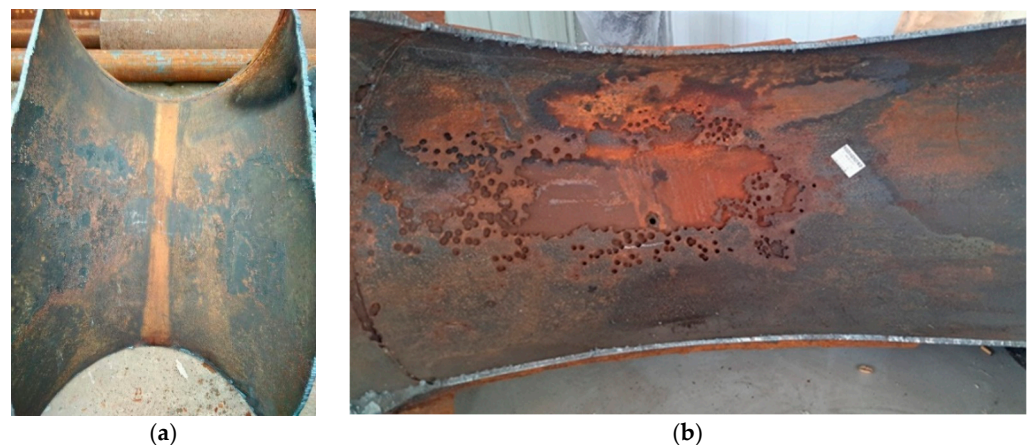
Figure 3. The corrosion profile of the elbow: (a) inside wall of the elbow; (b) outside wall of the elbow.

The morphology of the inner and outer wall surfaces of the elbow is shown in Figure 3. The inner and outer wall of the elbow is relatively rough, and a variety of corrosion holes with different sizes could be observed. The inner wall of the elbow did not show significant wall-thinning, while the mass loss on the outer wall was severe. The area of severe wall-thinning was generally honeycombed and covered with corrosion holes. The corrosion holes expanded and joined together to form a completely broken area. A total of 103 complete holes with a maximum hole diameter of 21.1 mm and a minimum hole diameter of 7.5 mm were found in the area of severe wall thinning on the outer wall of the elbow. The diameter of the holes near the center line of the outer wall was larger and decreased along the radial direction. In addition, there was a phenomenon worthy of attention. The wall thinning on the outer wall was serious while the corresponding position of the additional steel plate was intact.

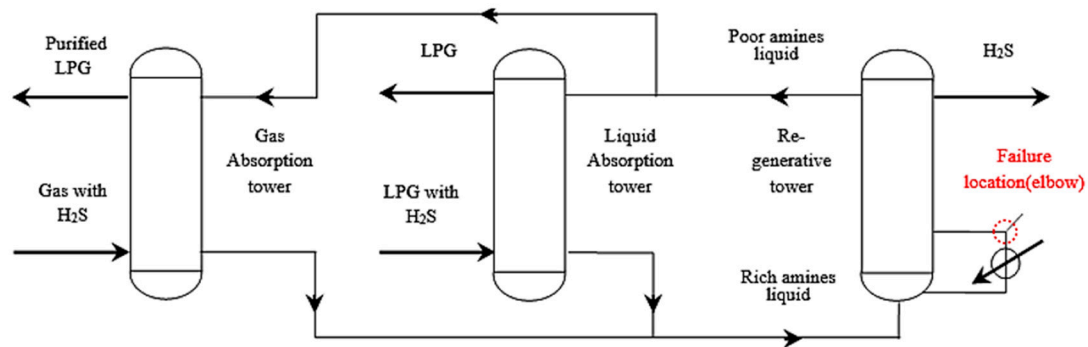
Figure 4. Desulfurization process and failure location.

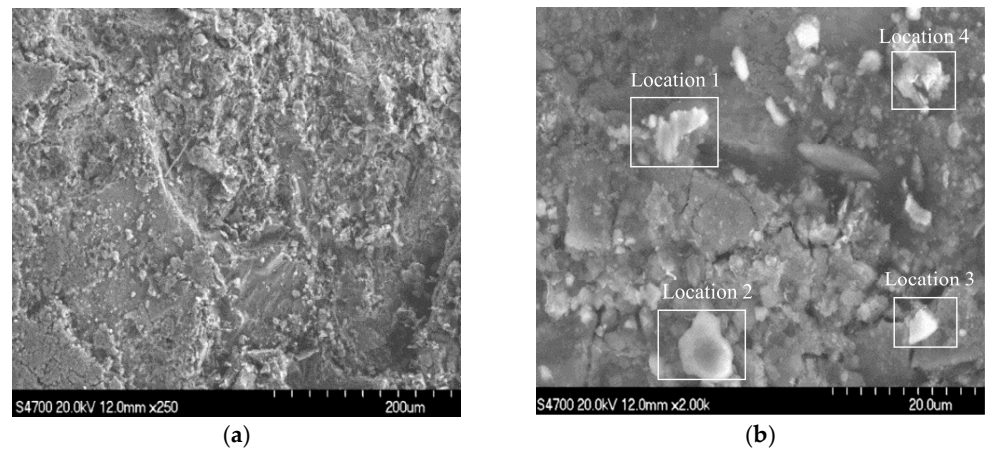
Samples were taken in the area of serious wall thinning for SEM, and the results are shown in Figure 6, with magnifications of 250 and 2000 times in Figure 6a,b. It can be seen that the surface of the sample was uneven and rough. When the magnification was 2000 times, thin flakes and lumps of corrosion products remaining on the sample surface and in the crevices could be observed, which indicates that the bond between the corrosion products and the substrate was not enough to produce a protective effect on the substrate.

Figure 6. SEM images of the samples: (a) $\times 250$; (b) $\times 2000$.

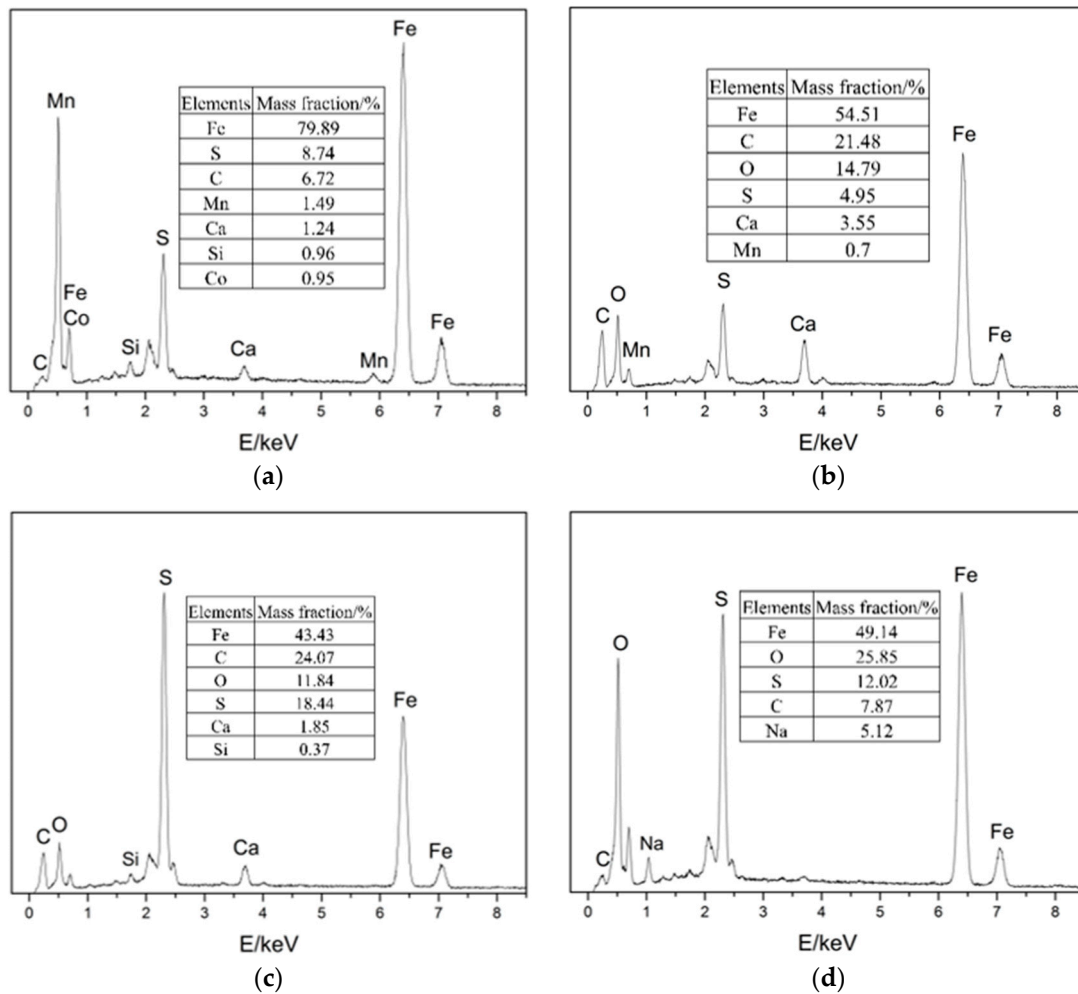
EDS was performed on four locations of the samples, as shown in Figure 7. The results show that the four main elements of the corrosion products were Fe, C, S, and O.

Figure 7. EDS images of the samples: (a) location 1; (b) location 2; (c) location 3; (d) location 4.

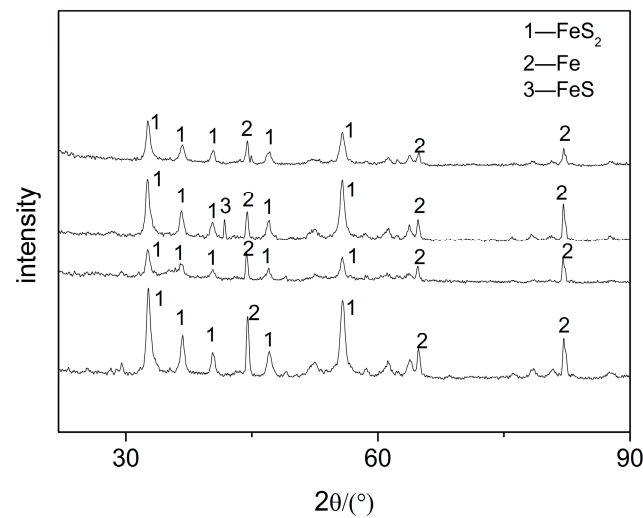
The corrosion product composition can be obtained by XRD, which helps to further understand the failure mechanism of the elbow. The XRD results of the four positions, which is a cumulative chart for cases, are shown in Figure 8. The results show that the

physical phase of the samples was mainly FeS_2 and Fe , and individual samples contained a small amount of FeS .

Figure 8. XRD images of the samples.

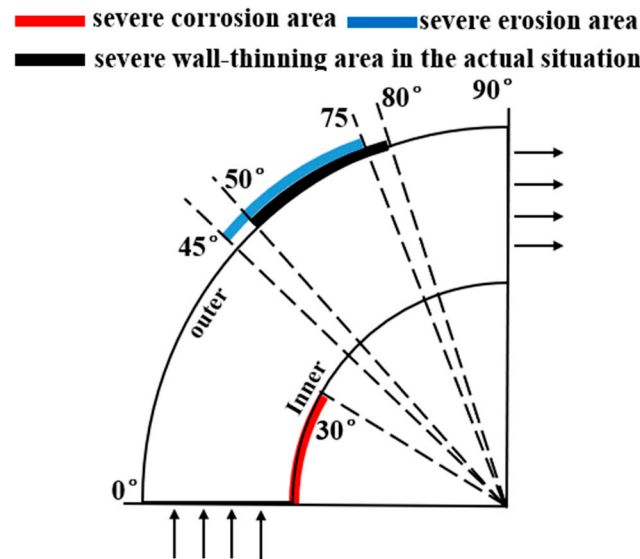
A comparison between the severe area of erosion–corrosion obtained by numerical simulation and the serious area of wall thinning in actual conditions is shown in Figure 14. The area where the erosion–corrosion rate reached or exceeded 90% of the maximum erosion–corrosion rate is defined as a serious area of erosion–corrosion. The severe electro-chemical corrosion area was located at the elbow inside the wall axial angle of 0–30° while the serious erosion area was located at the elbow outside the wall axial angle of 45–75°. In practice, the elbow serious wall thinning region is located in the elbow outside the wall 50–80°. The numerical simulation of the severe erosion area and the actual corrosion serious area matched, indicating that the droplet erosion was the main cause of the elbow wall thinning, also illustrating the accuracy of the numerical simulation results. The numerical

simulation of the severe erosion area and the actual severe wall thinning area had a slight shift, probably as a result of neglecting the droplet particle size distribution.

Figure 14. Comparison between the simulation results and the actual situation.
