Restoration of Properties of Heat-Resistant Steel After Long-Term Operation in Steam Pipeline Bends of TPP by Heat Treatment

Abstract: To improve the microstructure and mechanical properties of heat-resistant 12Kh1MF steel after long-term operation in the stretched bend zone of the main steam pipeline of a thermal power plant, restorative heat treatment (RHT) was proposed. The RHT mode consisted of two normalization stages (from temperatures of 1100 and 960 °C, respectively) followed by tempering at a temperature of 740 °C. The RHT mode, regulated for steel in the initial state, was applied only after its normalization from a significantly higher temperature (1100 °C). It was shown that the proportion of fine grains in the steel structure increased to 55% over the entire pipe wall thickness after using RHT. At the same time, the proportion of large grains in the restored steel decreased significantly (to 10%), while in exploited steel, their proportion reached almost 50%. The proposed RHT mode increased the hardness, strength, plasticity, and resistance to brittle fracture of the restored steel relative to the corresponding characteristics of the operated steel. The maximum positi

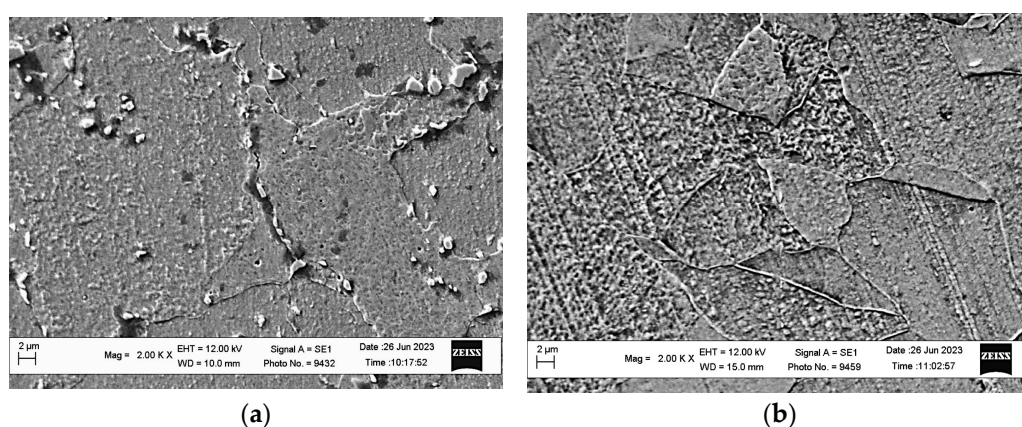
Figure 2. Typical microstructure of 12Kh1MF steel (a) after long-term operation in the stretched bend zone and (b) after restorative heat treatment.

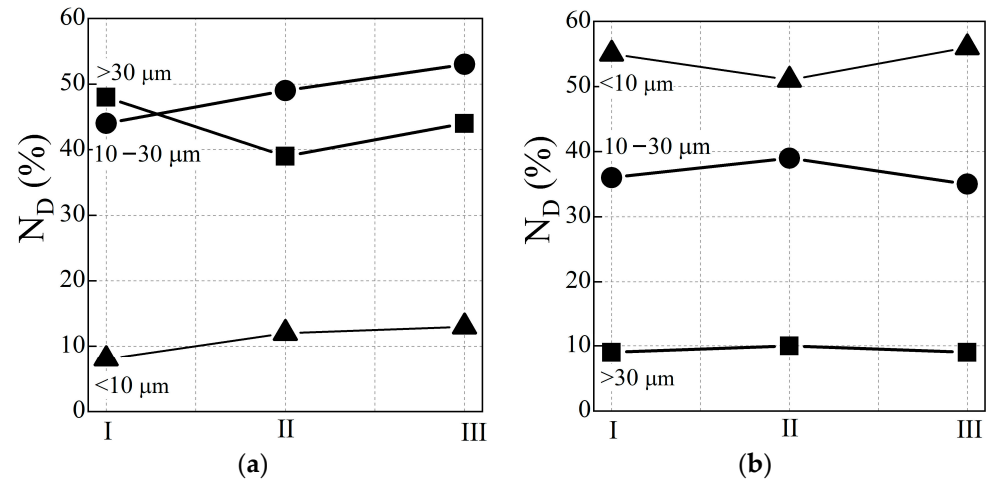
The percentages of grains belonging to certain size categories in the structure of the operated steel varied unevenly along the pipe wall thickness (Figure 3a). In particular, the proportions of small and medium grains gradually and slightly increased from the outer to the inner surface of the pipe. Thus, the number of medium-sized grains in percentage terms was the smallest near the outer surface of the pipe (44%) and the largest near its inner surface (53%). In the center of the pipe section, the number of grains with sizes from 10 to $30\ \mu\text{m}$ reached 49%. As for large grains, their amount changed ambiguously. Their amount in percentage terms was the largest near the outer surface of the pipe (48%), compared with their amount in the center of the pipe wall (39%) and near its inner surface (44%). Such an ambiguous change in the number of grains with the maximum size ($D > 30\ \mu\text{m}$) along the thickness of the pipe wall in the operational state indicated that these grains were responsible for the increased tendency of the operated steel to creep. After all, the force conditions for creep were also most favorable near the outer surface of the pipe. In addition, the energy capacity of dislocation pileups at their boundaries increased with an increase in grain size. This facilitated the penetration of dislocations through these boundaries into neighboring grains.

After the RHT of the operated steel, the proportion of small grains increased with a simultaneous decrease in the proportion of medium and large grains throughout the entire thickness of the pipe wall (Figure 3b). The proportions of grains with the smallest size ($D < 10\ \mu\text{m}$) were 55%, 56%, and 51% near the outer and inner surfaces of the pipe and in the center of its cross-section, respectively. The percentage of medium grains (10 to $30\ \mu\text{m}$) near the outer and inner surfaces of the pipe was slightly lower (36 and 35%,

Figure 3. The proportion of grains N_D of a certain size category relative to their total number in the structure of 12Kh1MF steel from the stretched bend zone of a pipe after its long-term (2.86×10^5 h) operation (a) and restorative heat treatment, according to the optimal mode (b) determined near the outer (I) and the inner (III) surfaces of the pipe, as well as in the center of its cross-section (II).

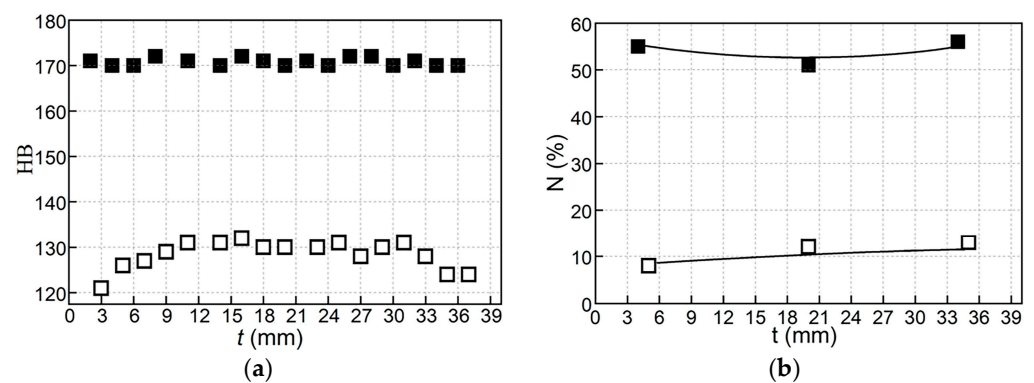
Since the proportion of fine grains, as a key structural indicator of steel condition, increased after the RHT, a significant rise in hardness was also expected. Hardness measurements showed that, after operation, its value in the center of the pipe section did not exceed 130 HB, while near both its surfaces, the hardness decreased to 120 HB (Figure 4a). Neither of the two hardness values obtained for the long-term service steel met the standard industry requirements [41]. At the same time, the application of the optimal mode of RHT to this steel made it possible to increase its hardness to 170 HB, indicating the restoration of its serviceability for this indicator (Figure 4a).

Figure 4. Change in the hardness HB (a) and the proportion of fine ($\leq 15 \mu\text{m}$) grains of N in the structure of 12Kh1MF steel (b) across the pipe wall thickness t of the stretched bend zone after its operation for 2.86×10^5 h on the main steam pipeline of a TPP (\square) and after additional application of restorative heat treatment to it according to the optimal mode (\blacksquare).

In our opinion, the established increase in steel hardness was due to a significant increase in the proportion of small grains relative to large ones in the steel structure. Our measurements showed that, after RHT, the proportion of small grains increased over the entire thickness of the pipe wall by more than five times (Figure 4b). The energy costs

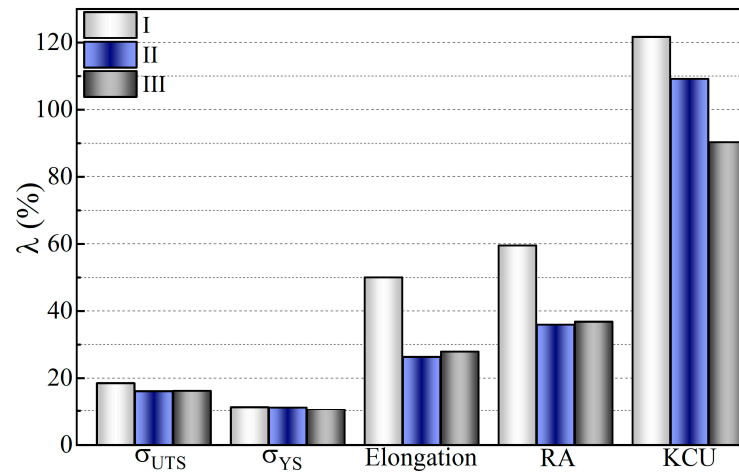
Tensile tests of samples from restored and operated steel revealed increases in both strength characteristics (σ_{UTS} and σ_{YS}) after RHT (Figure 5). Moreover, the effect of RHT on σ_{UTS} was even greater than that on σ_{YS} . The increases in these indicators were observed at all three levels of analysis by pipe wall thickness. In particular, the maximum increases in the σ_{UTS} and σ_{YS} characteristics after RHT reached 18.5 and 11%, respectively. These were recorded on samples cut near the outer surface of the pipe. Thus, the application of the optimal RHT mode confirmed its effectiveness in the restoration of 12Kh1MF steel for both strength indicators. It should be noted that, near the outer surface of the pipe, there was a barely noticeable tendency for greater increases in both strength indicators compared to near its inner surface. This is important, since the most favorable conditions for creep and, as a consequence, the most intense degradation of steel usually occur near the outer surface of the pipe. However, these negative consequences of the long-term operation of steel in a steam pipeline were successfully overcome after the use of RHT. This may be a weighty argument considering the question of the feasibility of extending the service life of steel in critical elements of the main steam pipelines of TPPs.

As for the plasticity characteristics (elongation and RA) of the long-term operated 12Kh1MF steel, an even more pronounced gradient of both characteristics across the pipe wall thickness was revealed after steel restoration (Figure 5). The maximum increases in both indicators after RHT were also recorded near the outer surface of the pipe. In particular, the value of elongation increased to 50% and RA reached 60% compared to the corresponding characteristics of the operated steel. The RHT effect in the center of the pipe cross-section and near its inner surface was significantly smaller. The increases in elongation and RA were only 28 and 38%, respectively. Based on this, it was concluded that the RHT largely eliminated the negative consequences of the long-term operational degradation of 12Kh1MF steel in the SBZ of the steam pipeline. This increases confidence in the validity of the proposed processing mode as an effective method for increasing the plasticity characteristics of operated steel. This concerns zones with the most favorable creep conditions, since a sufficient reserve of steel plasticity is a necessary condition for extending the service lives of long-operated steam pipeline elements.

Figure 5. Change in mechanical properties (in percentage terms λ) for 12Kh1MF steel at different levels along the pipe wall thickness (I and III—near the outer and inner surfaces of the pipe; II—in the center of its cross-section) after its restorative heat treatment in comparison with the corresponding properties of this steel after 2.86×10^5 h of operation in the stretched bend zone of a TPP steam pipeline.

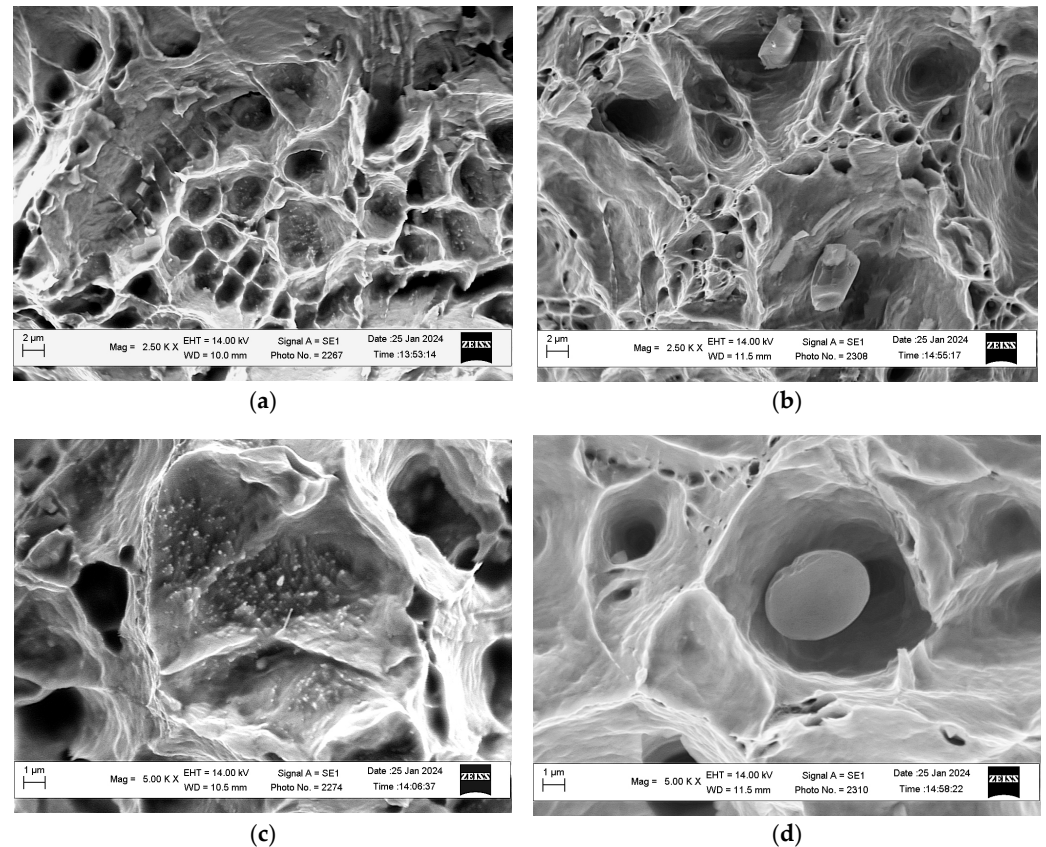
In the central parts of the fractures of the samples, where the initiation of their failure under uniaxial tension usually occurs, ductile dimple relief prevailed, and this mechanism dominated regardless of the location of the samples near the outer or inner surface of the pipe in the SBZ. However, on fractures of samples cut near the outer surface of the pipe, dimples grouped into conglomerates were quite often observed. Ridges with signs of a shear mechanism were formed along the perimeters of these areas (Figure 6a). The presence of such shear ridges indicated the formation of voids on carbides and non-metallic inclusions near the outer surface of the pipe even before tensile testing. The bridges between such individual voids were destroyed during the tensile testing of the samples due to the mechanism of their stretching until they broke, thereby forming a larger cavity. Merging with similar cavities formed by other nearby void conglomerates occurred due to a shear in the bridge between them. In contrast, the fractures of samples cut near the inner surface of the pipe had a uniform ductile relief characterized by uniform equiaxed dimples (Figure 6b). Similar results for steels exposed to high temperatures were obtained in other works [42].

Figure 6. Microfractograms of the central part of the fractures of tangentially oriented tensile specimens taken near the outer (a,c) and inner (b,d) surfaces of a pipe made of 12Kh1MF steel that operated for 2.86×10^5 h in the stretched bend zone of the main steam pipeline of a TPP.

Fractographic signs confirming this phenomenon were also found on fractures of the used 12Kh1MF steel. In particular, at the bottom of the dimples on the fractures of samples cut near the outer surface of the pipe, a significantly smaller number of inclusions were found than on samples from the vicinity of its inner surface. It was believed that this fractographic feature indicated a more intense degradation of steel near the outer surface of the pipe due to the loss of cohesion of carbides and especially large non-metallic inclusions with the surrounding matrix (Figure 6). Additionally, at the tops of the ridges along the boundaries of the large dimples on the fractures of the steel operated near the outer surface of the pipe, there were no much smaller dimples with signs of the stretching of the bridges between them (Figure 6a,c). On the contrary, on the fractures of samples from the same pipe but cut near its inner surface, a noticeable feature of relief was chains of small equiaxed dimples. They were formed under the influence of normal tensile forces and located along the tops of the ridges, outlining larger dimples (Figure 6b,d). This, in itself, indicated a greater plasticity in the steel near the inner surface of the pipe. After all, the bridges between large dimples at least partially retained the ability to stretch during the tensile tests, instead of breaking due to shear.

It was also noted that a characteristic feature of the fractures, indicating the more intense degradation of the 12Kh1MF steel near the outer surface of the steam pipe, was the absence of large inclusions at the bottom of large dimples. Instead, only clusters of very small (nanosized) particles (no more than 300 nm) were observed at the bottom of the large dimples (Figure 6a,c). It was assumed that these clusters were formed by micro fragments of large carbides and inclusions that remained at the fractures after the final separation of large particles from the matrix during the tensile testing of the samples. In contrast, on the fractures of samples cut near the pipe's inner surface, traditional inclusions and carbides of various shapes and sizes were found at the bottom of the dimples (Figure 6b,d). It was suggested that a significant portion of the large carbides that were visible and coagulated at the grain boundaries during long-term high-temperature steel operation still retained at least partial cohesion with the ferrite matrix. It was believed that the nanoscale fragments at the bottom of the large dimples on the fractures of samples cut near the outer surface of the pipe were traces of their final decohesion. Their final separation from each other occurred during the tensile testing of the samples. As a result, against the background of a generally typical ductile fracture relief, nanosized particles in the form of fragments of large carbides were preserved at the bottom of large dimples. It was noted that they could be visualized only at a high magnification.

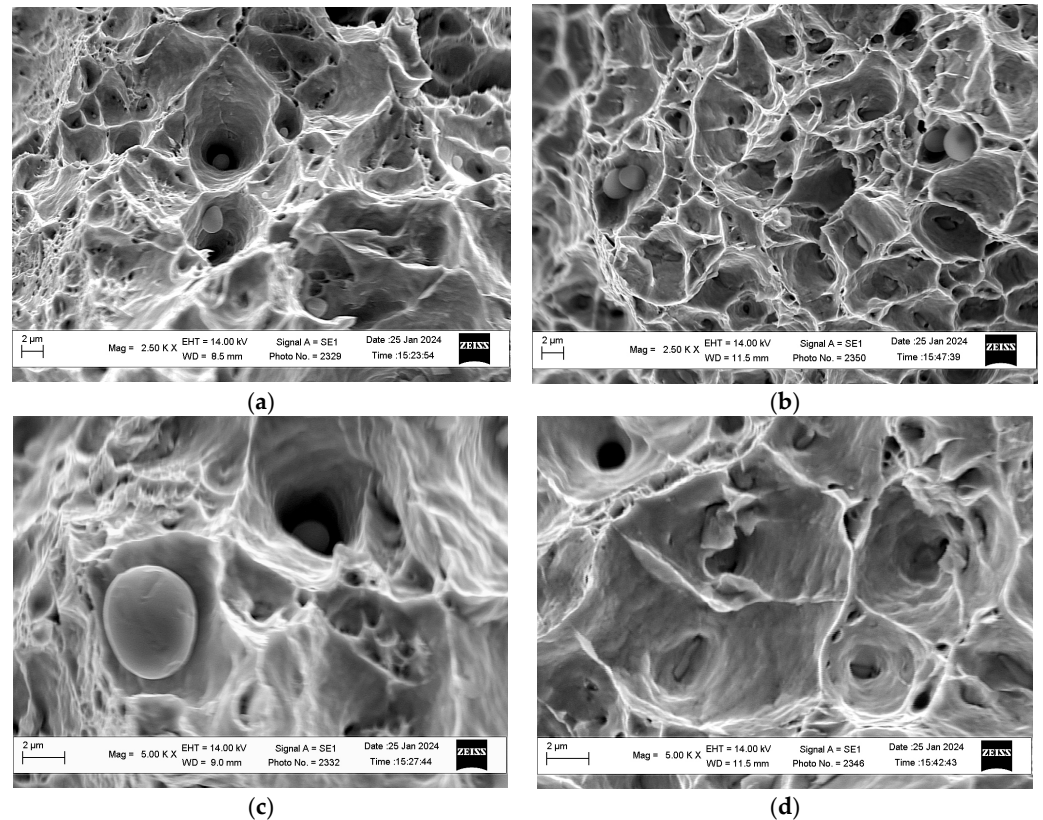
As for the fractographic features of the restored steel, conglomerates of dimples united by common shear ridges, characteristic of exploited steel, were not found in its fractures. In addition, the relief of ductile dimples at the fracture surface of the restored steel was higher and more pronounced than on the fracture surface of the exploited steel. This indicated that more energy was spent on their formation. Thus, the distinctive feature of steel degradation under operating conditions (the presence of large dimples with nanosized particles at the

bottom, separated from large carbides during the tensile testing of the samples) was not detected at the fractures after using the proposed RHT mode (Figure 7).

Figure 7. Microfractograms of the central part of fractures of tangentially oriented samples of 12Kh1MF steel cut near the outer (a,c) and inner (b,d) surfaces of an operating pipe and tested for tension after applying restorative heat treatment according to the proposed mode.

On the fracture surface of steel subjected to RHT, small equiaxed dimples predominated. They were formed by the mechanism of the stretching of bridges between adjacent voids up to their rupture. It was believed that the small (tenths of a micron) carbides observed at their bottom were precipitated during the high-temperature tempering of steel at the final stage of its RHT. The predominance of dimples on the fractures of the restored steel, formed due to the mechanism of the stretching of bridges between adjacent voids before their rupture, indicated that the role of the shear mechanism (which played a significant role in the formation of the dimple relief on the fractures of the operated steel) was practically levelled out after RHT. Additionally, clusters of small dimples caused by the destruction of finely dispersed pearlite were found in the structure of the restored steel (Figure 7). Small particles of cementite within the pearlite grains were responsible for the nucleation of these small dimples directly during the tensile testing of samples. On the contrary, large and deep dimples were found inside the ferrite grains, visible against the background of small dimples surrounding them. The presence of large dimples on the fractures of the restored steel was associated with inclusions that did not dissolve at the initial stage of RHT (normalization from 1100 °C). Their preservation in the structure of the restored steel was due to a significant (and often complete) loss of cohesion of large carbides (or non-metallic inclusions) to the matrix due to the creep of the steel during long-term high-temperature operation in a steam pipeline. As a result, their dissolution became difficult (due to an insufficient austenitization temperature) or even impossible (due to the loss of diffusion paths). The defects formed due to the decohesion of the matrix and large carbides at the grain boundaries remained virtually unchanged after the RHT
