Tribological Properties of Plough Shares Made of Pearlitic and Martensitic Steels

Abstract: Tribological properties of ploughshares made of pearlitic and martensitic steels were compared in field tests. Sectional ploughshares consisting of separate share-points and trapezoidal parts were subjected to examinations. Contours of the examined parts were similar, but the thickness of the parts made of pearlitic steel was 1 to 3 mm greater for the share-points and 0.5 to 2 mm greater for the trapezoidal parts. Within the tests, sandy loams, loams, and loamy sands with circa (ca.) 13% humidity were cultivated. A greater intensity of thickness reduction and mass wear of the parts made of pearlitic steel was found, which indicates a lower resistance of this steel to wear in soil. However, contour changes of the share-points and the trapezoidal parts made of pearlitic and martensitic steels were comparable, which was probably influenced by the greater thickness of the parts made of pearlitic steel. The roughness of the rake faces of the parts made of pearlitic steel was greater than that for the parts made of martensitic steel, which can be attributed to lower hardness of the former. The la

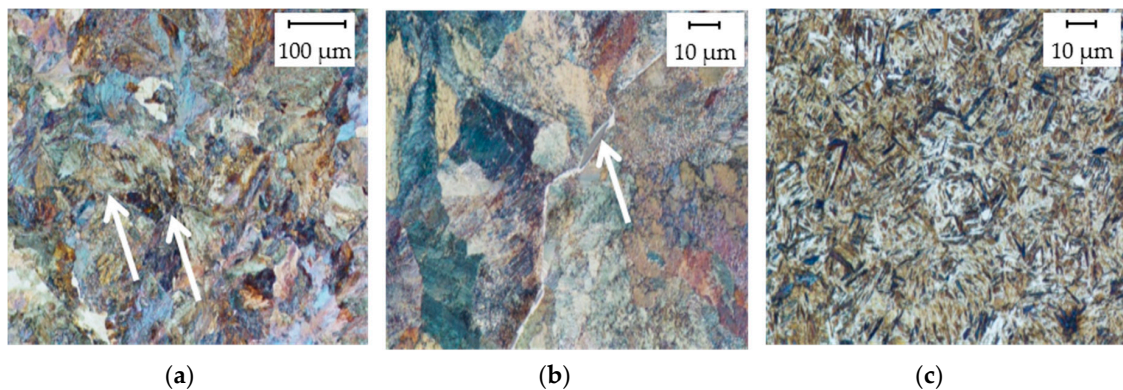
Microscopic examinations were carried out on cross sections of steel specimens etched with 3% HNO₃ (according to PN-H-04512-1975) at magnifications between 100 and 500×. Observations were made using a metallographic microscope (Nikon Corporation, Tokyo, Japan) coupled with a charge-coupled device (CCD) camera. The structure of the ploughshares made of railway rails was found to be pearlitic (non-homogeneous in some places) with ferrite crystallized on grain boundaries of former austenite. Moreover, numerous inclusions were observed, probably sulfides, see Figure 1a,b. The structure of the reference shares was found to be martensitic, composed of medium-carbon and fine-acicular tempered martensite, see Figure 1c.

Figure 1. Microstructures of ploughshare materials: (a) pearlitic steel with ferrite on grain boundaries (indicated by arrows); (b) pearlitic steel with ferrite on grain boundaries, in some places non-homogeneous, with visible inclusions, probably sulfides (indicated by an arrow); (c) martensitic steel, the structure of fine-acicular tempered martensite.

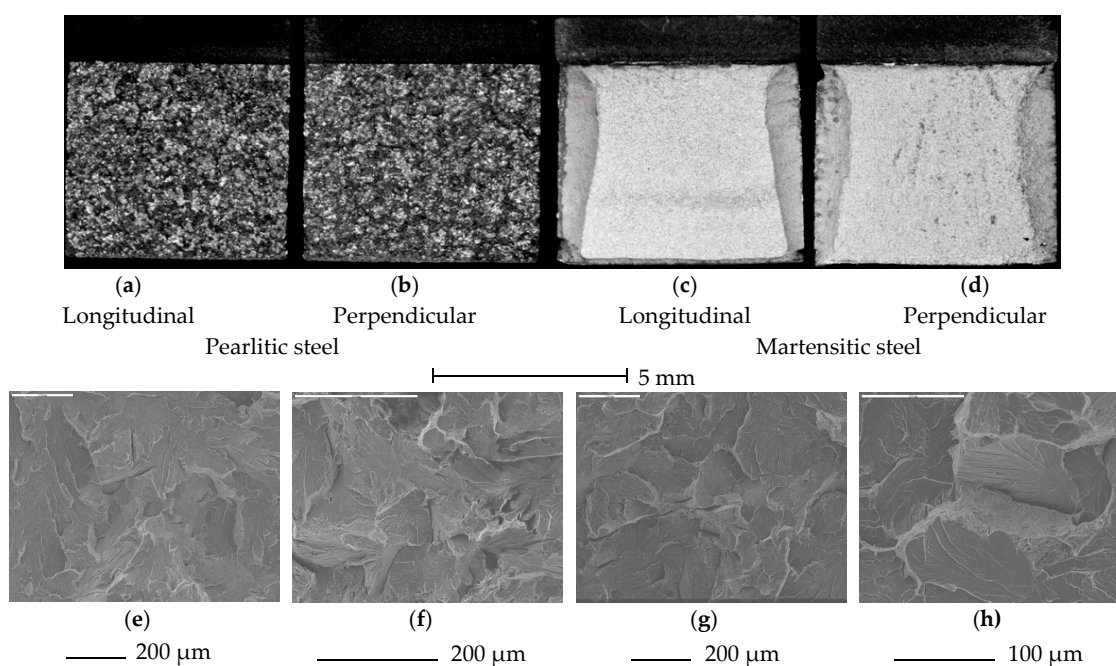
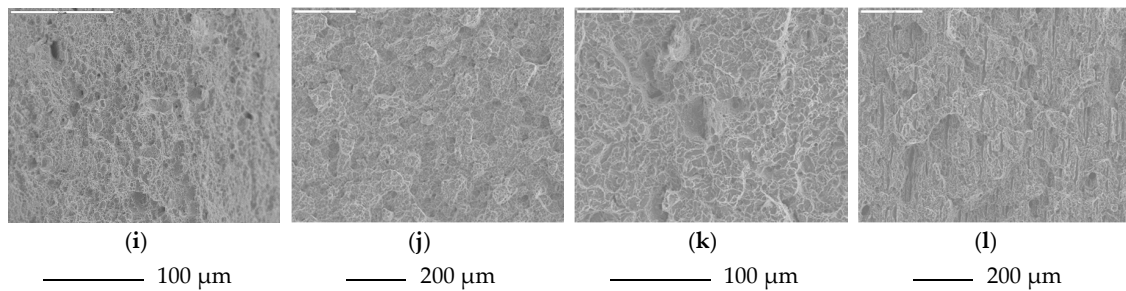
Microscopic analysis of fracture surfaces obtained in impact tests showed 100% of the brittle zone for pearlitic steel, but significant plastic zones in the side parts for martensitic steel, see Figure 2a–d.

Specimens of pearlitic steel showed cleavage fractures with fragments of plastic fracture between the facets, with characteristic profiles of “rivers”, see Figure 2e–h. In the places where cracks propagated through grain boundaries, “fan” profiles could sometimes be seen (Figure 2h). On surfaces of the facets, marks of secondary cracks also occurred, propagating at a certain angle to the main cracking surface, see Figure 2e–h.

Fractures of the specimens of martensitic steel for both longitudinal and perpendicular directions are shown in Figure 2i–l. Side zones, as well as small zones under the notch, are plastic fractures with voids of various diameters, see Figure 2i. Brittle non-metallic inclusions that initiated the fracture occur within larger voids. Pits have parabolic shapes, which evidences action of tangential forces during cracking. The central zone is the so-called quasi-cleavage fracture (Figure 2j,k). This is typical for steels with martensitic and bainitic structures. Even though these facets are similar to cleavage facets (because of occurrence of the “river” profile), it is almost impossible to identify crystallographic planes. Ridges of quasi-cleavage facets are characterized by developed topography, which also evidences intensive plastic deformation during their creation. Moreover, numerous transverse cracks and cavities left by non-metallic inclusions were observed, see Figure 2k,l.

Figure 2. Fracture surfaces of pearlitic and martensitic steels after the impact test. (a–d) macroscopic images of fracture surfaces after the impact test; Pearlitic steel: (e,f) cleavage fracture with characteristic “river” profile (longitudinal), (g,h) cleavage fracture with characteristic “river” and “fan” profiles (perpendicular); Martensitic steel: (i) plastic side zone (longitudinal), (j) quasi-cleavage fracture with developed topography (longitudinal), (k) cavities after non-metallic inclusions (longitudinal), (l) cavities after non-metallic inclusions (perpendicular).

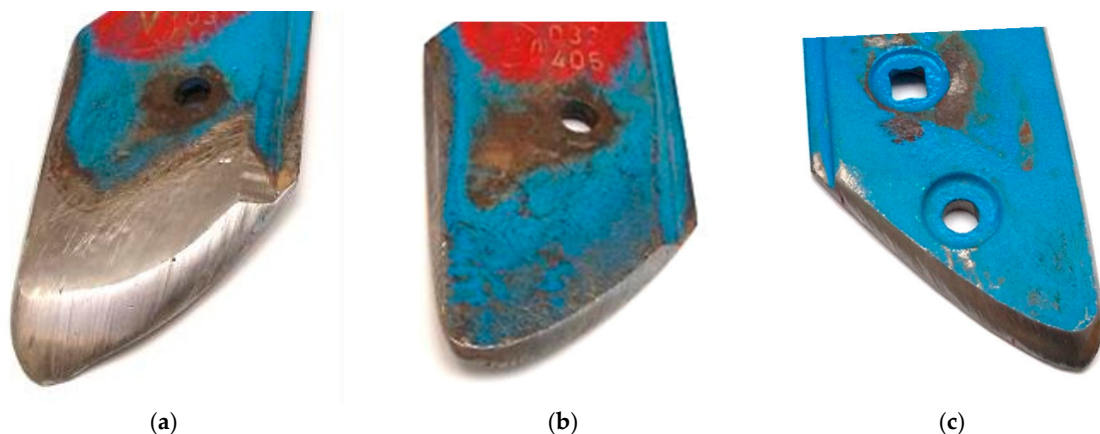
Bending of the share-points made of pearlitic steel resulted in various widths of the wear band formed on the flank faces of the parts, see Figures 11 and 12. This parameter is important insofar as, at the wide wear band, difficulties can happen in sinking the plough or in maintaining its set working depth. Bending the share-points “forward” resulted in a ca. 1.6–1.2-fold wider wear band at Measuring Lines L₂ and L₃, respectively.

Figure 12. Wear band on the flank faces of the share-points: (a) pearlitic steel, “forward” bent; (b) pearlitic steel, slightly “backward” bent; (c) martensitic steel.

The width of the wear bands in the share-points made of pearlitic steel, which were not bent “forward”, was ca. 1.3 times greater than that in the parts made of martensitic steel. However, the width of the wear bands in the trapezoidal parts made of pearlitic steel was ca. 1.1–1.2 times smaller (Figure 11), which can be related to their clearly greater thickness reduction, see Figure 5.

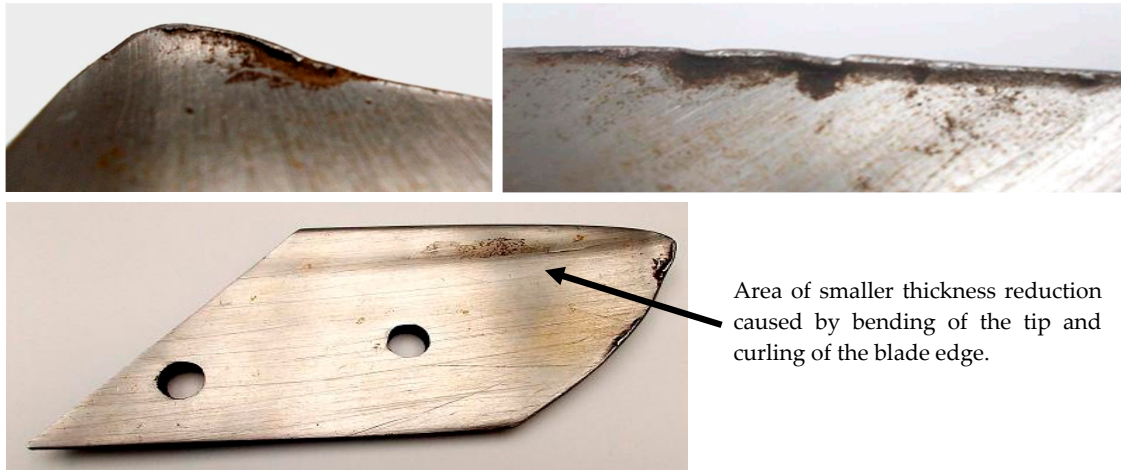
In some share-points made of pearlitic steel, a bending of their tips on a small length and a curling of the blade edges were observed, see Figure 13. These phenomena contributed to more irregular thickness reduction of the parts. Bending the share-points “forward” facilitated the a.m. processes because of the smaller thickness of the parts in their blade areas.

Area of smaller thickness reduction caused by bending of the tip and curling of the blade edge.

Figure 13. Exemplary bending of the tip and curling of the blade edge in the share-point made of pearlitic steel.

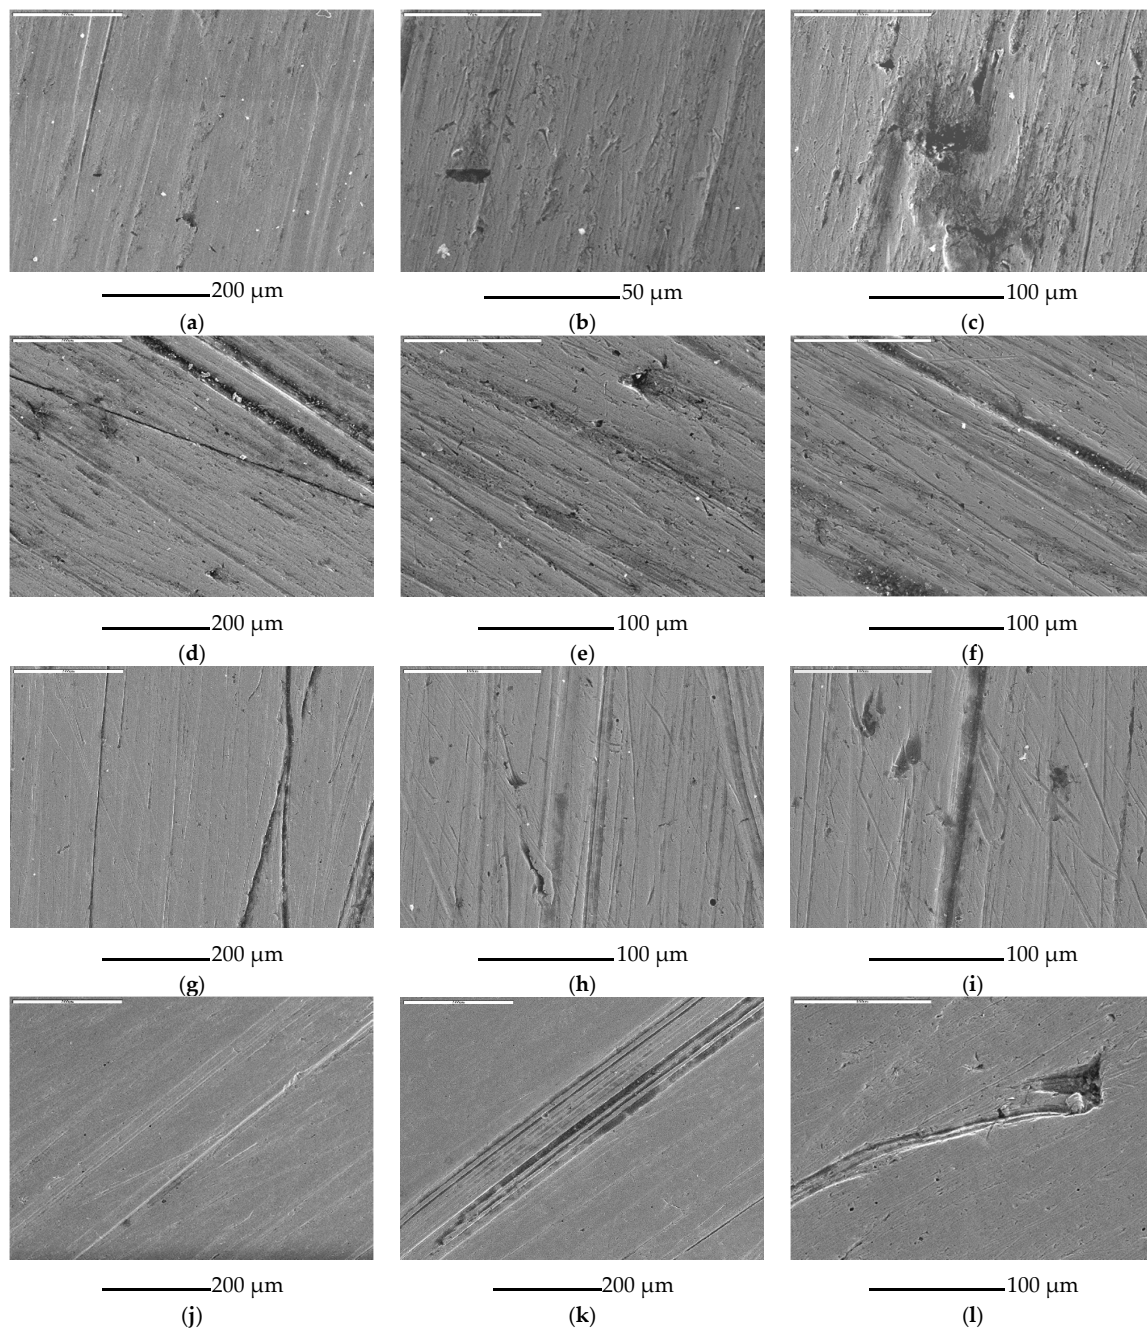
Figure 15. Rake faces of the examined parts (SEM). Rake face surface of a share-point made of pearlitic steel: (a) scratches and grooves, (b) pit hole, (c) fragments of embedded abrasive particle; Surface of a trapezoidal part made of pearlitic steel: (d) scratches and grooves, (e) fragments of embedded abrasive particle, (f) groove and plastic deformation; Surface of a share-point made of martensitic steel: (g) scratches and grooves, (h) holes formed during a particle impact, (i) groove and holes formed during a particle impact and embedded abrasive particle; Surface of a trapezoidal part made of martensitic steel: (j) scratches and grooves, (k) grooves, (l) groove formed during a particle impact and embedded abrasive particle.

Analysis of the wear surface of a share-point made of pearlitic steel shows rough surface topography due to microcutting and microploUGHing caused by abrasive particles. The scratches and grooves are wide, deep, and randomly orientated, see Figure 15a. There are also visible scratches and scrapes randomly orientated. Moreover, some traces of spalling and pitting, originating in the places where larger areas of material were removed (Figure 15b), were observed at the surfaces. An examination of some pit holes showed the plastic deformation and displacement of material from the impact sites to the crater rims. These phenomena caused formation of grooves with pronounced lips at their rear ends. Abrasive particles could also cause surface fatigue. In these lips, detachment could occur due to these particles. In some pit holes, fragments of embedded abrasive particles are visible (Figure 15c). It can be seen on a surface of a trapezoidal part made of pearlitic steel that the proportion of microploUGHing increases (Figure 15d–f). The other observation on the surfaces of a share-point (Figure 15g–i) and a trapezoidal part (Figure 15j–l) made of martensitic steel is that scratches and grooves are arranged parallel to the movement direction of abrasive particles along the surface. The grooves are relatively narrow and shallow, but some areas are visible, where scratches and grooves are more concentrated (Figure 15k). Some shallow, randomly orientated scratches can be observed. Grooves formed by moving soil particles and plastically deformed material are visible on the crater rims, see Figure 15i,l.
