# Investigation of Stress-Oriented Hydrogen-Induced Cracking (SOHIC) in an Amine Absorber Column of an Oil Refinery

**Abstract:** Stress-oriented hydrogen-induced cracking (SOHIC) of an amine absorber column made of a Hydrogen Induced Cracking (HIC) resistant steel and operating under wet H<sub>2</sub>S service was investigated. SOHIC was not related to welds in the column and evolved in two steps: initiation of HIC cracks in the rolling plane and through-thickness linking of the HIC cracks. Both the original HIC cracks as well as the linking cracks propagated with a cleavage mechanism. The key factors identified were periods with high hydrogen charging conditions, manifested by high H<sub>2</sub>S/amine ratio, and stress triaxiality, imposed by the relatively large thickness of the plate. In addition, the mechanical properties of the steel away from cracked regions were unaffected, indicating the localized nature of SOHIC.

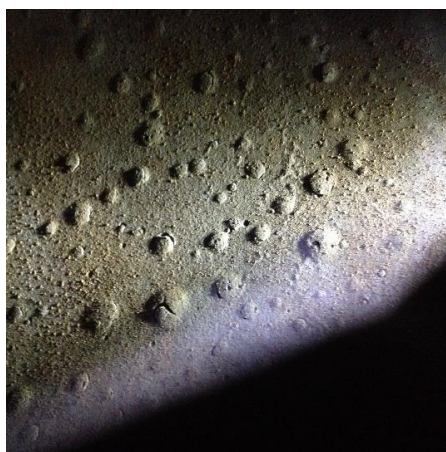
A decommissioned amine absorber column, which exhibited hydrogen blistering in the internal wall, was made available for study. Blistering is shown in Figure 1. The aim of the present work is to investigate the underlying SOHIC damage and to identify the contributing factors that led to cracking.

Figure 1. Blistering in internal surface.

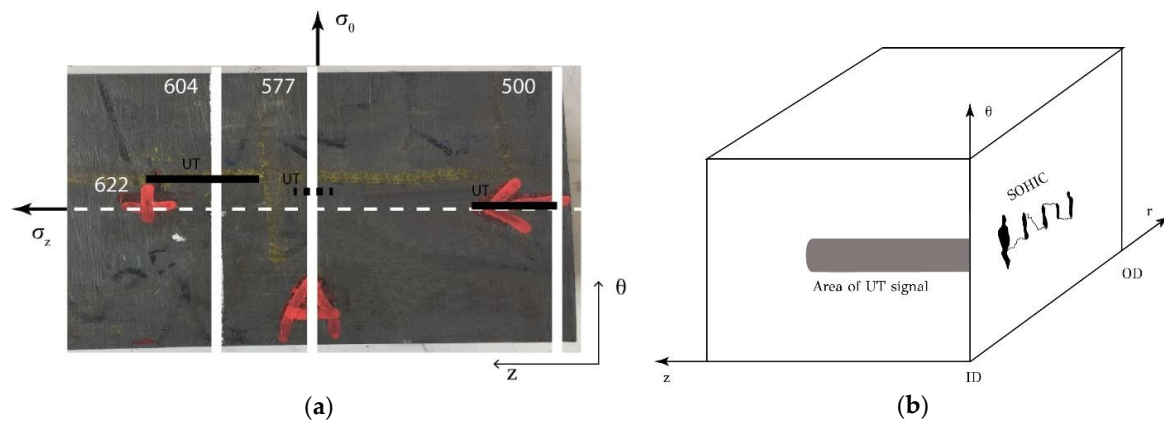
A section of the column shell was cut for investigation. The position of the section was 5 m from the bottom of the column. In the inside diameter, blistering was evident (Figure 1). The shell section is shown in Figure 3. The section was inspected by ultrasonic testing (UT). Locations with UT signals

are indicated by thick black horizontal lines (UT) in Figure 3. The positions of the metallographic sections are indicated by perpendicular white lines. Three positions were considered in this work: positions 500, 577, and 604, which pass through the UT signals. The numbers indicate distances, in mm, from a reference point on the vessel shell. It should be noted that the UT signal from position 577 was scattered and not concentrated in a line, as the signals from positions 500 and 604. As will be shown below, the UT signals from positions 500 and 604 correspond to SOHIC cracking, while the signal from position 577 corresponds to HIC, i.e., isolated HIC cracks without linking. An explanation is provided in Figure 3b, correlating the UT signal with the respective metallographic section.

**Figure 3.** (a) Shell section for analysis (top view) indicating locations of metallographic sections and positions of UT signals; (b) correlation of SOHIC with UT signal (SOHIC: Stress Oriented Hydrogen Induced Cracking, ID: Inside Diameter, OD: Outside Diameter, UT: Ultrasonic Testing).

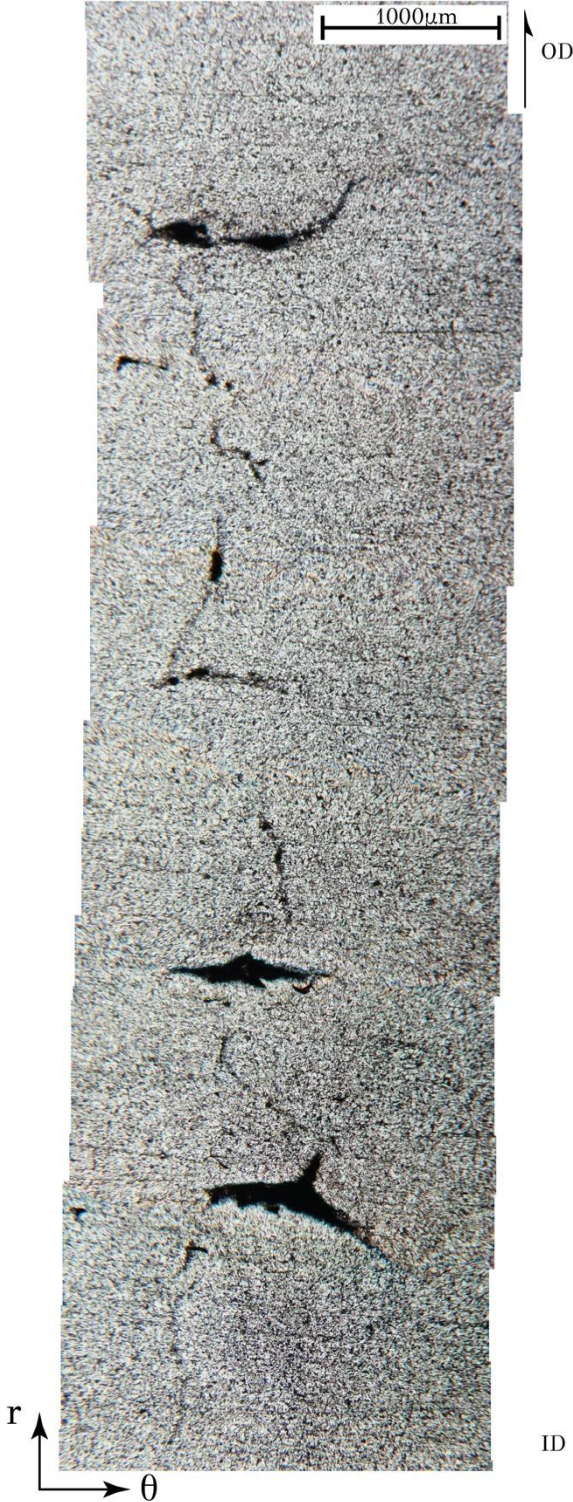
The microstructure of the steel is depicted in the micrograph of Figure 6, indicating that the microstructure consists of ferrite and pearlite. The metallographic section at location 604 is shown in Figure 7, which is an assembly of micrographs starting from the inside diameter (ID) of the

shell. This is a typical form of stress-oriented hydrogen-induced cracking (SOHIC). Although, microscopically, the crack direction changes several times during propagation, macroscopically, it is a through-thickness crack with a direction perpendicular to the applied stress. The crack appears to interconnect blisters/HIC cracks, which have formed at various levels across the thickness of the plate. The HIC cracks lie on the rolling plane and are stacked normal to the rolling plane. The HIC cracks are linked with cracks which run in a direction normal to the rolling plane and perpendicular to the applied hoop stress. The initiation is at 5 mm from the ID, while the overall crack length is 23 mm.

Both cracks at locations 500 and 604 (Figures 7 and 9) are, therefore, classified as SOHIC. They interconnect blisters/HIC cracks and they propagate from the ID towards the OD under the action of the applied stress. According to API RP 571 [1], SOHIC consists of arrays of small HIC cracks, initiated at internal blisters in the rolling plane. These HIC cracks are stacked in a direction normal to the applied hoop stress and are linked by cracks normal to the stress. SOHIC should not be confused with stepwise hydrogen-induced cracking (SWC), which exhibits a not-aligned stepped morphology in the absence of stress. The limited cases of SOHIC failures that are reported in Pargeter's review [4] indicate that SOHIC requires a combination of severe hydrogen cracking conditions and stress. In the present case, the amine absorber column was operated under high H<sub>2</sub>S/MDEA ratios for certain time periods, promoting high hydrogen charging conditions. In addition, it has been suggested [4] that triaxial loading can encourage the formation of small HIC cracks by increasing the hydrogen solubility in the steel. Stress triaxiality can be induced by the large plate thickness (91 mm). It is expressed by the ratio  $\sigma_h/\bar{\sigma}$ , where  $\sigma_h$  is the hydrostatic stress and  $\bar{\sigma}$  is the von Mises equivalent stress. The triaxiality ratio was calculated (see Appendix A) for the operating conditions and was found as 0.5, which is a number indicating that the material was subjected to a moderate triaxial stress state. In addition, it is interesting to note that the HIC cracks form even though the radial stress is compressive. However, these cracks do not propagate in the rolling plane, but instead they are linked in the radial direction under the action of the hoop stress.

Figure 7. SOHIC cracking at location 604.

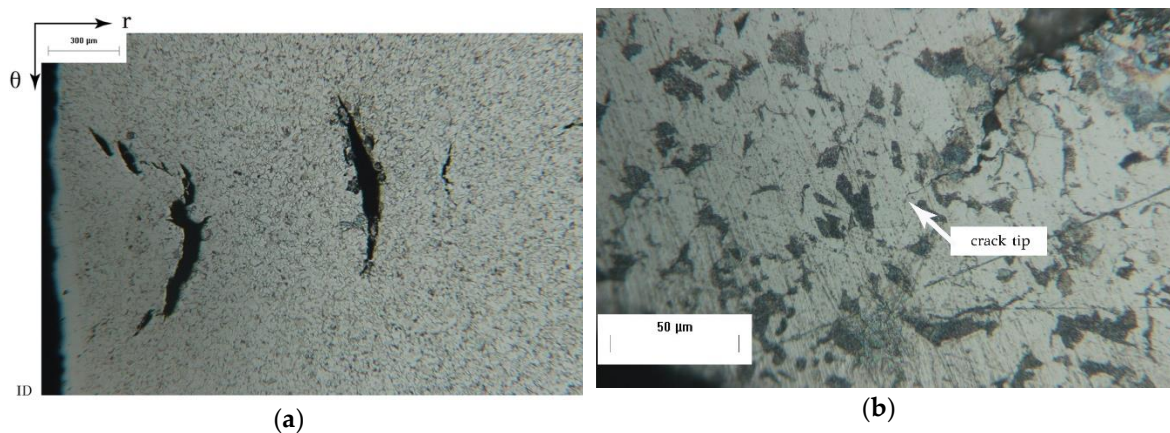
The metallographic section at location 577 is depicted in Figure 8a. Blisters/HIC cracks have formed, but they are not interconnected, at least at the plane of observation. This can explain the scattered mode of the UT signal at position 577. The propagation of HIC cracks is through the ferrite phase, between the pearlite colonies at ferrite/pearlite interfaces, as depicted in Figure 8b. A similar crack propagation mechanism has been also observed by Gingel and Garat [17] in an API 5L grade X60 pipeline steel.

**Figure 8.** (a) HIC cracks at location 577; (b) tip of HIC crack indicating propagation in ferrite between pearlite colonies.

It is important to note that location 577 exhibited only stacked HIC cracks with no evidence of crack linking. This indicates that the SOHIC sequence involves the formation of HIC cracks first, followed by through-thickness linking of the HIC cracks, in agreement with observations by Crolet and Adam [18] and Ohki et al. [19]. Both HIC formation and linking involve transgranular cleavage fracture mechanisms as indicated by the fractographic analysis of the opened crack at location 500. The transgranular propagation mode is in agreement with the findings of Bruckhoff et al. [20]; however, the cleavage mode of linking is not in agreement with the suggestion of Pargeter [4] that linking is through a slip mechanism, or that of Azevedo [21], who observed ductile fracture mode in linking hydrogen blisters in an API 5L X46 steel. Slip may be involved in the transport of hydrogen, as shown by several studies [22,23], but the propagation of the linking cracks is clearly through a cleavage mechanism. The cleavage mode of the linking cracks confirms the important influence of stress triaxiality in SOHIC, since triaxiality introduces plastic constraint and promotes cleavage fracture. Triaxiality effects have been discussed by other investigators, such as the effect on hydrogen concentration by Toribio et al. [24], the effect on ductility by Mirza et al. [25], and the effect on fracture behavior by Borvik et al. [26].

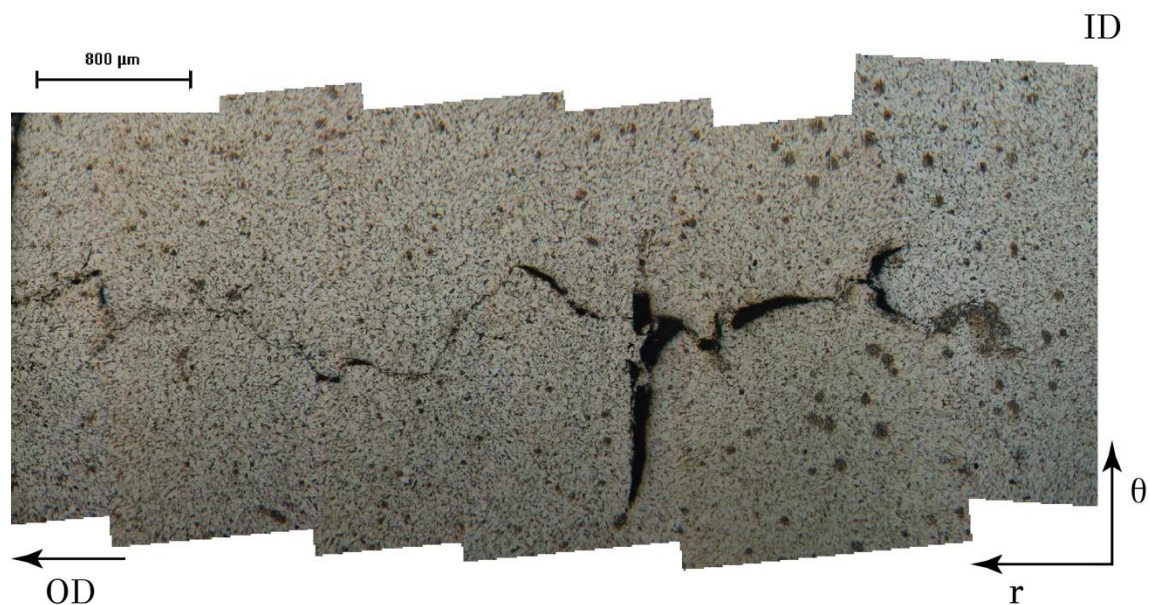
The metallographic section at location 500 is depicted in Figure 9. The crack has initiated at 5 mm from the ID and has an overall length of 30 mm. This type of cracking is also classified as SOHIC.

**Figure 9.** SOHIC at location 500.

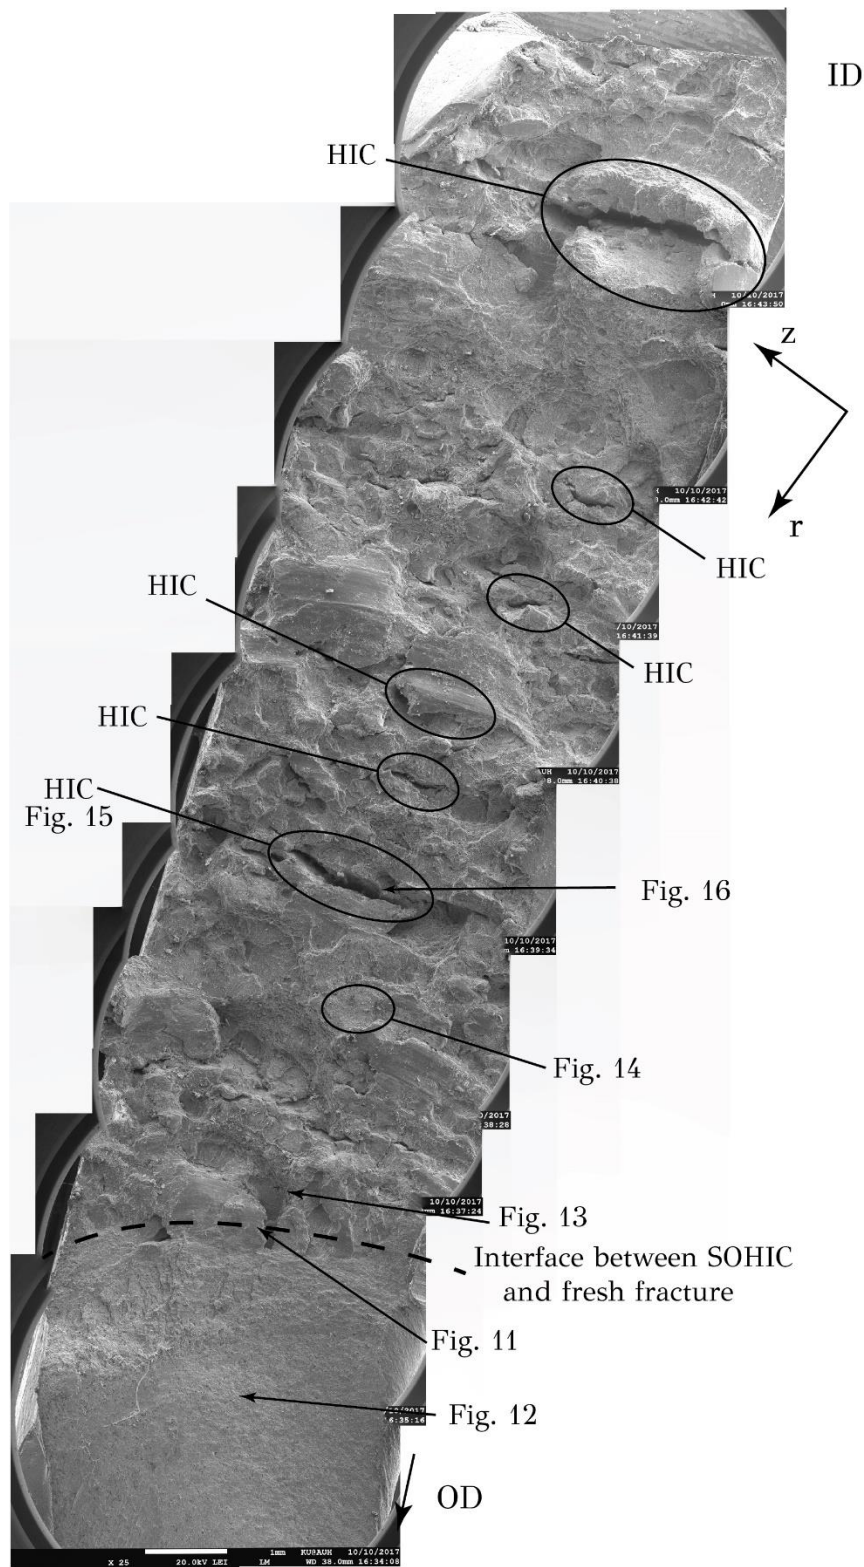
As discussed above, the SOHIC crack at location 500 was opened for fractographic analysis. A low-magnification assembly of SEM micrographs is shown in Figure 10. The region of “fresh” fracture resulting by the opening procedure and the region of SOHIC fracture are indicated. The boundary between the fresh fracture and SOHIC is depicted in Figure 11. It is clear that there are two fracture modes. The fresh fracture area is characterized by dimple fracture, also indicated in Figure 12, while the SOHIC area is characterized by cleavage, indicated in Figure 13. In addition, several blisters/HIC cracks can be seen on the fracture surface. The entire SOHIC region, including the areas between blisters, is characterized by cleavage as indicated in Figure 14. No black deposit, related to FeS, was found on the fracture surface. In addition, Energy Dispersive X-ray (EDX) analysis performed on the cleavage areas did not detect the presence of sulfur. The absence of black deposits and sulfur indicate clearly that cracking is not related to sulfide stress cracking (SSC). A large blister/HIC crack is depicted in Figure 15. It was possible to approach the interior of this blister in order to investigate the morphology of the blister wall as it resulted by the HIC crack opening due to the buildup of hydrogen

**Figure 10.** Assembly of SEM micrographs depicting the fracture surface of the opened SOHIC crack at position 500. The location of HIC cracks and individual SEM micrographs is indicated.

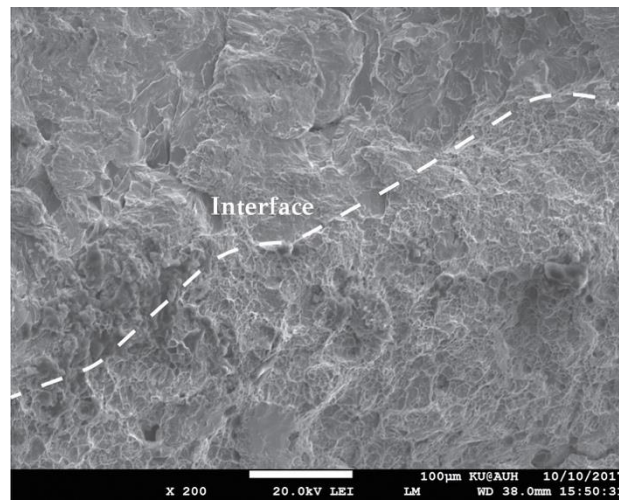
Figure 11. Boundary between SOHIC and "fresh" fracture.

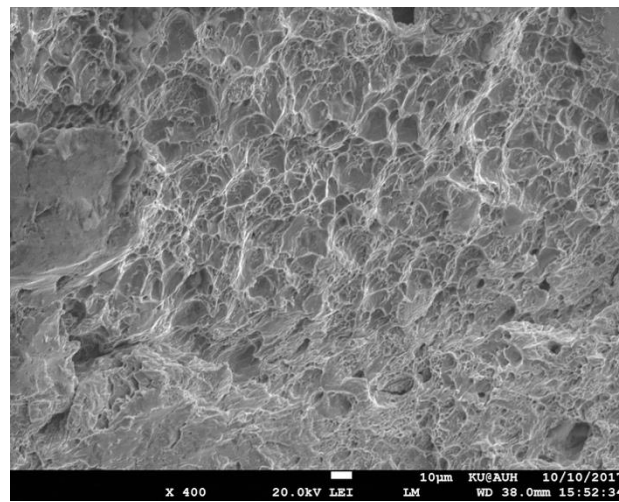
Figure 12. Dimple fracture in the "fresh" fracture region.

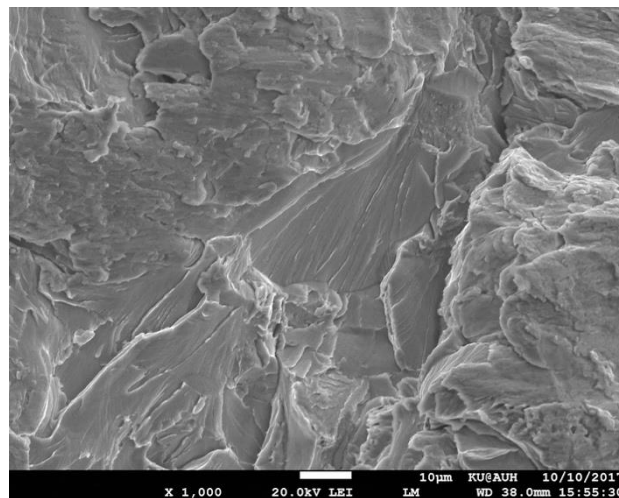
Figure 13. Cleavage fracture at SOHIC region.

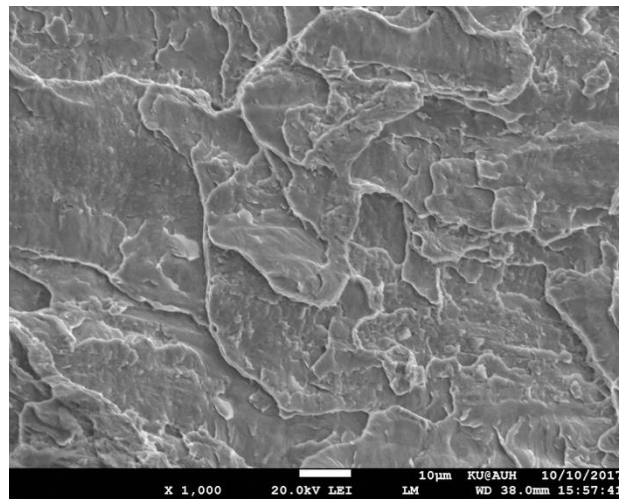
Figure 14. Cleavage fracture in SOHIC region between HIC cracks.

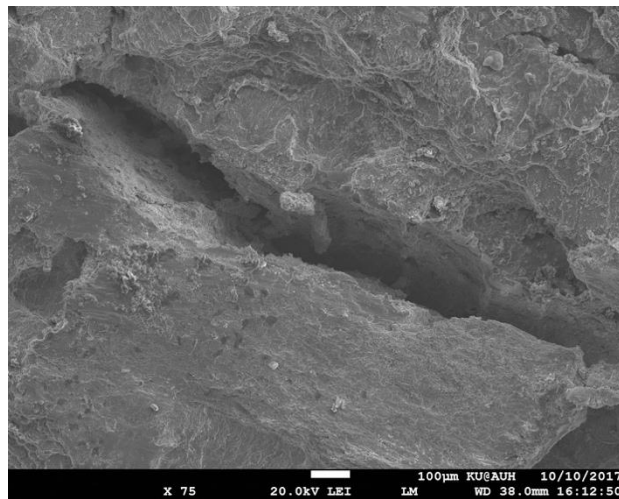
Figure 15. A large HIC crack at the SOHIC fracture region.

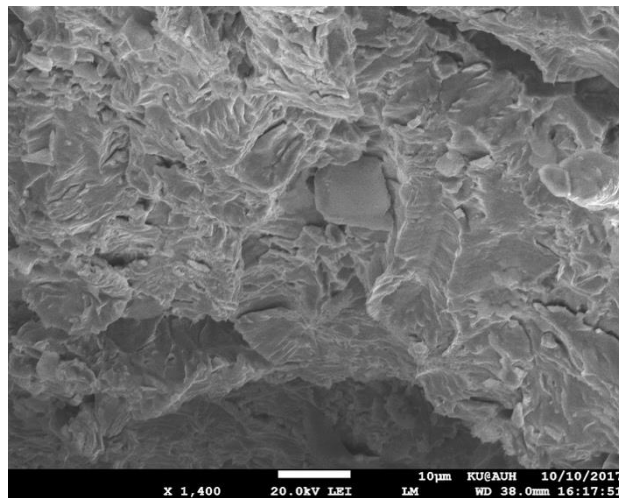
pressure. The internal wall is depicted in Figure 16, indicating a cleavage fracture surface. Thus, blistering and HIC cracking proceeded with cleavage of the material.

Figure 16. Cleavage fracture morphology of the internal blister/HIC crack wall.
