Creep Failure of Reformer Tubes in a Petrochemical Plant

Abstract: This paper investigates a failure in HP-Mod radiant tubes in a petrochemical plant. Tubes fail after 90,000 h of working at 950 °C. Observed failure is in the form of excessive bulging and longitudinal cracking in reformer tubes. Cracks are also largely branched. The microstructure of service-exposed tubes was evaluated using optical and scanning electron microscopes (SEM). Energy-dispersive X-ray spectroscopy (EDS) was used to analyze and characterize different phases in the microstructure. The results of this study showed that carbides are coarsened at both the inner and the outer surface due to the long exposure to a carburizing environment. Metallography examinations also revealed that there are many creep voids that are nucleated on carbide phases and scattered in between dendrites. Cracks appeared to form as a result of creep void coalescence. Failure is therefore attributed to creep due to a long exposure to a high temperature.

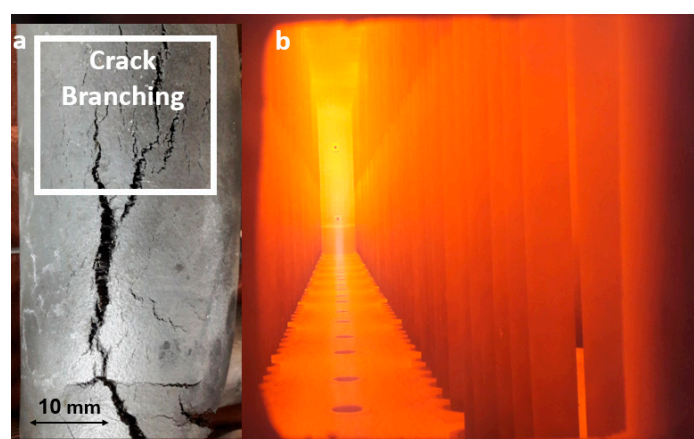
Figure 1 shows an example of failed reformer tubes together with an image, showing how tubes are installed in a reforming unit. As can be seen, cracks have propagated longitudinally. Extensive branching is also observed overall on the outer surface. It is also noticeable that in some parts tubes are largely deformed in such a way that a clear bulging is observed. Cracks are often seen in areas of localized deformation/bulging.

Figure 1. (a) Example of failed tubes and (b) an image of tubes in service.
