# Most Frequent Problems of Building Structures of Urban Apartment Buildings from 2nd Half of 19th Century and the Start of 20th Century

Klara Kroftova

**Citation:** Kroftova, K. Most Frequent Problems of Building Structures of Urban Apartment Buildings from 2nd Half of 19th Century and the Start of 20th Century. *Buildings* **2021**, *11*, 27. <https://doi.org/10.3390/buildings11010027>

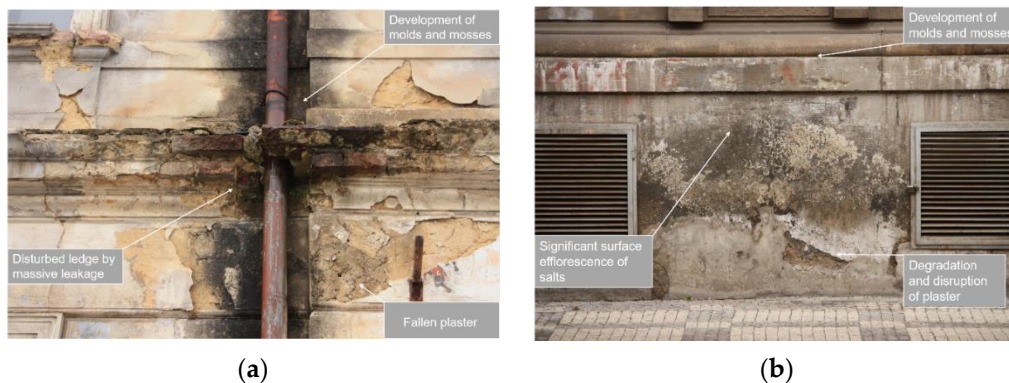
**Figure 2.** Images clearly showing the most common failures of structures from the second half of the 19th and the early 20th centuries caused by degradation processes initiated in these cases by the combination of moisture, an incorrect design solution and neglected maintenance. The following are clearly visible on images: (a) fallen plaster, damaged ledge by massive leakage, mold and mosses; (b) degradation and disruption of plaster, significant surface efflorescence of salts, mold and mosses.

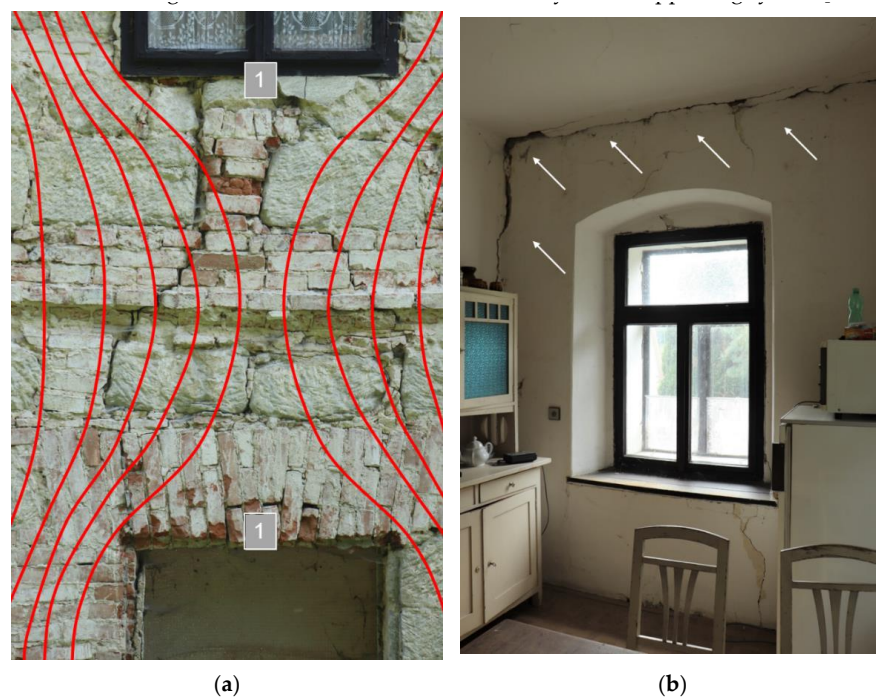
- tensile and shear cracks due to the effect of spatial stress states arising in the place of the concentration of compressive stresses in masonry exerted by the mounting of floor beams and girders (or masonry crushing due to the effect of concentrated compression);

- sinking of a cantilevered floor structure on which the perimeter masonry of a bay window is mounted; the sinking will cause the appearance of tensile cracks in the bay window masonry whose pattern corresponds to the time pattern of compression trajectories;

- failures of vertical masonry structures built on heterogeneous foundations, in unstable subsoil conditions or in undermined areas is caused by forced deformations, due to the effect of a change in the shape of the footing bottom, i.e., non-uniform subsidence (e.g., due to waterlogging of the foundation joint, e.g., due to leaks in utility networks, waste pipes and incorrect slope of the prepared terrain) or curvature of the footing bottom [35,36].

**Figure 6.** Examples of structural failures of structures from the second half of 19th and the start of the 20th century: (a) prominent tensile cracks in masonry weakened by openings, with the representation of pressure trajectories, 1—area of normal stresses and tensile cracks; (b) crack between the perimeter structure and the ceiling caused by forced deformation due to the effect of a change in the footing bottom.

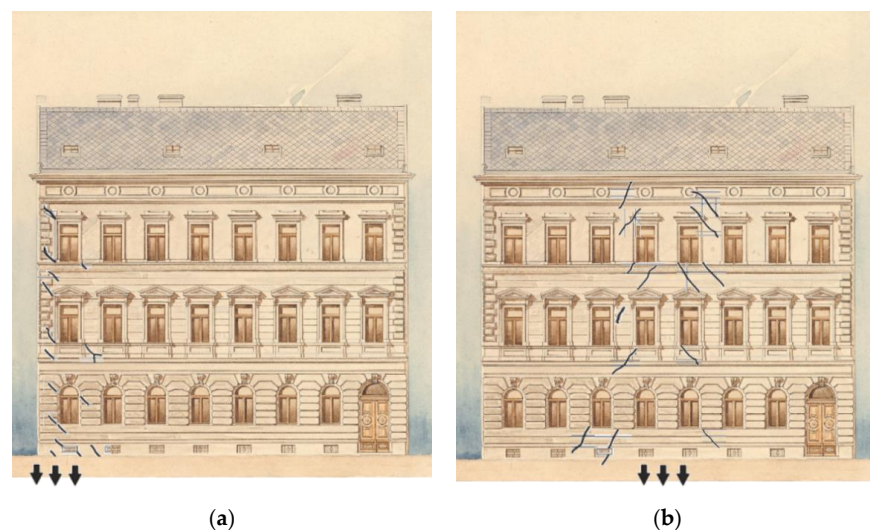
A change in the shape of the footing bottom and subsequent masonry failures might also have occurred as a result of building activity in the surroundings, e.g., extension of the building, vehicle traffic (dynamic effects causing compaction of the subsoil, shocks of the building), or a change in hydrogeological conditions, waterlogging or frost penetration into the footing bottom of the existing foundation during the erection of a neighbouring

building, additional loading of the foundation, dynamic effects and shocks during the construction of a neighbouring building, etc. (Figure 7) [37].

**Figure 7.** Graphical representation of the course of cracks and failures of vertical masonry - characteristic tensile cracks on the side (a), resp. in the middle (b) parts of the building, which arose as a result of the decrease of the affected part and thus the change in the shape of the foundation joint, e.g., an uneven foundation conditions (sands – rock), uneven compaction of the substrate or waterlogging of the soil, etc. (arrows indicate the place of decline of part of the foundations) [41].

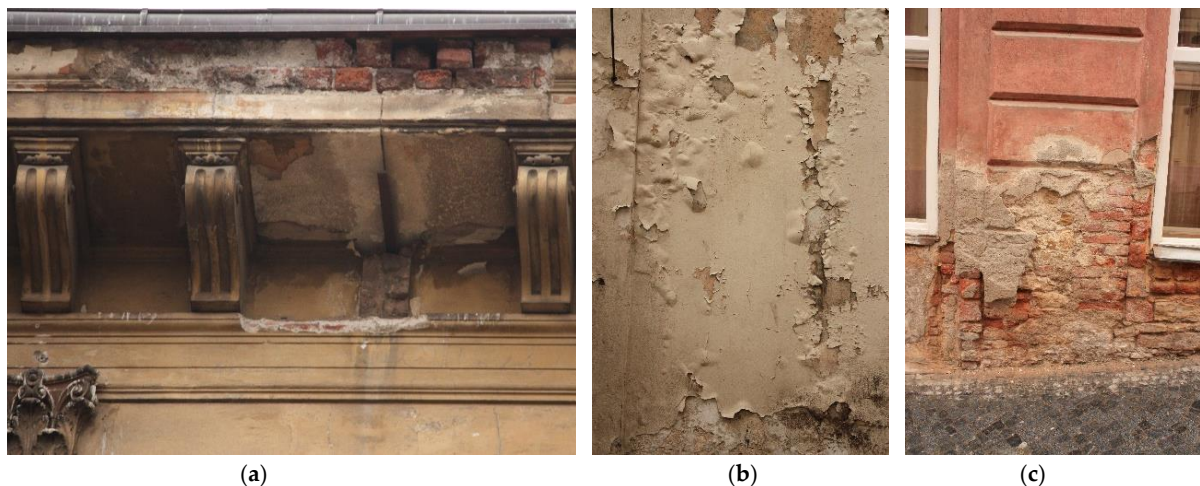
The increased moisture levels of underground and partly overground masonry are usually accompanied by chemical and biological degradation processes, whose intensity depends on the value of increased moisture levels and its aggressiveness. The knowledge and assessment of salinity, especially the content of sulphates, chlorides and nitrates in masonry, are essential for the evaluation of the severity of increased moisture levels and the design of an effective remediation method (Figure 8) [42,43]. Salts with hygroscopic properties and the presence of bacteria and mould in the pore system of masonry, which increase the masonry hygroscopicity, can significantly affect the equilibrium moisture content. Degradation processes usually reduce the content of binder components in the masonry. For these reasons, the assessment of the condition of building structures should include, inter alia, an analysis of the change in total porosity and pore distribution and an assessment of the content of water-soluble salts (Figure 9) [44,45].

**Figure 9.** Examples of non-structural failures caused by the effects of the external environment, especially the synergic effect of increased moisture levels and temperature, which are accompanied by chemical, mineralogical and biological processes in structures from the second half of 19th century and the start of 20th century: (a) damage of the ledge and its surface finishes, visible salt efflorescence; (b) closed and open blisters in the surface layers due to their low diffusion permeability; (c) extensive damage to the plinth part caused by the long-term effect of humidity and salts.

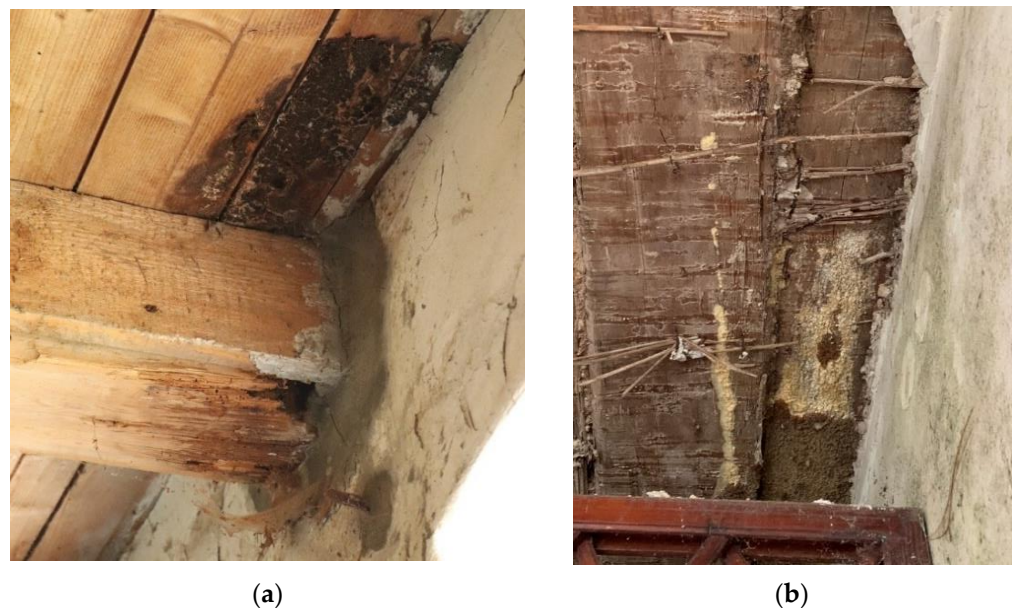
- excessive overall or local loading, wood damaged by unprofessional interventions,
- wood-destroying agents (e.g., due to installation of infested or damp wood without a natural possibility of drying, effect of moisture from leakage and condensation, insufficient ventilation and permeability of the structure) (Figures 10 and 11),

**Figure 10.** Examples of failures of wooden parts of horizontal load-bearing structures caused by mounting wood without a natural possibility of drying and with insufficient permeability of the structure: (a) rotting head of a wooden ceiling beam; (b) yellow patch of wet rot on ceiling wooden panel.

The reinforcement of a wooden floor structure must be preceded by a detailed survey of wooden structures—particularly a mycological and construction and technical survey, removal of damaged or infested wood and basic chemical protection of wood by a suitable coating, or the sterilization of wood at an elevated temperature [50,51]. The most reliable protection measures of wood against biotic wood-destroying agents are preventive measures against their appearance and development, mainly the protection of wood against increased moisture levels (above 15%).

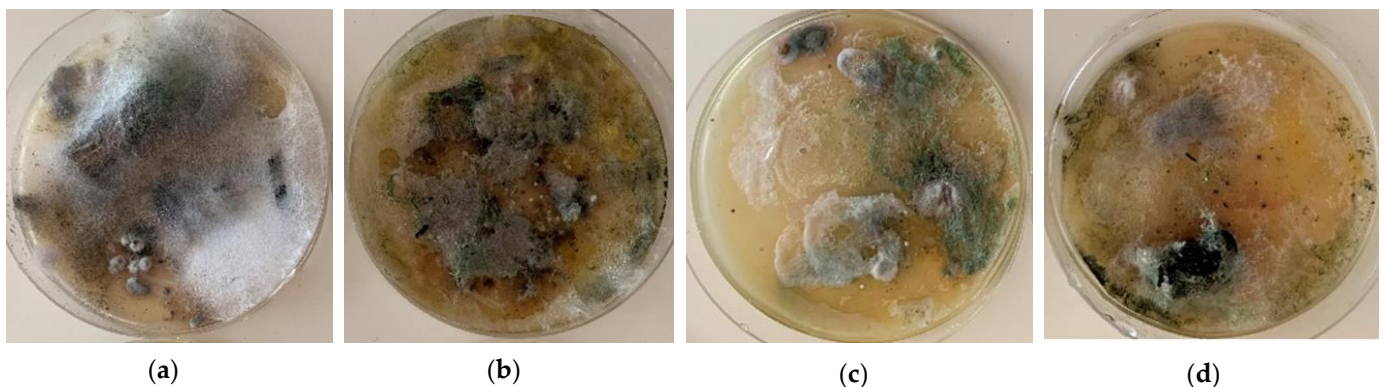
**Figure 11.** Example of laboratory evaluation of bioderivatives in cultures of a sample of a damaged ceiling structure in Prague 7—confirmed presence of bacteria and fungi. In all cases, massive development and growth of microscopic fibrous fungi was noted. In cultures of samples were identified: (a) *Trichoderma* sp. and bacteria; (b) *Trichoderma* sp., *Mucor* sp., wood-destroying fungus and bacteria; (c) *Mucor* sp. and wood-destroying fungus; (d) *Penicillium* sp., *Acremonium* sp., *Aspergillus* sp. and bacteria [52].
