Seismic Retrofitting of Dual Structural Systems—A Case Study of an Educational Building in Croatia

Abstract: On 29 December 2020, a devastating Mw6.4 earthquake struck near the town of Petrinja, Croatia. The main earthquake was preceded by a Mw4.9 foreshock the day before. The earthquakes caused extensive damage to buildings, especially historic buildings made of unreinforced masonry but also to buildings of other typologies and to critical infrastructure. Today, recovery efforts in Croatia focus primarily on reconstruction and seismic retrofitting. Family homes and public, cultural, educational, and other facilities are top priorities. In this paper, a comprehensive study of existing building in the educational sector is presented as a case study. The seismic performance of the building is evaluated using numerical methods, first for the as-built condition and then for the retrofitted building. For each condition, the collapse mechanisms of the building were determined and critical structural elements were identified. The presented retrofit strategy of the dual structural system consisting of RC frame system and masonry walls aims to reduce the displacements of the RC frame syste

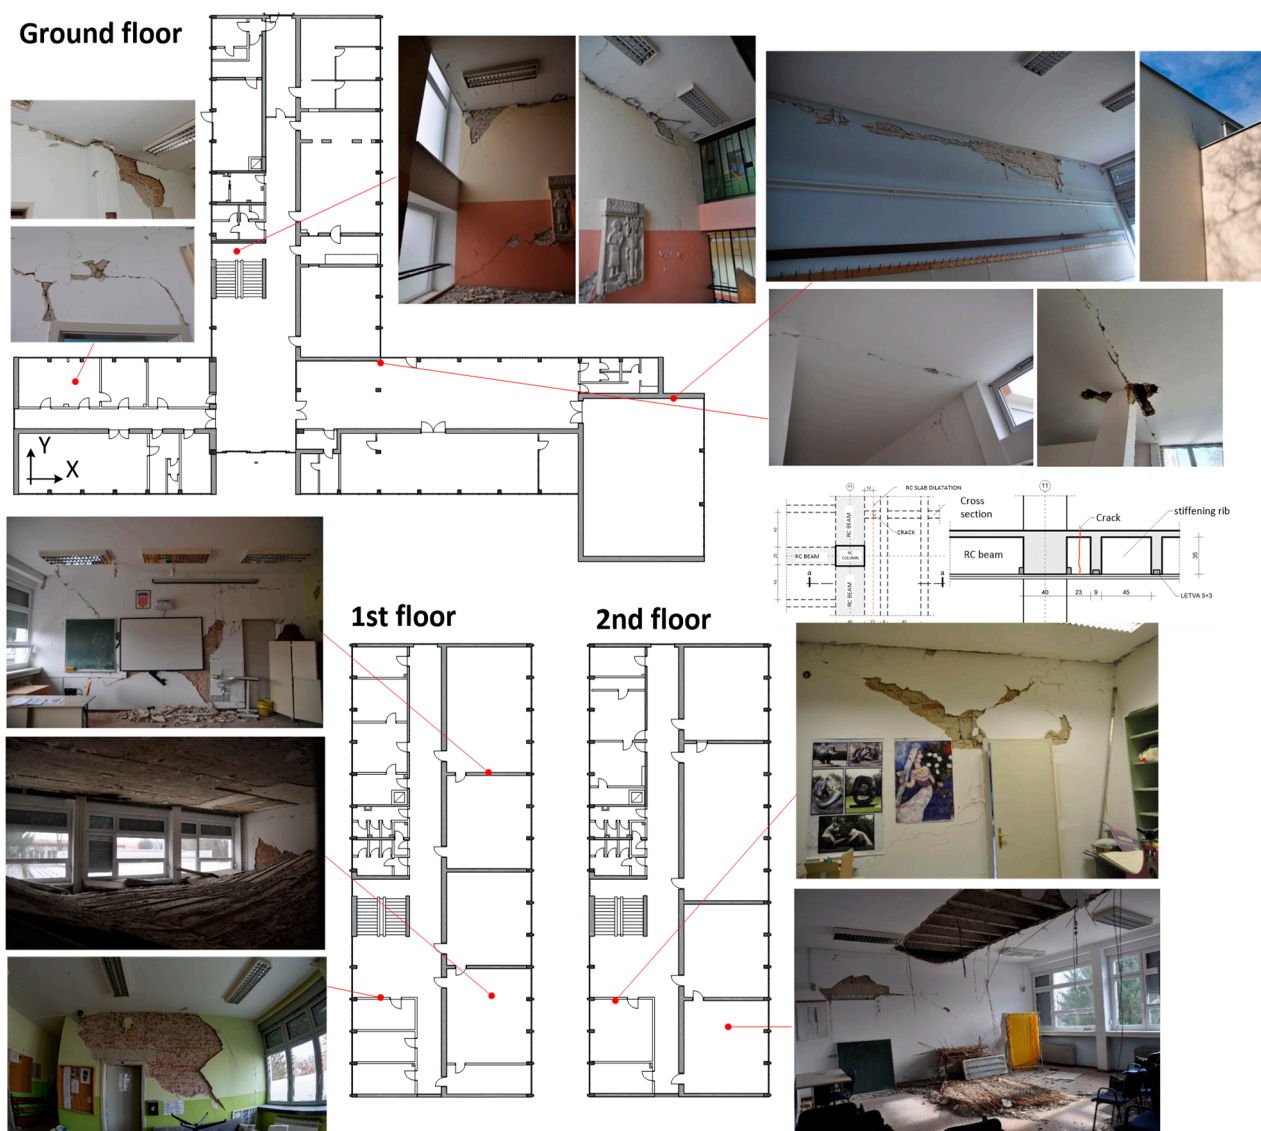
The building was damaged during the 29 December 2020 Petrinja earthquake. After a preliminary inspection, it was labelled as temporarily unusable with the need for emergency intervention measures due to the suffered damage. There was a risk of plaster and installations falling from the callings and the out-of-plane failure of severely damaged partition walls, so access was restricted in some parts of the building. The inspection revealed slight damage to the floor structures, moderate damage to the vertical elements and severe damage to the staircase and partition walls. The overall damage to the structure was classified as Level 3, according to the EMS scale. Characteristic damage can be seen in the Figure 6 with indicated location information.

Figure 6. Photographs of damage to the building (photos: courtesy of Joško Krolo and Karlo Jandrić, 2021; and CCEE, 2021).

Further detailed inspection in particular revealed that the damage to the brick wall to which the staircase landing is connected is significant and possess a considerable risk for usage. It is the only staircase in the building. Due to the structural irregularities, special attention was given to the locations where different volumes connect. Although there is no dilatation, the detailed inspection showed that the slabs are partially separated and that the stiffening ribs connect the different units of the building. In this location, between the lower and upper parts of the building, damage to the floor structure was observed. To determine the extent of the damage found, the lower layers of the ceiling were removed, and cracks were also found on the stiffening ribs of the slab in this area. Furthermore, in the section connecting volumes V1 and V3, cracks were recorded on the part of the wall located above the ground floor. Other observed damage included minor damage to the load-bearing masonry walls, extensive cracking of partition walls and major damage to the lower layers of ceiling structures, with cracking and the falling of plaster on almost all walls.

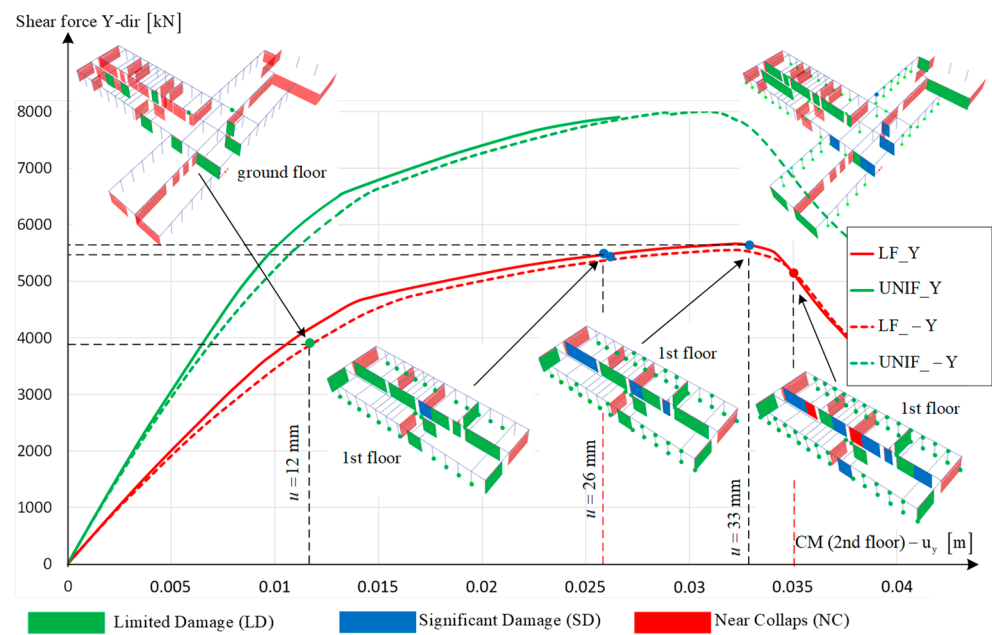
Figure 16 shows the most significant pushover curves for the action of the lateral force in the positive Y-dir with markings of the points, indicating the state of structural damage. At a force of 3900 kN (B.S. = 12.1%) and a displacement of 12 mm, limited damage occurs on several elements. Significant damage in the structural system occurs at a force value of 5500 kN (B.S. = 17%) and a displacement of 26 mm. The critical elements that first reach the SD limit state are the masonry walls in the central axis on the 1st floor. Subsequently, other walls in the same axis reach the SD limit state. Eventually, the failure of several walls occurs, and the bearing capacity of the structure decreases significantly with a maximum displacement of about 33 mm. The walls on the ground floor and the 2nd floor have not been shown to be critical to the action in the Y-dir.

Figure 16. Pushover curves in Y-dir for as-built structure.

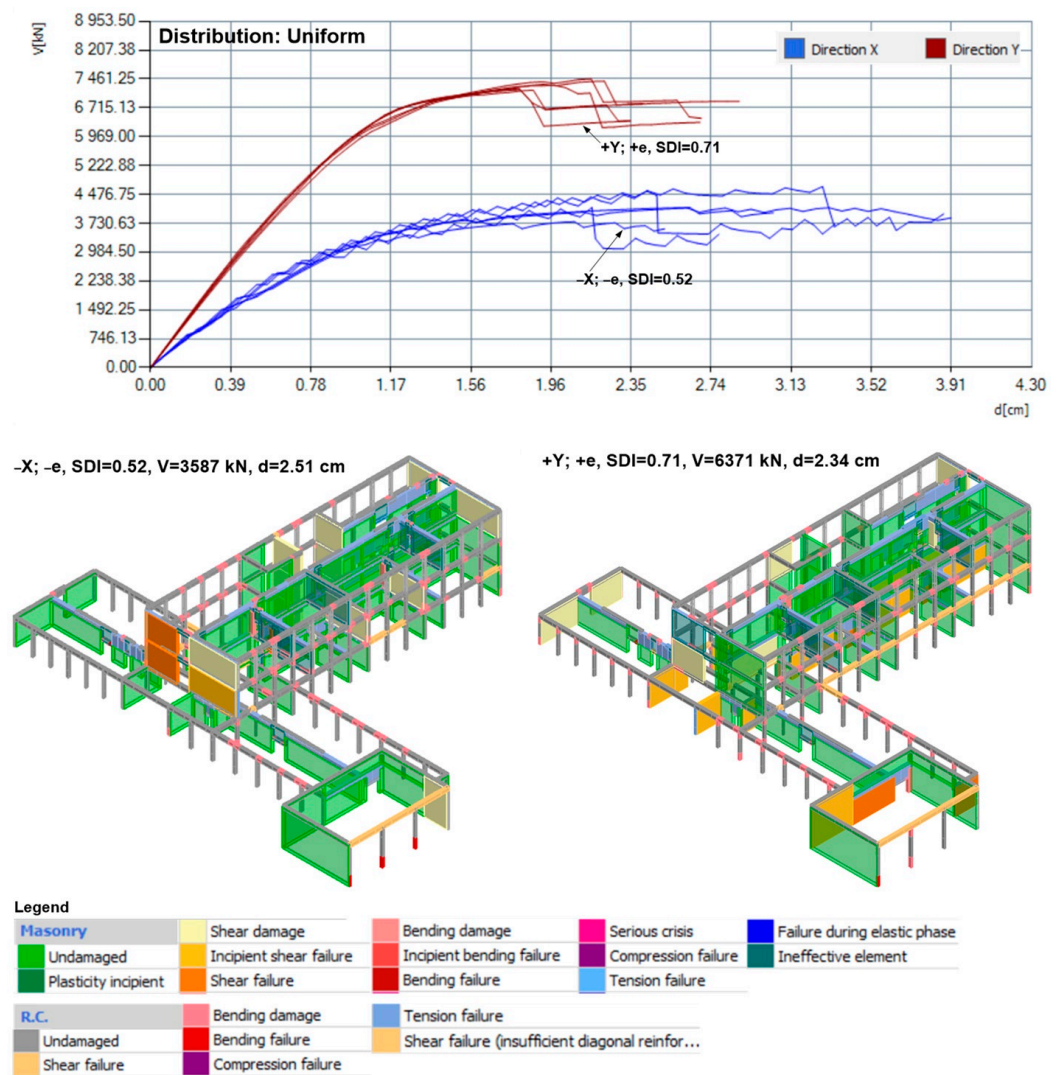
In the case of uniform distribution (Uniform, Figure 20) in the X-dir, the maximum value of the lateral force ranges from 3700 kN to 4500 kN, and the relevant analysis indicates a failure mechanism caused by the shear failure of the perimeter walls on the P20 axis, and of the walls that are not continuous in height on the axes P14, P21, P23, and P24, as well as the wall of the staircase P7 and the walls on the 2nd floor on the axis P3. Damage also occurs on the elements of the edge frames, most of which is damage to beams and columns due to bending, while the shear failure of beams is visible on axes P1, P2, and P19. The critical value of SDI for the X-dir is 0.52. The pushover curves obtained in the Y direction indicate the structure has a significantly higher load capacity, which is approximately 7400 kN, and the relevant damaging mechanisms indicate that the walls of the ground floor on axis P9 and the walls of the large hall on axis P17 are particularly critical. Furthermore, damage to the walls on axis P1 and P12 due to the shear mechanism is also noticeable, and in addition to this, there is shear damage to the walls in the X-direction on axes P3 and P20. On the edge frames, the failure of the beams at the ground floor level due to shear is critical. The smallest value SDI is 0.71 and corresponds to the +Y-dir and a positive eccentricity value.

Figure 20. EFM results: pushover curves and corresponding damage mechanism of the building obtained using the uniform load pattern.
