The Assessment and Retrofitting of Cultural Heritage—A Case Study of a Residential Building in Glina

Karlo Ožić¹, Ivan Markić², Antonela Moretić^{1,*} and Luka Lulić¹

Keywords: earthquake; structural strengthening; cultural heritage; nonlinear static analysis; in situ tests

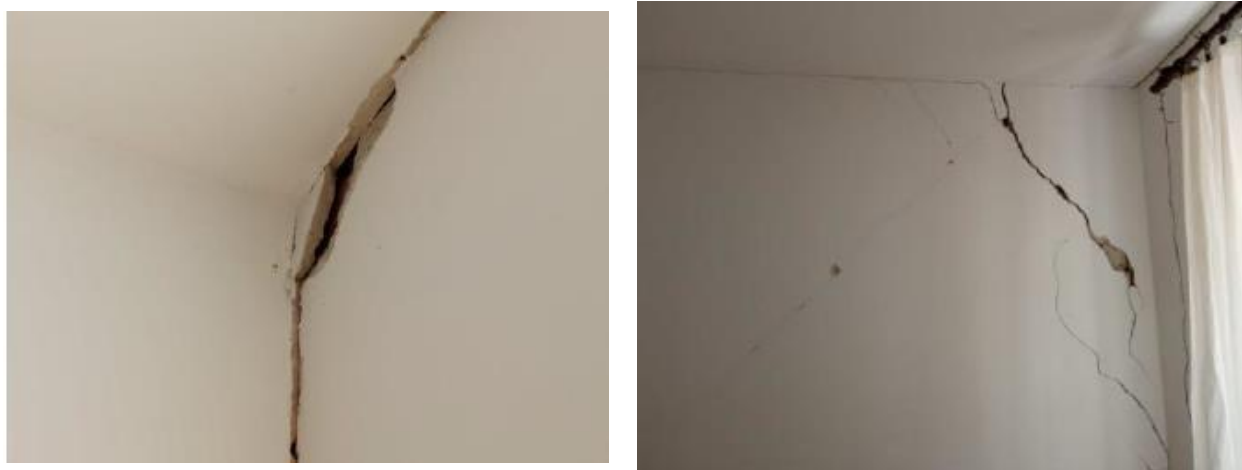
Detailed inspections of the residential building (former gymnasium building) revealed the following recorded instances of damage: on the ground floor, there is visible damage in the form of cracks in the wall coverings (Figure 8), arches, vaults and ceilings, as well as separation and localized falling off of the plaster. Minor local damage to structural elements (walls, columns, and arches) is also visible. Damage is visible on all floors in the form of cracks and falling plaster on the walls. Minor local damage to the walls is also visible, and there are locally visible cracks at the junctions of load-bearing walls and ceilings (Figure 9). At the edges of the building, oblique cracks are visible on the load-bearing walls, and can also be seen on the facade of the building. In addition to the previously documented damage to the construction elements of the building, damage to other elements was observed. The partition walls are mostly damaged. Other instances of damage include the chipping of plaster on structural and non-structural elements, damage to the finishing coverings on the walls and floors, and the collapse of part of the cornice and other decorative elements (Figure 10). The roof was damaged in several places, and the roof covering near the chimneys collapsed (Figure 11).

Figure 9. Cracks at the junctions of load-bearing walls.

Based on the detailed assessment, the entirety of the building necessitates rehabilitation and retrofitting measures. Subsequently, it is imperative to conduct a comprehensive examination encompassing both static and dynamic analyses of the existing structural conditions. Before that, it is necessary to carry out investigative work to determine the characteristics of the walls and other necessary data for the analysis of the structure.

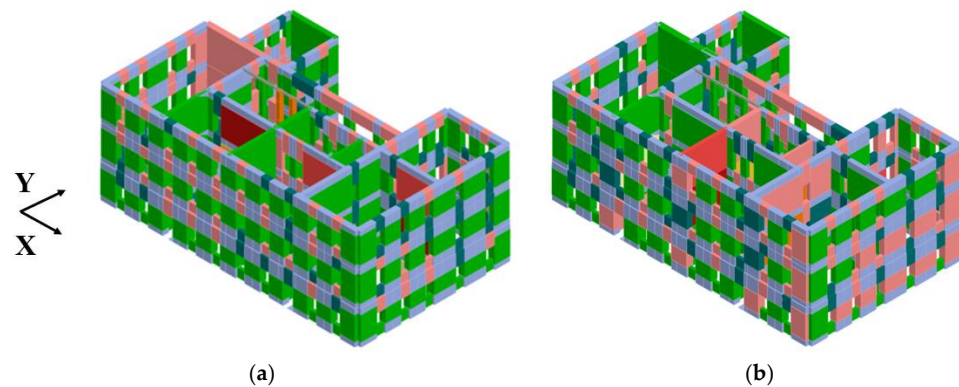
A visualization of the damage from the critical analyses is displayed in Figure 16. The images highlight the critical parts of the structure, which correspond to the actual damage scenarios (damaged spandrels and load-bearing walls in the longitudinal and transversal direction of the central part). Figure 17 displays the capacity curves in the X and Y direction, which are derived from the pushover curves with the lowest risk indices. The radial lines defined by the slope of the first part of the capacity curve represent the elastic structural period T^* . The intersecting point of the period and the seismic demand is the elastic displacement of the SDoF. It is visible that the seismic capacity is equal in both directions. Still, the seismic demand is lower for the Y direction than the X direction. The latter justifies the higher risk indices in the Y direction, which are shown in Table 6. Accordingly, the structure does not satisfy the seismic requirements.

Figure 16. Damage visualization for the most critical analysis in the (a) X direction and (b) Y direction.

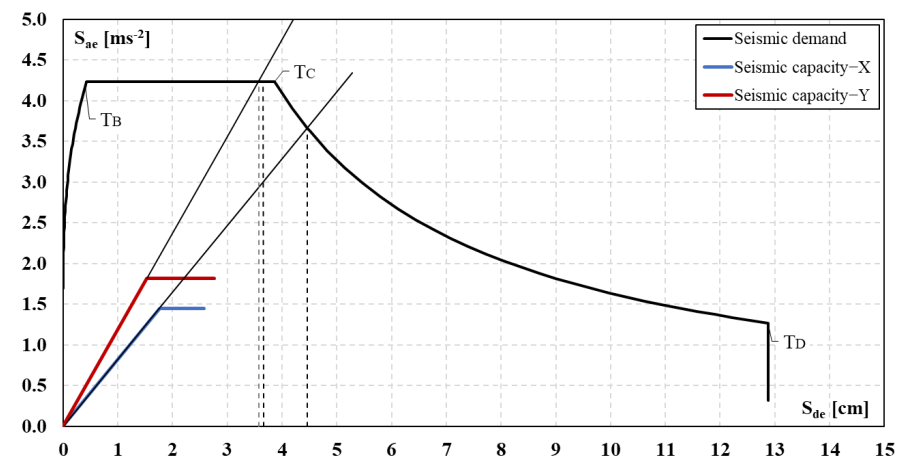
Figure 17. Seismic demand and capacity of the existing structure.

Limit State	Return Period (Years)	α (X Direction)	α (Y Direction)
Significant damage	475	0.424	0.565
Significant damage	225	0.606	0.807
Damage limitation	95	0.819	0.891
