Reflections from the 2019 Durrës Earthquakes: An Earthquake Engineering Evaluation for Masonry Typologies

Abstract: Two earthquakes struck the NW region of Albanian territory on 21 September 2019 ($M_w = 5.6$) and on 26 November 2019 ($M_w = 6.4$). The epicenters of the seismic activity were located offshore NW Durrës, one of Albania's most populated cities, located 30 km from the capital Tirana. Various aftershocks followed subsequently. While there were no reported injuries, a number of buildings sustained significant damage near the epicenter following the initial event. Subsequently, during the second event, there was loss of life and extensive damage to civilian structures, resulting in multiple collapses. This study focuses on the earthquake damages observed in residential and public buildings in the earthquake-affected region. The earthquakes predominantly affected low-rise masonry buildings, while the newly constructed RC structures built according to the latest seismic rules were almost unaffected. The commonly encountered building typologies in the region, together with photos showing the amount of destruction are presented here. As observed by the authors during the rec

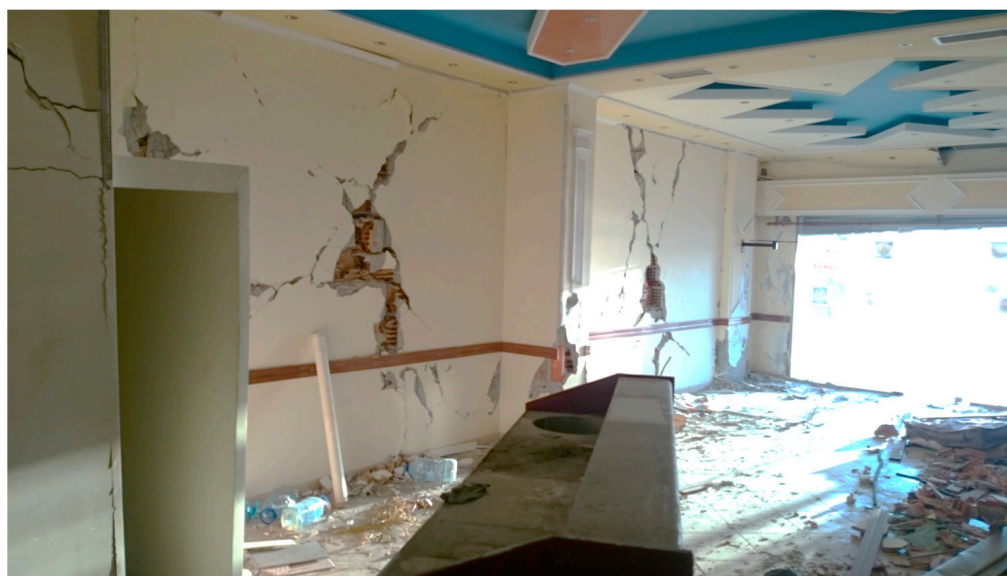
The behavior of RC buildings during earthquakes is influenced by the distribution of stiffness and mass in two orthogonal directions. Typical damage in these buildings is often associated with non-structural elements, particularly infill walls. A common form of damage observed is the detachment of infill walls from the concrete frame. This often leads to out-of-plane displacement and cracking caused by bending forces, as illustrated in Figure 4. Additionally, shear damage in columns can be observed, potentially caused by the influence of infill walls on the supporting columns.

Figure 4. Infill wall damage in an RC building due to out-of-plane bending and shear failure.

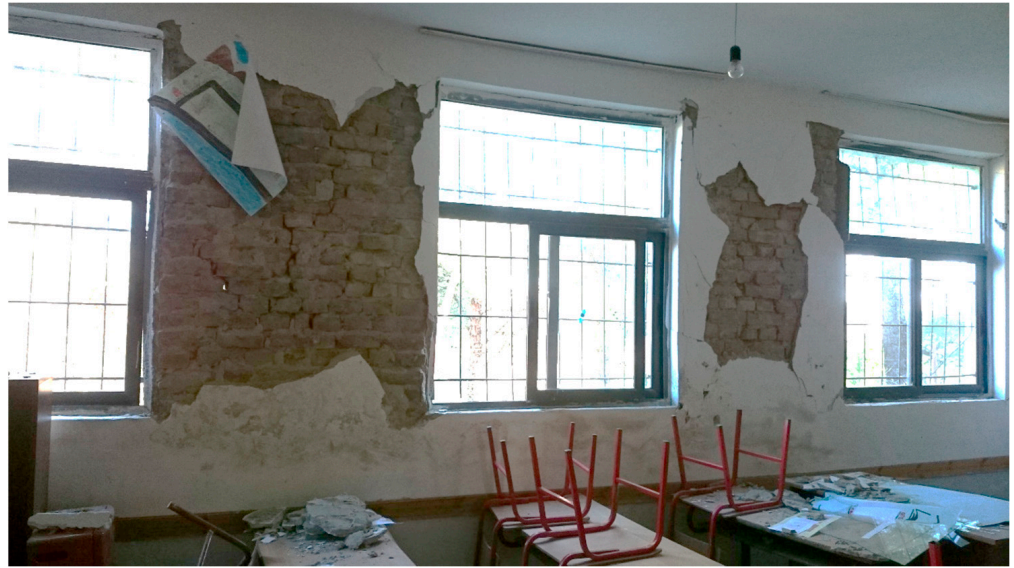
Figure 5 illustrates an instance of in-plane shear failure observed in a poorly confined masonry wall at a primary school in Durrës. The cracking observed in the masonry exhibits a characteristic diagonal shear crack pattern that follows a zigzag path.

Figure 5. In-plane shear failure of inadequately confined masonry wall due to windows opening.

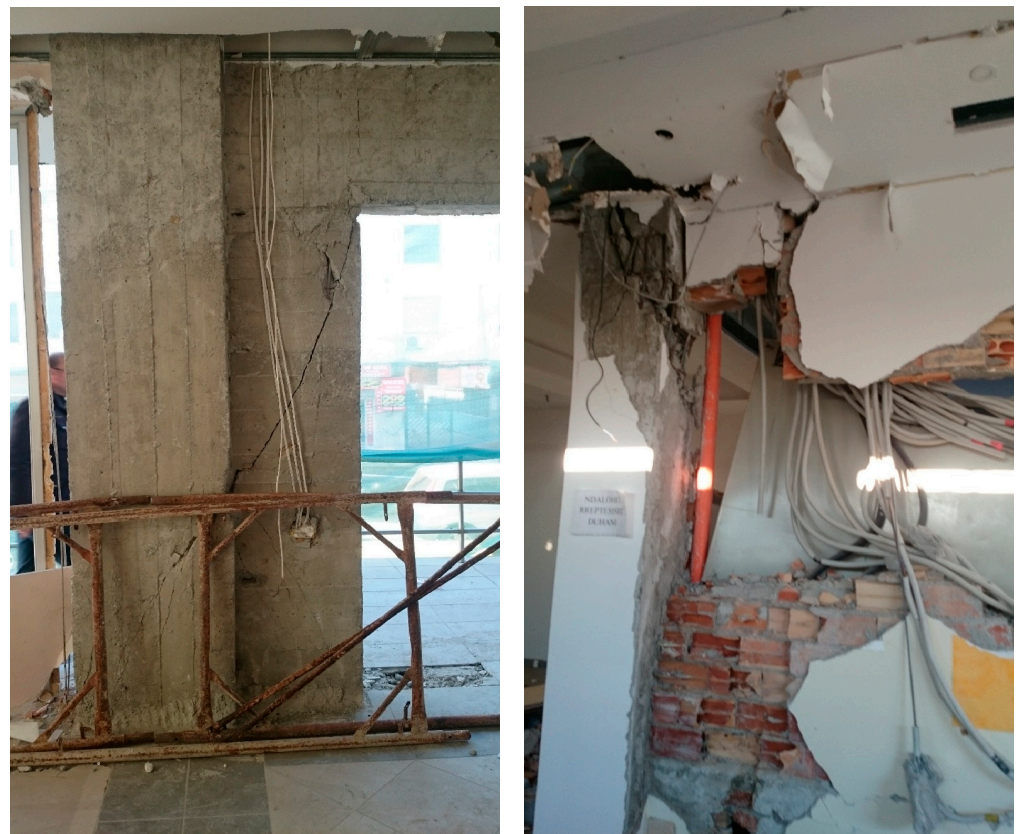
Although a significant part of RC buildings experienced merely non-structural damage, there were instances of severe damage, as shown in Figures 6 and 7. The severe damage to RC buildings was primarily concentrated on soft-story ground floors. These buildings were predominantly designed and constructed before 2000. Due to the absence of shear reinforcement and reduced stiffness resulting from open ground floors, shear failures occurred in columns and beam-to-column joints. The lack of adequate shear reinforcement and the structural characteristics of open ground floors contributed to such failure patterns.

Figure 6. Shear failure of columns on RC buildings in Durrës. (a) Typical shear failure of columns; (b) Buckling of rebars in plastic hinge regions of columns due to insufficient transverse reinforcement.

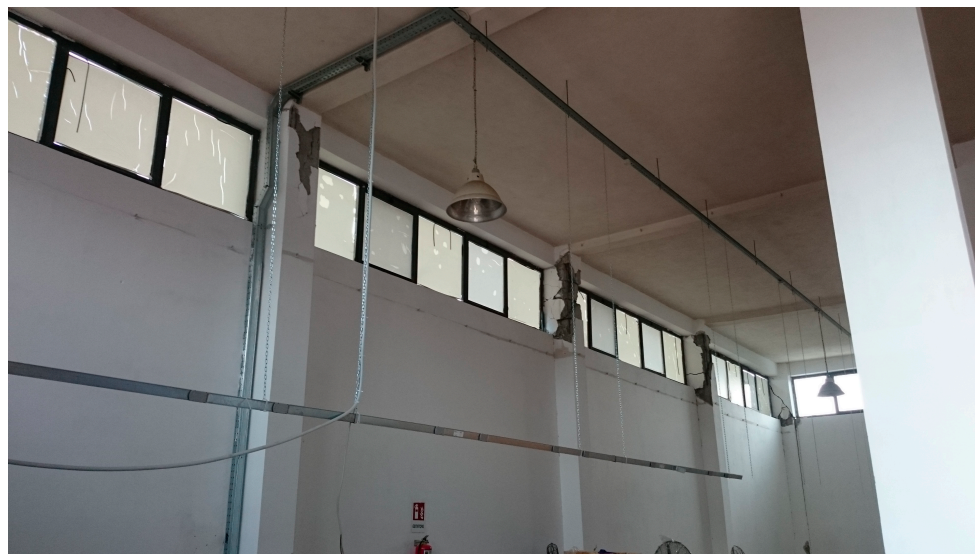
Insufficient horizontal reinforcement, such as stirrups, led to the buckling of longitudinal rebars in the columns (as shown in Figure 7). While the strong beams remained relatively unaffected, severe damage and the formation of plastic hinges were observed at the top of the columns. This highlights the importance of proper horizontal reinforcement to ensure the structural integrity and performance of columns during seismic events.

Figure 7. Short column failures due to bad window openings.

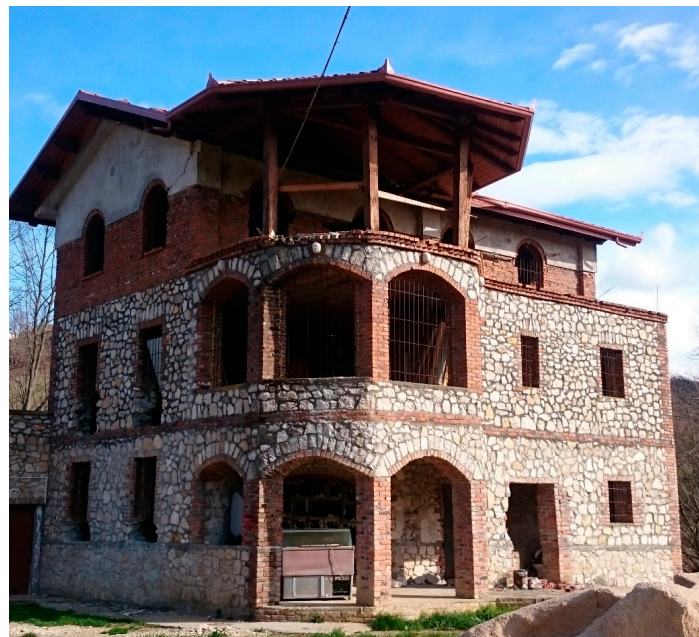
Residential masonry buildings in the country have experienced significant damage (Figure 10). The extent of damage fluctuates between different buildings as well as across various regions. These buildings constructed before 1990 were built either by following pre-modern code requirements or without following any structural regulations, and their age and lack of maintenance have contributed to their vulnerability. Pre-existing ground settlements and minor out-of-plane deformations could have also affected some structures, potentially contributing to the observed damage and compromising their structural integrity.

Figure 10. Masonry dwelling with large openings and wooden lintels above openings in Vore. The 1st and 2nd floors are constructed of stone brick while the 3rd story is built of clay bricks.

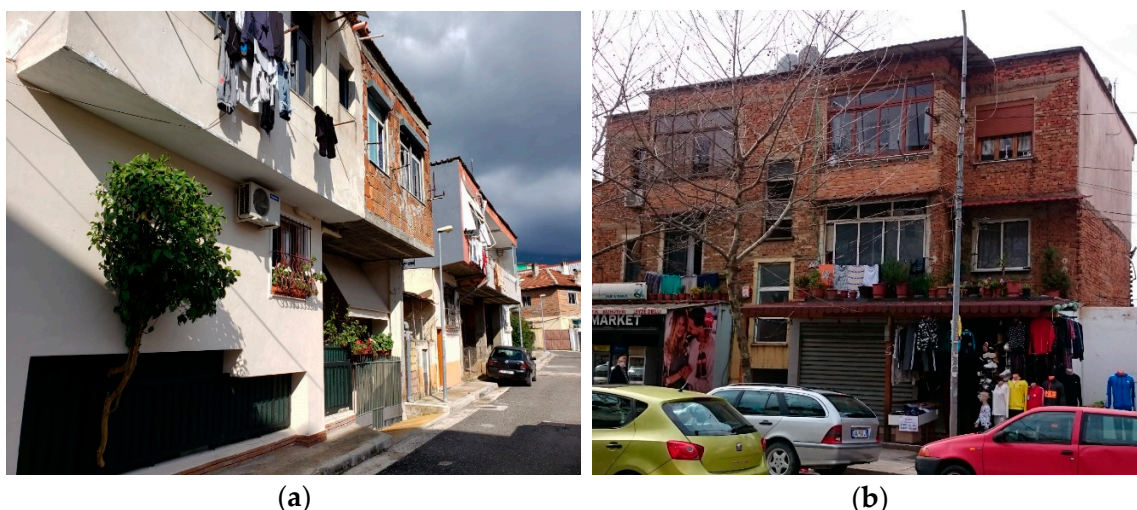
The survey identified several significant deficiencies in these buildings, primarily related to unauthorized interventions and modifications carried out by owners without proper engineering consultation. These interventions included closure and creation of new openings, the use of unique types of masonry for repairs, and the addition of extra stories [28]. Examples of these irregularities are shown in Figure 11a,b. Such alterations, combined with a lack of preservation, degradation of material properties over time [29], and changes in load paths [30,31], can contribute to damage and deterioration, ultimately increasing the structures' seismic vulnerability throughout their lifespan.

Figure 11. Intervention examples on URM buildings: (a) expanded overhangs as balconies and use of different construction materials; (b) Interventions done after its construction on the ground floor (New openings).

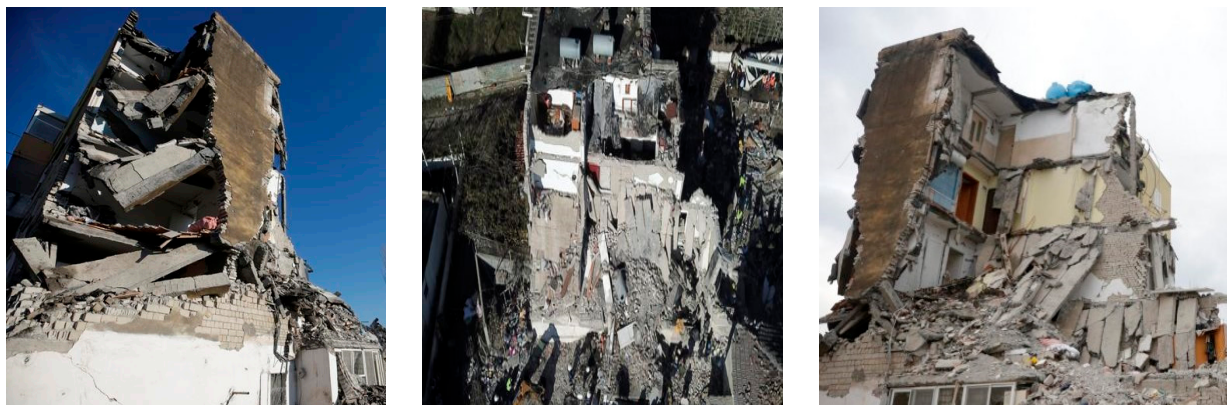
The evaluation disclosed that the buildings flagged as unsafe by local engineers had already undergone substantial deterioration prior to the earthquake owing to a lack of maintenance. The existence of corroded and exposed reinforcements, crushed brick units, and peeling paint served as indicators of the poor condition of these buildings. These signs of deterioration further contributed to their vulnerability and increased the likelihood of damage during the earthquake. Furthermore, these buildings had undergone multiple structural modifications over time, which likely significantly affected their extensive damage. The construction of additional floors and the creation of large openings at the ground

level may have caused alterations in the load distribution and load-bearing paths within the structures. These modifications could have weakened the overall structural integrity and made the buildings more susceptible to the effects of the earthquake.

Figure 12. Collapsed building in Thumanë (1- added story before the collapse).

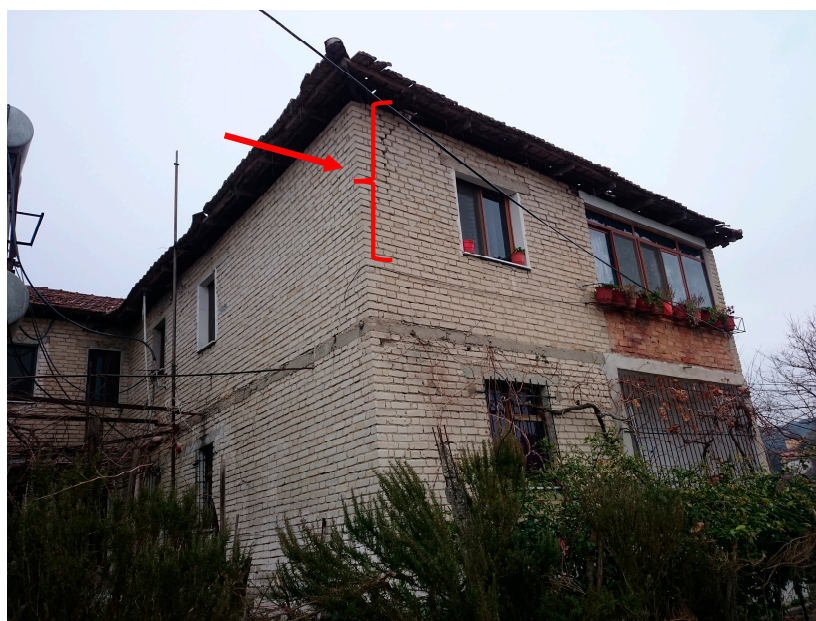
The lack of essential structural elements further contributed to the vulnerability of buildings in the country [32]. Most buildings did not have a ring beam below the roof, which is an important element for distributing seismic forces and providing stability to the structure. Furthermore, the lack of rigid in-plane diaphragms at the floor and roof levels further compromised the overall structural integrity of the buildings. Figure 13 depicts buildings with loosely connected walls and the absence of a sturdy top floor or reinforced concrete (RC) ring beam. The weak connection between the walls and the roof, coupled with the poor quality of stone arrangement and weak mortar, significantly heightened the risk of collapse during the earthquake.

Figure 13. Separation of walls because of improper connection between the roof and the underlying masonry and flexible top floor.

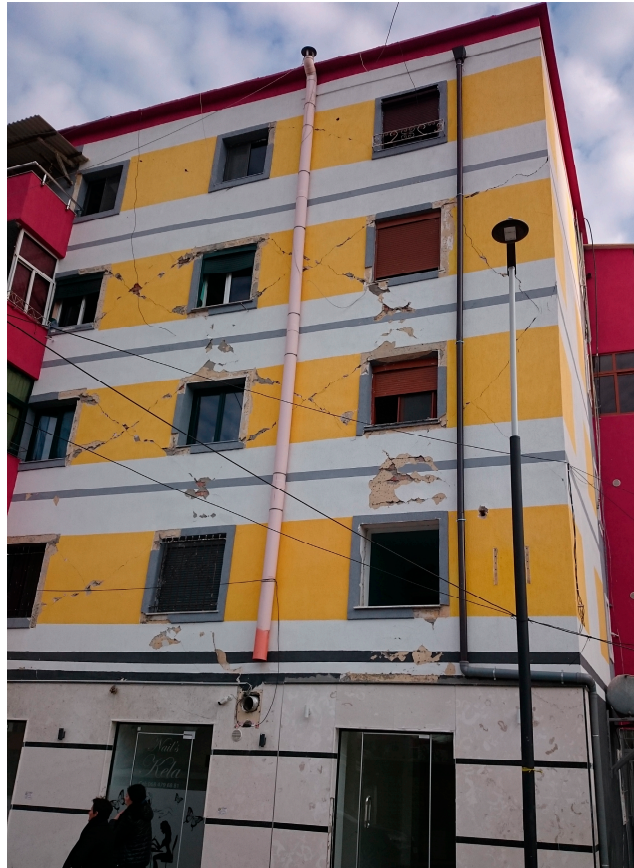
A significant number of masonry buildings in the region displayed damage to walls in the form of double-diagonal shear (X) cracking. This type of cracking is a typical vulnerability observed in unreinforced masonry walls subjected to shear forces. When a complete diagonal shear crack develops during an earthquake, the triangular sections created by the cross-diagonal crack become unstable and pose a risk of collapse, particularly when subjected to subsequent aftershocks.

Figure 14 provides typical patterns of diagonal shear failures observed in load-bearing walls as a result of the earthquake in Albania. These cracks highlight the vulnerability of unreinforced masonry walls to shear forces and emphasize the need for appropriate seismic design and reinforcement measures to improve their resistance to such failures.

Figure 14. Shear cracks stemming from diagonal tension in residential masonry buildings in Albania.

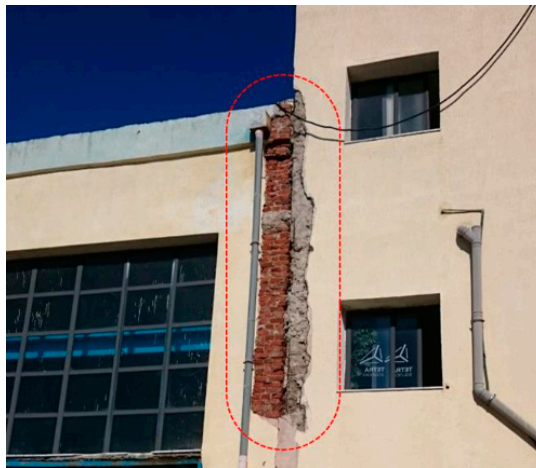
Figure 15 depicts an example of pounding, which refers to the collision or impact between adjacent buildings during an earthquake. In this case, the reinforced concrete (RC) building slab is seen to have penetrated the masonry wall of the adjacent building at the corner where the wall meets the roof.

Figure 15. Pounding failure b/w adjacent masonry and RC buildings.

This earthquake led to minor damages in several buildings attributed to pounding, a phenomenon stemming from inadequately sized or absent seismic gaps, alongside variations in story heights. The structure depicted in Figure 15 encountered damage from pounding, primarily resulting from its proximity to an adjacent masonry building and an inadequate seismic gap.

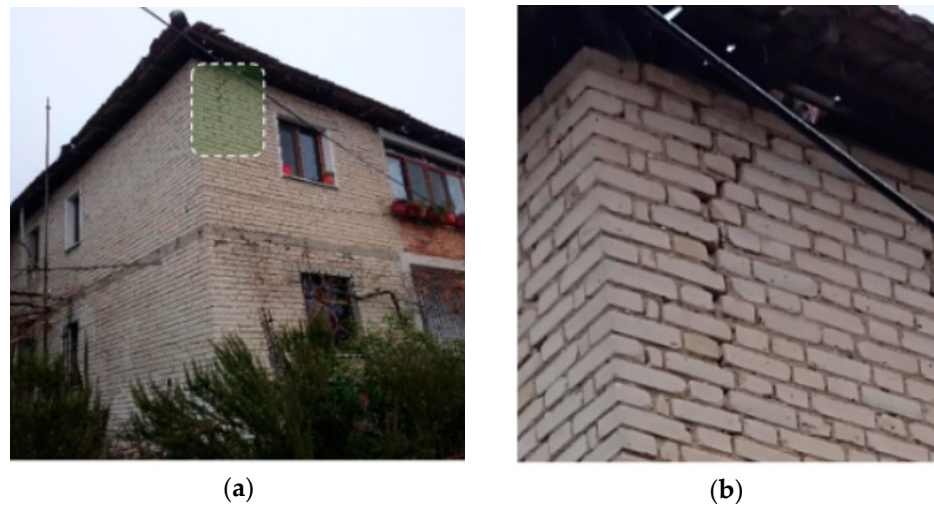
Figure 16a,b showcase significant vertical cracks and gaps that have developed and spread along the height of the intersections of bearing walls. This particular type of damage can be attributed to the absence of horizontal diaphragms. Horizontal diaphragms are structural components that provide rigidity and distribute forces within a building. Without these diaphragms, the building's ability to withstand and distribute seismic forces is compromised, leading to the formation of such vertical cracks and gaps.

The lack of proper connections between the load-bearing walls at the intersections and between the load-bearing walls and the roof leads to compromised structural stability. Consequently, the walls act individually along the in-plane and out-of-plane directions during the earthquake, as indicated by the absence of diagonal shear cracks. The vertical cracks and gaps indicate significant distress and compromised load-bearing capacity in the masonry walls. This type of damage can lead to instability, reduced structural strength, and potential collapse if the load-bearing capacity is further compromised. To enhance the seismic performance of masonry buildings, it is crucial to incorporate effective horizontal diaphragms that can distribute forces and provide structural continuity. Proper design and construction of connections between bearing walls and diaphragms are essential to ensure the effective transfer of forces and maintain the structural stability of the building during earthquakes.

Figure 16. Vertical cracks on corners of the building indicates the lack of rigid diaphragm action of the roof and floor systems. (a) Loosely connected walls; (b) Absence of a sturdy top roof or lack of RC ring beam.

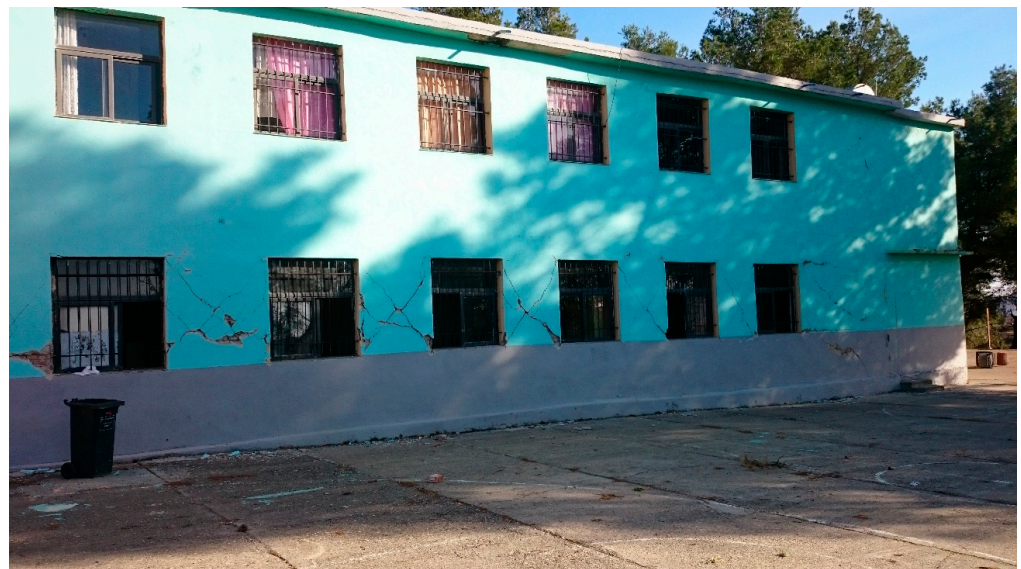
Figure 17 depicts the extent of damage in a school building located in the NW Durres. Fortunately, all students and teachers were unharmed, as the collapse of some local masonry walls did not result in casualties since the earthquake hit in the early morning. The damage in the school building includes localized out-of-plane failures of the load-bearing walls and diagonal shear cracks between the window openings on the ground floor (Figure 18).

Figure 17. The extent of damage on a school building.

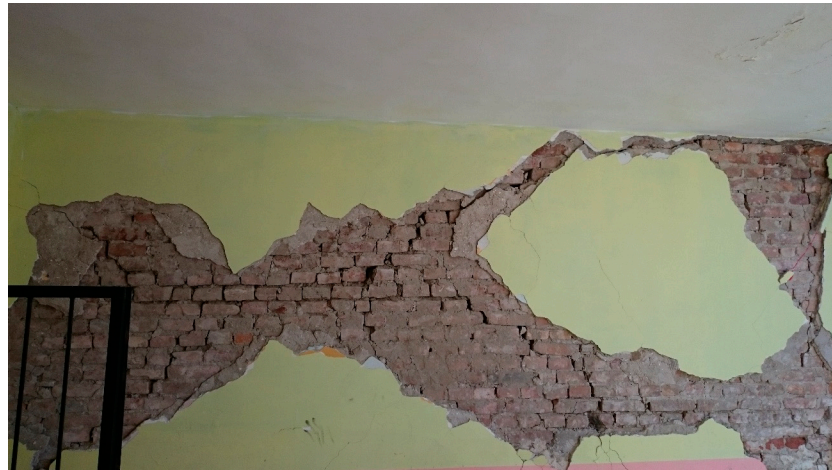
Figure 18. Showing shear cracks and in-plane failure of the masonry walls.

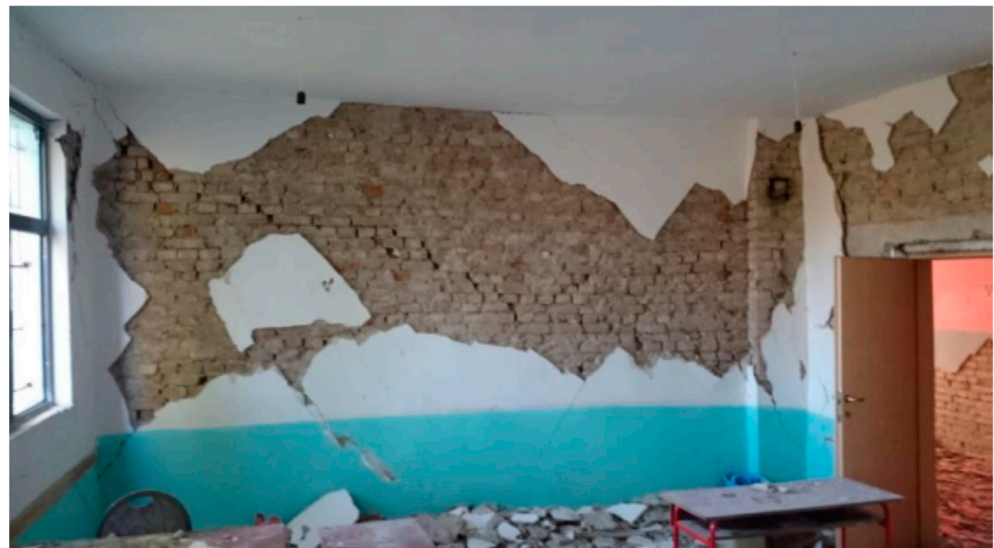
Significantly, the school's front facade experienced more damage than the backside. This discrepancy can be attributed to the higher concentration of openings at the front, where the classrooms were situated, in contrast to the back side, which primarily consisted of a corridor leading to the classrooms. Upon inspection inside the building, prominent diagonal shear failures were observed in the masonry walls, along with the separation of coating materials from the walls and the toppling of furniture and equipment (Figure 19). The overall structural condition of the building was deemed unsuitable, leading to its demolition a few weeks after the initial strong earthquake. These observations highlight the vulnerability of masonry school buildings in Albania and emphasize the importance of implementing proper seismic design and retrofitting measures to ensure the safety of students and staff during earthquakes.

Figure 19. Damage pattern observed on load-bearing wall of the masonry school building.
