Underwater Inspection of Submerged Elements in Masonry Bridges and Other Old Civil Structures Using Drones

Rubén Rodríguez Elizalde

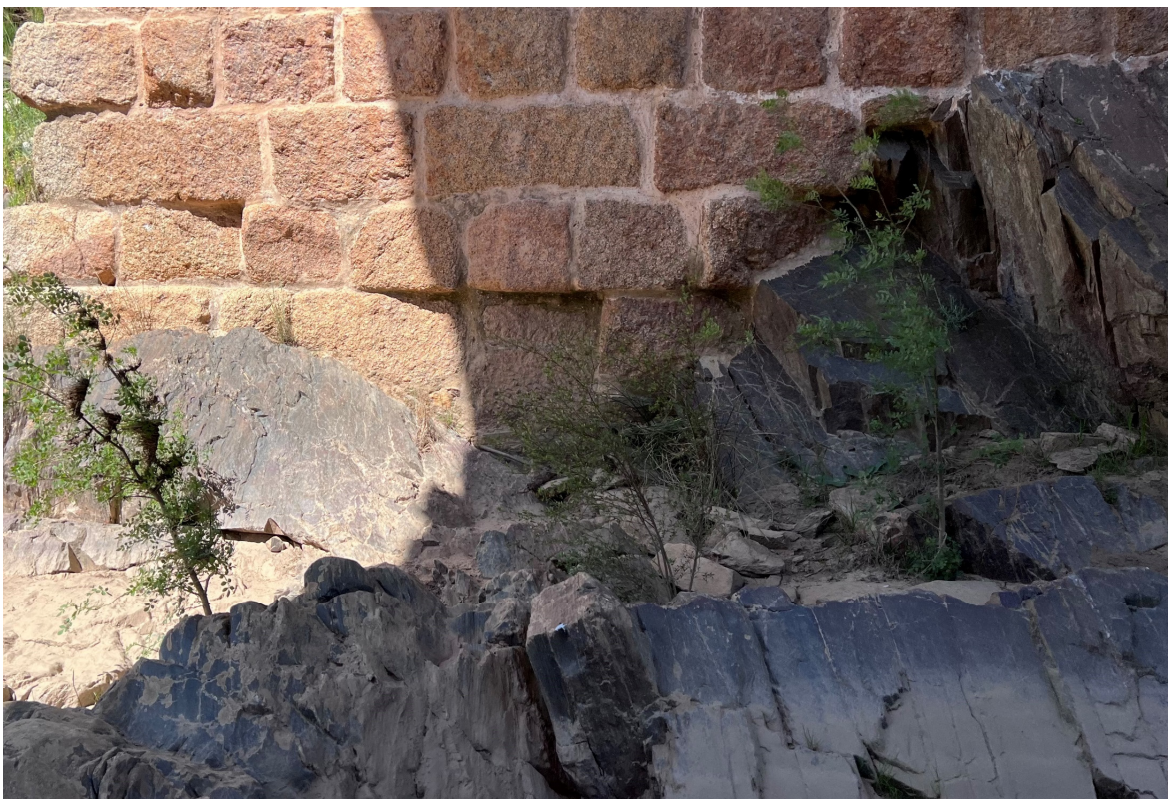
Figure 5. Close-up of the abutment on the Portuguese side, showing the arrangement of its first rows on the rocky material (photo by the author). This photo serves to give an idea about the foundation of the bridge elements because not all of them were visible.

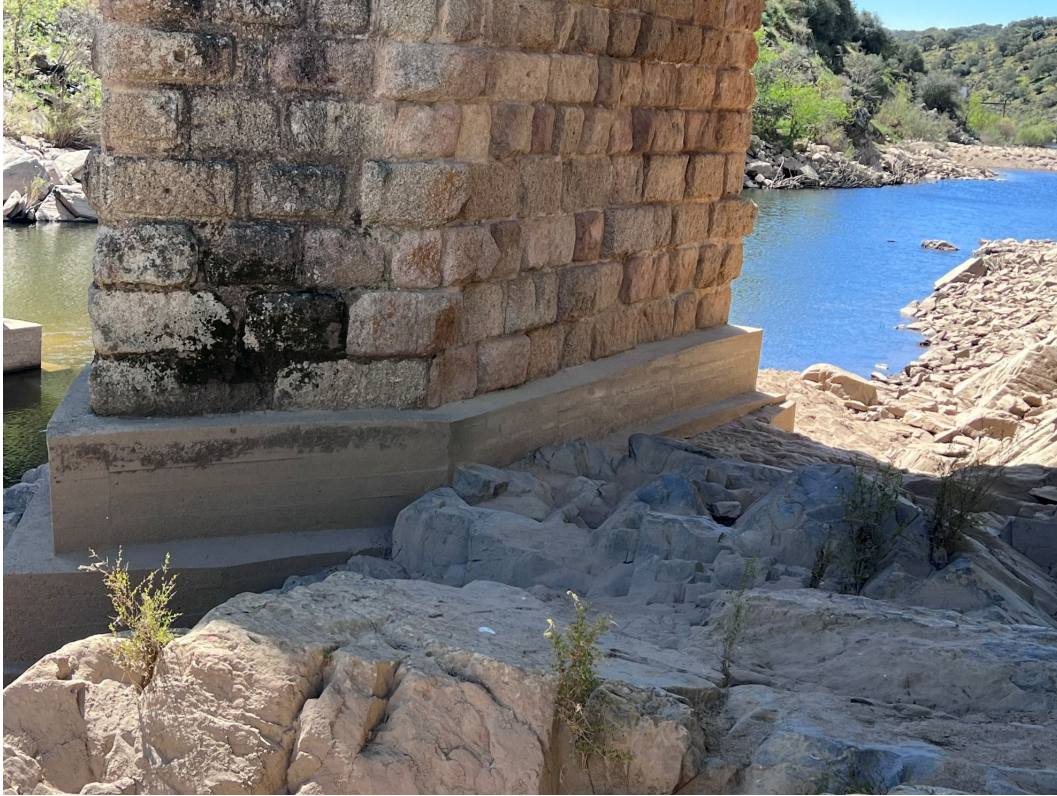
Figure 6. First pier, starting from the Portuguese side, showing the concrete casing and supporting rock (photo by the author).

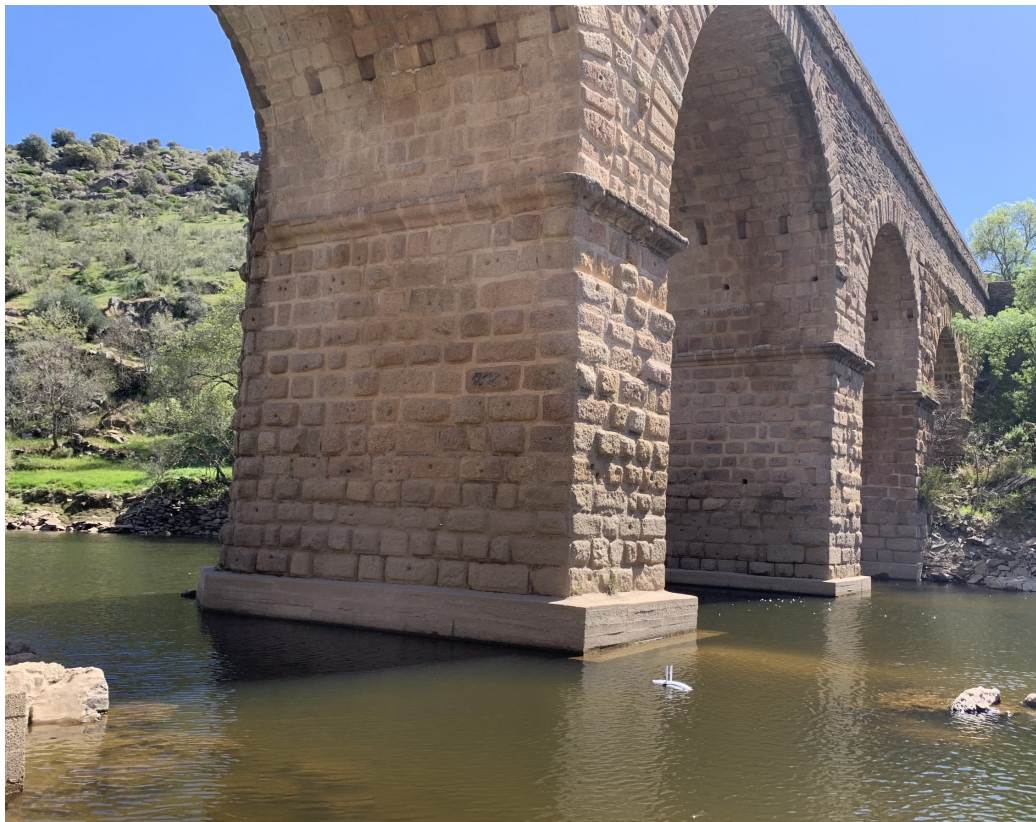
This made it possible to check that there was no deterioration damage to the bridge. The element inspected was the concrete casing mentioned above, which had recently been installed to protect the lower ashlar at the expense of hiding them. The texture of the concrete showed no loss of material due to the direct action of the water (Figure 8) and was relatively healthy despite being submerged and exposed to flowing water. The drone was able to verify that there were no cracks in the concrete, no exposed steel reinforcement and no disaggregation.

Figure 7. Underwater drone approaching one of the central piers of the Segura Bridge from downstream/the south (photo by the author). At that point, the drone made it possible to observe the submerged concrete lining and supporting rock.

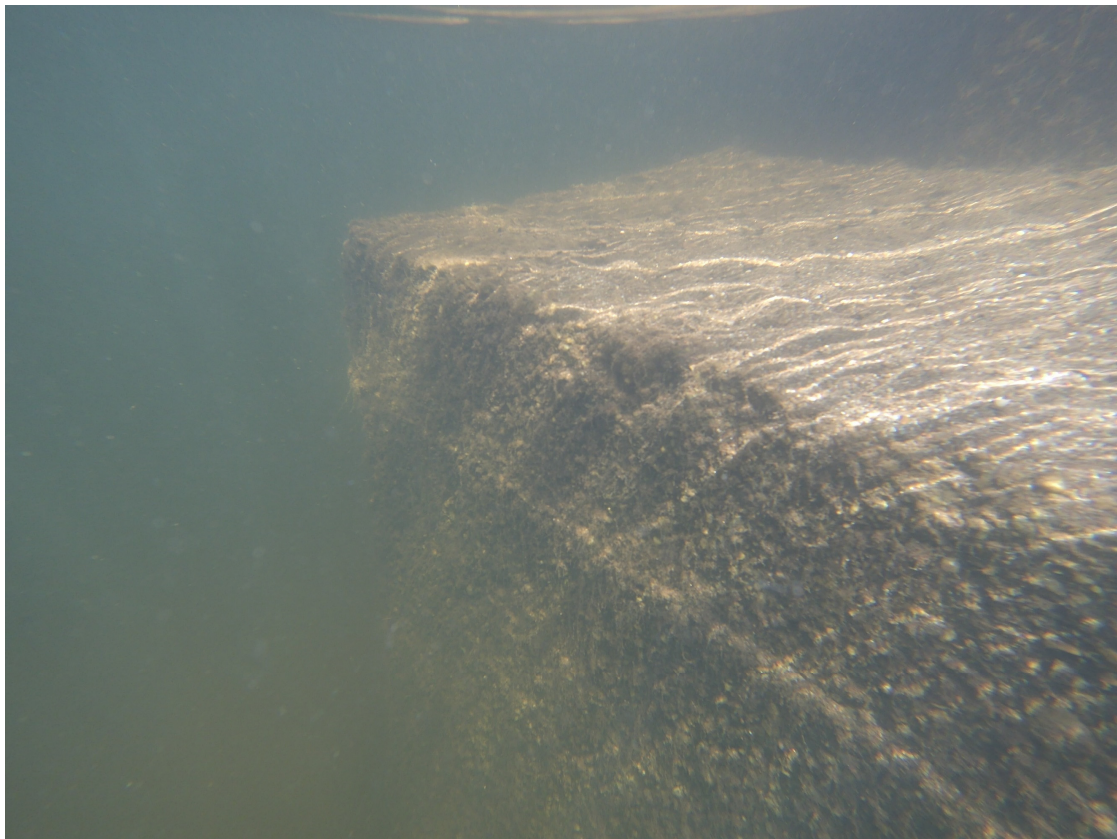
Figure 8. Underwater drone image showing the condition of the foundation inspected in Figure 5 (photo by the author).

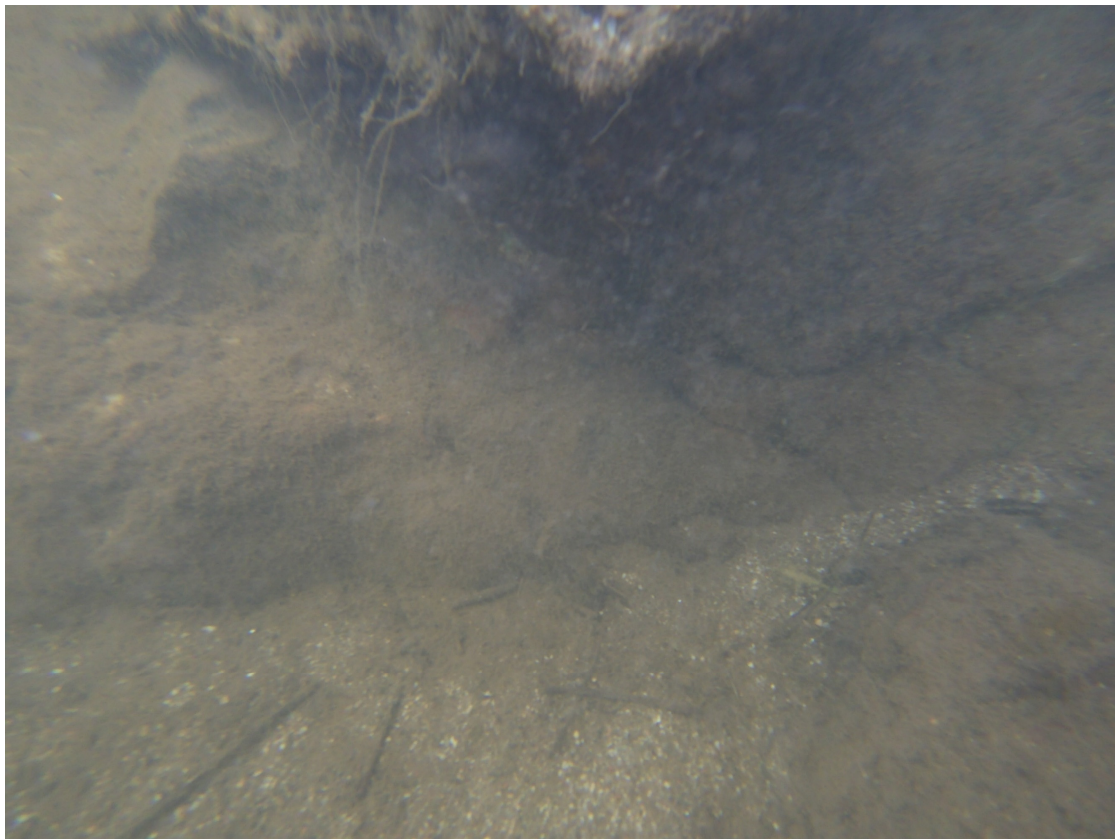
The lack of evidence of destabilisation and mobilisation of significant thicknesses in the riverbed, along with the good condition of the concrete protection, indicates that there has been no increase in the erosive power of the water, at least in recent times. Analysis of the area around the base of the submerged breakwaters showed that no bed material had been torn from the edge by the vertical component of the flow, lifted, and carried by the current. When one of the piles was removed (the first, counting from the abutment on the Portuguese side), no evidence of conical depressions in the bed was found. A small depression was found at the edge of the breakwater of this first pile, but its size and depth were minimal and therefore not of concern (Figure 9).

Figure 9. Underwater drone image of the junction between the foundation and the riverbed (photo by the author). This was the only singular point discovered during the underwater inspection, but it was not dangerous.

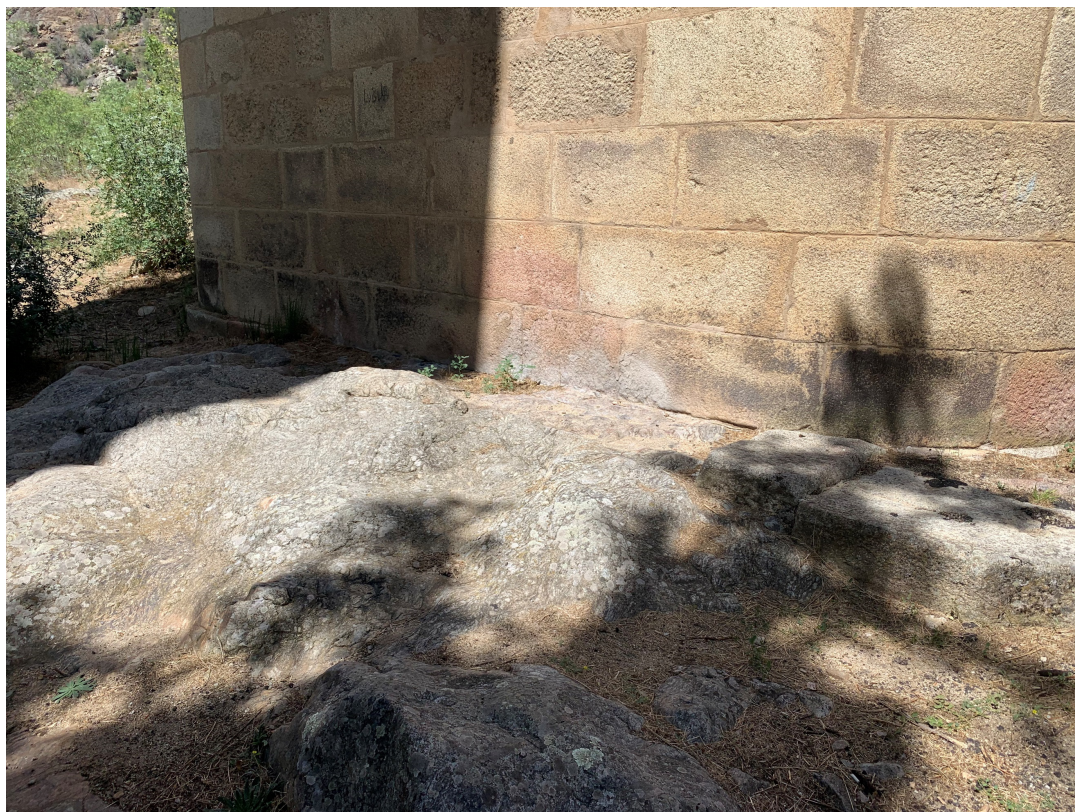
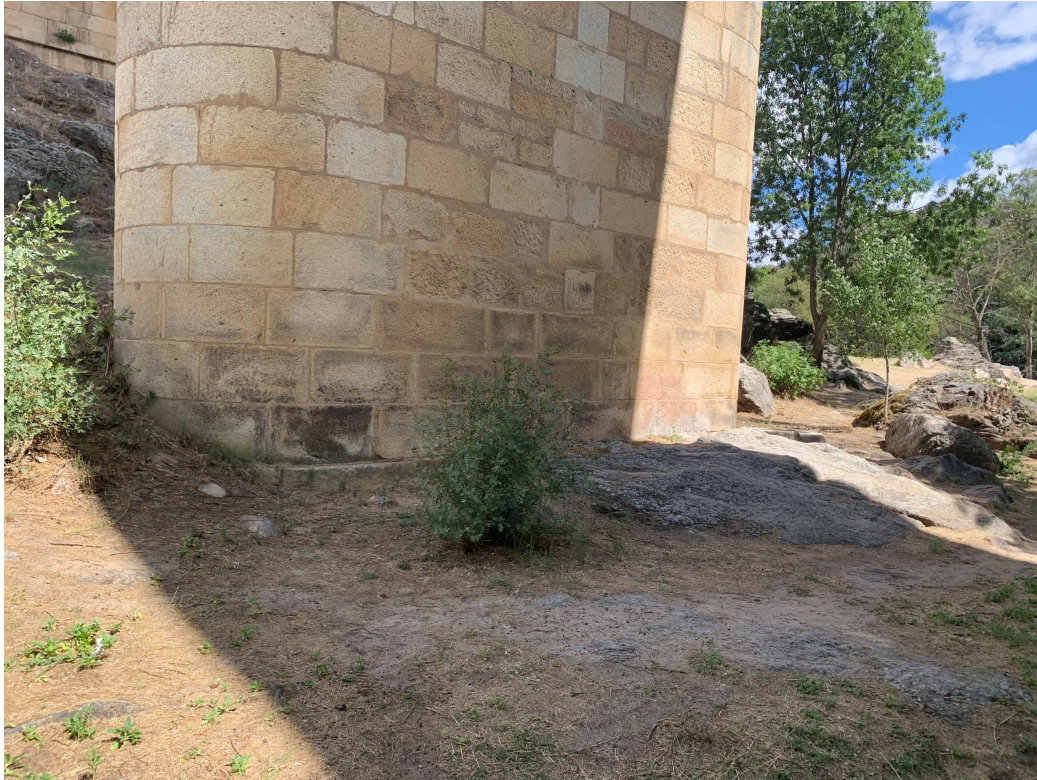
Unlike the Segura Bridge, the piers here have no additional concrete elements. The underwater drone confirmed the observation made on the non-submerged elements (Figures 12 and 13): the piers rest directly on the ground and the first ashlars rise out of the sand of the riverbed (Figures 14 and 15). As in the previous case, detailed observation allowed us to verify that there were no symptoms of the type that may appear in the superstructure as a result of the main foundation defects: twisting, absolute settlement or differential settlement. A quadcopter drone was used for this purpose.

Figure 12. View of the first pier of the bridge, counting from the northern abutment (Zamora side), showing its support (photo by the author). This photo served to give an idea of the foundation of the bridge elements, as not all of them were visible.

Figure 13. Another view of the pile shown in Figure 12, with the northern abutment in the background (photo by the author). This photo also served to give an idea of the foundation of the bridge elements, as not all of them were visible.

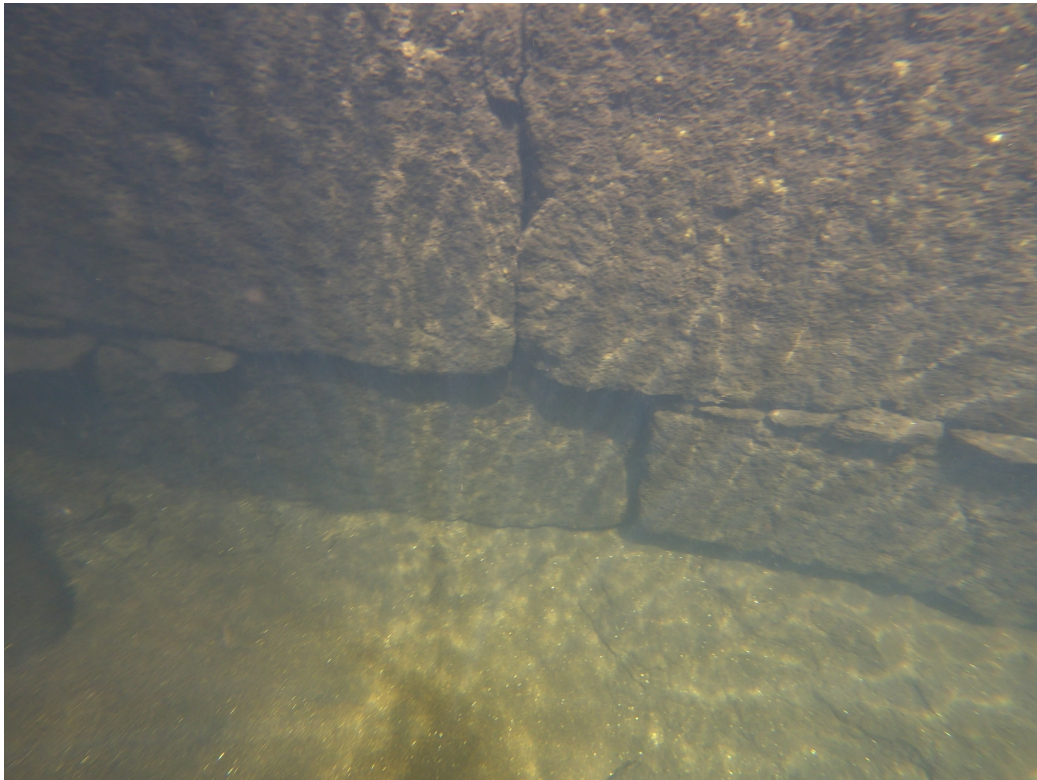
The underwater drone inspection of the submerged parts confirmed the correct state of the elements underwater: there were no missing granite ashlars, and the granite forming the submerged ashlars was in an adequate state of preservation. The presence of stone slabs in various joints between the ashlars and their appropriate location (Figure 14) appeared to help maintain the position of the ashlars by mutual friction against the erosive action of the river. This would have prevented the need to use grouting mortar, which inevitably tends to dissolve or be lost over time due to the washing action of the flowing water.

Figure 14. Underwater drone image showing the status of a fragment of the lower part of the pile inspected in the position of Figure 11 (photo by the author). The granite ashlars and the fixing slabs can be seen in the image.

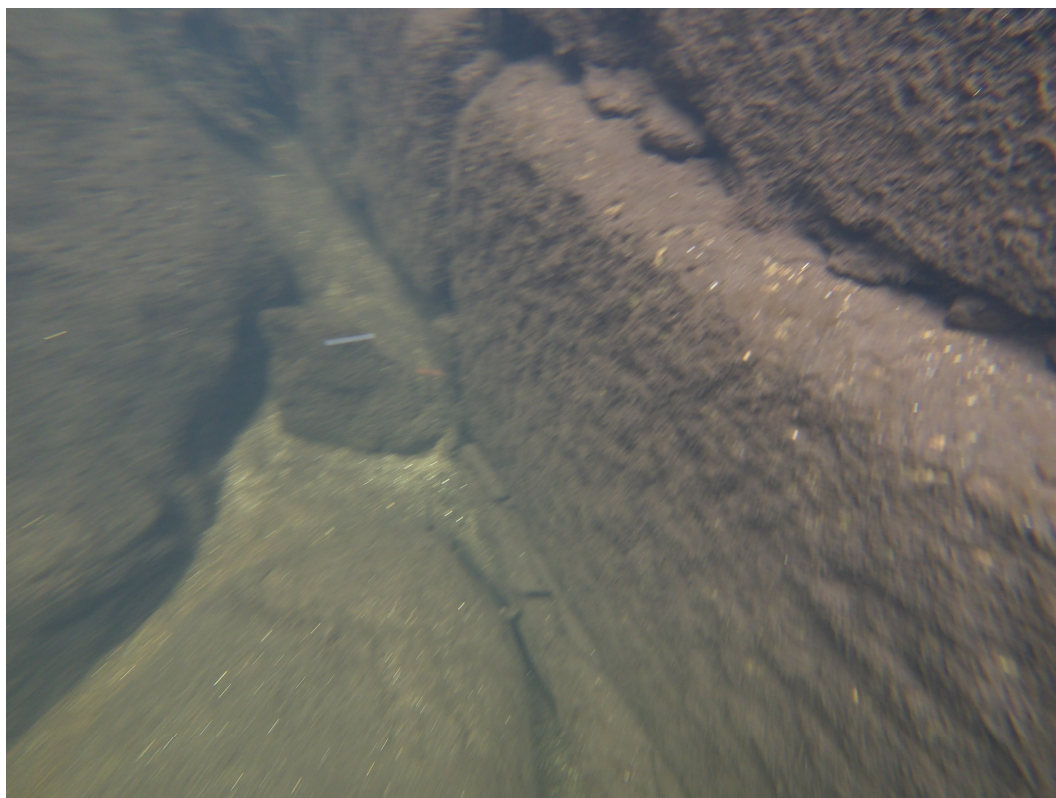
It was also possible to verify that the lower part of all the submerged piles was in complete contact with the riverbed. This, together with the absence of deformations in the position of the ashlars, allowed us to confirm the absence of undermining under these piles.

Figure 15. Condition of another fragment of the lower part of one of the inspected piles, in an image captured by the underwater drone (photo by the author). The stone elements on the river bottom, around the base of the piles, can be seen in this photograph.

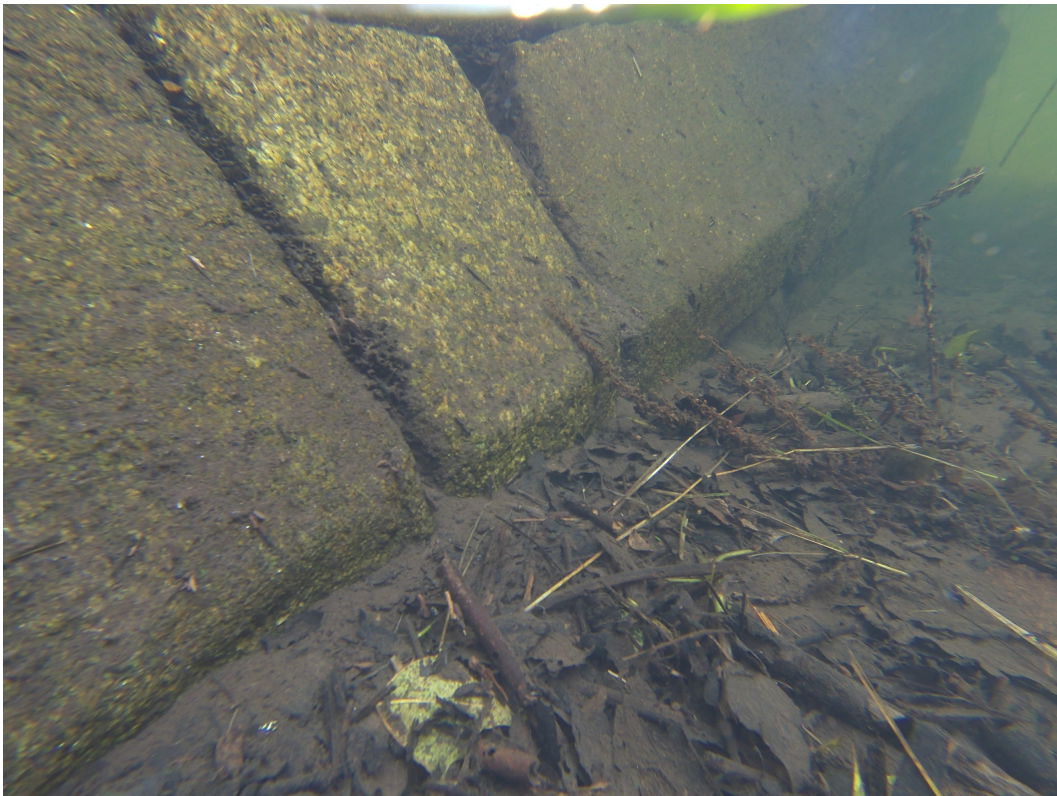
The drone inspection showed that the materials forming the base of the submerged piles were in adequate condition: the granite showed no signs of deterioration or erosion from the action of the water, nor were there any missing elements, particularly ashlar.

Figure 18. Underwater drone image of a fragment of the base of one of the central piers of the Brandomil Bridge (photo by the author).
