Article

Diagnosis and Seismic Behavior Evaluation of the Church of São Miguel de Refojos (Portugal)

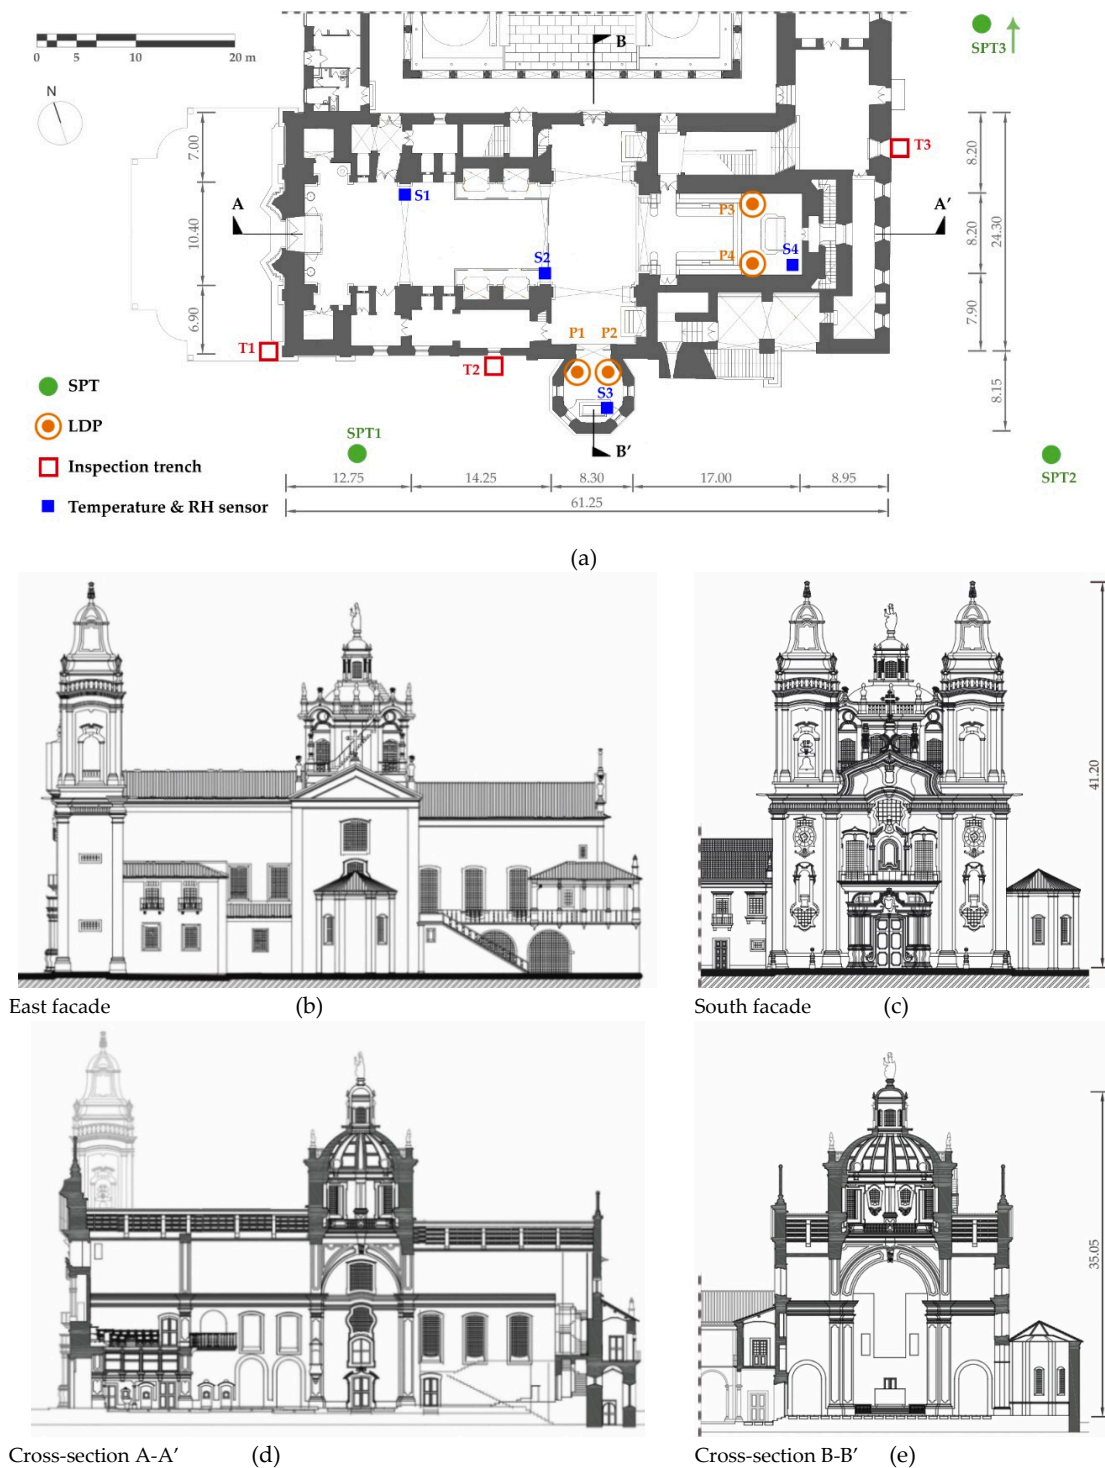
The identification of damage involved a detailed visual inspection of all of the structural elements, both from the outside and the inside of the building. The inspection revealed the presence of structural and non-structural problems. The non-structural damage corresponds to moisture stains, vegetation, fungi, and deterioration of plaster and stone. Additionally, the building shows low to moderate structural damage. There are cracks at the top of the south facade, on the transept walls, on the walls behind the high altar, and on the arch between the crossing and the chancel. The most significant

damage appears in the connections between the front facade and the south tower, and in between this tower and the south wall of the nave. Moreover, the open cracks allow for rainwater infiltration with the subsequent deterioration of the internal elements. The floors of the high altar and the octagonal chapel present significant deformations probably caused by consolidation of the soil. Similarly, other deformations in the structure might be associated with a foundation settlement.

Figure 1. Architectural definition of the church of São Miguel de Refojos: (a) ground floor plan, (b) longitudinal elevation, (c) front elevation, (d) longitudinal cross-section, (e) transversal cross-section. Dimensions in m.

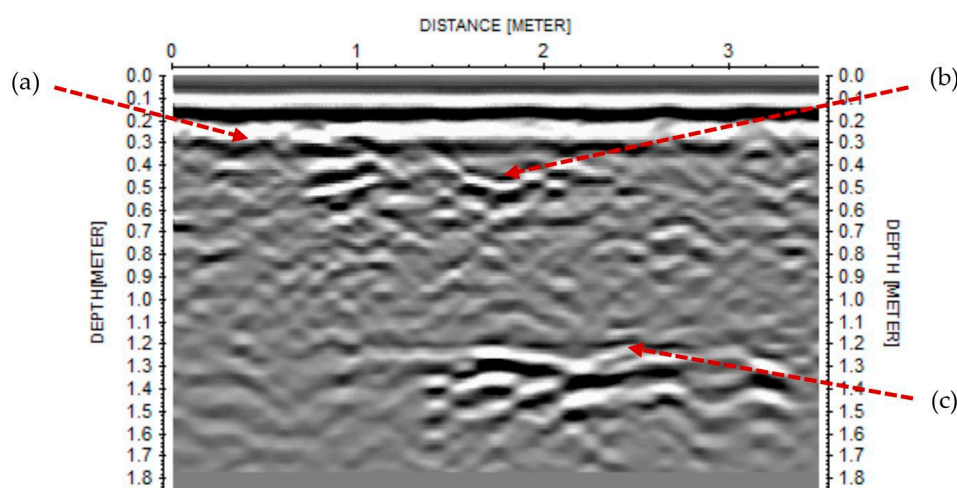
In some cases, the constitution of the walls is visible at plain sight because there is no rendering layer covering the surface. That is the case of the thinner walls behind the altar, made up by a unique leaf of ashlar masonry. For the rest of the walls, the Ground Penetrating Radar was used to identify the internal composition. Thus, GPR readings were carried out, both in the horizontal and in the vertical direction, in various locations of the walls, namely the main facade, the longitudinal walls of the nave, the walls of the transept, and the walls of the octagonal chapel. In general, the results show that the structure is made up by composite walls with three masonry leaves (Figure 5): an outer layer of irregular stone blocks, a similar internal layer, and a rubble core.

Figure 5. Horizontal georadar reading on the south wall of the nave: (a) inner surface of the interior leaf at 35–40 cm depth; (b) inner surface of the interior leaf at 55 cm depth (irregular inner surface); (c) opposite side (inner surface of the exterior leaf) at 1.20–1.25 m depth.

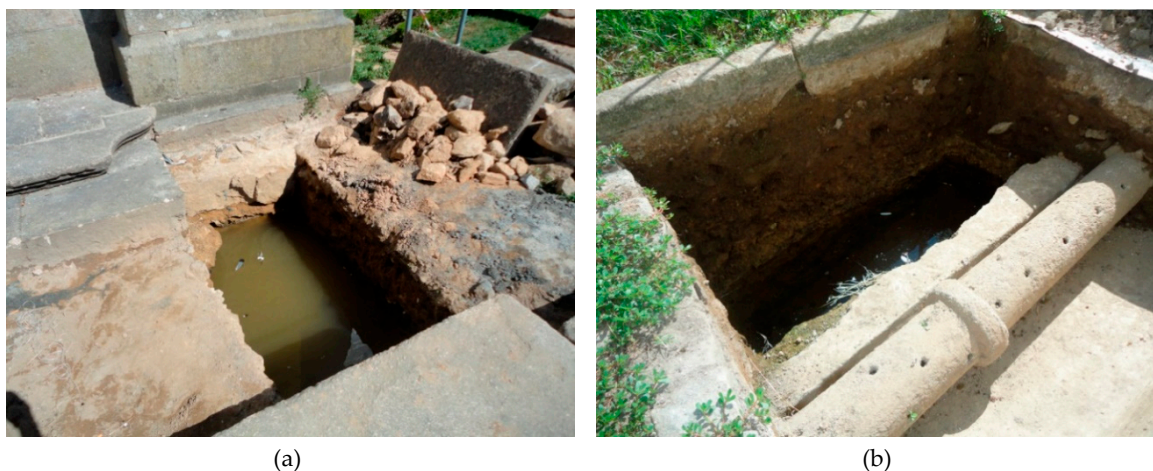
The trenches and boreholes of the drilling tests showed that the water table is very close to the ground level of the church (summer period), less than 1.00 m depth in some cases (Figure 6). The shallow water level made it impossible to identify the actual depth of the foundations under the walls. Nonetheless, the geotechnical survey allowed us to identify the geological profile. The superficial layer is constituted by soft clay, with low resistance and very deformable, until a depth of about 4.00 m. The following layer corresponds to a transition layer of gravelly sand. Finally, the last layer of the soil consists of highly altered and fractured rock (starting at depths between 4.20 to 5.50 m).

The existence of a surface layer with poor geotechnical characteristics might be the cause of the settlements detected on the church pavements. Some of the observed structural damages could also be the result of localized foundation settlements.

Figure 6. Water table visible in the inspection trenches days after the excavation (summer period). (a) Excavation 1: water level at -0.93 m below the nave floor; (b) Excavation 3: water table at -1.10 m measured from the floor of the nave.

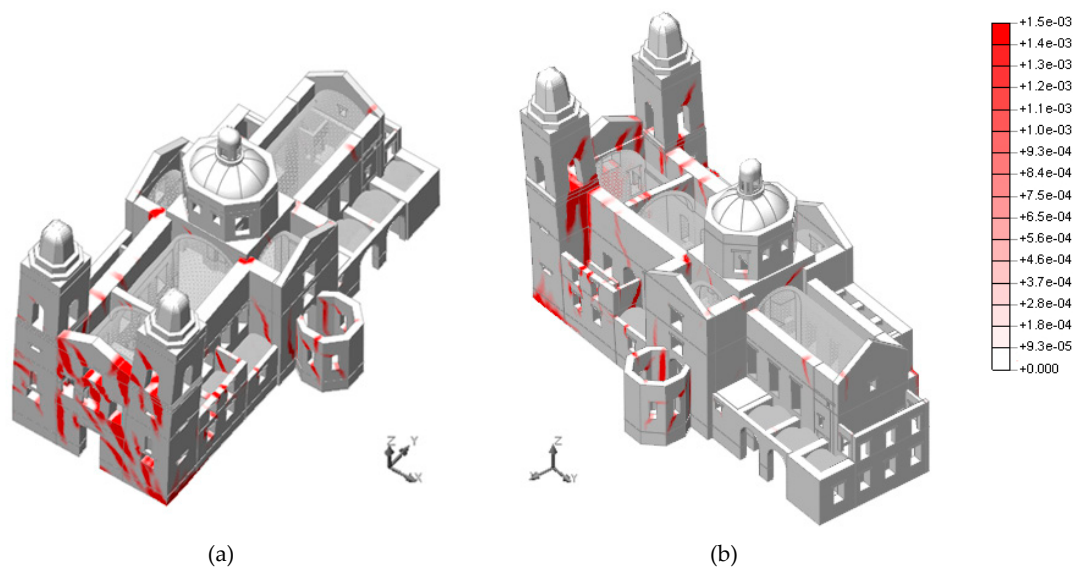
The seismic analysis in the positive transversal direction (+XX) indicates that the maximum horizontal capacity is equal to 0.28 g (Figure 10). The horizontal maximum displacement occurs at the top of the south tower. The damage pattern is characterized by shear cracks in the plane of the walls and cracks in the connections between structural elements (Figure 11). The most severe damage occurs in the main facade (diagonal cracks) and in the connections of the south tower with the orthogonal walls.

Figure 11. Crack width associated with the maximum principal strain at the end of the capacity curve for the pushover analysis in the positive transversal direction (+XX). (a) South-West view; (b) South-East view. Units in m.

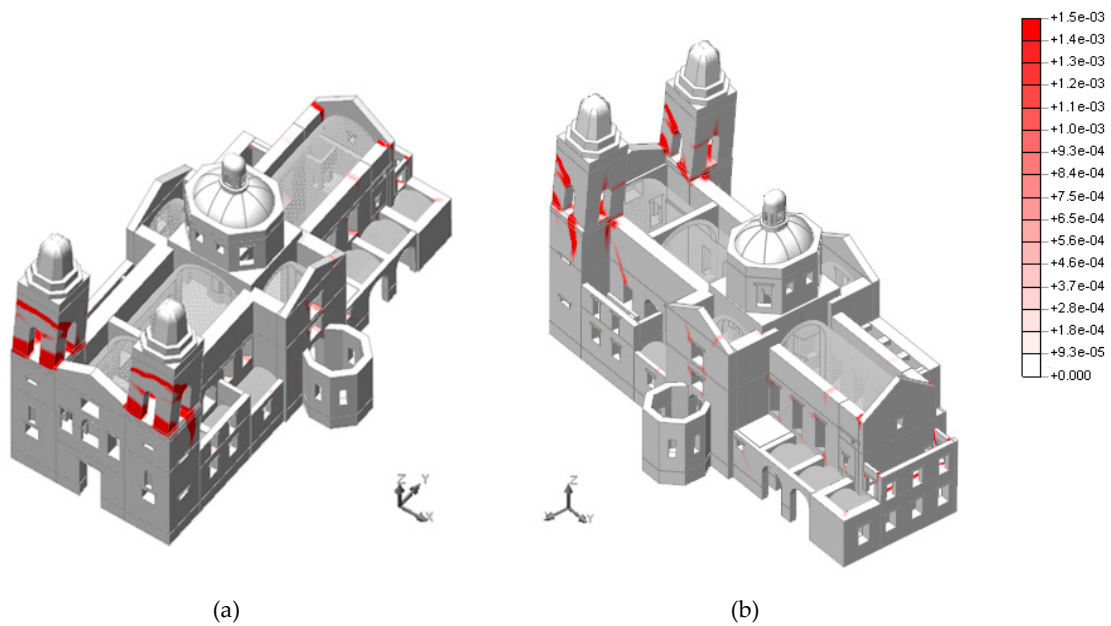
The curve for the positive longitudinal direction shows a stiffer response, with a maximum capacity equal to 0.29 g (Figure 10). The maximum displacement occurs at the top of the towers. In fact, the main failure involves the local collapse of the belfries (Figure 12). In addition, there is also damage in the connections between the rear facade and the longitudinal walls of the chancel.

Figure 12. Crack width associated with the maximum principal strain at the end of the capacity curve for the pushover analysis in the positive longitudinal direction (+YY). (a) South-West view; (b) South-East view. Units in m.

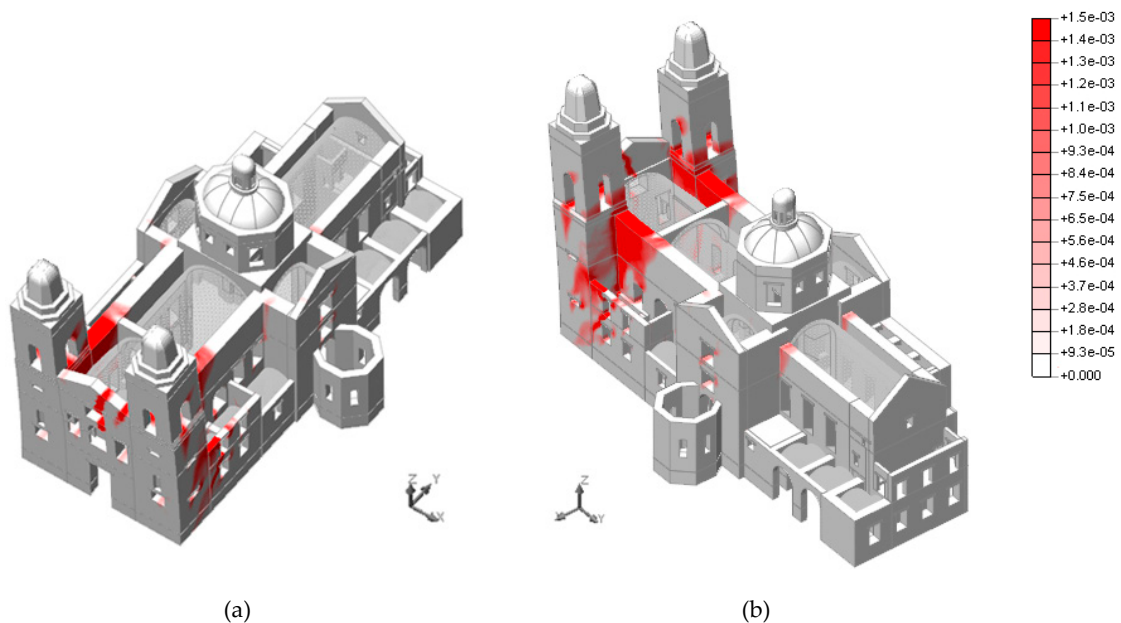
The pushover analysis in the negative longitudinal direction (−YY) presents a maximum base shear factor equal to 0.24 (Figure 10). This value represents the lowest capacity obtained from the different pushover analyses and therefore indicates the most vulnerable direction of the church. This response is associated with a significant deformation of the main facade and the towers in the out-of-plane direction (Figure 13). The damage pattern is characterized by cracks in the connections between the towers and the longitudinal walls of the nave as well as vertical cracks in the main facade.

Figure 13. Crack width associated with the maximum principal strain at the end of the capacity curve for the pushover analysis in the negative longitudinal direction (−YY). (a) South-West view; (b) South-East view. Units in m.

Mechanism 4 (overturning of facade and towers) corresponds to a failure mode also observed in the pushover analysis (Figure 13). In this case, the maximum capacity obtained from both approaches is the same (0.24 g). Additionally, Mechanism 6 (overturning of the tower in the direction parallel to the facade) results in a maximum capacity (0.25 g) similar to the one obtained by means of the nonlinear static analysis in the positive transversal direction (0.28 g). The lower value of the limit analysis could be explained by the differences between the failure mechanisms defined for one and the other methods.

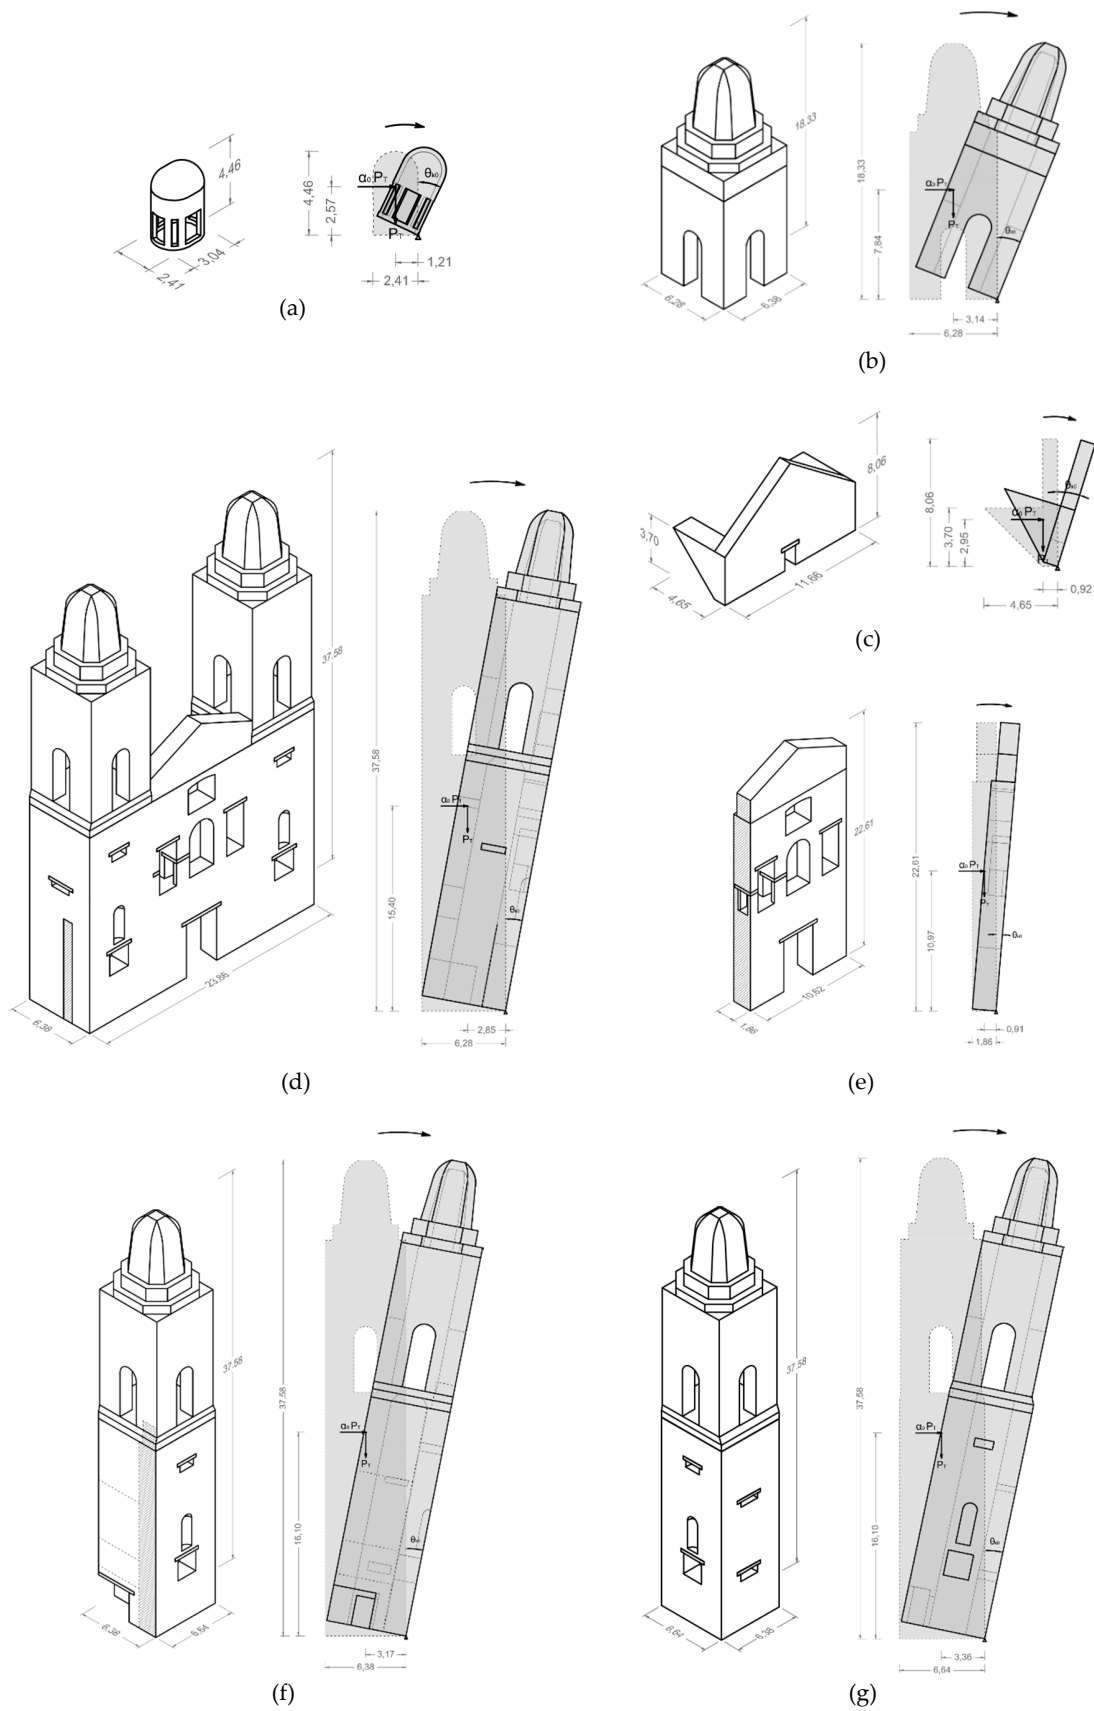
- Mechanism 1: Overturning of the lantern with rotation at the base (Figure 14a);
- Mechanism 2: Overturning of the belfry with rotation at the base (Figure 14b);
- Mechanism 3: Overturning of the gable of the rear facade (high altar) with rotation at the base and diagonal wedges from the lateral walls of the chancel (Figure 14c);
- Mechanism 4: Overturning of the main facade and towers with rotation at the base (Figure 14d);
- Mechanism 5: Overturning of the main facade with rotation at the base (Figure 14e);
- Mechanism 6: Overturning of the south tower with rotation at the base in the direction perpendicular to the facade (Figure 14f);
- Mechanism 7: Overturning of the south tower with rotation at the base in the direction parallel to the facade (Figure 14g).

Mechanism 2 (collapse of the belfry) results in a maximum capacity equal to 0.48 g, which is significantly higher than the capacity obtained from the pushover analysis in the positive longitudinal direction (0.29 g). However, it must be noted that the collapse obtained from the pushover analysis involves diagonal cracks in the columns of the belfry (Figure 12), which differs from the mechanism proposed for the limit analysis (horizontal cracks at the base of the belfry).

Figure 14. Collapse mechanisms considered for limit analysis: (a) Mechanism 1, (b) Mechanism 2, (c) Mechanism 3, (d) Mechanism 4, (e) Mechanism 5, (f) Mechanism 6, (g) Mechanism 7. Units in m.

Finally, the limit analysis proves that the collapse mechanisms considered in this study comply with the stability criteria for seismic actions defined in the Italian code NTC-08 (Table 3), with a minimum safety factor of 2.30. Overall, the limit analysis results in capacity values equivalent to those obtained by means of the nonlinear static analysis, despite some differences in the damage patterns associated with the mechanisms.

Taking into account the assumptions and results of this study, the safety condition of the structure is guaranteed. However, a set of preventive measures should be put into practice in order to guarantee a more efficient structural behavior and the necessary works for the conservation of the building, namely the filling of existing cracks, repair of deformed floors, and development and application of a monitoring plan including the revealing aspects for the structural condition, such as regular visual inspection.
