Assessing Structural Damage after a Severe Wildfire: A Case Study

Angeliki Papalou * and Dimitrios K. Baros

Department of Civil Engineering, University of Peloponnese; 26334 Patras, Greece

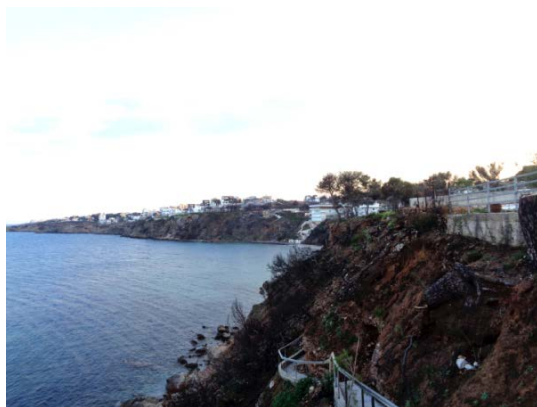
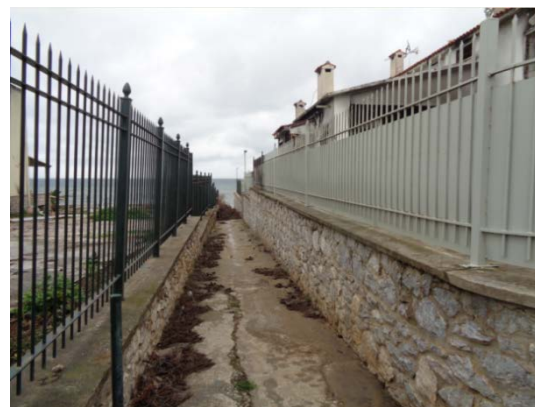
Figure 3. Pictures of Mati after the fire: (a) Coastal area; (b) narrow path leading toward the sea.

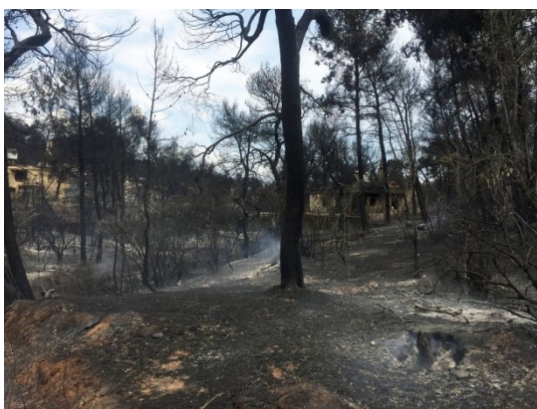
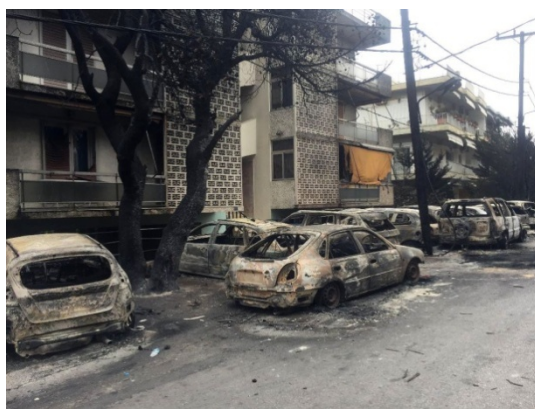
The total death toll in Mati and the villages next to it reached 102. Figure 4 shows part of the destruction the day after the fire.

Figure 4. Pictures of Mati the day after the fire (a) forest area (b) damaged buildings and vehicles.

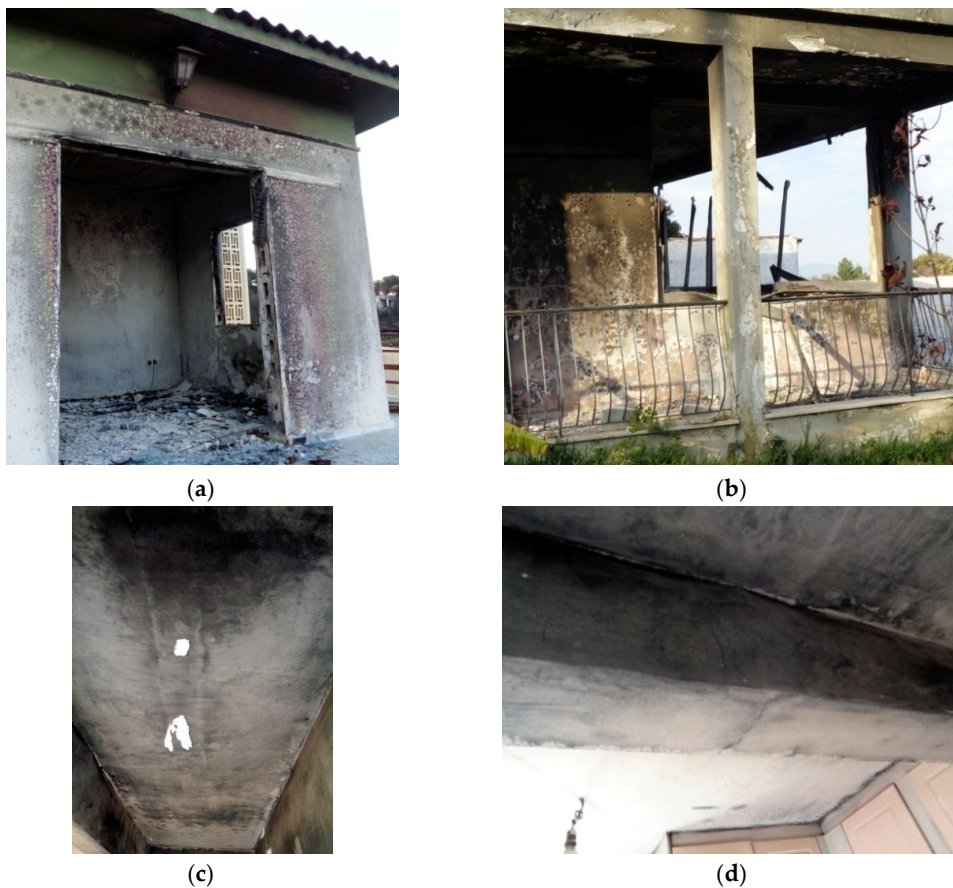
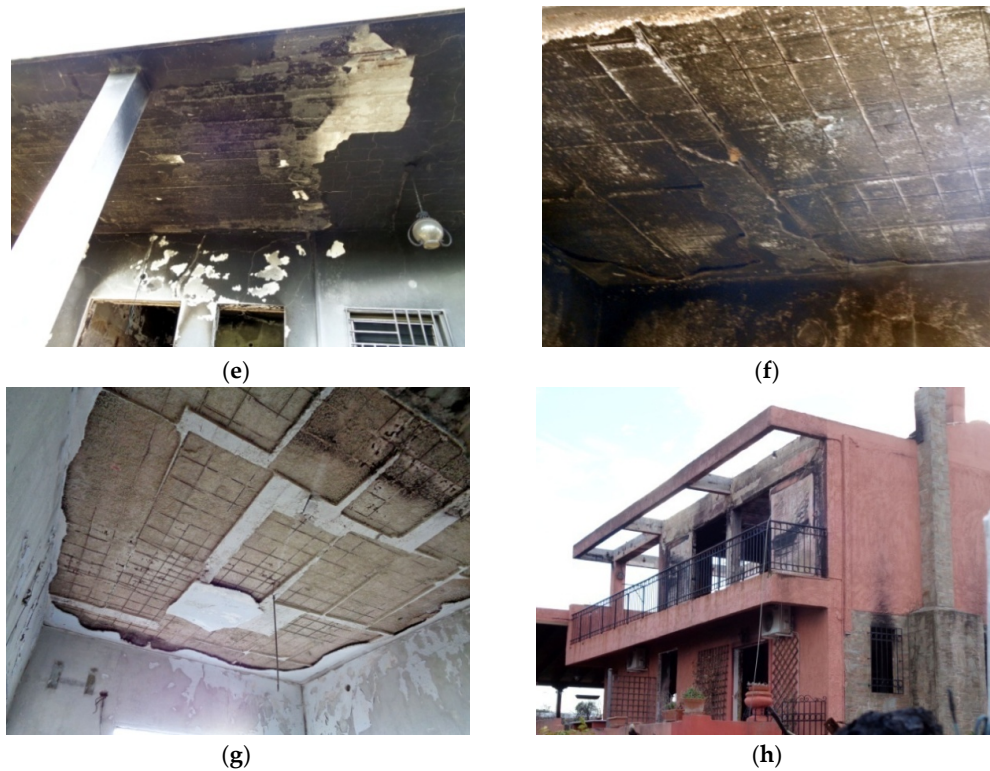
The buildings depicted in Figure 5 consisted of a reinforced concrete frame and brick infill walls. Discoloration of the cement plaster occurred in the walls exposed to fire, especially around the windows (Figure 5a). The different observed colors reveal the temperatures that developed. Aside from the discoloration, more severe damage was observed, including cracks in small-section concrete columns (Figure 5b), the sagging of concrete slabs (Figure 5c), cracks in the middle section of beams (Figure 5d), and spalling of the slab's plaster (Figure 5e), which in some cases proceeded to the concrete cover of the steel bars, exposing them to high-temperature conditions (Figure 5f,g). Most of the windows were destroyed, and the melting of the frame increased the temperature, as can be observed from the colors around the windows (Figure 5a,h). When the fire entered the house, it burnt everything in its way, leaving standing the frame and the walls of the building. Even though considerable damage occurred, most of the buildings with concrete frames and infill walls were still repairable.

Figure 5. Pictures showing damage that occurred in reinforced concrete frame buildings and infill walls after the wildfire in Mati: **(a,h)** discoloration around openings; **(b,d)** cracking on concrete members; **(c)** sagging of slabs; **(e–g)** spalling of concrete cover.

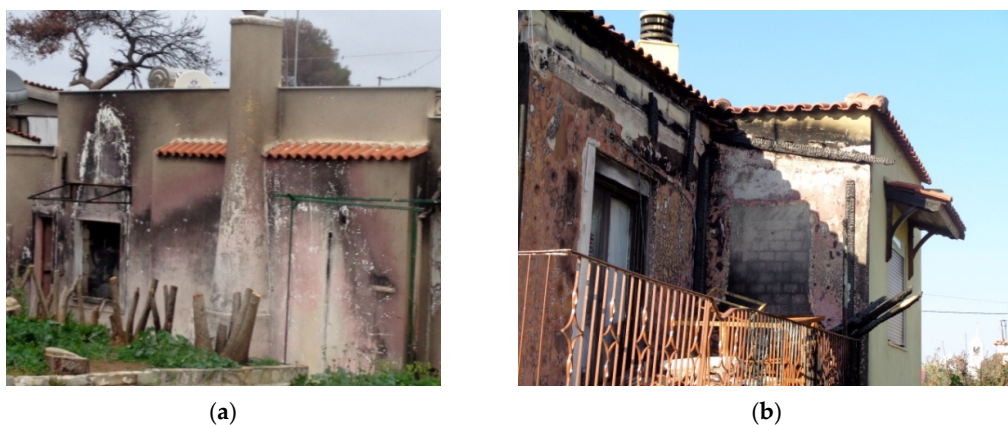
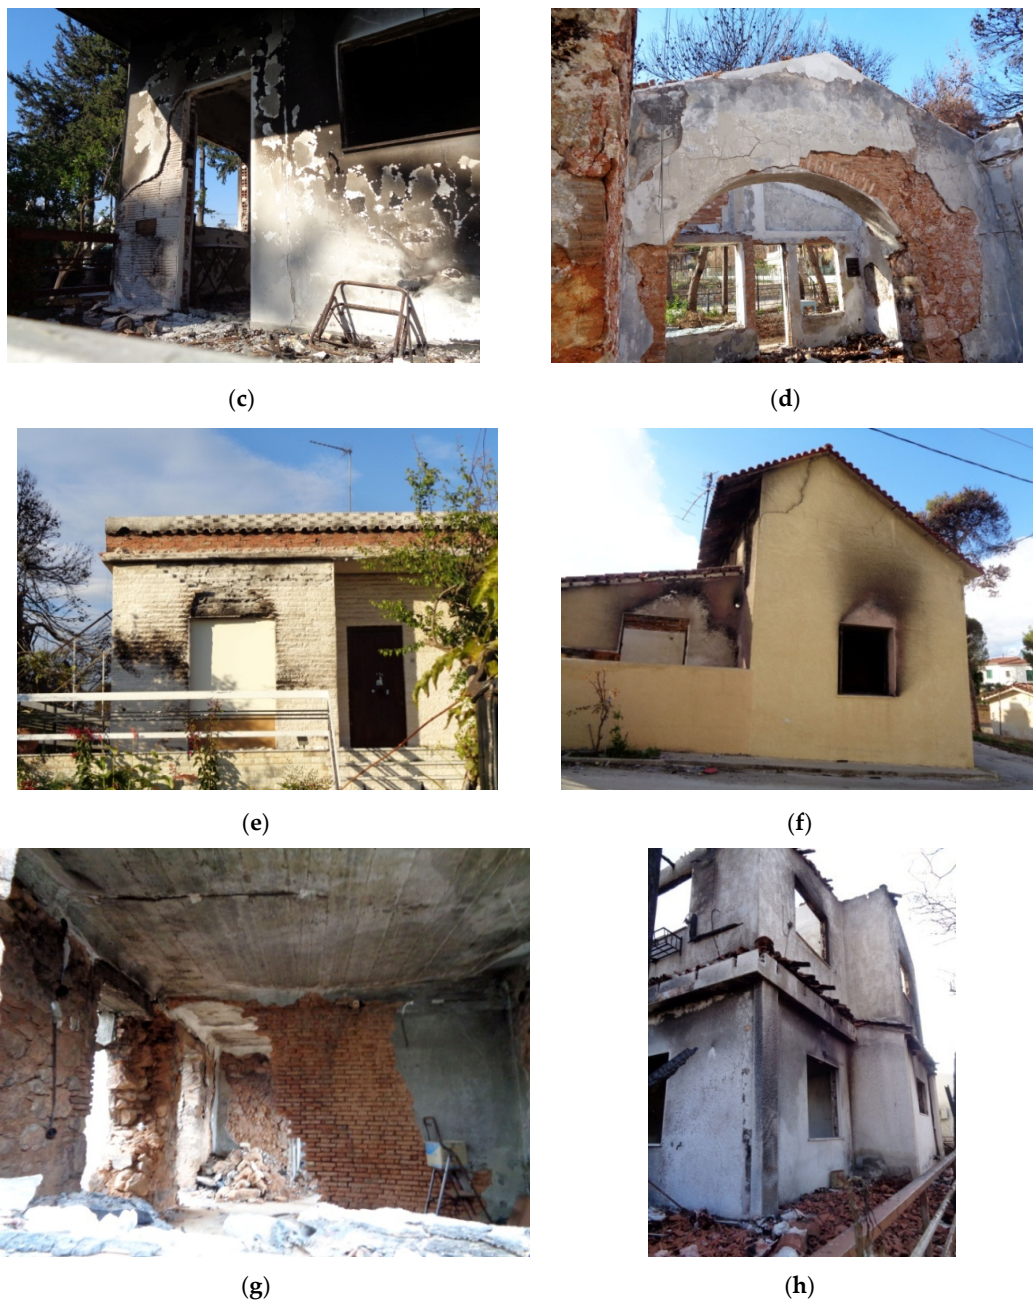
The houses from masonry in Mati were composed from stone, brick, cement blocks, or a combination of them. Discoloration of the units exposed to fire was observed, especially above the windows (Figure 6a,b). Cracking and peeling were observed in walls covered with paint or plaster (Figure 6c,d). The windows exposed to fire were burnt. Cracks appeared above the windows and below the wooden roof (Figure 6e,f). Some units fell down, destroying part of the masonry walls (Figure 6g). The roofs that were made from wood were burnt (Figure 6h). The pictures show that the windows, the roof, and everything inside the house may have been destroyed, but the walls in most of the buildings were still standing, experiencing damage in the form of cracks above the windows, discoloration, and destruction of the plaster covering the walls.

Figure 6. Photographs of damage in masonry buildings after the wildfire in Mati: (a,b) discoloration of exposed surfaces; (c–f) cracking of walls; (g) extensive damage; (h) destroyed wooden roof.

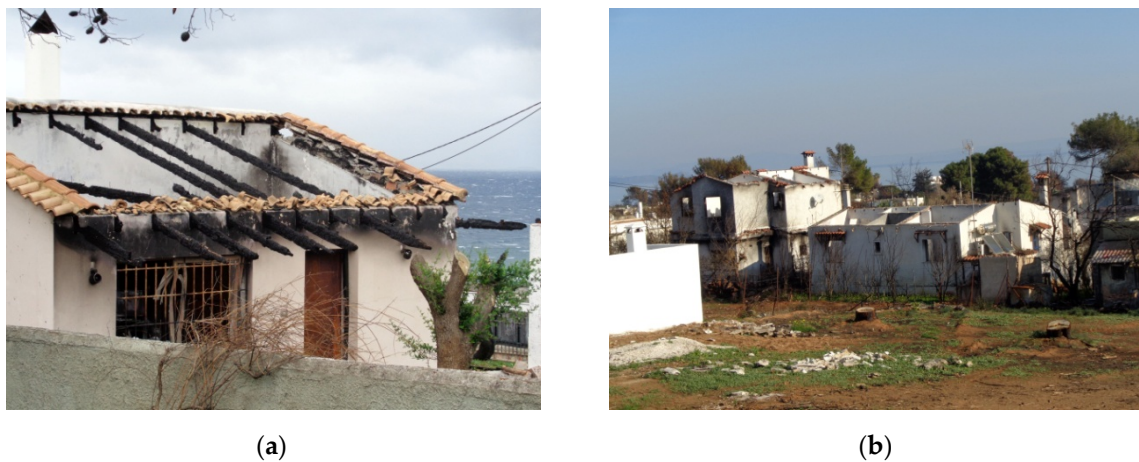
Only a few structures were made solely from wood in Mati. Wood was used mostly as a structural framework in roofs, as a patio cover, and in windows. These parts of the buildings were destroyed when they were exposed to fire (Figure 7).

Figure 7. (a,b) Photographs presenting damage that occurred in wooden roofs after the wildfire in Mati.

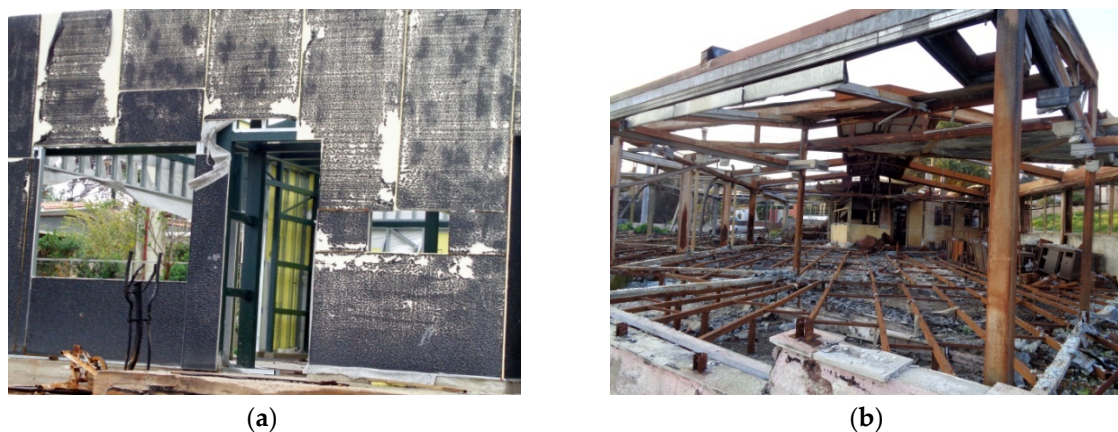
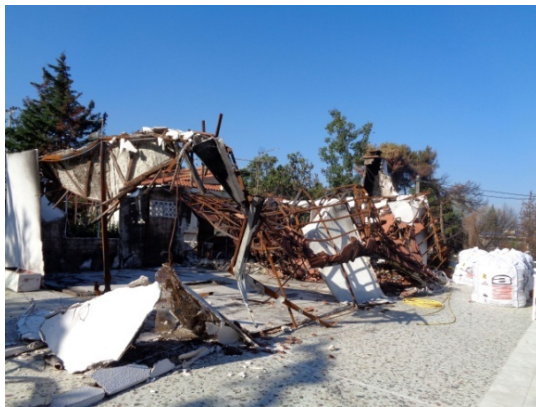
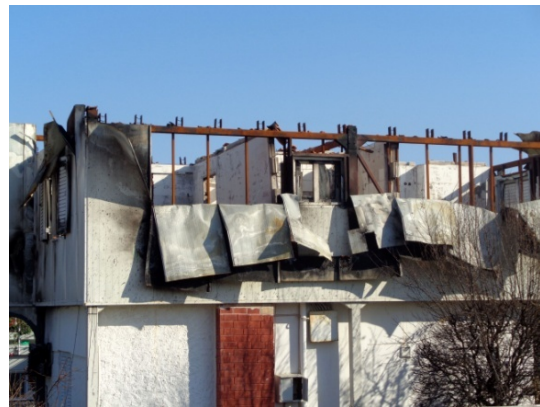
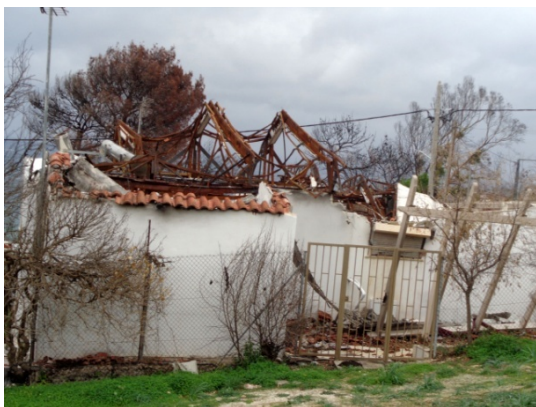
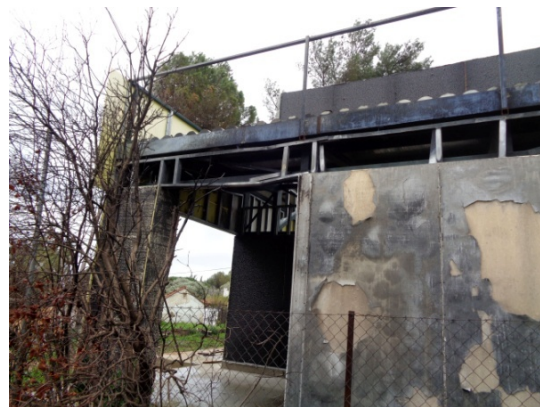
Few buildings in Mati had a steel frame as a structural form. These buildings were light-weight, with cement boards as infill walls and in some cases metal siding panels with thermal insulation for exterior walls. The strong beams and columns of the buildings either were not affected or exhibited some oxidation (Figure 8a,b). Most of the thin metal members were oxidized and buckled, revealing the temperatures that developed and the prolonged period of time they were exposed to fire (Figure 8c). In some buildings, cement boards with their light wire mesh followed the collapse of the structural form (Figure 8c). In others, the external walls from metal siding panels buckled (Figure 8d). The members of steel roof trusses exposed for a prolonged time to fire exhibited oxidation, severe damage, and buckling (Figure 8e). Some thin aluminum parts in the window frames buckled (Figure 10f).

Figure 8. Photographs depicting damage that occurred in buildings with a steel frame after the wildfire in Mati: (a,b) relatively unaffected strong members; (c) corrosion and buckling of thin metal members; (d) buckling of metal panels; (e) severe damage of trusses; (f) buckling of aluminum frames.

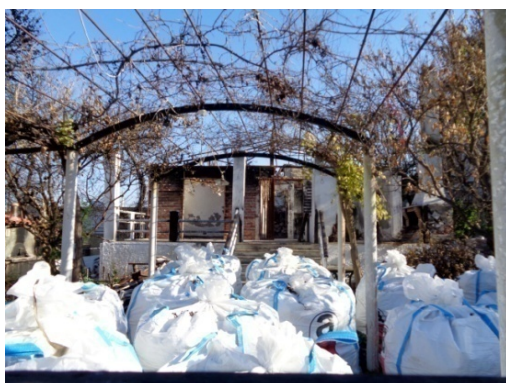
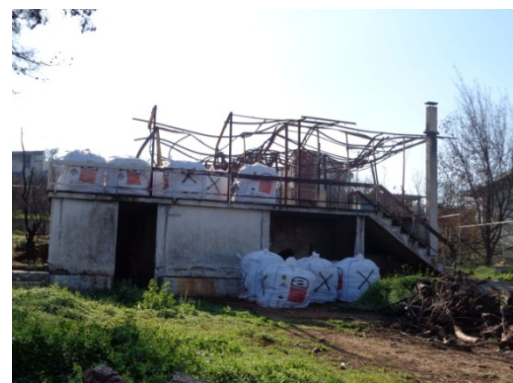
Asbestos existed in more than 200 buildings in the area exposed to fire (Figure 9). After the fire, the remains were collected and put inside special bags in order to be carried away and deposited in a safe place.

Figure 9. (a,b) Pictures of the remains of buildings containing asbestos, which was enclosed in special bags.

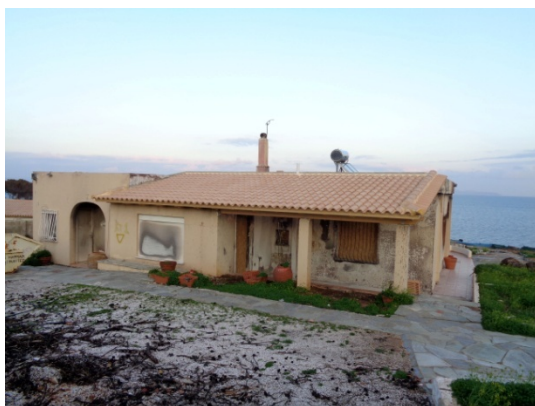
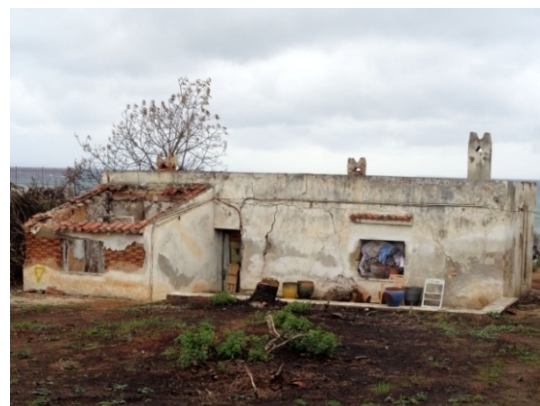
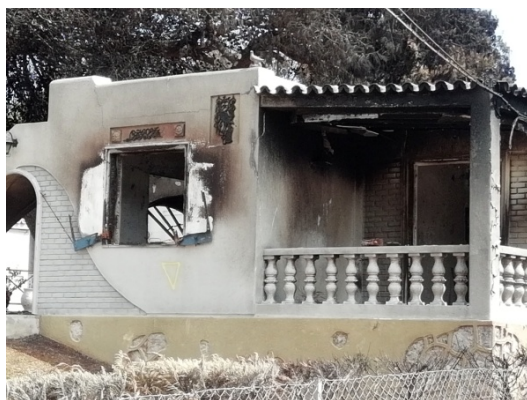
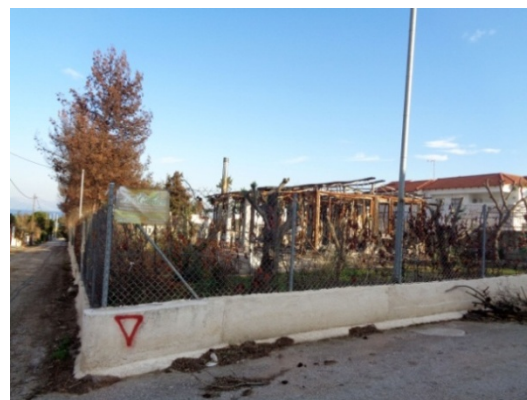
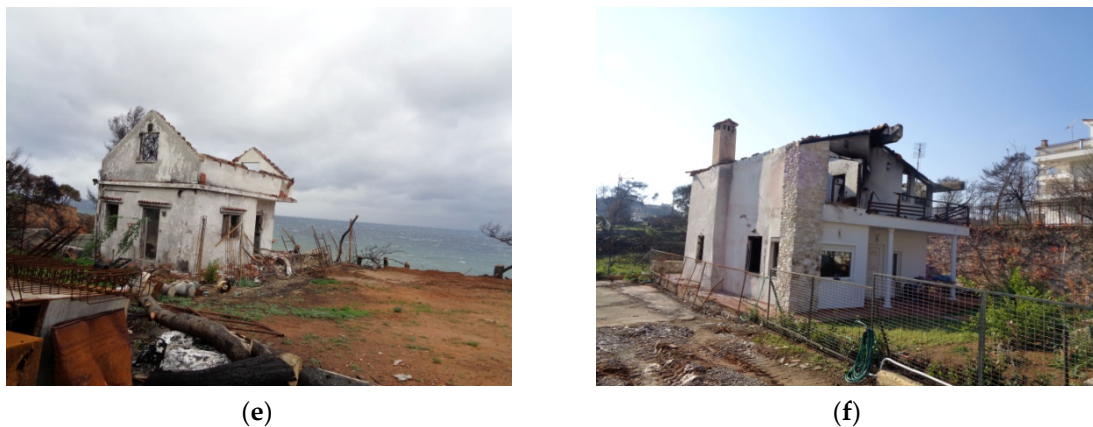
After the fire, a crew of engineers visited all of the buildings, characterizing them (depending on the observed damage) as repairable, nonrepairable, or without any damage. Depending on the characterization, the building was marked with a colored sign. A green sign corresponded to a building without damage, yellow to a building with repairable damage (Figure 10a–c), and red to a building with nonrepairable damage (Figure 10d,e). In some buildings, only one of the floors was characterized as nonrepairable (Figure 10f). Almost half of the buildings were characterized as green, 23% as yellow, and 28% as red.

Figure 10. Pictures of buildings characterized as repairable (a–c), non-repairable (d,e), or with a nonrepairable upper floor (f).
