Data-Driven Field Observational Method of a Contiguous Bored Pile Wall System Affected by Accidental Groundwater Drawdown

Elizabeth Eu-Mee Chong ^{1,*} and Dominic Ek-Leong Ong ^{1,2}

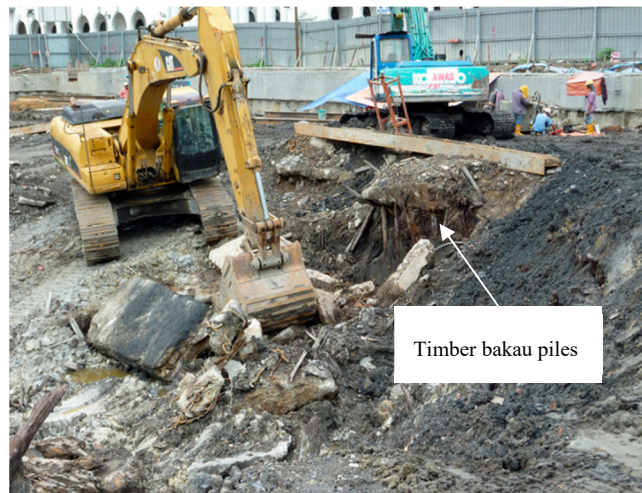
Figure 2. Timber bakau piles used as support system for the demolished buildings.

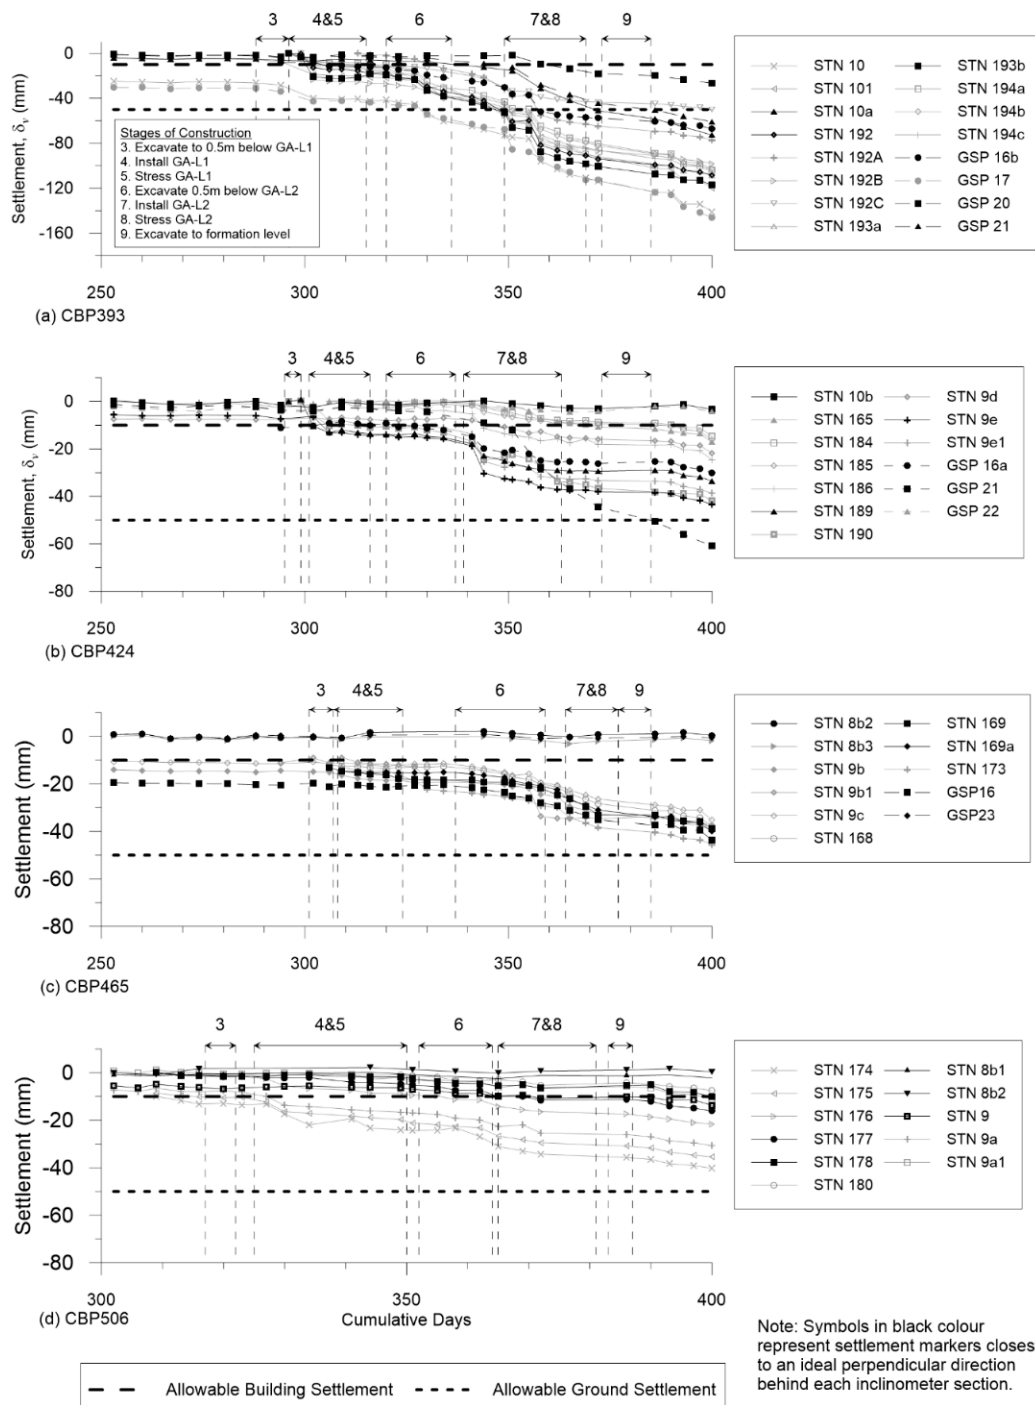
As mentioned in the preceding section, the building and ground settlement along Walls E and F were relatively large during the main excavation works. Figure 6 presents the measured settlements near four inclinometer sections along Walls E and F that had experienced rather substantial movement during the main excavation works and warrant for a closer examination. The main excavation works consist of Stages 3 to 9, that is, the three stages of excavation and ground anchor installation and pre-stressing in between the excavation works. These activities contributed up to 98.3 mm and 93.3 mm settlement, accounting for 55% and 53% of the total building and ground settlement, respectively. Based on the settlement markers that were ideally lined perpendicularly to the inclinometer section (marked by black color line in the figure), STN193b near CBP393 recorded 117.4 mm building settlement at Day 400. For other inclinometer sections, the largest settlement for CBP424, CBP465 and CBP506 measured at 60.9 mm, 43.6 mm and 13.8 mm, respectively. There were other settlement markers that recorded larger settlement than reported here but these settlement markers were not in a perpendicular direction behind the inclinometer sections. Upon the alarming settlement observation, additional settlement markers, mostly building settlement markers, were installed and increased monitoring of twice weekly were practiced.

Figure 6. Specific building and ground settlement profiles throughout the main excavation works at (a) CBP393; (b) CBP424; (c) CBP465; and (d) CBP506.

It was observed that Stages 4, 5, 7, and 8, which are the ground anchor works, contributed to large and immediate settlement. Table 4 summarizes the percentage of settlement during the ground anchor works and excavation works. The ground anchor works had caused building settlement of up to 47% and ground settlement of up to 37%. Meanwhile, the excavation works caused smaller percentage of settlement, except for CBP506 with 80% and CBP465 with 53%. These two outliers could be ignored as the final settlement was only 1.5 mm, and thus the large percentage of settlement was caused by fluctuation in the data. The installation of GA-1 caused smaller settlement compared to GA-2, while

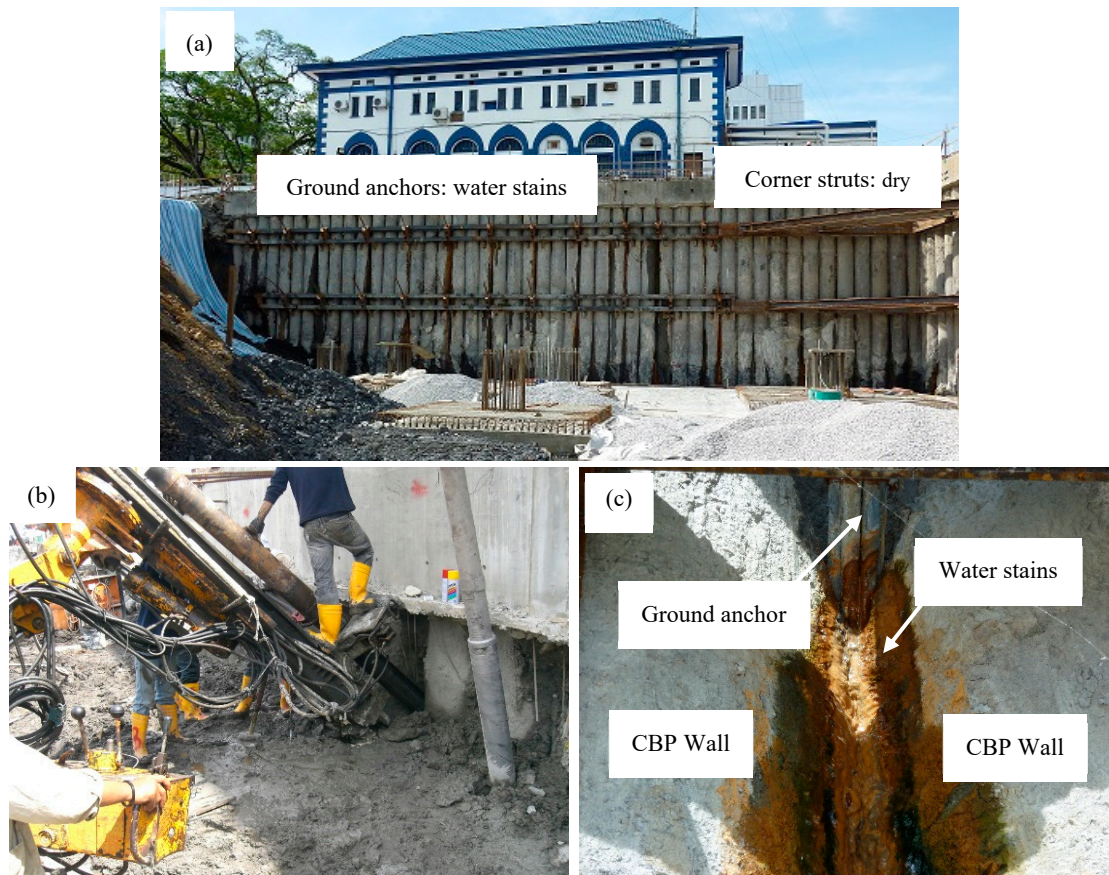
the second stage of excavation had the largest settlements. Rotary wash drilling method had been used in the ground anchor installation works. Due to the use of water during drilling process, the soil particles may possibly be washed out from the holes and thus causing large settlements. Kempfert and Gebreselassie [21] reported that for an excavation project in soft soil with soldier piles and tied back with a single layer of ground anchor spaced at 0.90 m, it recorded 60–72% settlement that occurred during anchor installation. They attributed the appreciable settlement to fresh cement–bentonite slurry in the drill hole and the vibration arising from the anchor installation method.

Another possible reason for the relatively large settlements is groundwater loss. An acute observation revealed continuous water stain marks below the ground anchor positions for most of the wall sections, especially Walls D, E, and F, as can be seen in Figure 7a. The CBP wall was considered to be watertight as cement grout columns were used to seal off the gaps in between successive bored piles for the entire wall. This was confirmed through the dry CBP walls at the corner of the main basement (right side of Figure 7a), where corner struts were used instead of ground anchors. However, as the ground anchor center-to-center spacing is 2.25 m, it coincides with the cement grout columns that provides water proofing. The ground anchor drilling process (Figure 7b) cut through the grout columns and ‘punctures’ the water-tightness of the CBP wall. Clough and O’Rourke [3] described several cases where potential water flow may lead to ground settlement, among them are flow through wall flaw as shown in Figure 8. Although the ground anchors were grouted immediately after the insertion of ground anchor, fresh concrete requires curing time to effectively seal the gap. Site observations indicated that at the first opportunity when the puncture occurred, the groundwater showed immediate response by seeping through the drill hole as shown in Figure 7c. As the groundwater table was generally about 1.0m below the existing ground level, which is higher than GA-1 level, the water stain marks occurred for both GA-1 and GA-2 levels. This response further confirms the previously discussed Figure 6, where the large and immediate settlement could be observed during ground anchor works as discussed earlier. The groundwater loss issue ceased when skinwall was constructed. Unfortunately, water standpipes were not available at the main basement, as it was thought to be unnecessary due to the presence of cement grout column.

Figure 7. (a) Groundwater leakage from where ground anchors were installed; (b) drilling of ground anchor in between bored piles; and (c) close-up of the water leakage from the ground anchor.

3. For the cut-and-cover tunnel where no CGC were available, the groundwater level was immediately drawn according to the excavation rate. Settlement rate slowed down upon the casting of skinwall. The construction of skinwall had effectively sealed off the site and

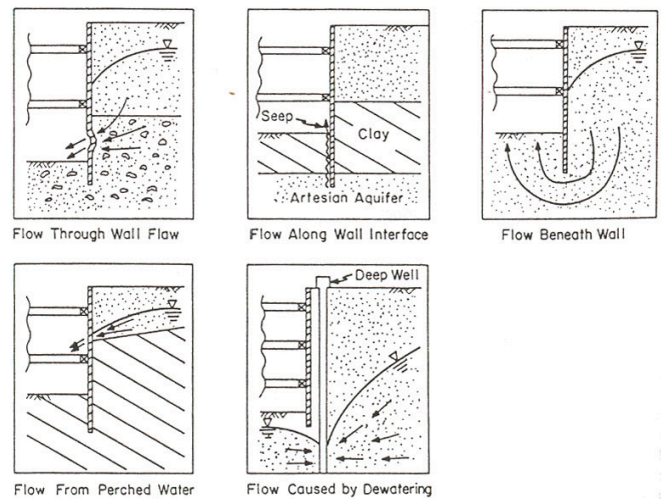
Figure 8. Potential water flow which may lead to ground settlement [3].

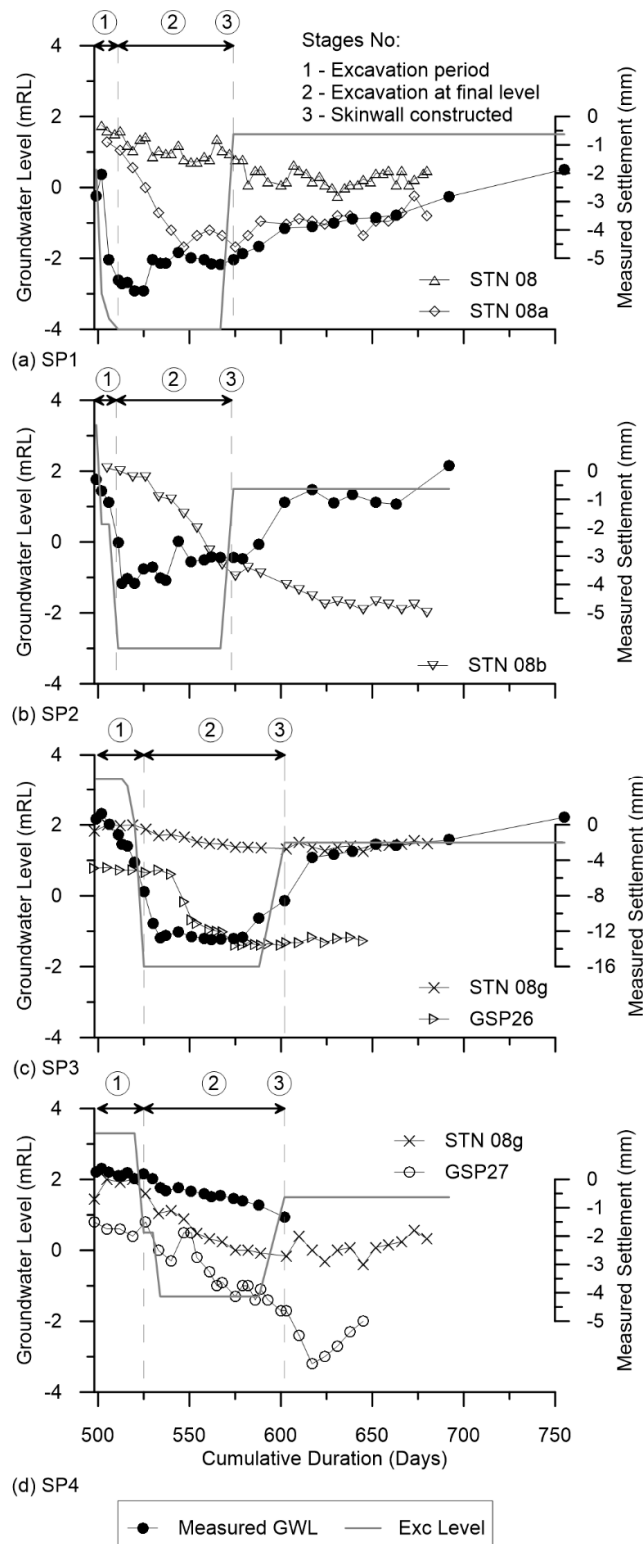
The groundwater monitoring was only available at the cut-and-cover tunnel where the CBP walls were considered to be ‘permeable’ due to the absence of cement grout column. During the early stages of construction, it was observed that the soils in the gaps between the pile were constantly damp, indicating slow groundwater leakage through the wall. Figure 10 displays the measured groundwater level and the corresponding settlement profiles for SP1, SP2, SP3, and SP4. It is observed that when the excavation was carried out, the groundwater level behind the wall were immediately drawdown. During the quiescent period for skinwall preparatory works, the groundwater level was noted to maintain at the final excavation levels consistently for SP1, SP2, and SP3. This demonstrated the groundwater loss through the gaps in between the piles experimented by Richards et al. [12]. Prior to concreting the foundation slab, submersible pumps were placed in depressed pump sumps to extract the seepage water on the excavation floor so that concreting can be carried out in the dry. Similarly, the casting of skinwall was carried out in dry condition. Casting of skinwall cut off the groundwater flow through the wall and re-established the groundwater to its original level. Although the settlement was less than 5 mm, the settlement profiles for the three water standpipes showed a similar trend where during the excavation induced groundwater lowering, the settlement occurred at higher rate and slowed down considerably upon the construction of skinwall. This observation also strengthens the earlier observation where groundwater lowering induced by ground anchor installation works had caused relatively large settlement to occur along Walls E and F. At the end of the tunnel, the groundwater level was observed to drawdown gradually with the excavation as shown in Figure 10d. Similarly, with the settlements near the other three standpipes, minimal settlement was observed. Unfortunately, due to SP4 being destroyed during construction activity, no data could be obtained after skinwall construction.

Figure 10. Measured groundwater and settlement profiles for (a) SP1; (b) SP2; (c) SP3; and (d) SP4.
