The 2017, Md = 4.0, Casamicciola Earthquake: ESI Scale Evaluation and Implications for the Source Model.

Table S1. Descriptive sheet of the environmental effects allowed the estimation of the degrees of ESI intensity and the reconstruction of the isoseismal map.

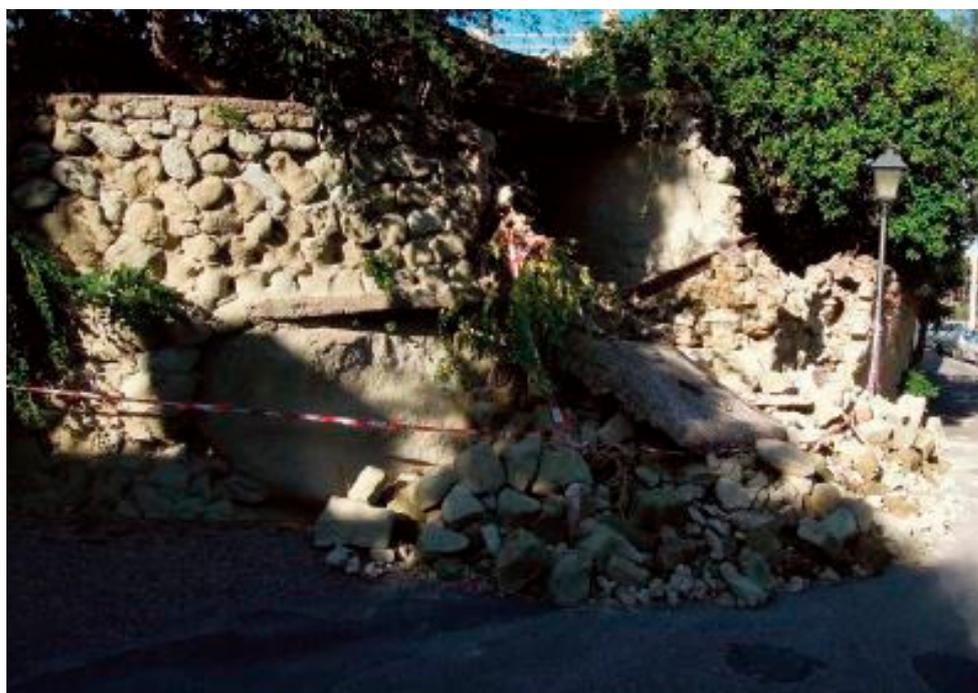
Site number	1
Latitude	40.746131°
Longitude	13.888086°
Locality	Via Fango , Lacco Ameno (NA).
Type of effect	Earth Slide
Description	Drywall collapse for a length of ca. 5 m
ESI Intensity	Data reported because located in the immediate vicinity of ground effects
Geomorphic setting	Urban area, hilly topography

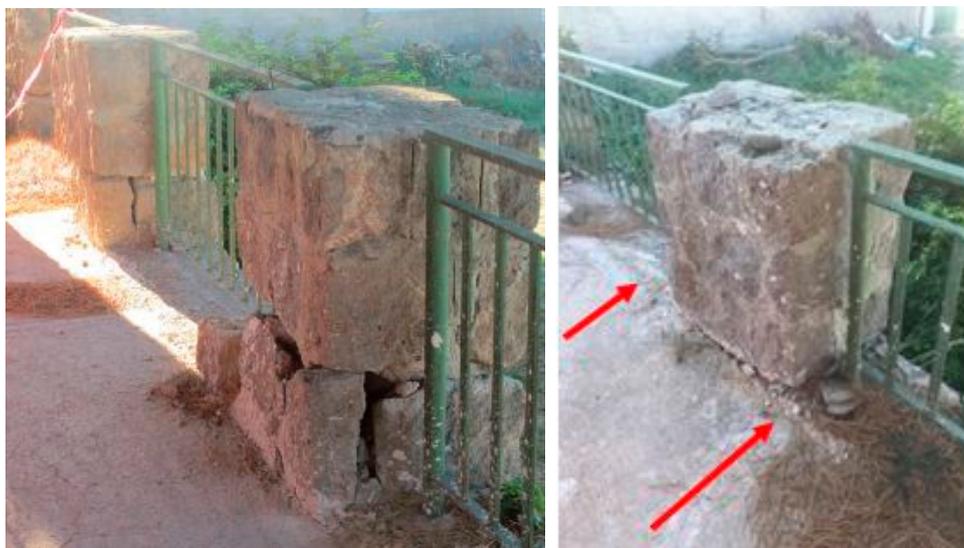
Sources of reference	Emergeo Working Group, 2019.
Site number	2
Latitude	40.742495°
Longitude	13.884802°
Locality	Via Borbonica, Lacco Ameno (NA).
Type of effect	Fracturing
Description	On the left, fracturing of small pillars along via Borbonica; the collapse of these was prevented by the metal scaffolding of the handrail; on the right fracture in the asphalt at the base of the pillars.
ESI Intensity	Data reported because located in the immediate vicinity of ground effects
Geomorphic setting	Urban area, hilly topography

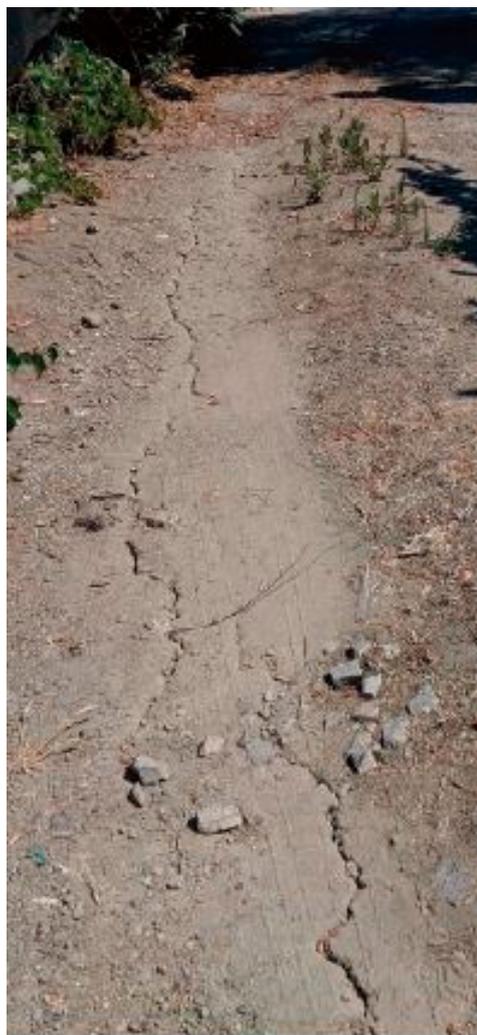
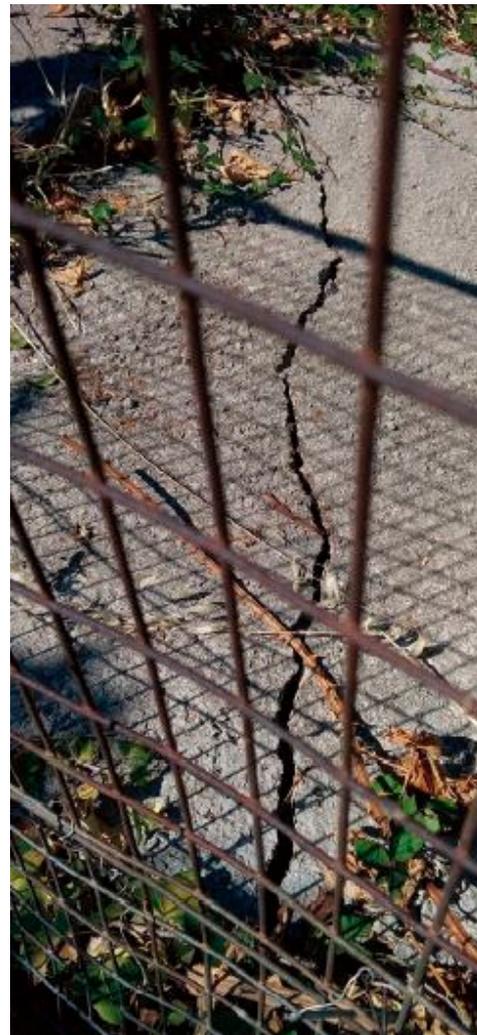
Sources of reference	Emergeo Working Group, 2019
Site number	3
Latitude	40.742028°
Longitude	13.887070°
Locality	Via Crateca, Lacco Ameno (NA).
Type of effect	Ground fractures
Description	Coseismic fracturing of the soil that extends for 30 m, through a private property and an asphalted road. The fracture opening is 1-2 cm.
ESI Intensity	VII
Geomorphic setting	Urban area, hilly topography

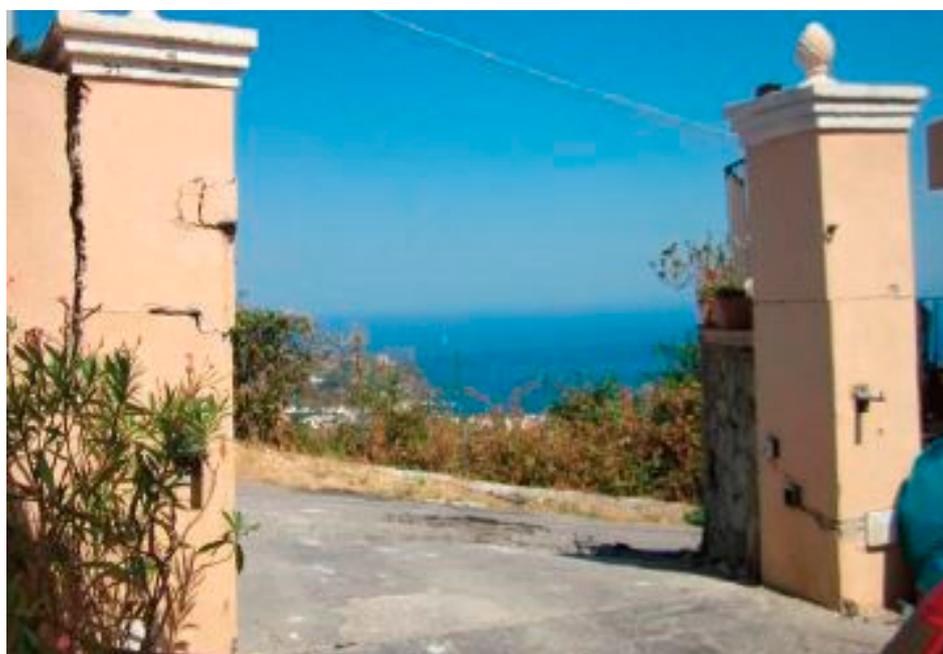
Sources of reference	Emergeo Working Group, 2019.
Site number	4
Latitude	40.741216°
Longitude	13.886989°
Locality	Via Crateca, Lacco Ameno (NA)
Type of effect	Fractures
Description	Fracturing of two pillars constituting the entrance to a private property, in which there are also fractures and lifting, of a few centimeters, of the paved ground.
ESI Intensity	VI
Geomorphic setting	Urban area, hilly topography.

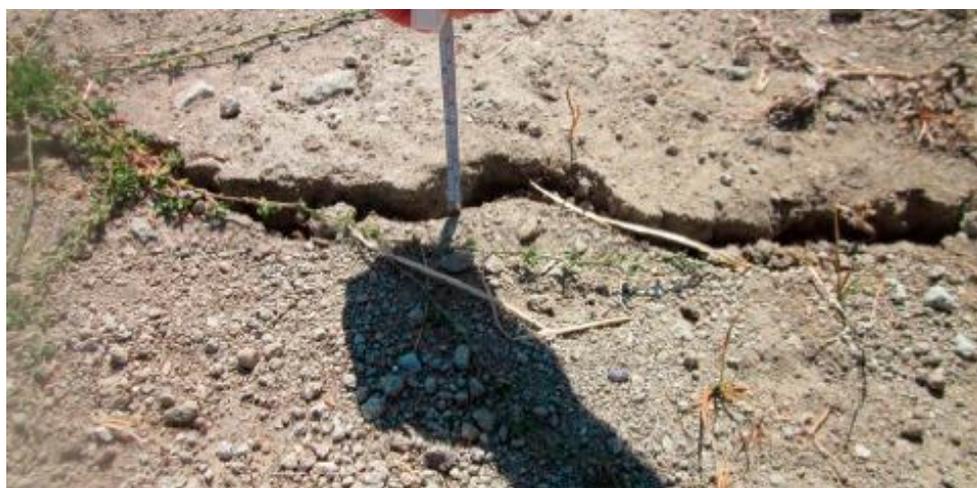
Sources of reference	Emergeo Working Group, 2019.
Site number	5
Latitude	40.740865°
Longitude	13.886959°
Locality	Via Crateca, Lacco Ameno (NA).
Type of effect	Ground fracture
Description	Ground fracture, E-trending, 10 m long, 2 cm wide, 2-3 cm of vertical offset, down to the N
ESI Intensity	VII
Geomorphic setting	Urban area, hilly topography.

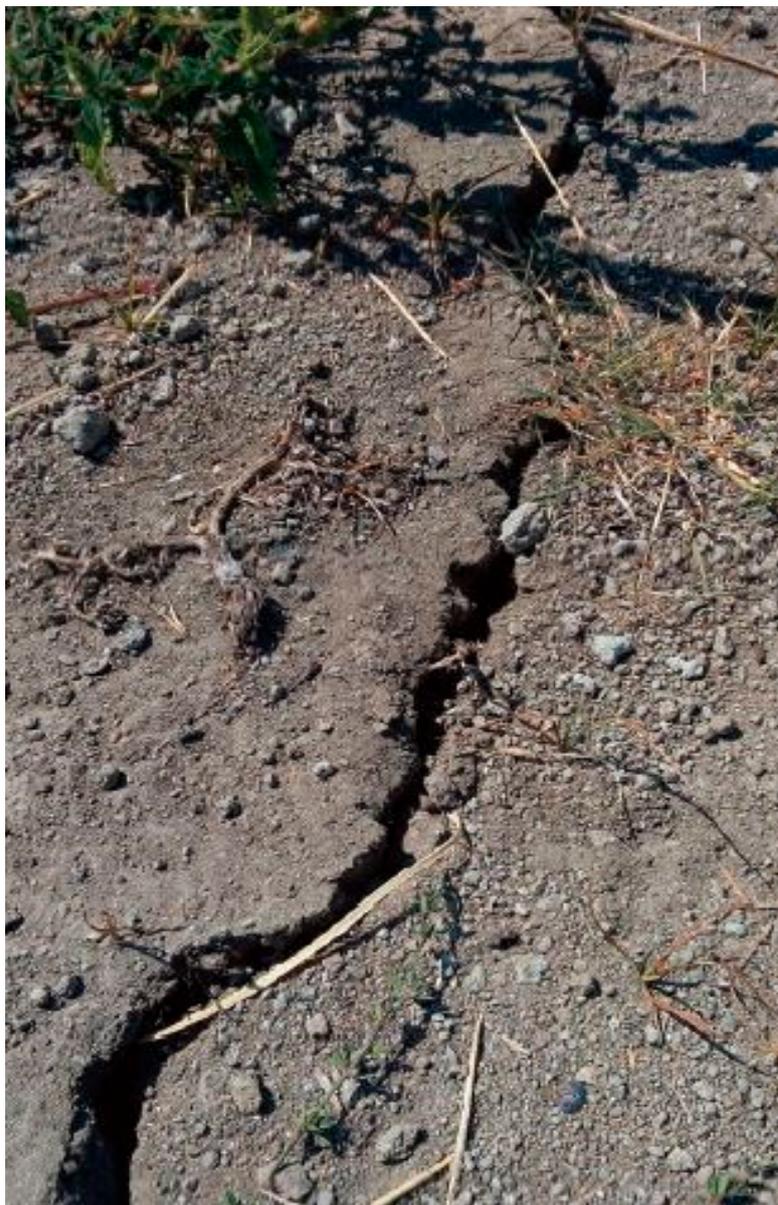
Sources of reference	Emergeo Working Group, 2019.
Site number	6
Latitude	40.741025°
Longitude	13.887702°
Locality	Via Crateca, Lacco Ameno (NA).
Type of effect	Ground fracture
Description	Ground fracture, E-trending, 18 m long, 2 cm wide, 2 cm of vertical offset, down to the N
ESI Intensity	VII
Geomorphic setting	Urban area, hilly topography.

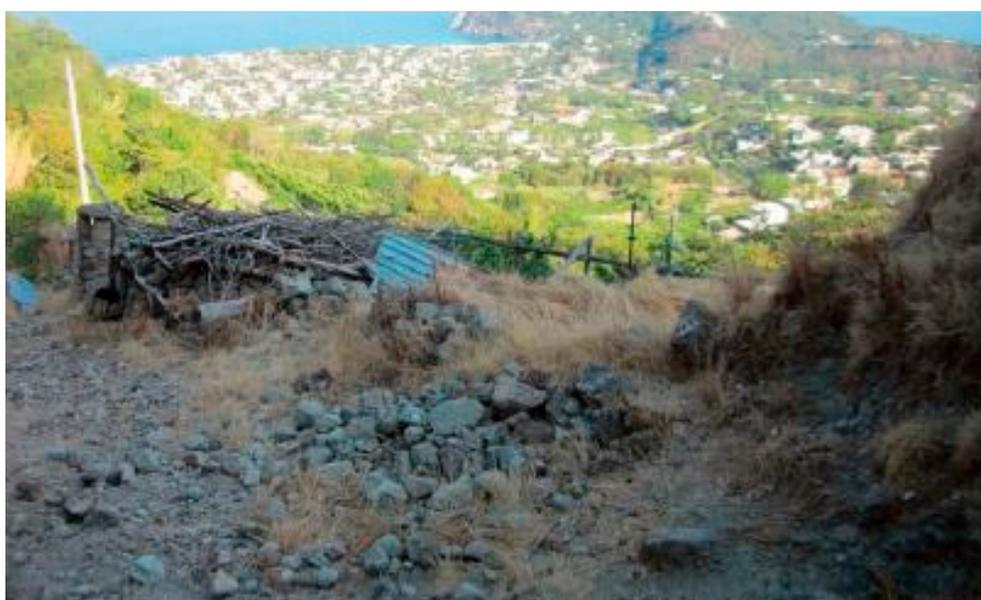
Sources of reference	Emergeo Working Group- 2019.
Site number	7
Latitude	40.736831°
Longitude	13.885297°
Locality	Fumaroles near Pizzone, Lacco Ameno (NA).
Type of effect	Rockfalls
Description	Widespread small rockfalls .
ESI Intensity	IV
Geomorphic setting	Rural area, sparsely populated, hilly topography with steep slopes

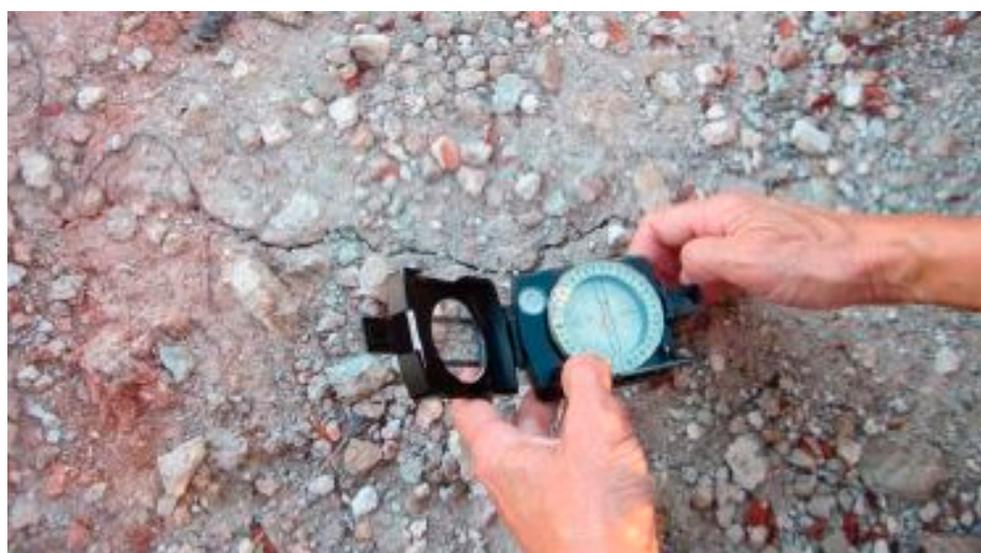
Sources of reference	Emergeo Working Group- 2019.
Site number	8
Latitude	40.736814°
Longitude	13.885357°
Locality	Fumaroles near Pantane, Lacco Ameno (NA).
Type of effect	Ground fractures
Description	Ground fractures in loose soil, 30 cm long, opening of few millimeters
ESI Intensity	IV
Geomorphic setting	Rural area, sparsely populated, hilly topography with steep slopes.

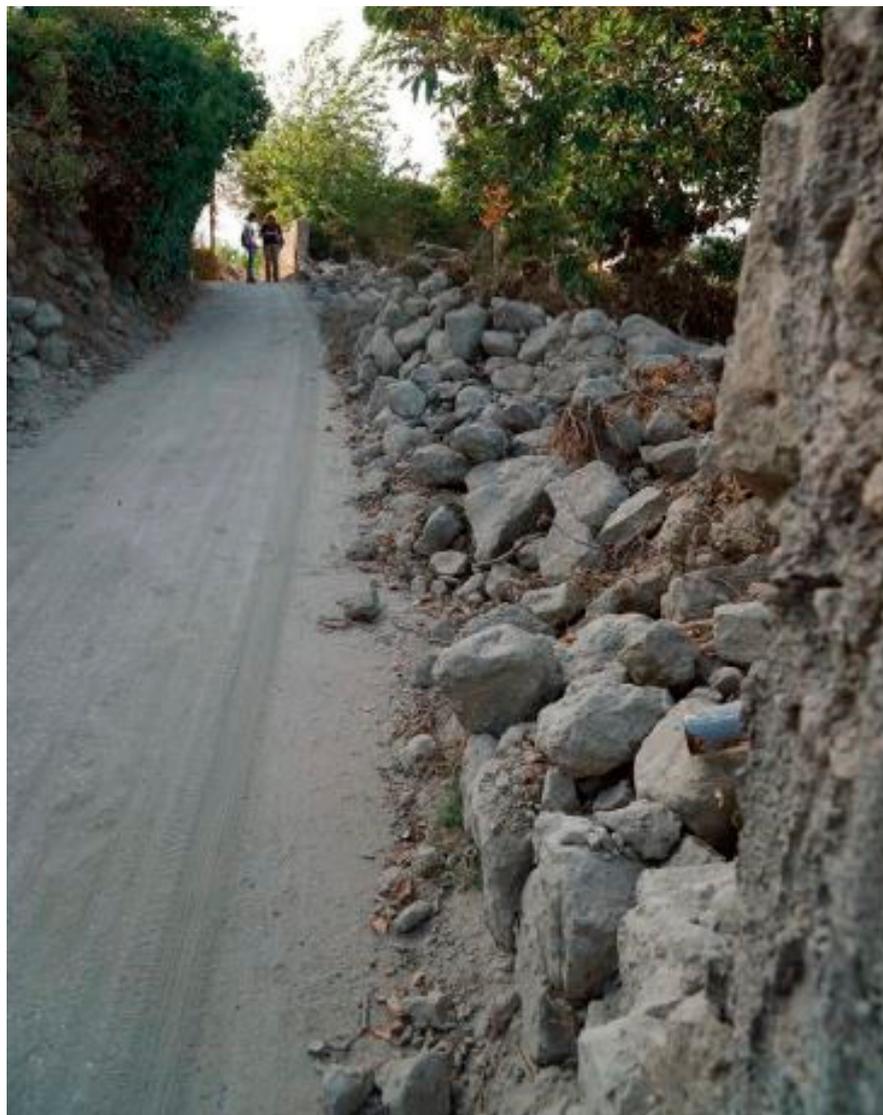
Sources of reference	Emergeo Working Group - 2019.
Site Number	10
Latitude	40.741903°
Longitude	13.888114°
Locality	Via dei Carri, Lacco Ameno (NA).
Type of effect	Earth Slide
Description	Drywall (parracina) collapse for a length of ca. 10 m
ESI Intensity	Data reported because located in the immediate vicinity of ground effects
Geomorphic setting	Urban area, hilly topography.

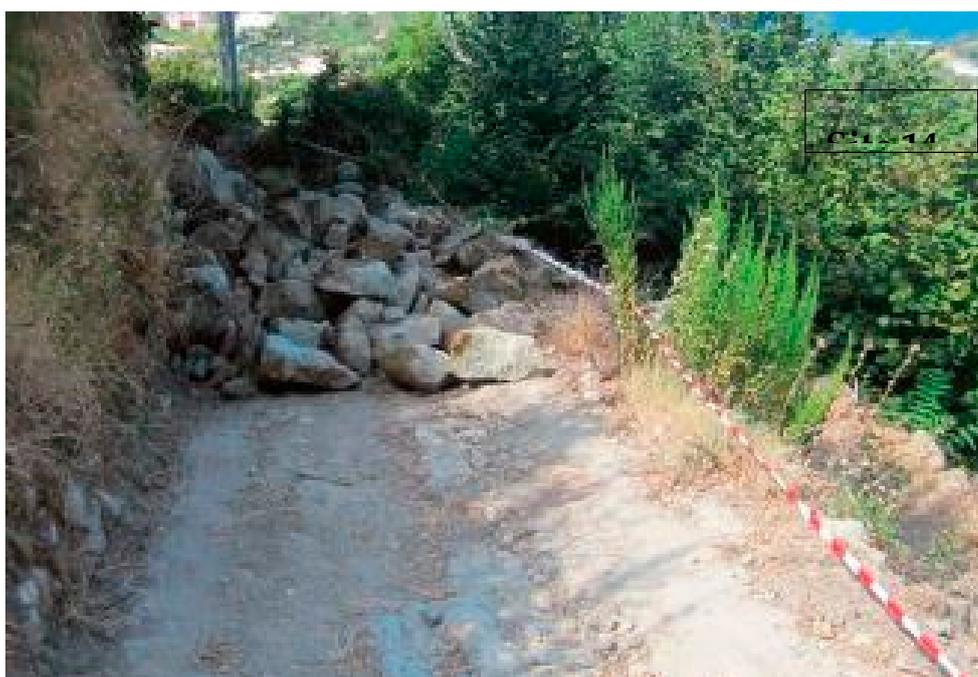
Sources of reference	Emergeo Working Group- 2019.
Site number	14
Latitude	40.739136°
Longitude	13.894196°
Locality	Via dei Carri, Casamicciola Terme (NA).
Type of effect	Earth slide
Description	Collapse of drywalls (parracine), on both sides of the road
ESI Intensity	Data reported because located in the immediate vicinity of ground effects
Geomorphic setting	Sparsely inhabited, hilly area, with steep slopes.

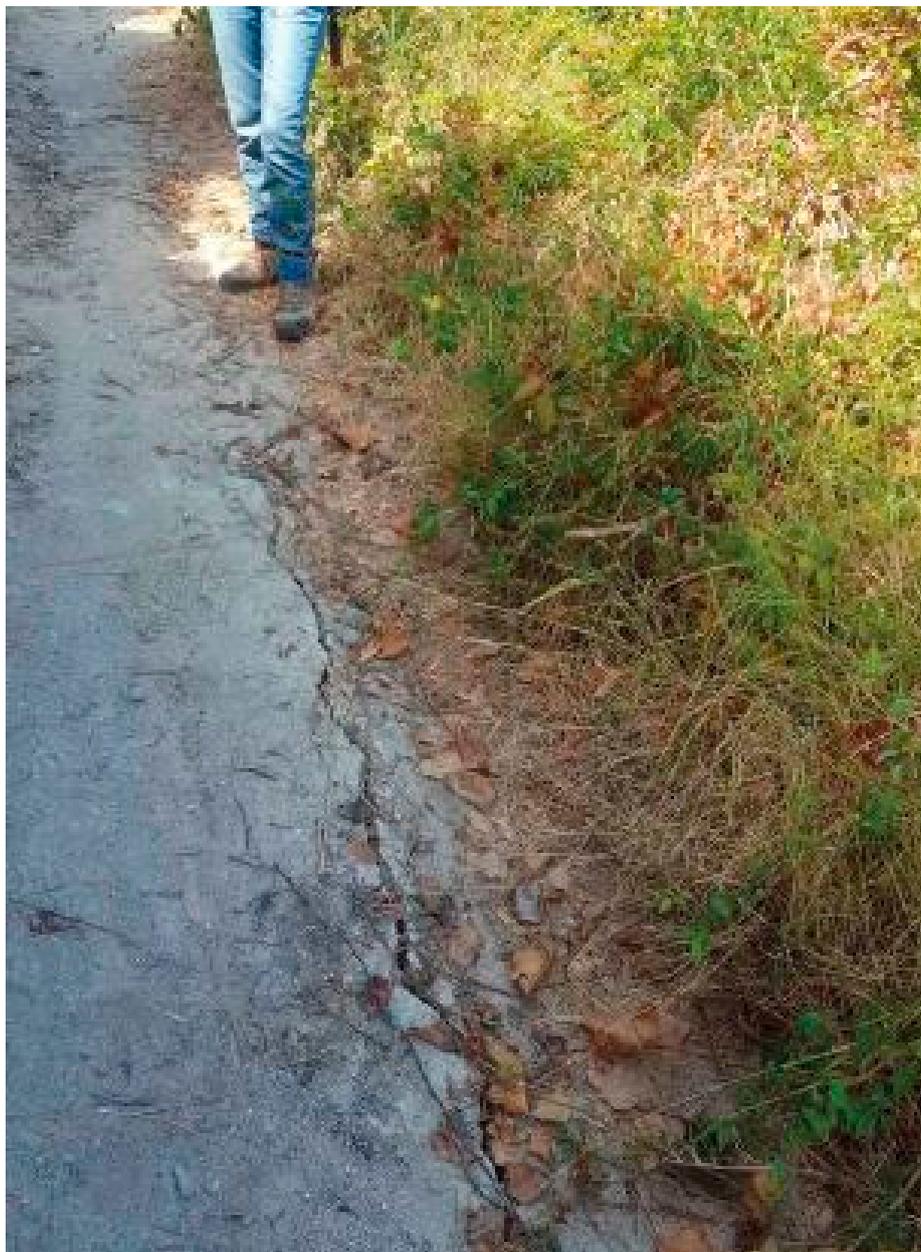
Sources of reference	Emergeo Working Group- 2019.
Site number	15
Latitude	40.739102°
Longitude	13.894529°
Locality	Via dei Carri, Casamicciola Terme (NA).
Type of effect	Ground fractures
Description	Fracturing of the soil, a couple of meters long and with an opening of about 1cm; vertical offset of 1-2cm, down to the N
ESI Intensity	V
Geomorphic setting	Sparsely inhabited, hilly area, with steep slopes.

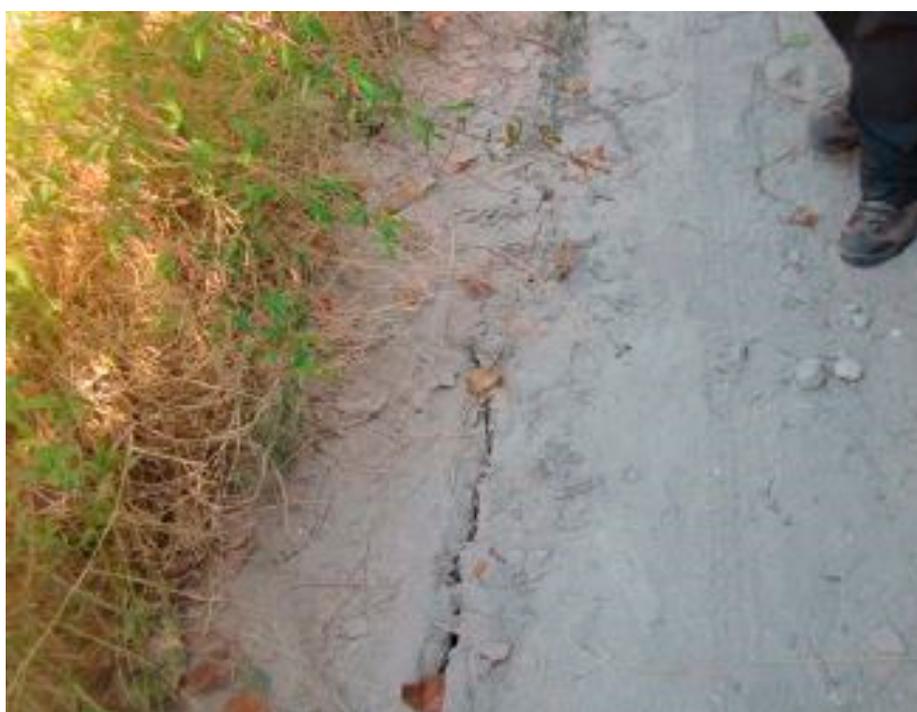
Sources of reference	Emergeo Working Group- 2019.
Site number	16
Latitude	40.739117°
Longitude	13.895028°
Locality	Via dei Carri, Casamicciola Terme (NA).
Type of effect	Ground fractures
Description	Fracturing in volcanic deposits, 1-2 m long, with an opening of about 1cm.
ESI Intensity	V
Geomorphic setting	Sparsely inhabited, hilly area, with steep slopes.

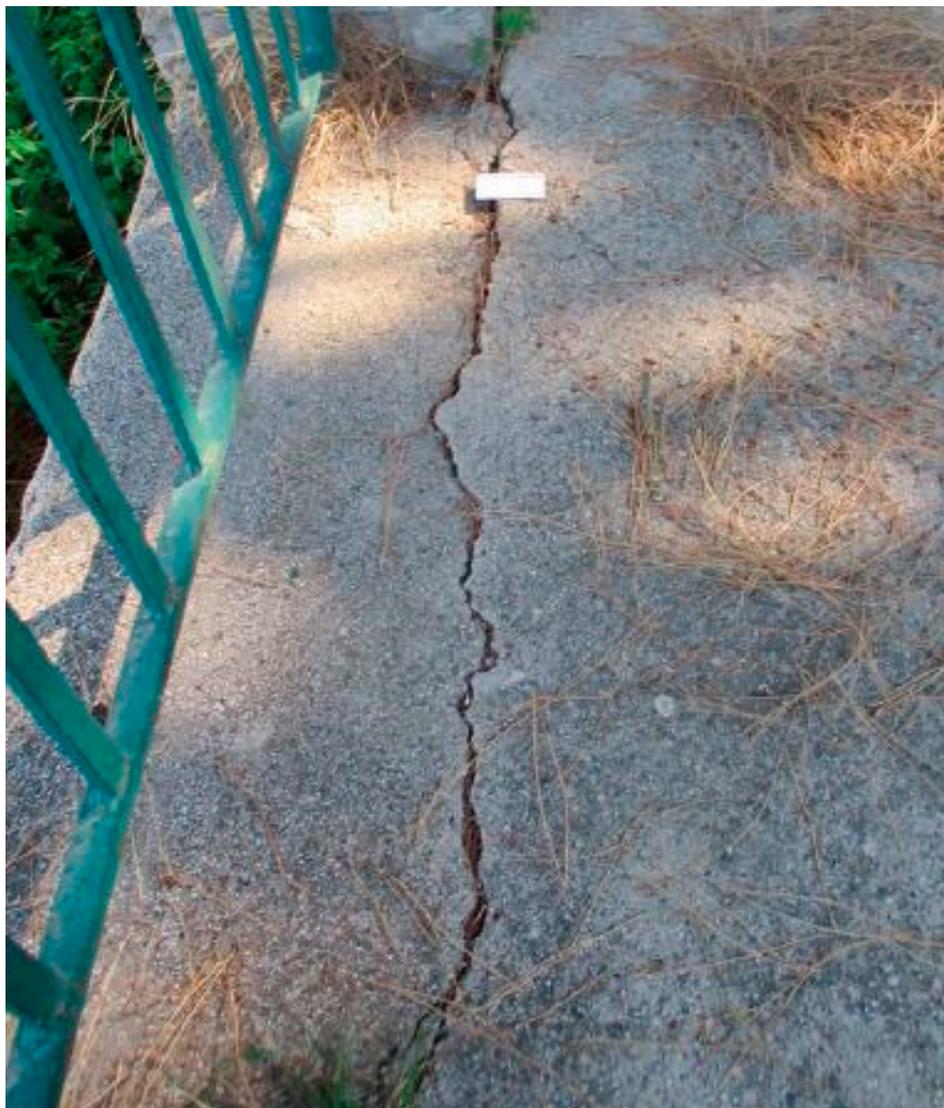
Sources of reference	Emergeo Working Group- 2019.
Site number	17
Latitude	40.742180°
Longitude	13.890433°
Locality	Via Montecito, Casamicciola Terme (NA).
Type of effect	Ground fractures
Description	Fracturing in the concrete of a sidewalk. The fracture extends for several meters, following the anchoring of the pillars of a handrail. It has an opening of less than 1 cm, but shows a vertical displacement of 1-2 cm, down to the N

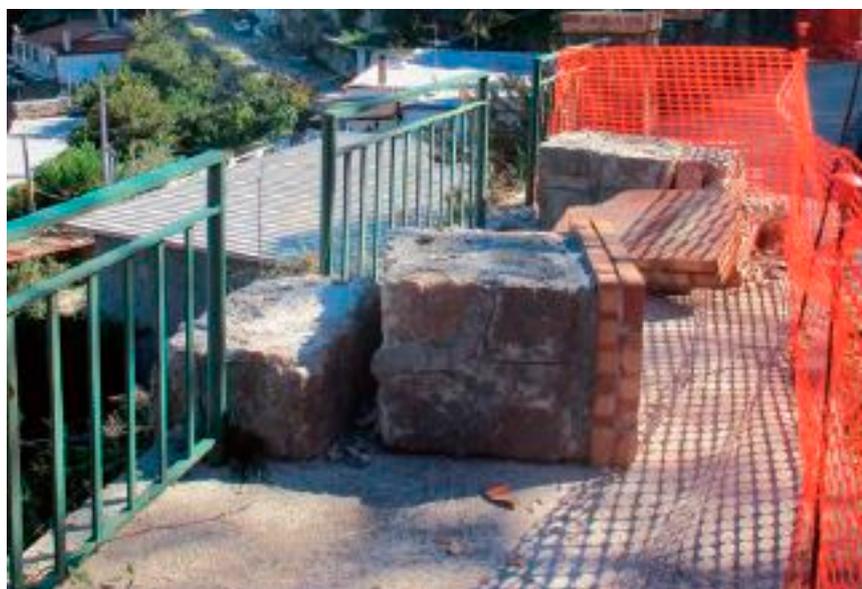
Sources of reference	Emergeo Working Group- 2019.
Site number	18
Latitude	40.741051°
Longitude	13.893538°
Locality	Via Montecito, Casamicciola Terme (NA)
Type of effect	Ground fracture
Description	Fracture and overturning of a small masonry pillar, forming part of a handrail, on the side of the road. At the base of the pillars there is a fracture in the concrete, with a vertical component of a couple of centimeters, down to the N
ESI Intensity	VI
Geomorphic setting	Urban area, hilly topography

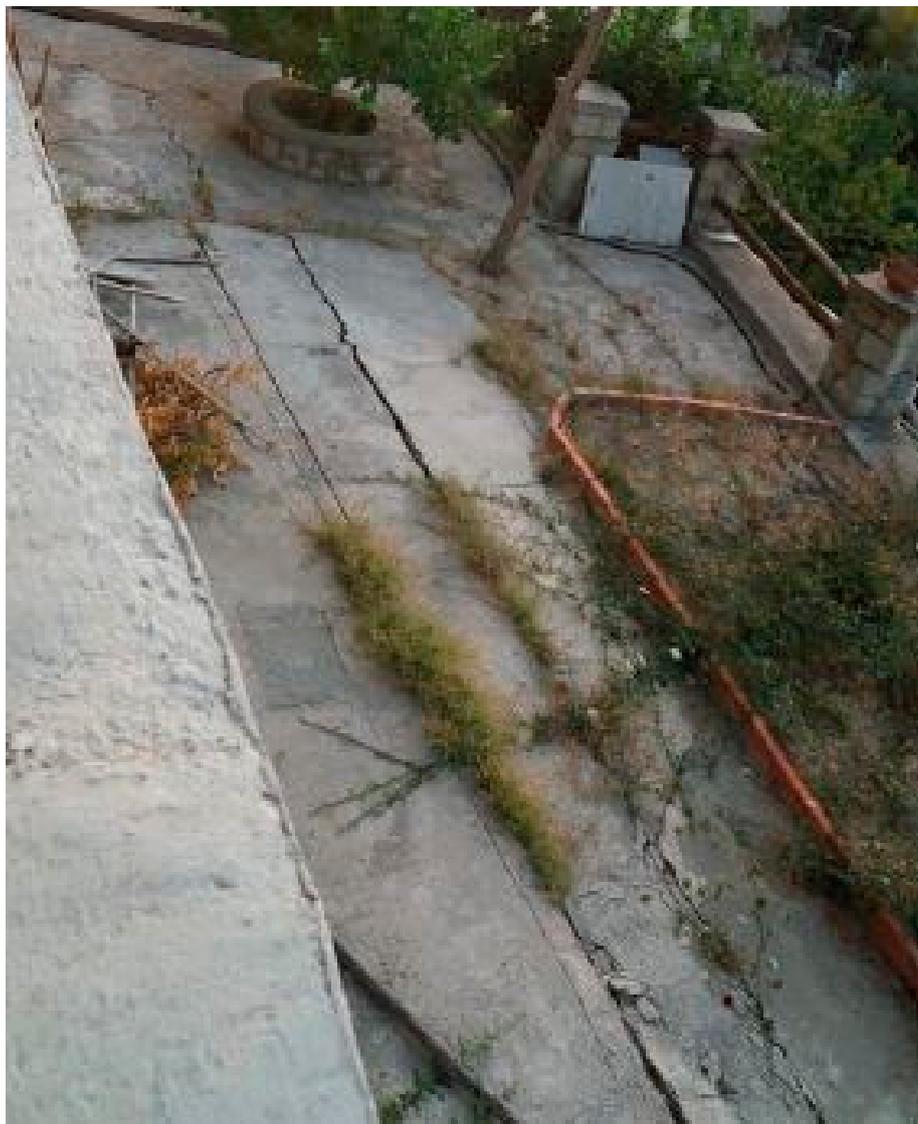
Sources of reference	Emergeo Working Group- 2019.
Site number	19
Latitude	40.740769°
Longitude	13.894643°
Locality	Via Montecito, Casamicciola Terme (NA).
Type of effect	Ground fractures
Description	Fracturing of the soil, of about 20 m, which also extends into a concrete pavement. The fracture has a variable opening of 1-2 cm.
ESI Intensity	VII
Geomorphic setting	Urban area, hilly topography

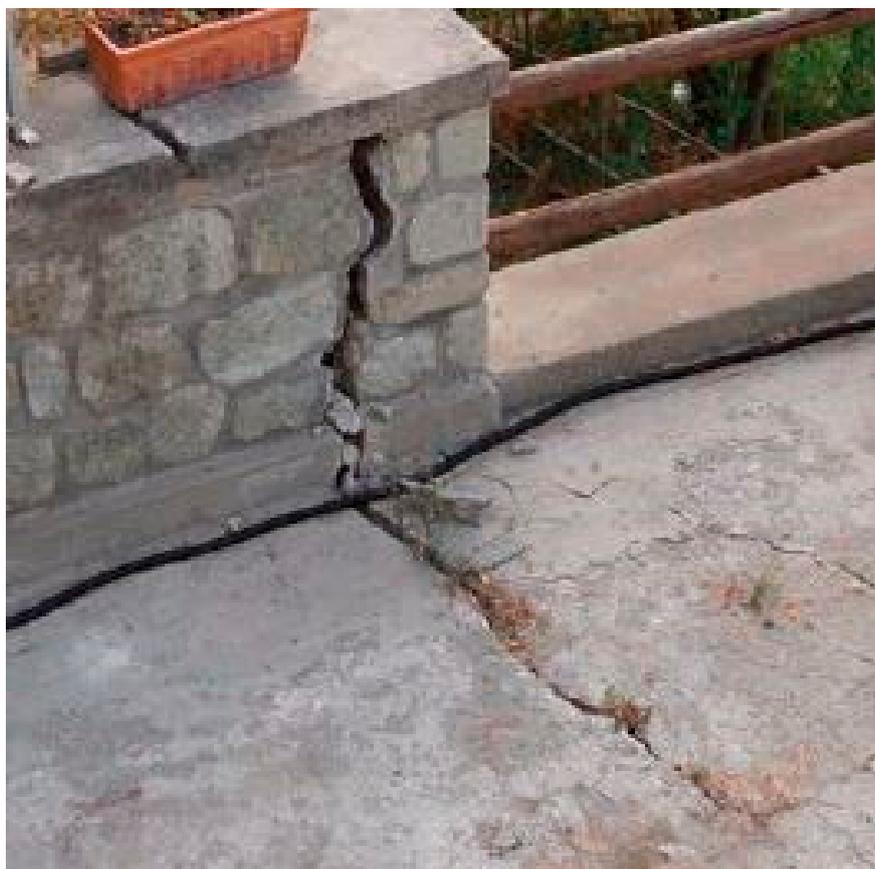
Sources of reference	Emergeo Working Group- 2019.
Site number	20
Latitude	40.740833°
Longitude	13.894542°
Locality	Via Montecito, Casamicciola Terme (NA).
Type of effect	Ground fractures
Description	Fracture about 50 cm long, which extends into the concrete pavement of the road, and continues into the side wall. The opening varies from 1 cm in the ground to 2-3 cm in the masonry.
ESI Intensity	VI
Geomorphic setting	Urban area, hilly topography

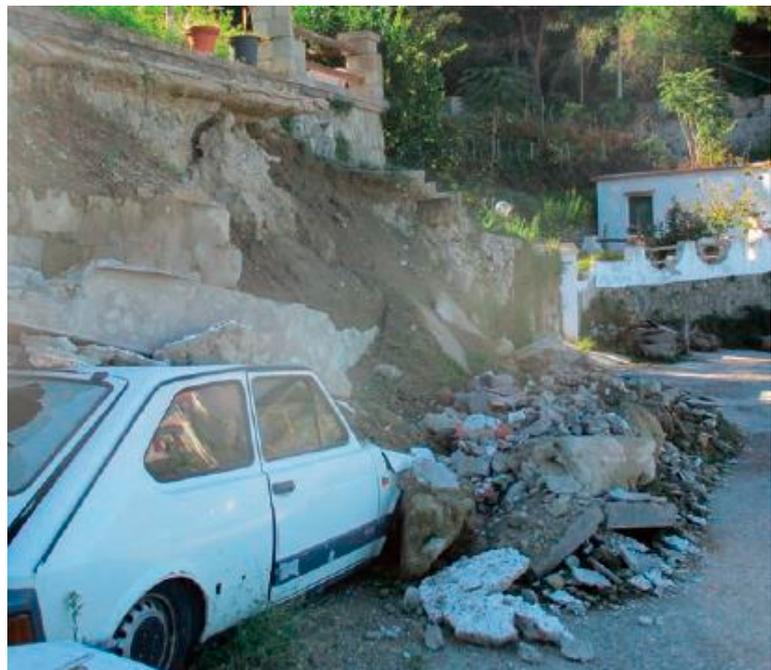
Locality	Via Montecito, Casamicciola Terme (NA).
Type of effect	Earth slide
Description	Collapse of a dry stone wall that surrounded a badly damaged house. The collapse affects about 5 m of the building.
ESI Intensity	Data reported because located in the immediate vicinity of ground effects
Geomorphic setting	Urban area, hilly topography

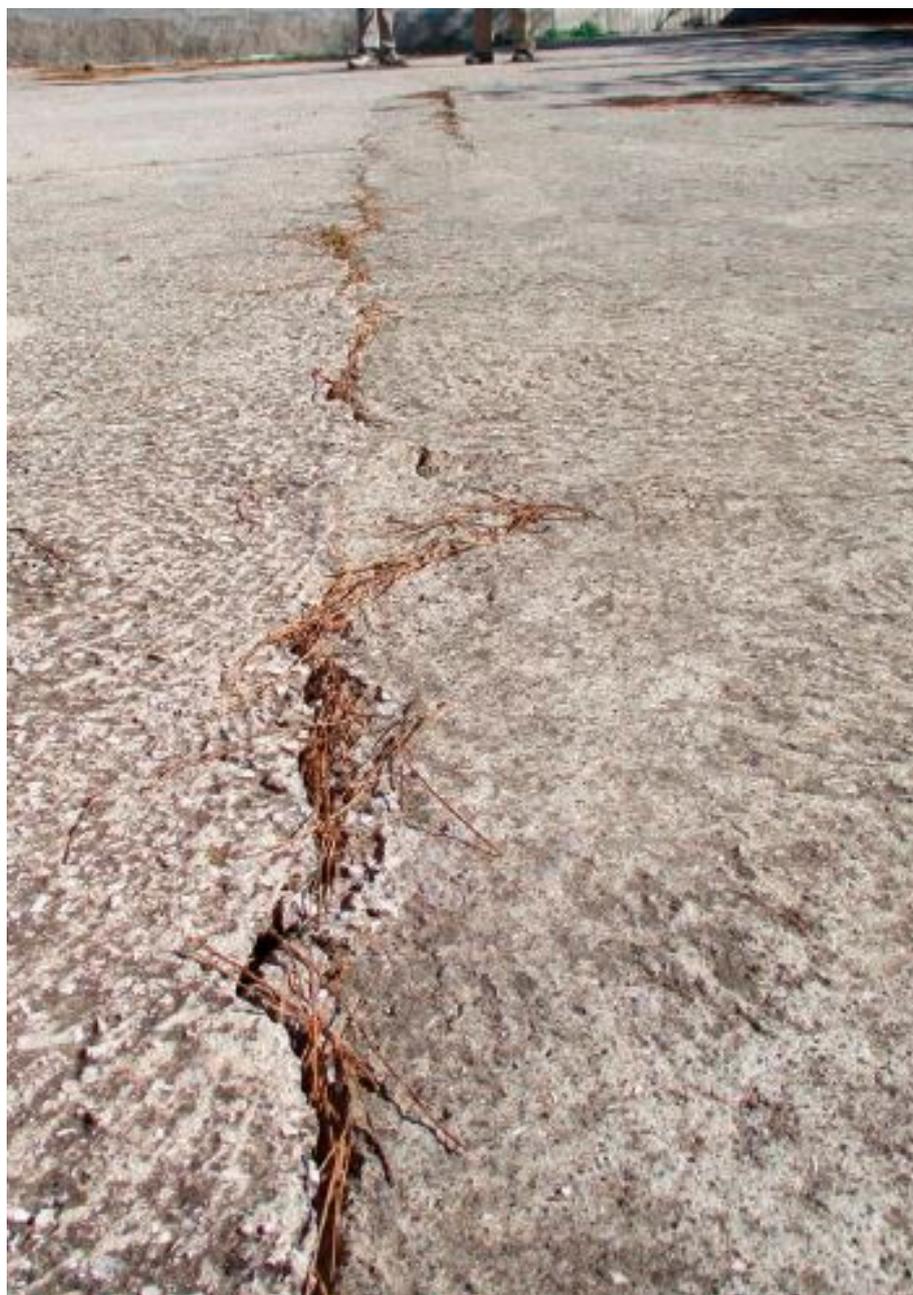
Locality	Via D'Aloisio, Casamicciola Terme (NA).
Type of effect	Ground fractures
Description	Fracture of the concrete pavement, which extends for about 10 m: the fracture has an opening of 1 cm and a vertical displacement of 2cm, down to the N
ESI Intensity	VII
Geomorphic setting	Urban area, hilly topography

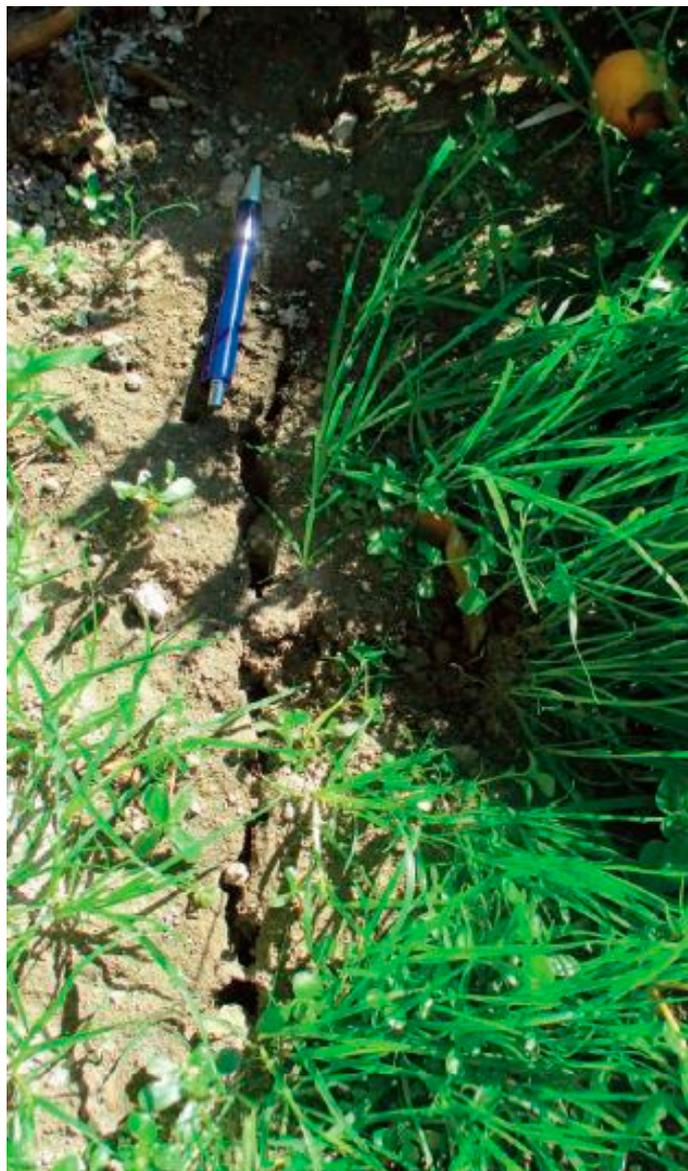
Sources of reference	Emergeo Working Group- 2019.
Site number	24
Latitude	40.743854°
Longitude	13.897108°
Locality	Via D'Aloisio, Casamicciola Terme (NA).
Type of effect	Ground fractures
Description	Fracture in incoherent soil extending for 1 m, with an opening of 1-2 cm.
ESI Intensity	V
Geomorphic setting	Urban area. Own garden. Flat area.

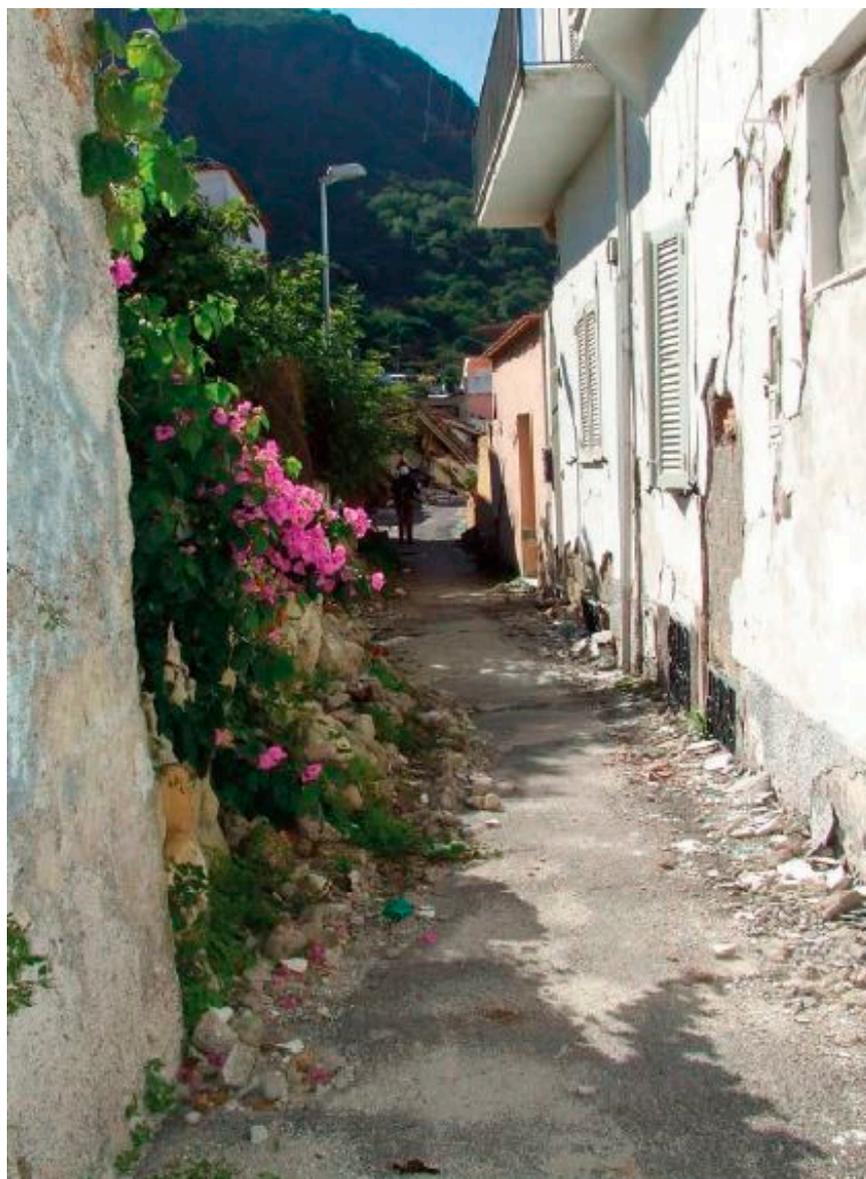
Sources of reference	Emergeo Working Group- 2019.
Site number	26
Latitude	40.743093°
Longitude	13.898186°
Locality	Via D'Aloisio, Casamicciola Terme (NA).
Type of effect	Earth slide
Description	Drywall (parracina) collapse for a length of ca. 3-4 m.
ESI Intensity	Data reported because located in the immediate vicinity of ground effects

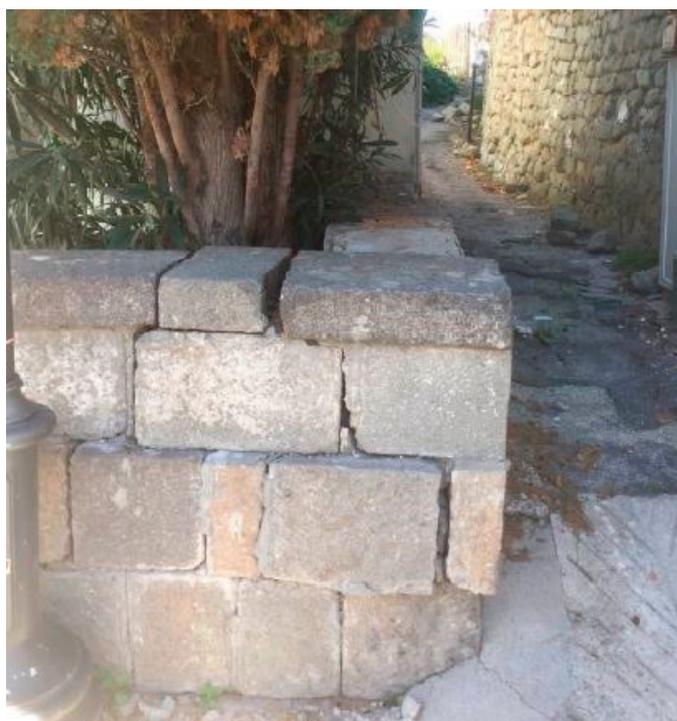
Sources of reference	Emergeo Working Group- 2019.
Site number	27
Latitude	40.743097°
Longitude	13.898661°
Locality	Via D' Aloisio, Casamicciola Terme (NA).
Type of effect	Ground fracture
Description	Fracturing of the paved soil which extends for about one meter and continues in the adjacent masonry wall. The opening of the fracture is less than 1 cm in the flooring, and about 2-3 cm in the low wall.
ESI Intensity	VI
Geomorphic setting	Urban area, hilly topography

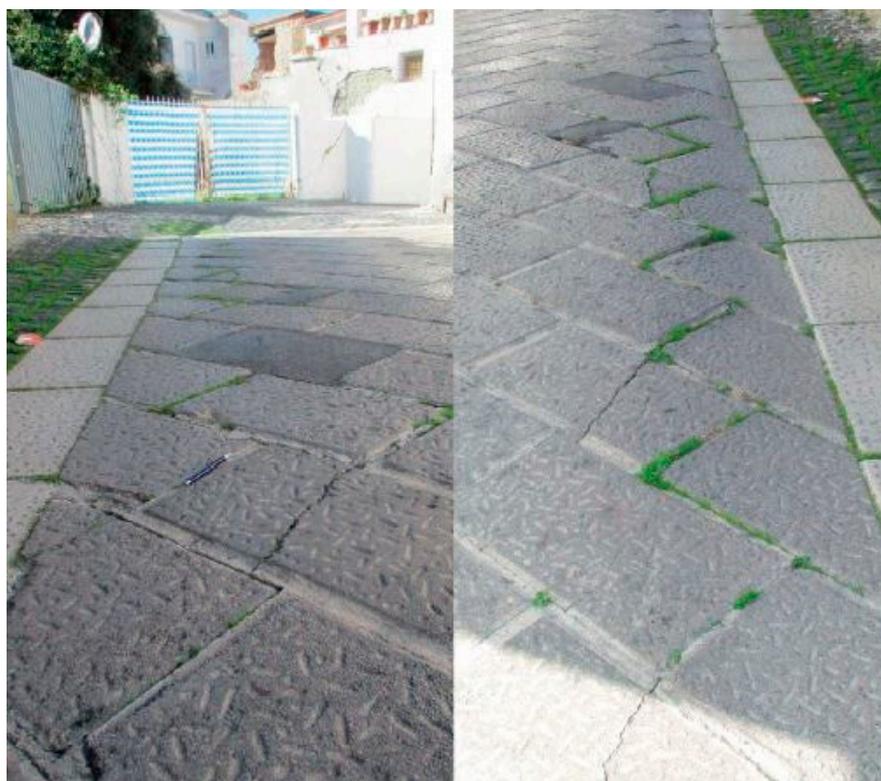
Sources of reference	Emergeo Working Group- 2019.
Site number	28
Latitude	40.742505°
Longitude	13.899797°
Locality	Via D'Aloisio, Casamicciola Terme (NA).
Type of effect	Ground fractures
Description	Fracturing of a paved road. The fractures extends for about 20 m, with an opening of no more than 1 cm, and continue into the wall of a severely damaged house.
ESI Intensity	VII
Geomorphic setting	Urban area, hilly topography

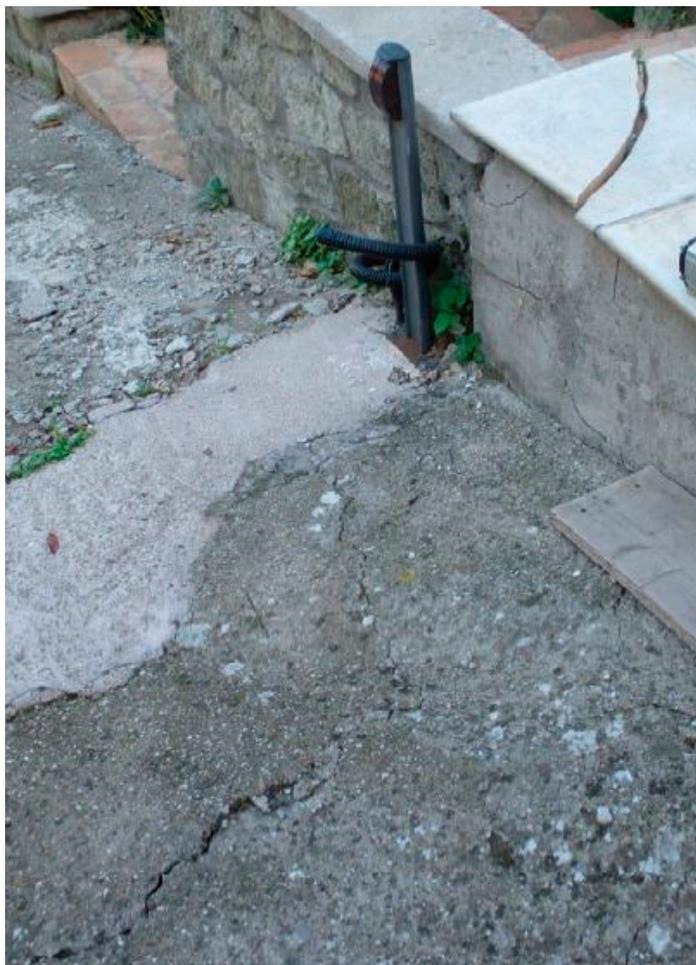
Description	Fracturing of the concrete road pavement, which continues in the adjacent wall. The fracture has an opening of no more than 1cm in the ground, while it increases up to 2-3 cm in the low wall. There is also a dislocation of about 2 cm of the wall covering
ESI Intensity	VI
Geomorphic setting	Urban area, hilly topography

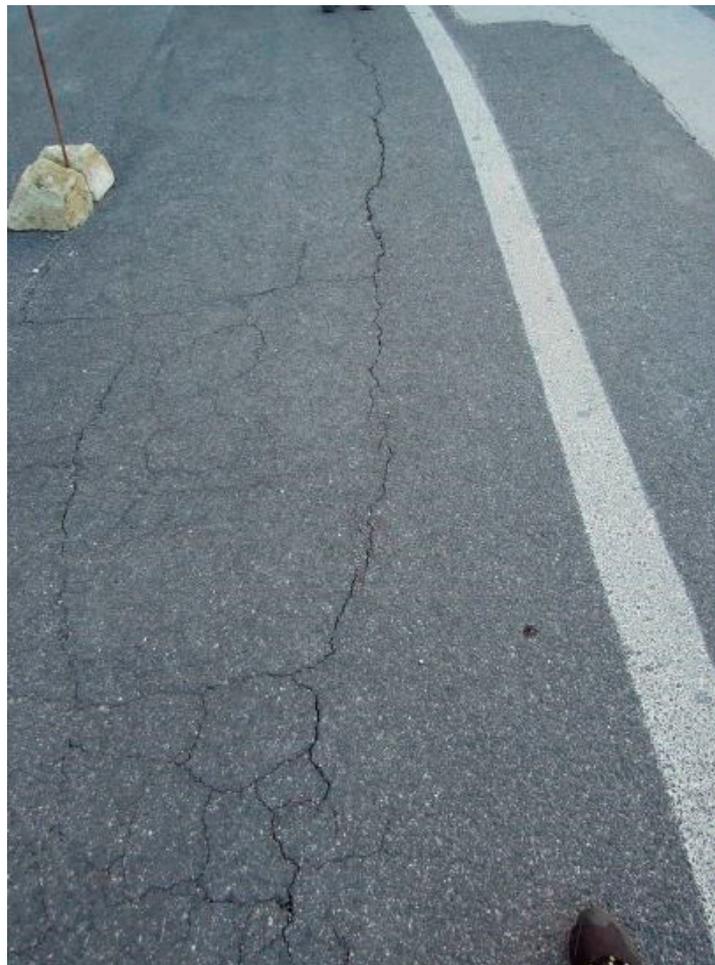
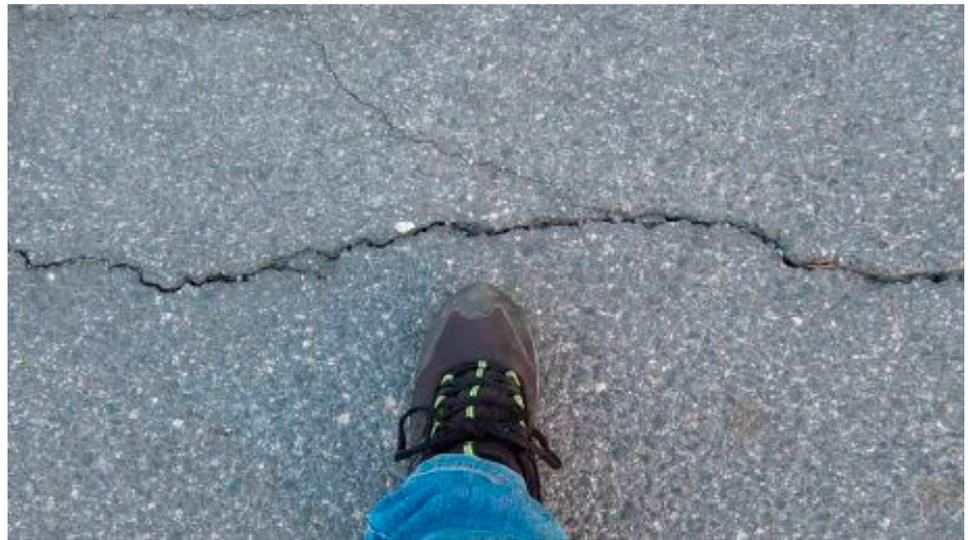
Sources of reference	Emergeo Working Group- 2019.
Site number	31
Latitude	40.742054°
Longitude	13.899618°
Locality	Via Montecito, Casamicciola Terme (NA).
Type of effect	Ground fractures
Description	Fracture of the asphalt road surface, approximately 10 m long, with an opening of 1 cm. Fracturing is observed along a stretch of road on the side of which the neighboring buildings have collapsed or severely damaged.
ESI Intensity	VII
Geomorphic setting	Urban area, hilly topography

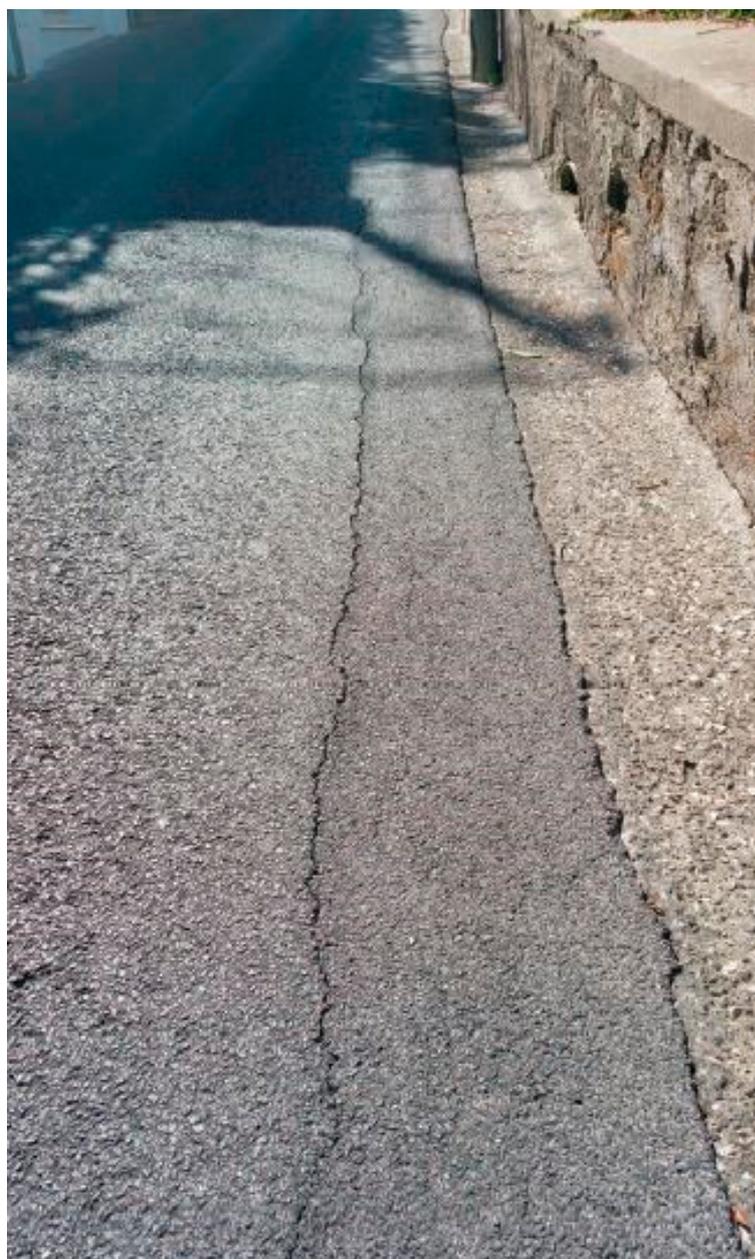
Sources of reference	Emergeo Working Group- 2019.
Site number	32
Latitude	40.745316°
Longitude	13.903518°
Locality	Via Castanito, Casamicciola Terme (NA).
Type of effect	Ground fractures
Description	Fracture of the asphalt road surface, which extends for about 5m and has an opening of no more than 1 cm
ESI Intensity	VI
Geomorphic setting	Urban area, hilly topography
