The 2017, Md = 4.0, Casamicciola Earthquake: ESI Scale Evaluation and Implications for the Source Model.

Table S1. Descriptive sheet of the environmental effects allowed the estimation of the degrees of ESI intensity and the reconstruction of the isoseismal map.

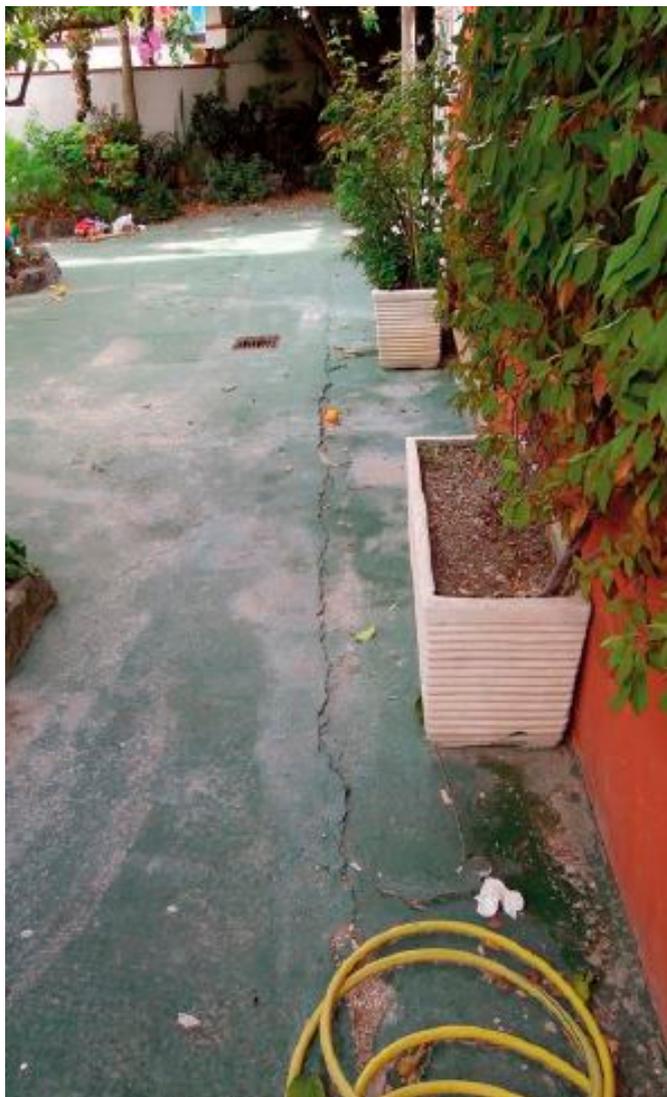
Sources of reference	Emergeo Working Group- 2019.
Site number	33
Latitude	40.743056°
Longitude	13.902477°
Locality	Via Sassolo, Casamicciola Terme (NA).
Type of effect	Ground fractures
Description	Fracturing of the cemented soil in front of a house. The fracture extends for 5m, showing an opening of less than 1 cm and a vertical dislocation of 1 cm, down to the north
ESI Intensity	VI
Geomorphic setting	Urban area, hilly topography

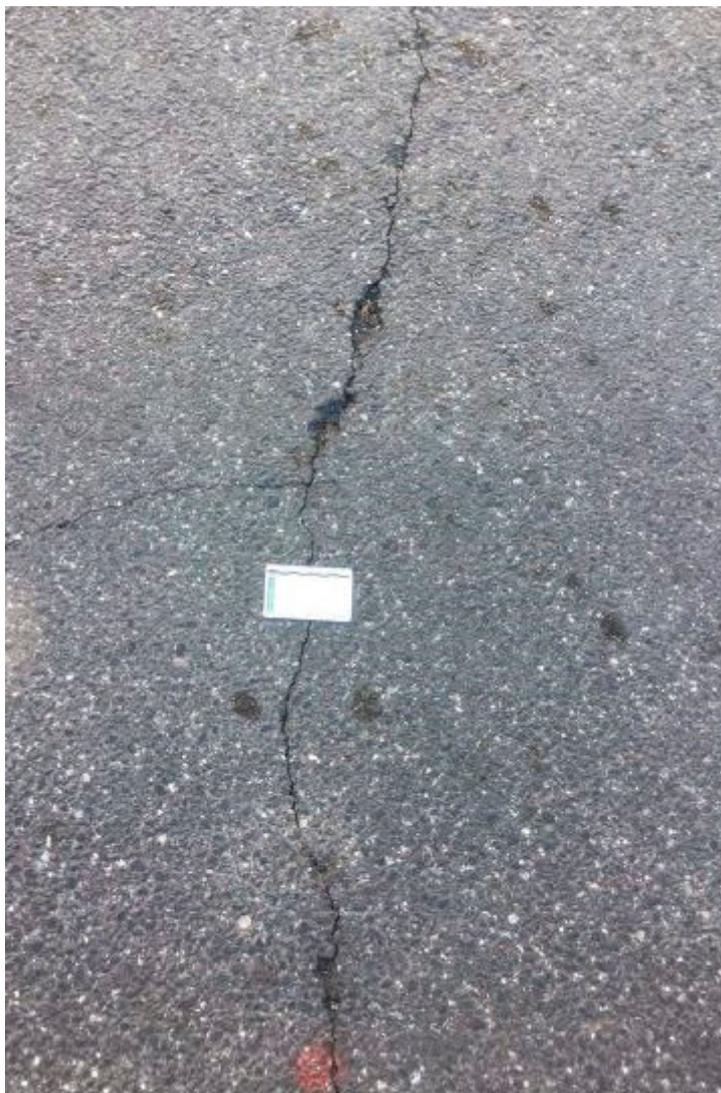
Sources of reference	Emergeo Working Group- 2019.
Site number	34
Latitude	40.742514°
Longitude	13.902068°
Locality	Via Ottringolo, Casamicciola Terme (NA).
Type of effect	Ground fractures
Description	Fracturing of an asphalted road, which extends for about 2 m, with opening and vertical displacement not exceeding 1 cm
ESI Intensity	VI
Geomorphic setting	Urban area, hilly topography

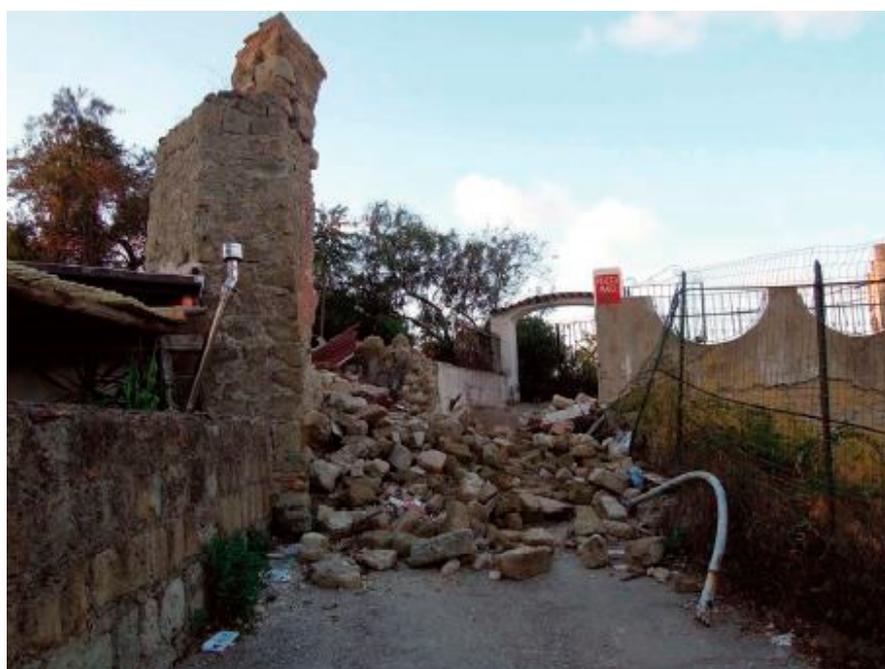
Collapse of several drywalls, which caused the interruption of the road. The walls collapsed for a length of 4-5 m

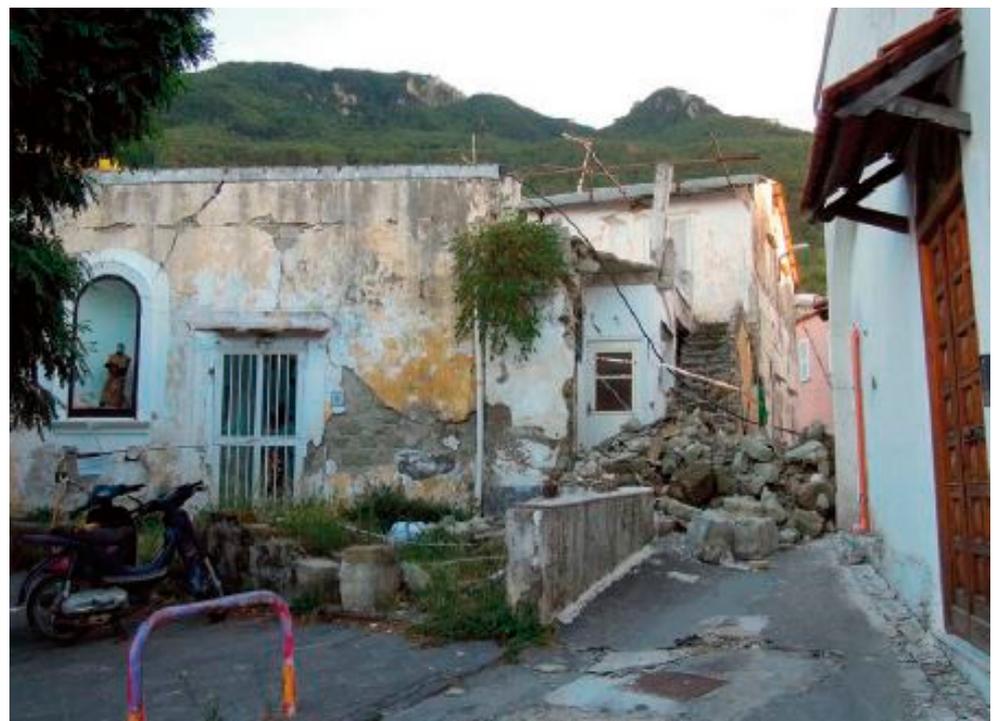
Description	Fracturing of the road at the intersection of the roads Spezieria, Ottringolo and Santa Barbara. The fracture extends for 5-6 m, also affecting the adjacent houses and causing the collapse of the wall of a house. A vertical offset of the fracture of 2-3 cm down to the north is observed.
ESI Intensity	VII
Geomorphic setting	Urban area, hilly topography

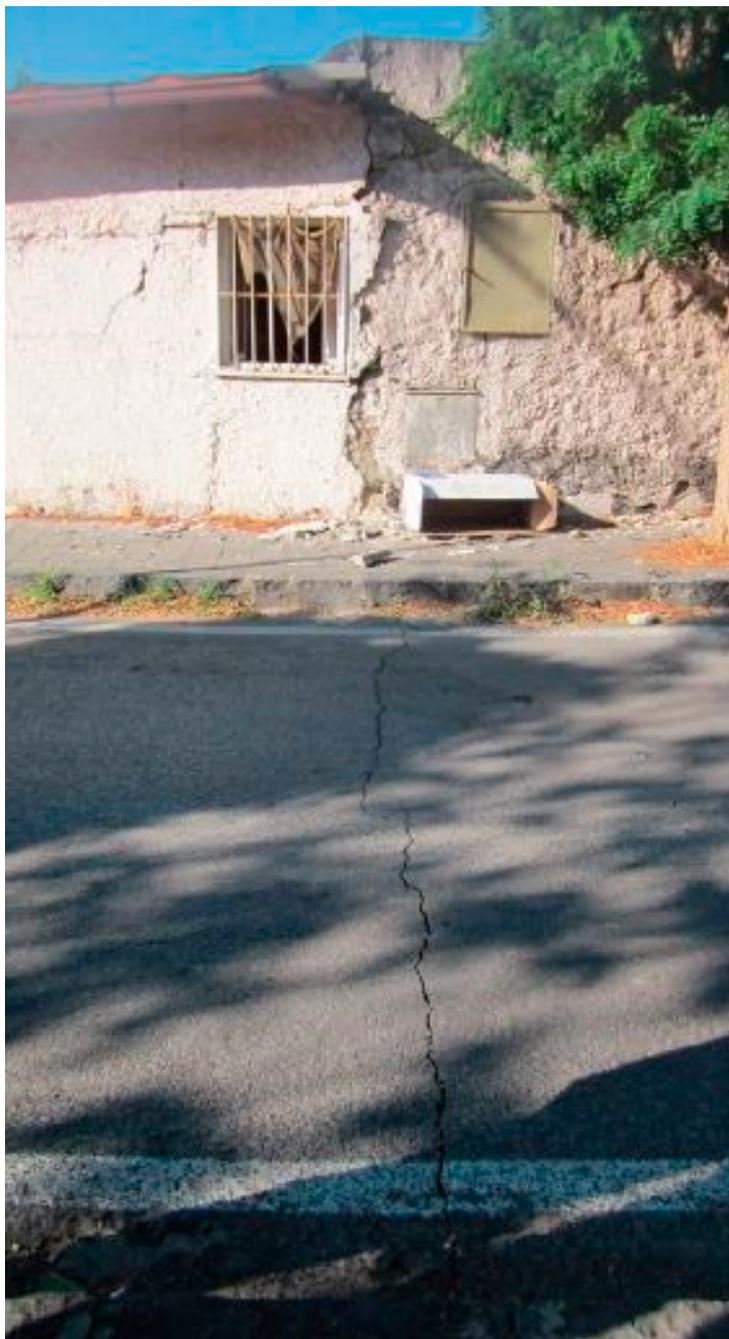
Longitude	13.902195°
Locality	Via Santa Barbara, Casamicciola Terme (NA).
Type of effect	Ground fractures
Description	Fracturing of the asphalt road; the fracture extends for 5 m, crossing sidewalks, streets and buildings. It has an opening of 1 cm
ESI Intensity	VII
Geomorphic setting	Urban area, hilly topography

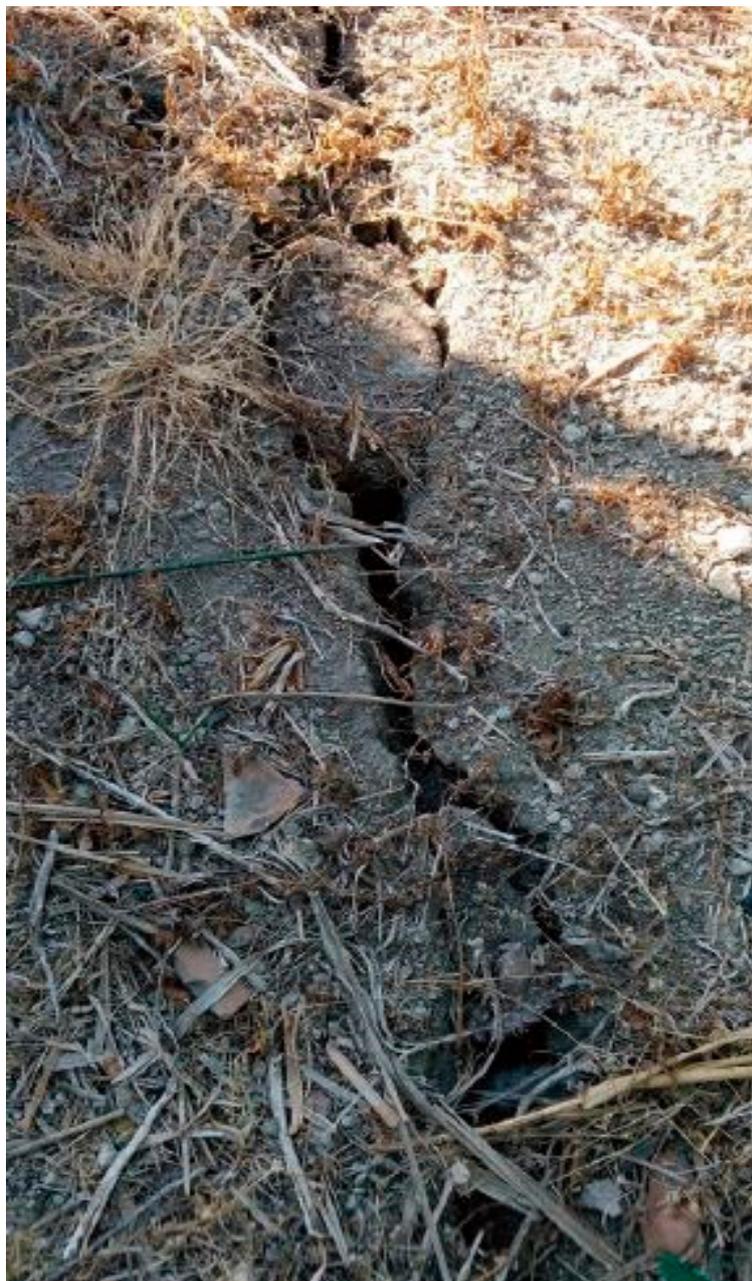
Sources of reference	Emergeo Working Group- 2019.
Site number	39
Latitude	40.742104°
Longitude	13.902934°
Locality	Via Santa Barbara, Casamicciola Terme (NA).
Type of effect	Ground fractures
Description	Fracturing of incoherent soil that extends for 20 m in the garden of a house. The fracture has an opening of 2-3 cm. A subsidence of the soil is observed north of the fracture
ESI Intensity	VII
Geomorphic setting	Courtyard of a house, urban area, hilly topography

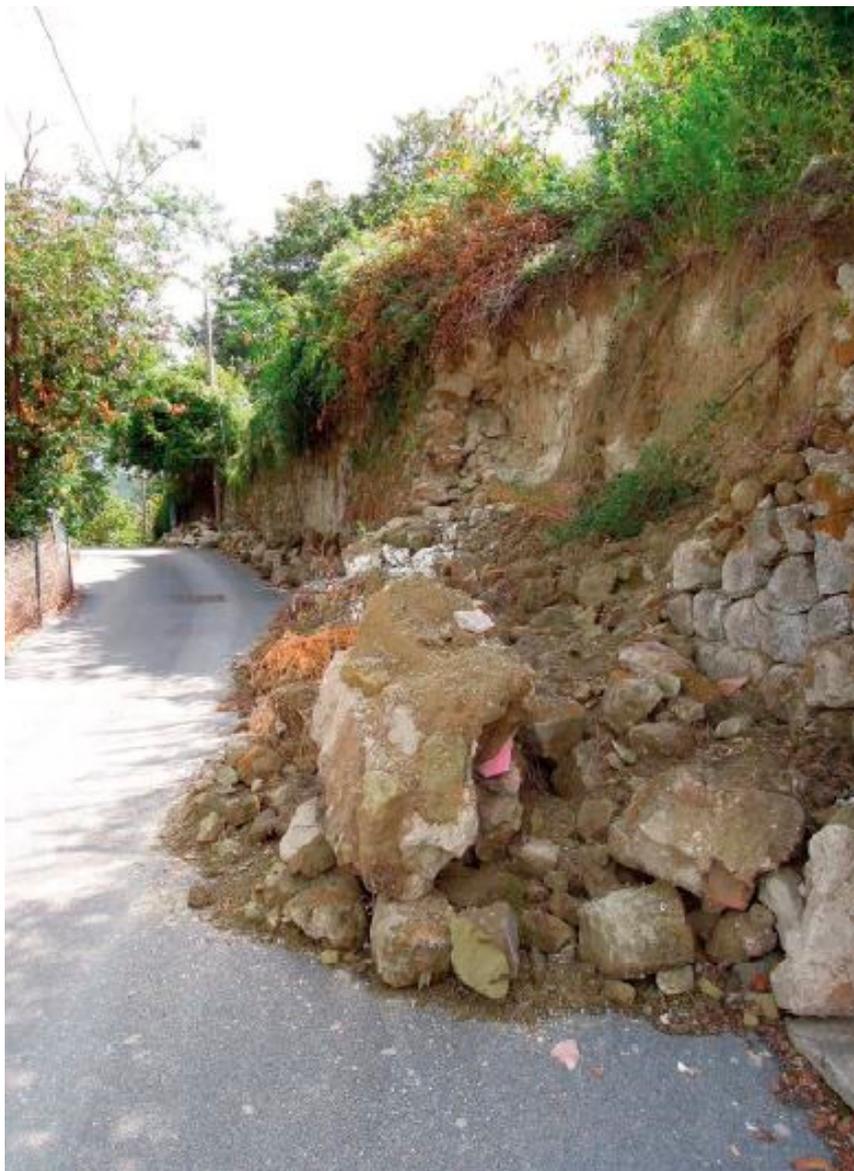
Sources of reference	Emergeo Working Group- 2019.
Site number	40
Latitude	40.742345°
Longitude	13.903753°
Locality	Via Nizzola, Casamicciola Terme (NA).
Type of effect	Earth slide
Description	Collapse of a drywall (parracina) for a length of 5 m
ESI Intensity	Data reported because located in the immediate vicinity of ground effects
Geomorphic setting	Urban area, hilly topography

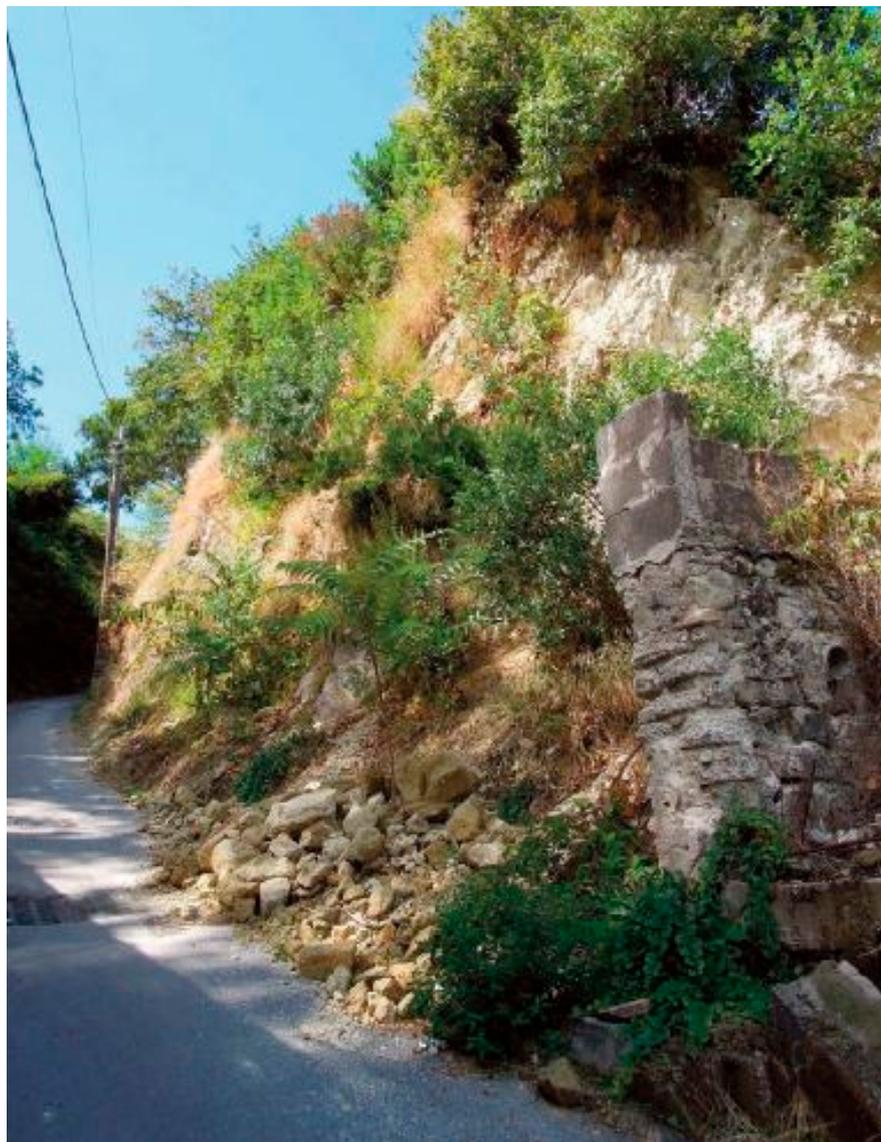
Sources of reference	Emergeo Working Group- 2019.
Site number	42
Latitude	40.742511°
Longitude	13.906498°
Locality	Via Nizzola, Casamicciola Terme (NA).
Type of effect	Earth slide
Description	Collapse of a dry stone wall (parracina) for a section about 3 m long
ESI Intensity	Data reported because located in the immediate vicinity of ground effects
Geomorphic setting	Urban area, hilly topography

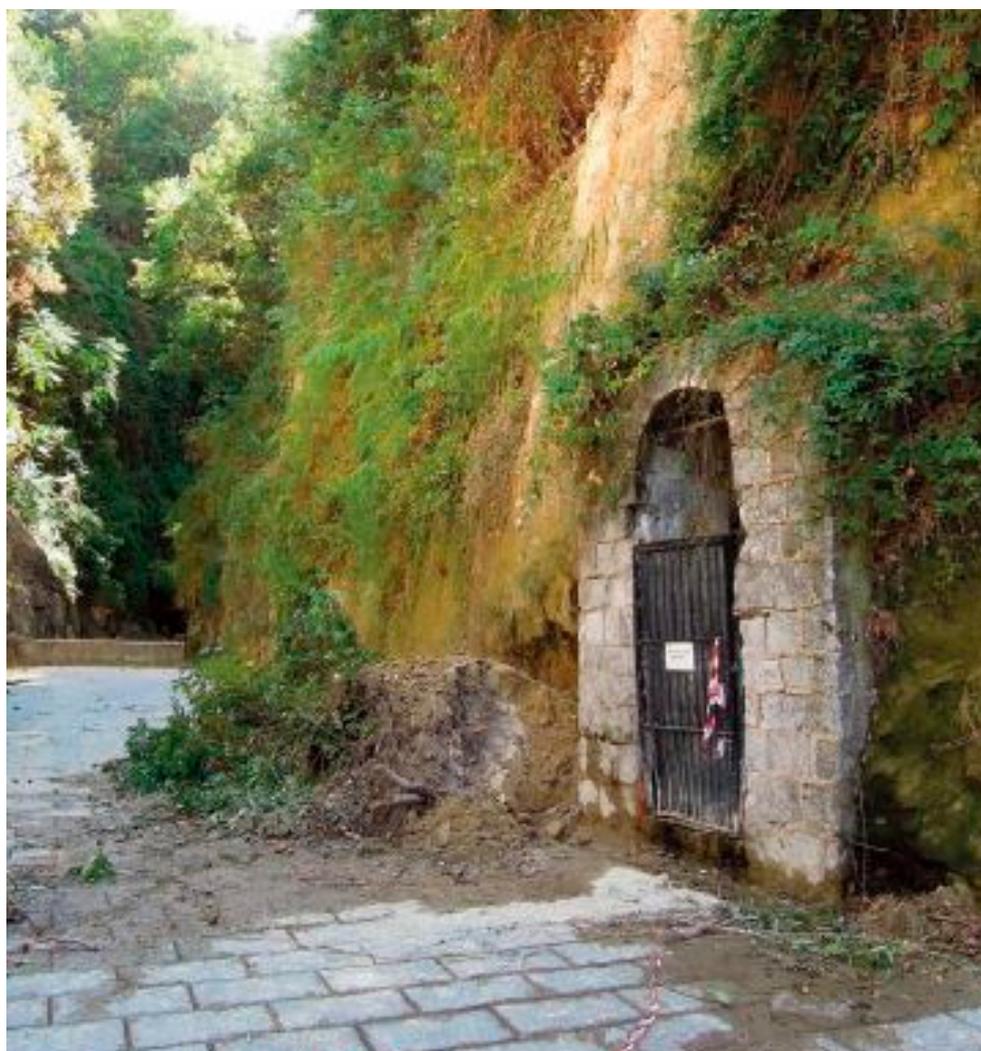
Sources of reference	Emergeo Working Group- 2019.
Site number	43
Latitude	40.741983°
Longitude	13.907134°
Locality	Via Nizzola, Casamicciola Terme (NA).
Type of effect	Landslide
Description	Landslide of modest size in volcanoclastic deposits
ESI Intensity	IV
Geomorphic setting	Rural area, sparsely populated, hilly topography with steep slopes

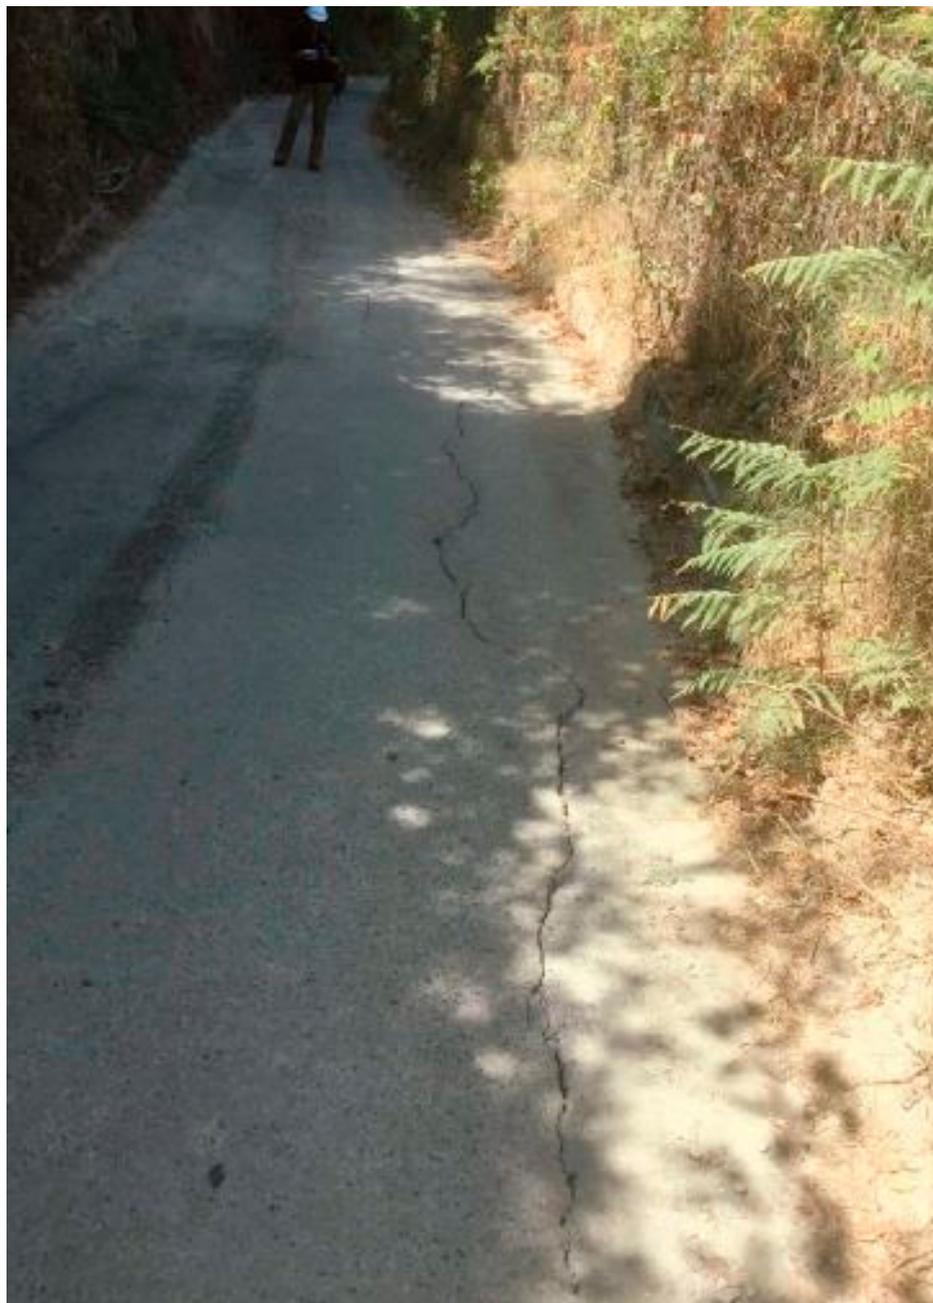
Sources of reference	Emergeo Working Group- 2019.
Site number	44
Latitude	40.739411°
Longitude	13.906299°
Locality	Via Campomanno, Casamicciola Terme (NA).
Type of effect	Ground fractures
Description	Fracturing of the asphalt road; the fracture extends for 100 m, with an opening of 1 cm
ESI Intensity	VII
Geomorphic setting	Rural area, sparsely populated, hilly topography with steep slopes

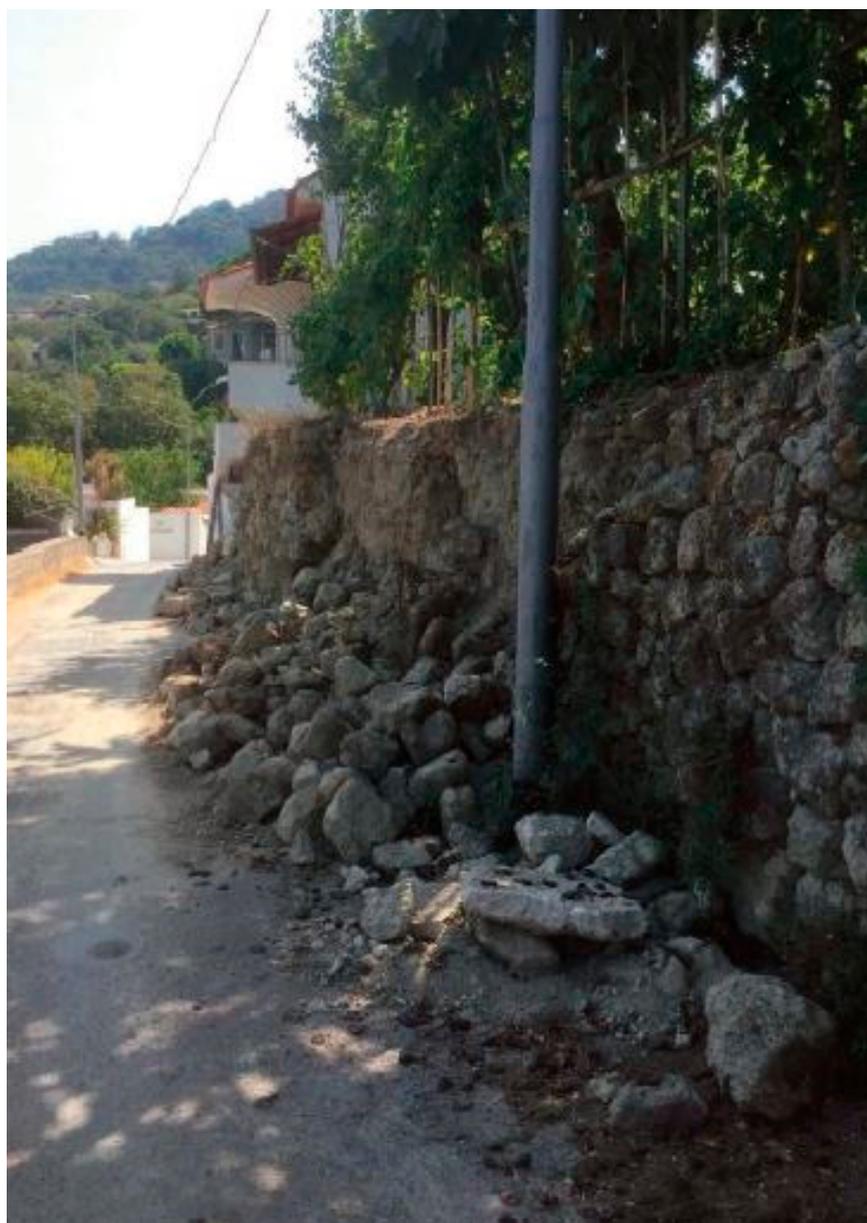
Description	Collapse of a dry stone wall (parracina), for a length of about 10 m
ESI Intensity	Data reported because located in the immediate vicinity of ground effects
Geomorphic setting	Urban area, hilly topography

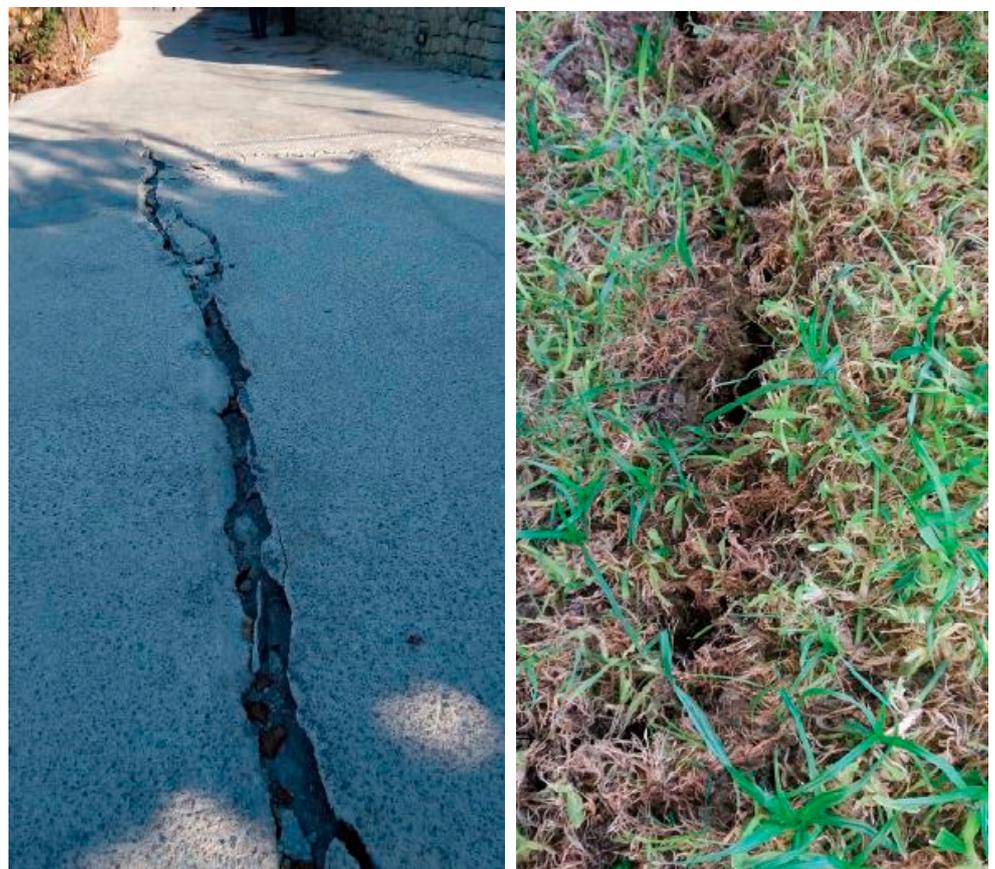
Sources of reference	Emergeo Working Group- 2019.
Site number	48
Latitude	40.741468°
Longitude	13.900964°
Locality	Via Santa Barbara, Casamicciola Terme (NA).
Type of effect	Ground fractures
Description	Fracturing of the soil involving the road surface, the garden and the paved terrace of the adjacent house. The fracture extends for a hundred meters, with a maximum opening of 4 cm. In some points a vertical displacement of a couple of centimeters is observed, down to the north
ESI Intensity	VII
Geomorphic setting	Urban area, hilly topography
