Damage to Churches after the 2016 Central Italy Seismic Sequence

Abstract: The present study focuses on seismic damage to 36 masonry churches observed after the 2016 Central Italy earthquake. In the sample, recurrent architectural and structural features were identified and accurately described. In order to classify the churches in the sample based on their safety level, their seismic vulnerability was assessed by adopting the simplified procedure proposed in the current Italian standards for cultural heritage. The observed damage, directly detected by the authors during the post-earthquake surveys, is presented and carefully described, highlighting the evolution of the damage. An analysis of the damage suffered by the inspected churches highlighted the most frequent causal mechanisms and the most vulnerable macroelements. Particular attention was devoted to computation of a damage index based on the observed damage as well as on the macroelements present in the surveyed churches. Moreover, a judgment of usability, i.e., whether a church could be occupied after a seismic event, was made using the official survey form and related to both the seismic intensity experienced and the ob

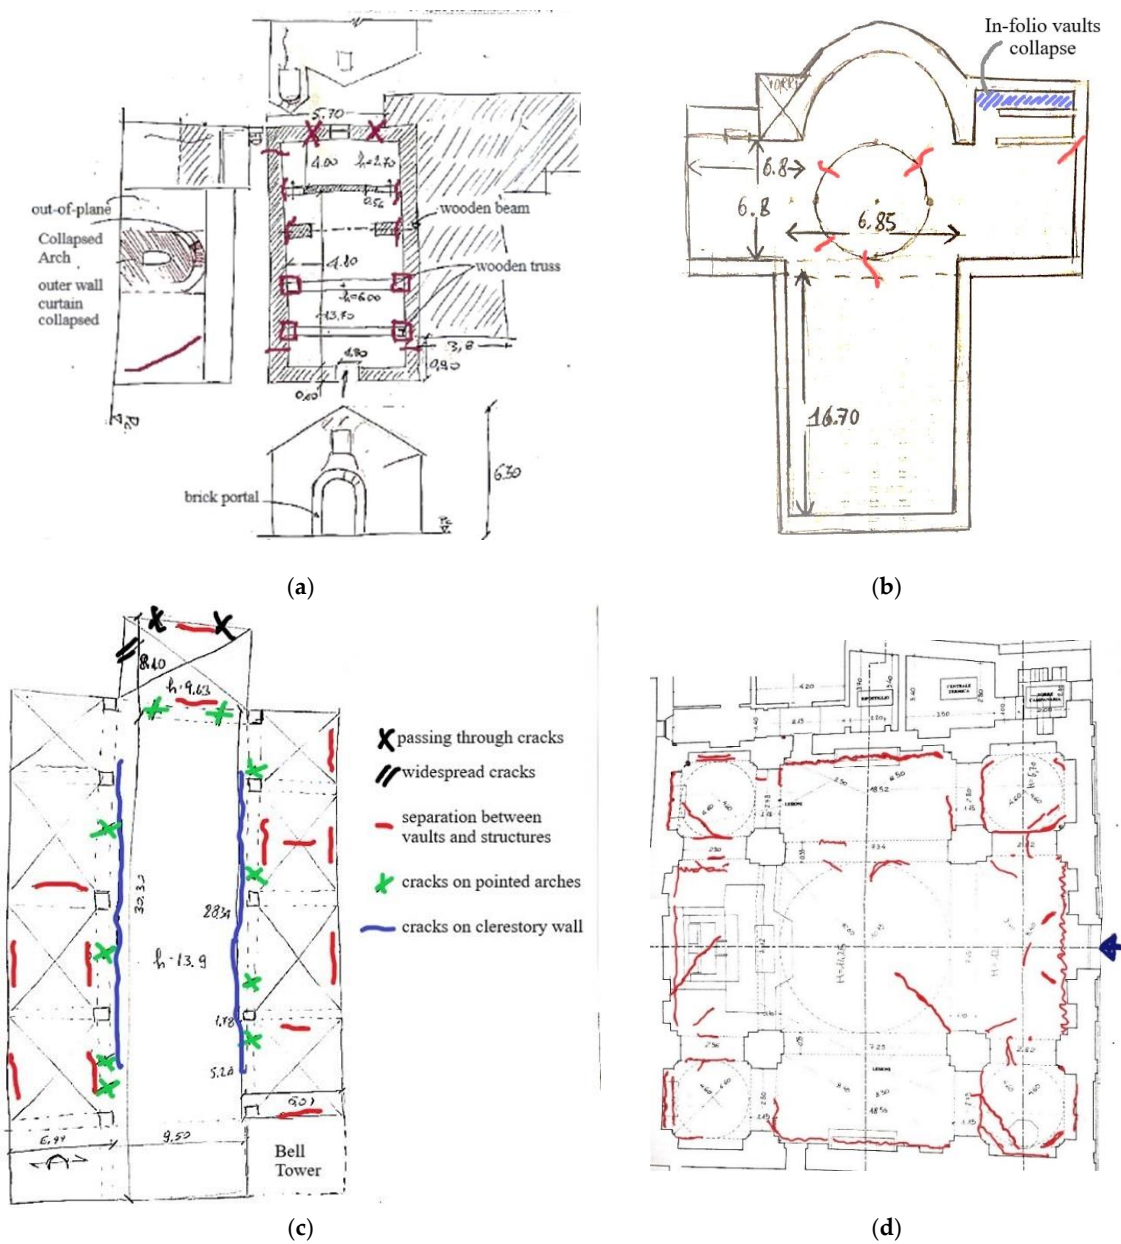
Figure 4. Plan configuration with observed crack patterns of some inspected churches: sketches made during the inspections. (a) Single nave (SN) typology: the church of Saint Elpidio in Campli. (b) One nave with transept (SNT): St. Lowrance in Civitella del Tronto. (c) Three naves and transept (3NT): the Dome of Campli, Holy Mary in Platea. (d) Central plan configuration (C): the church of Saint Savino in Gualdo.

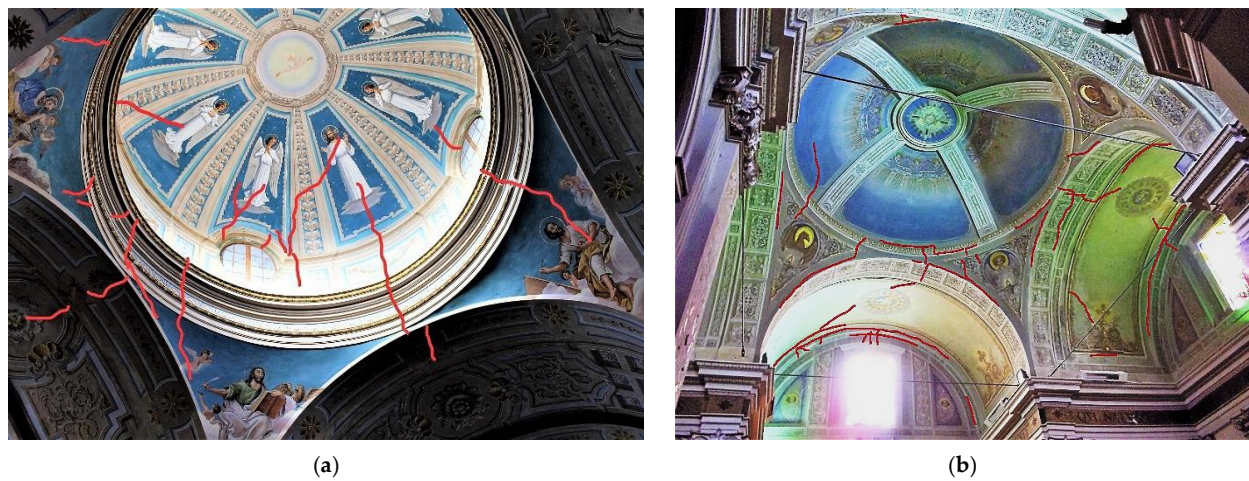
Figure 7. Surveyed domes: (a) St. Lowrance in Civitella del Tronto; (b) St. Savino in Gualdo, Macerata. The observed crack pattern has been highlighted in red.

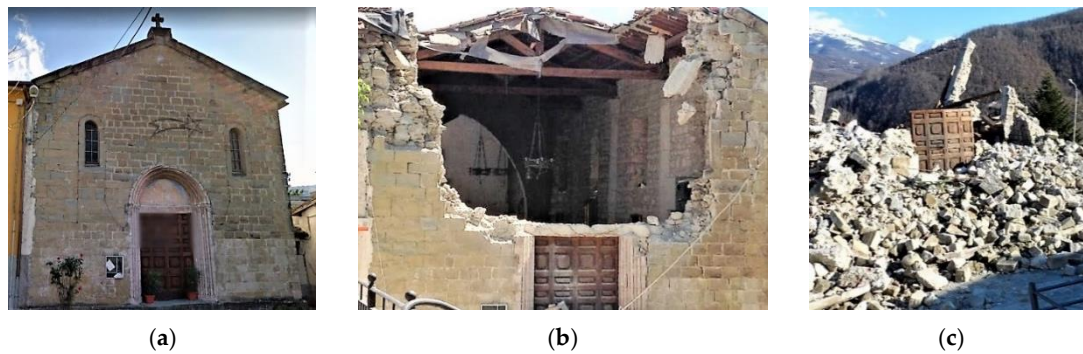
In the survey activities promoted by the Civil Protection Department and the Italian Cultural Heritage Ministry, the authors directly observed the damages caused by the two mainshocks of 24 August and 30 October. According to the lessons from the Friuli earthquake and the Emilia-Romagna earthquake [42], the cumulative damages in the Central Italy earthquake were significant and, in several cases, dramatic. Evidence of the damage evolution due to multiple seismic events is represented in Figure 10, where the evolution of damage in the St. Lawrence and St. Paul Church in Accumoli (C29) is depicted: the shock, which occurred on the 24 August, activated the rocking motion of the gable of the façade up to its collapse (Figure 10b); then, when the shock of the 30 October occurred, the church totally disintegrated (Figure 10c).

Figure 10. The St. Lawrence and St. Paul Church in Accumoli: (a) before the Central Italy earthquake; (b) after the 24 August strong motion; and (c) after the earthquake occurred on 30 October 2016.

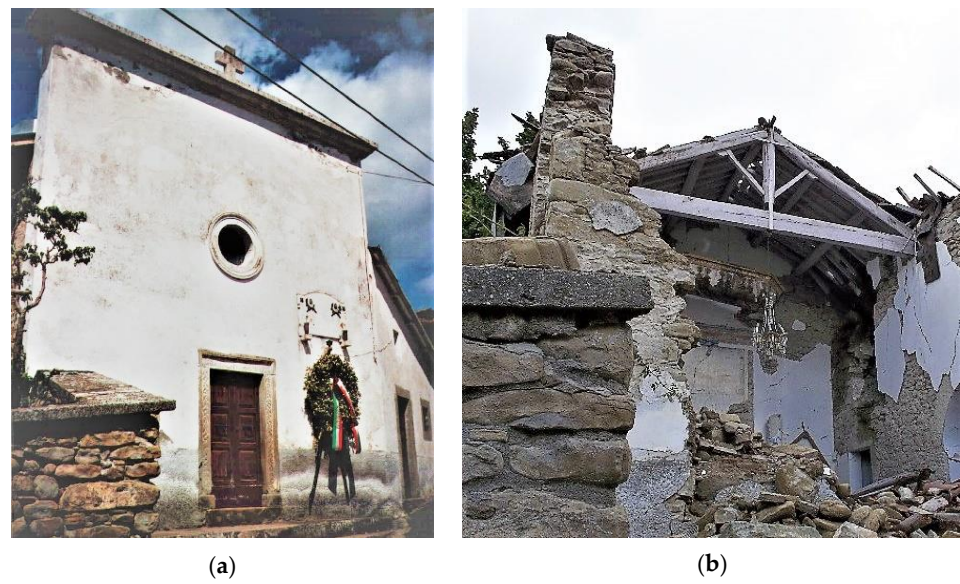
Figure 11. The St. Francis church in Cornillo Vecchio (Amatrice): (a) before and (b) after the earthquake occurred on 24 August 2016.

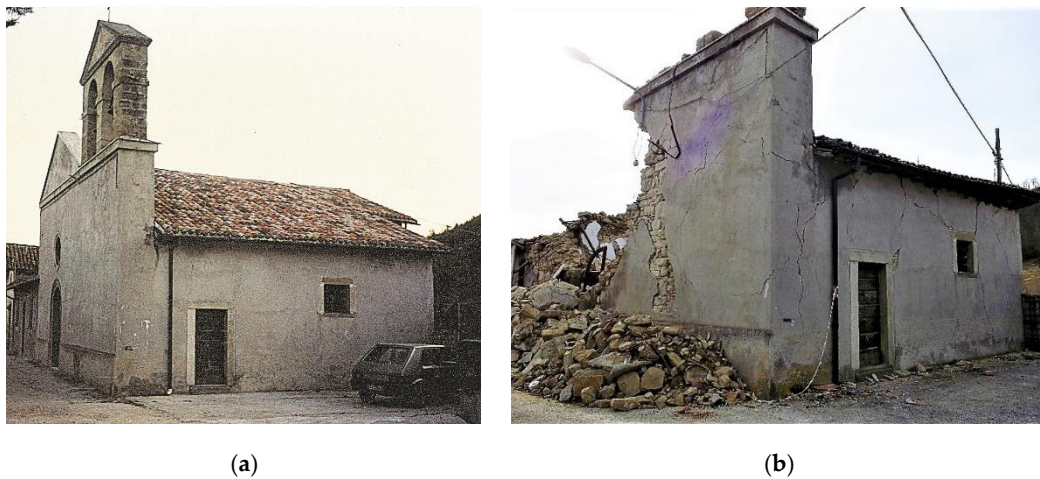
Figure 12. The St. Peter and Paul church in Macchia (Accumoli), before (a) and after (b) the earthquake occurred on 30 October 2016.

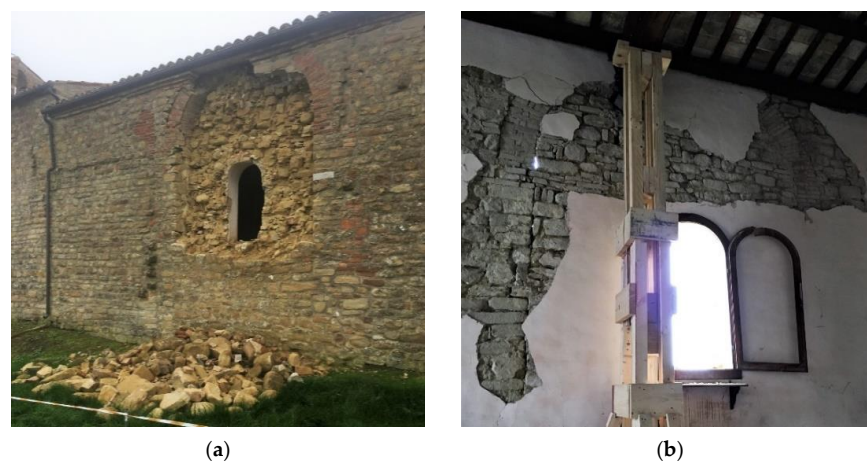
Figure 13. Disruption of the masonry leaf due to the out-of-plane behavior in the St. Elpidio church in Gualdo, Macerata: (a) external and (b) internal views.

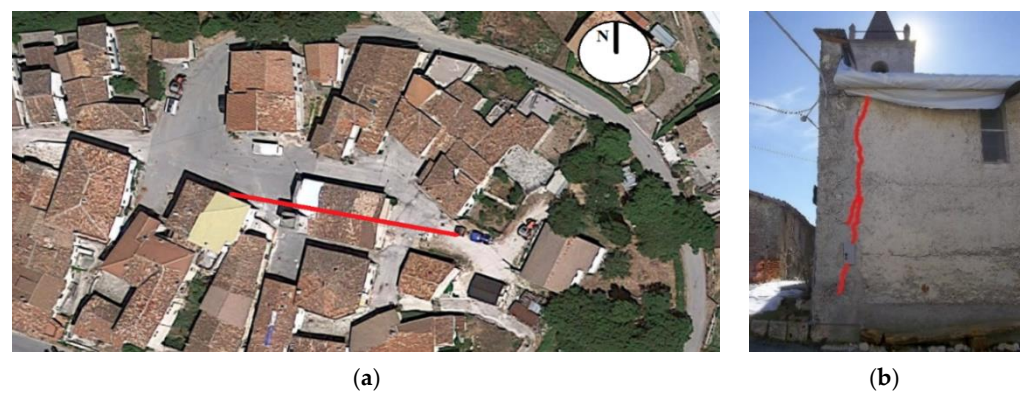
With specific reference to the out-of-plane motion of the façade, it is worth noting that the 2016 Central Italy earthquake presents a strong directionality, as suggested by the acceleration response spectra of the two main events (Figure 14). In particular, the higher seismic acceleration struck the region in the east–west direction, corresponding to the so-called “sacred direction” of the churches (east–west axis), until the II Vatican Council (1960). As an explanatory case, the example of the Saint George Church in Terracino (C35) is given, for which the overturning mechanism of the façade is evident (Figure 15).

Figure 15. St. George church in Terracino (Accumoli): (a) aerial photography (adapted from Google Maps) with east–west axis orientation (red line); (b) façade overturning mechanism (cracks emphasized in red).

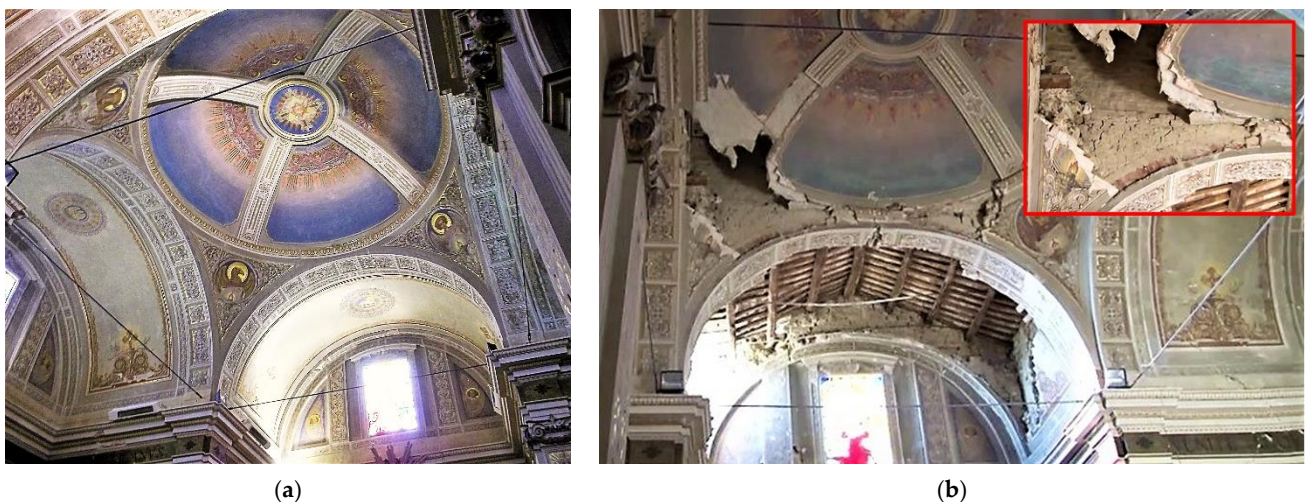
Aside from the façade mechanism, the overturning mechanism causes the abrupt displacement of the imposts of arches and vaults or domes; these structures, frequently made with bricks arranged in folio, can easily move into the minimum thrust condition, and then collapse, as in the example of St. Savino church in Gualdo (C36, Figure 16).

Figure 16. The dome in St. Savino church in Gualdo, before (a) and after (b) the earthquake occurred on 30 October 2016.

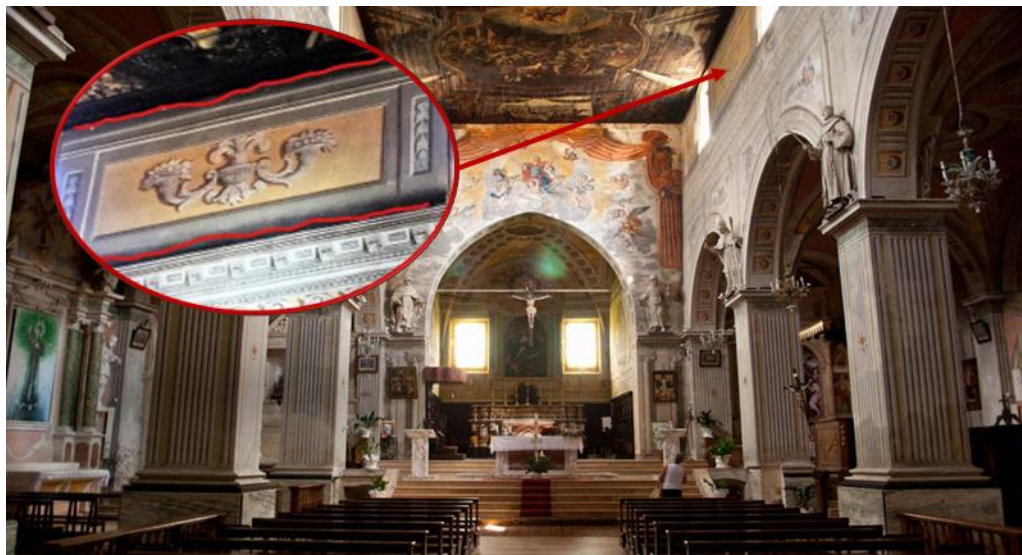
walls are typically slenderer than the other walls; moreover, they are often marked by full-height windows, allowing the appropriate brightness for the religious building. Both these aspects, coupled to the vertical amplification of seismic motion, promote the formation of splitting cracks spreading on the top and lower sections of the element, as observed in the example of the Dome of Campli (C34, Figure 17). It is interesting to recall that similar damages were recorded after the Emilia earthquake [42].

Figure 17. Out-of-plane of the clerestory wall in Holy Mary in Platea in Campli, Teramo.

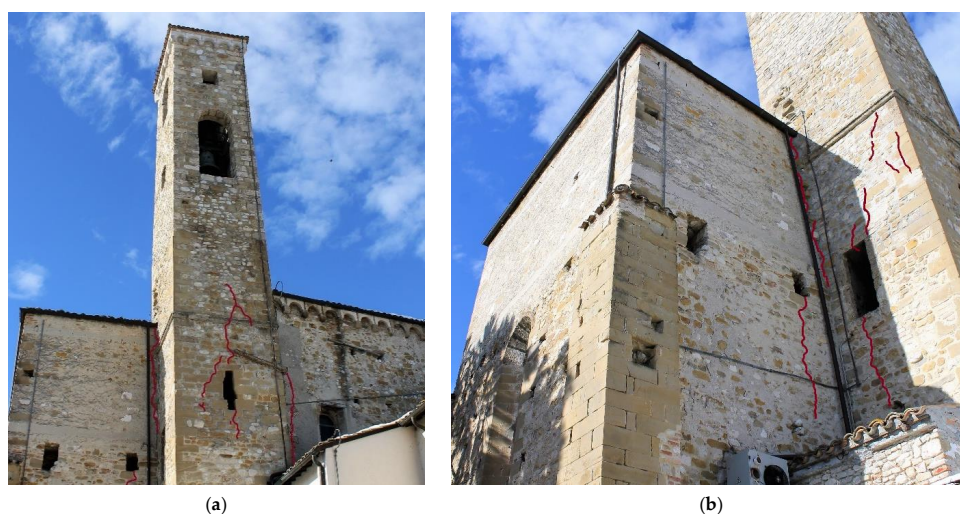
The belltowers frequently present damages in the pinnacles, in the bell cell, and along the tower. In particular, the damage on the stem can be detected when the variation of the vertical stiffness in the structure is significant, i.e., for towers connected to the church (Figure 18). Instead, the most damaged element becomes the cell when the variation in stiffness is more gradual. In fact, in all inspected cases these elements are characterized by the presence of large openings and by vertical bearing elements with reduced thickness, since the working loads that they should sustain are low. Consequently, the cells can experience a shear failure, as in the case of the St. Savino church in Gualdo (C36), where a significant crack pattern on the piers was detected (Figure 19a). Finally, when the piers are strong enough, the damages are localized on the upper part of the cell (Figure 19b).

Figure 18. Damages on the stem of the belltower (a,b): the case of the St. Francis church in Campli (C23). The observed crack pattern has been highlighted in red.

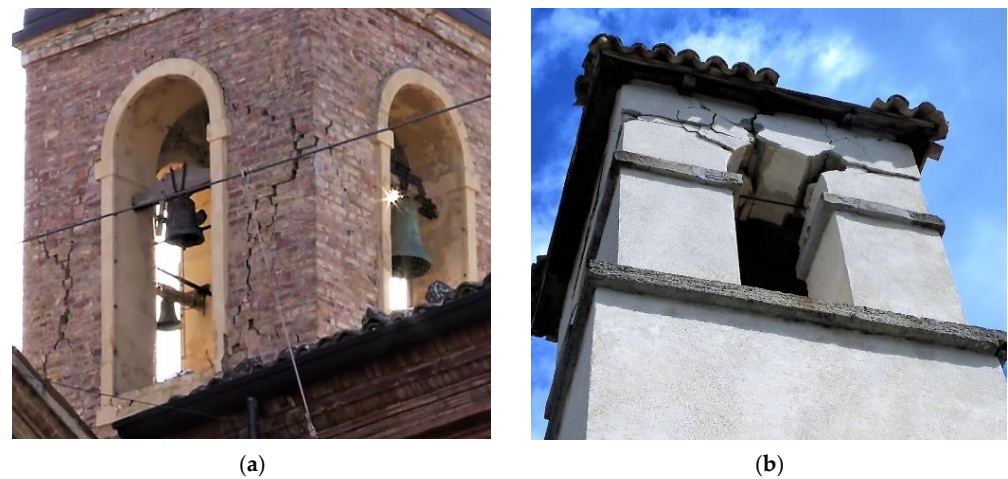
Figure 19. The structural component of the bell cell: (a) the case of St. Savino church in Gualdo (C36); (b) the case St. Maxim Oratory in Collalto, Amatrice (C8).

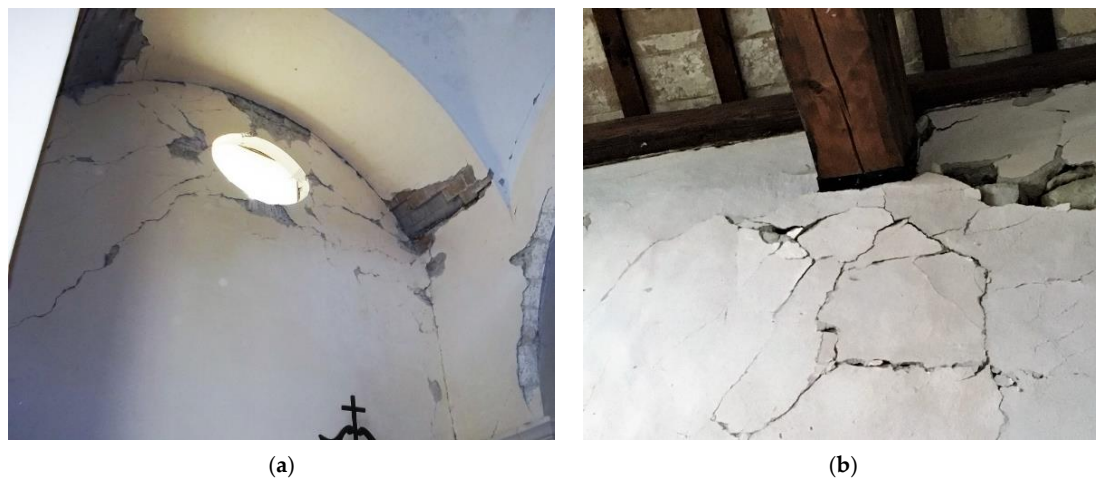
Among the mechanisms frequently detected in the post-seismic survey activities, the in-plane shear mechanism in the façade or in the lateral walls (Figure 20a) and the roof cover mechanism with the sliding of the timber beams (Figure 20b) must be mentioned. This mechanism could be very dangerous due to the possible loss of the support for the timber beams with the consequent roof collapse.

Figure 20. Other mechanisms activated in the wall: (a) shear mechanism in the lateral walls in St. Giovenale church in Roccasalli (C25); (b) roof covering mechanism in St. Elpidio church in Campli (C9).

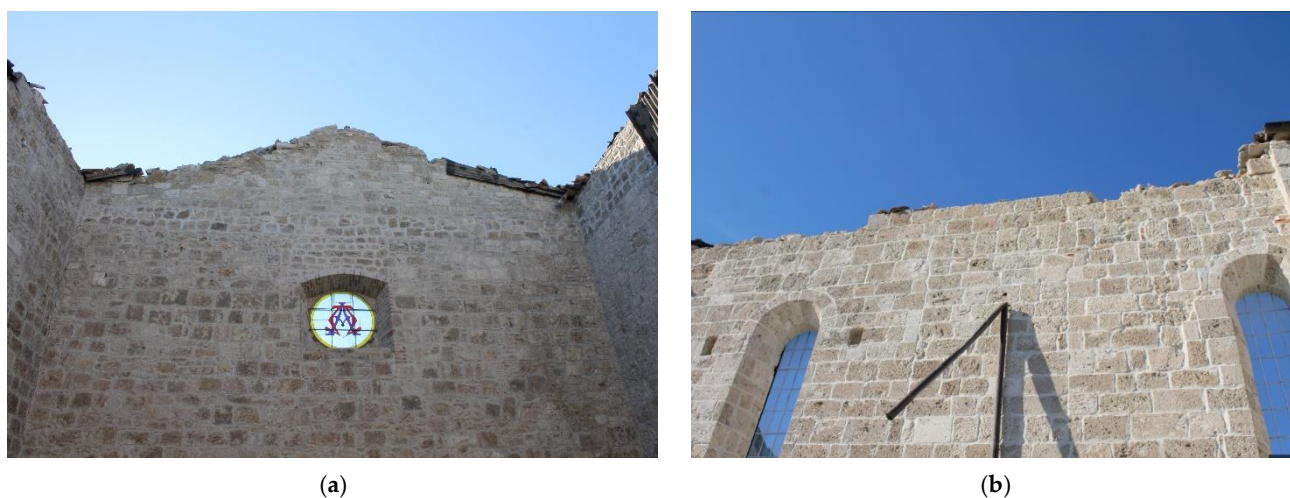
Figure 25. Limited damages and loss of usability in the Abbey in Montesanto (C25): (a) absence of damage in the façade and roof collapse; (b) absence of damage in the lateral wall.
