Deterioration of Sandstone in the Historical and Contemporary Sea Walls upon the Impact of the Natural and Man-Made Hazards

Rina (Irena) Wasserman

Department of Conservation of Sites and Monuments, Western Galilee Academic College,
POB 2125, Acre 24121, Israel; rinaw@edu.wgalil.ac.il

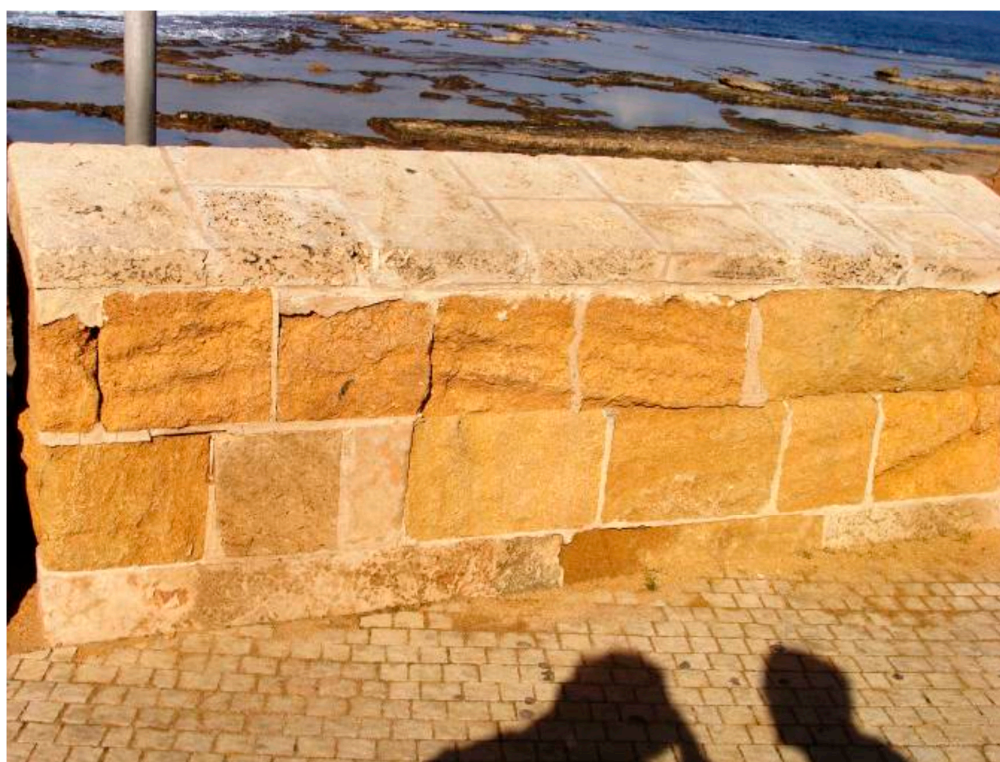
- **Group 1—Loss of stone material:**
 - Back weathering due to loss of crumbs/splinters, Figure 5;
 - Back weathering due to loss of undefinable stone aggregates/pieces, Figure 6;
 - Rounding/notching, Figure 6;
 - Weathering out of stone components, Figure 7;
 - Break out, Figure 8.
- **Group 2—Coloration/Deposits**
 - Efflorescence, Figures 7 and 10;
 - Coloration, Figure 9.

Figure 5. Back weathering of kurkar siding in the Panorama sea walls. Captured by the author on 22 July 2018.

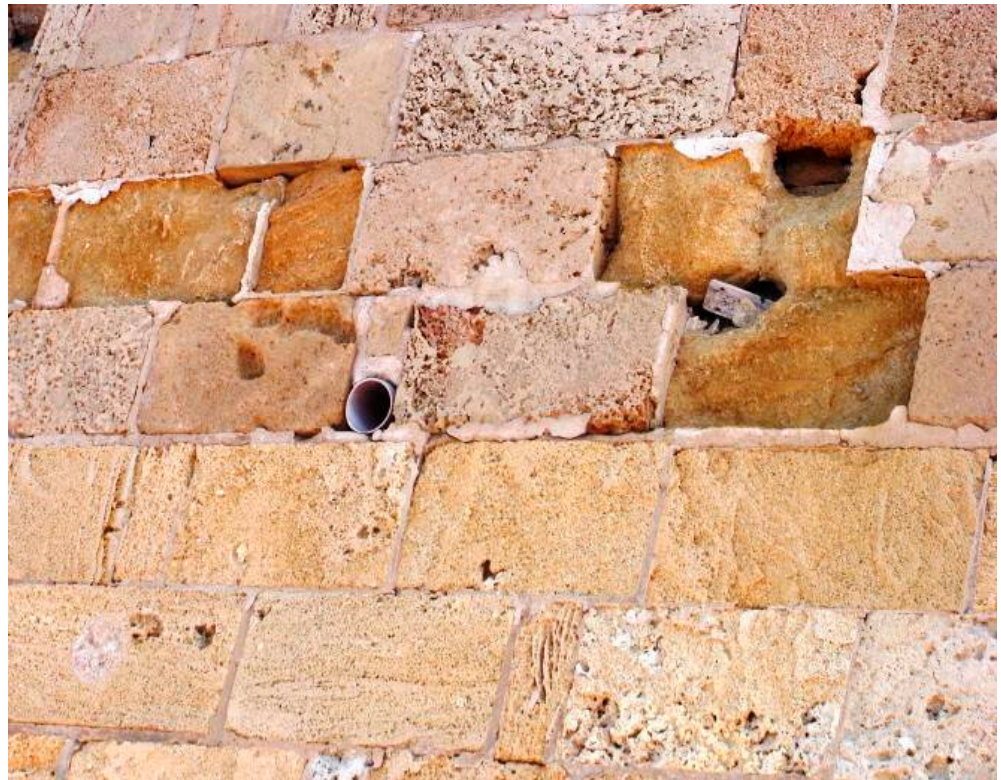
Figure 6. Back weathering of kurkar siding in the Panorama sea walls. Captured by the author on 27 November 2018.

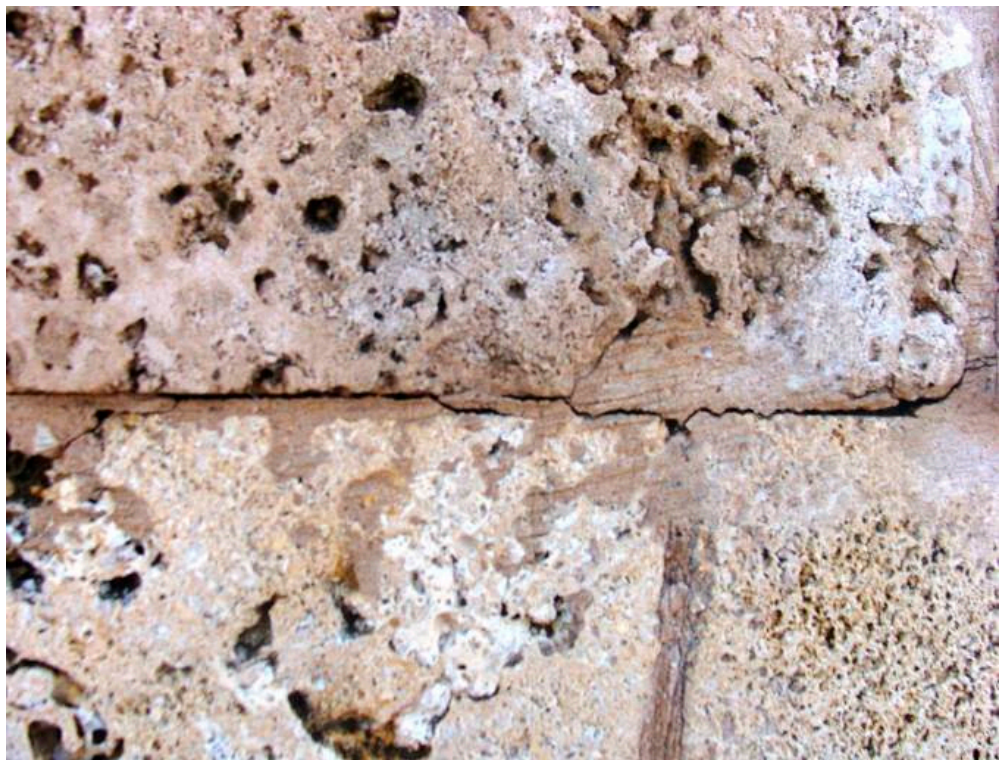
Figure 7. Weathering out of stone components in the Panorama sea walls. Captured by the author on 27 November 2018.

Those mentioned above physical and chemical processes caused a loss of kurkar components, see Figure 7; breaking out the stone matter, see Figure 8, and the rusty coloration of kurkar, see Figure 9.

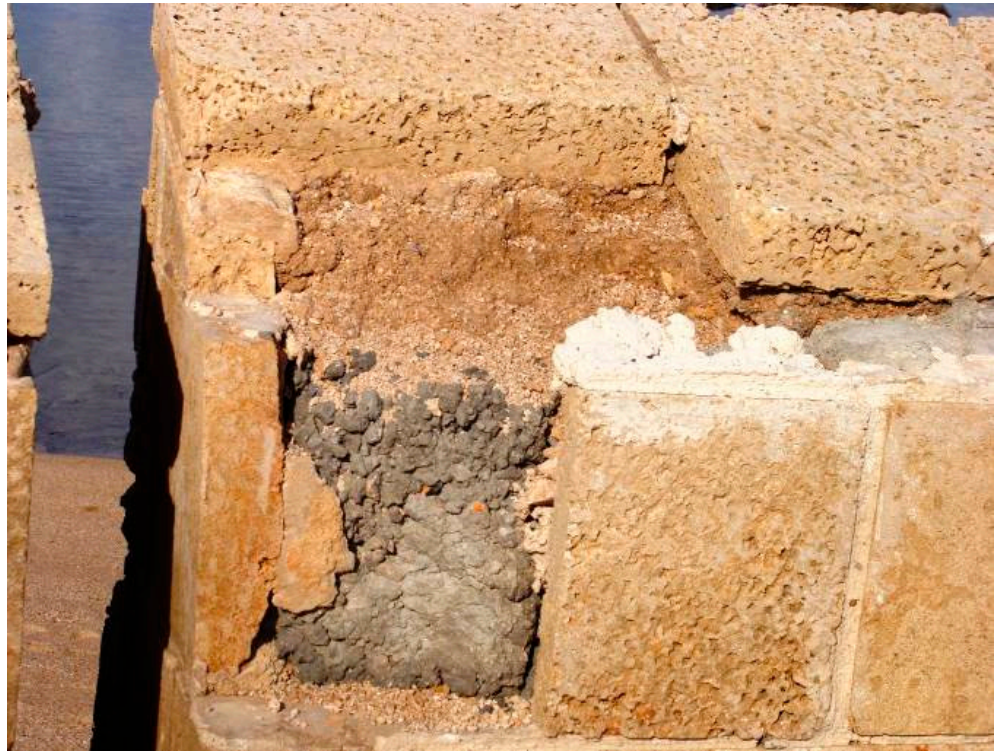
Figure 8. Break out of kurkar stone in the Panorama sea walls. Captured by the author on 27 November 2018.

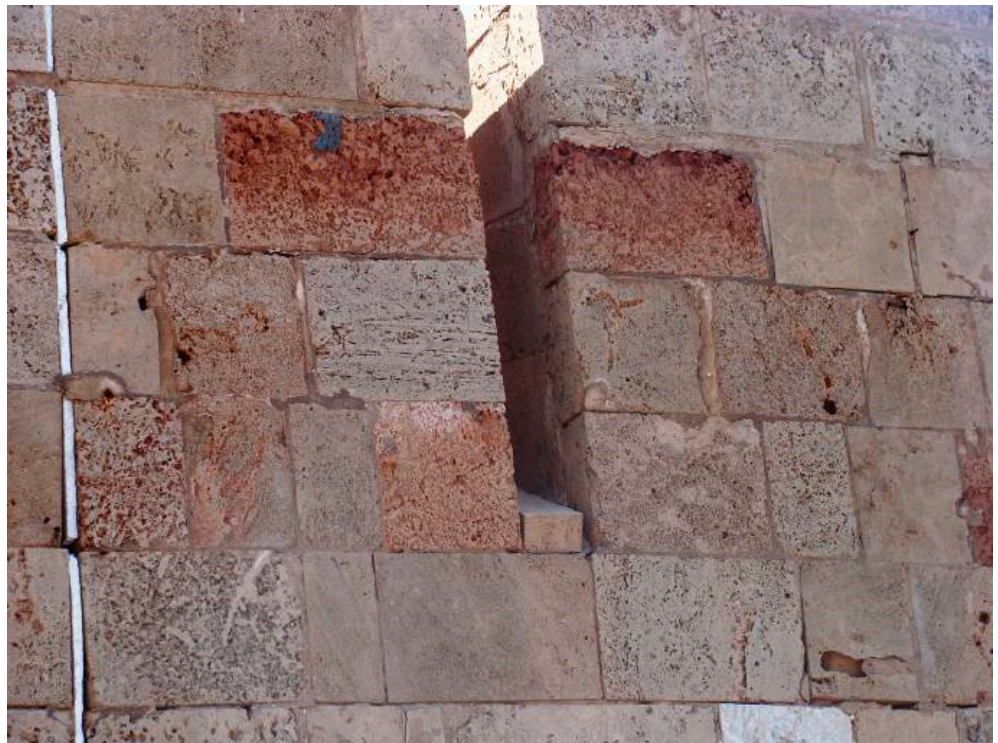
Figure 9. The coloration of kurkar siding in the Panorama sea walls. Captured by the author on 27 November 2018.

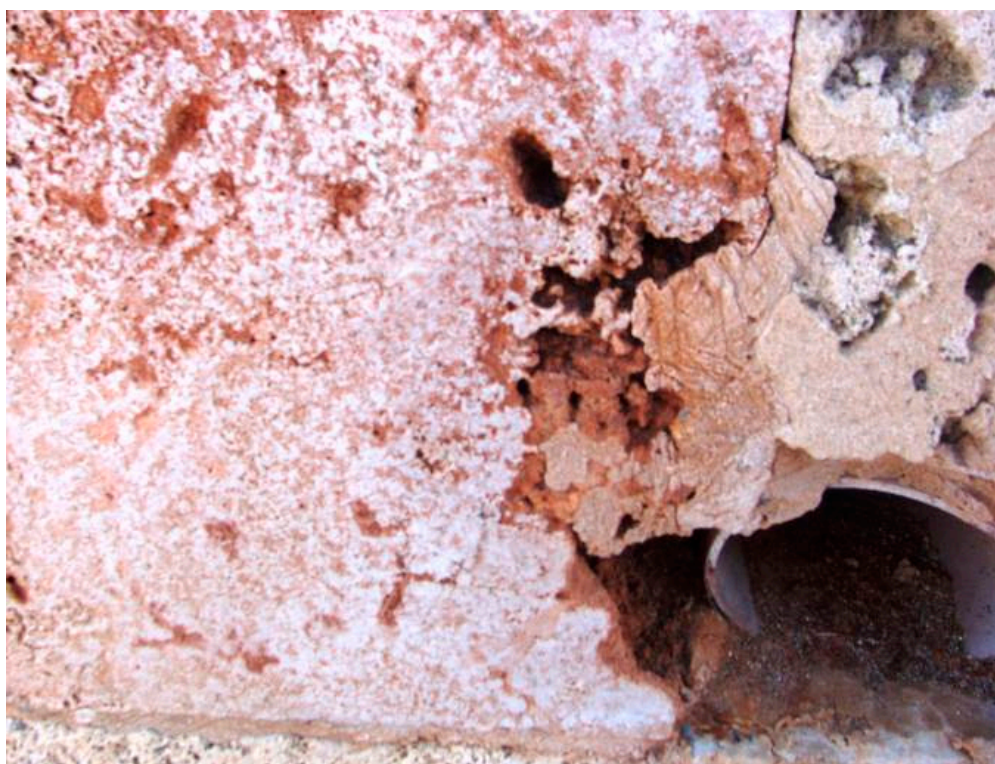
Figure 10. An efflorescence of kurkar siding in the Panorama sea walls. Captured by the author on 27 November 2018.

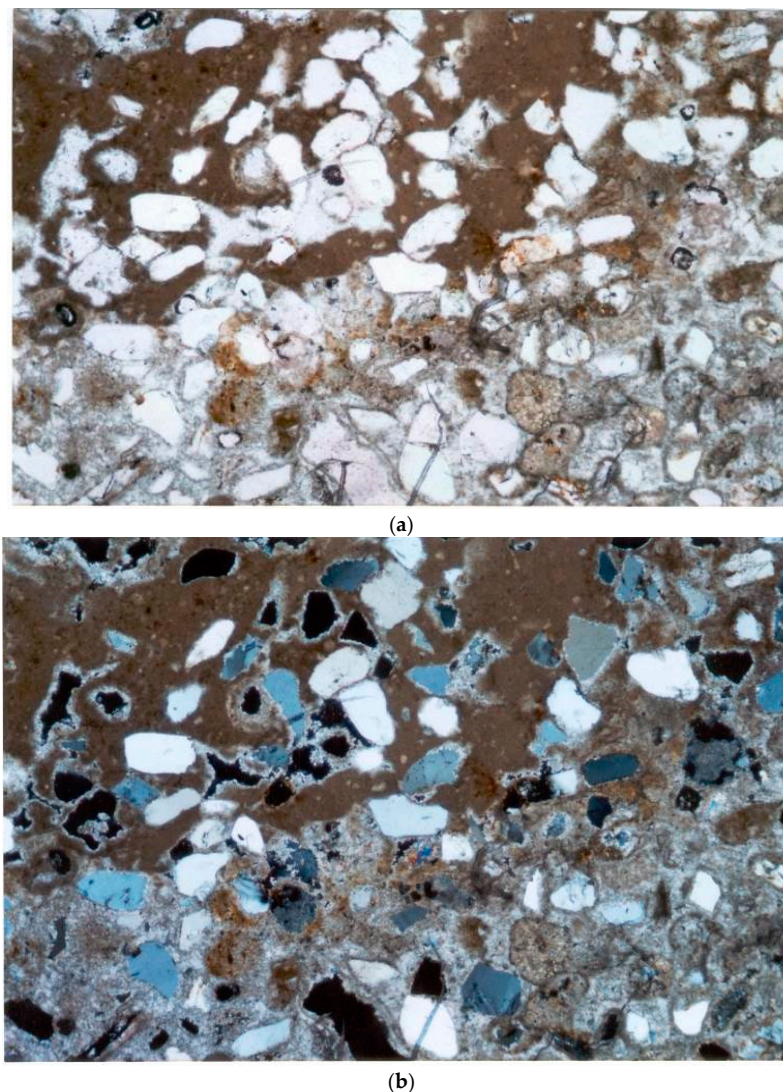
The investigated kurkar stone consists of well-sorted subangular to subrounded quartz, minor amounts of feldspar, heavy minerals, and allochems, all ca. 0.2 mm in size and constituting no less than 50% of the texture, Figure 12a. Sand grains are firmly cemented by micro-sparitic to dominantly micritic calcite of the different grain-size with minor porosity. Figure 12 shows the contact between the micritic cement (upper part of the picture) and the microsparitic, coarser calcite cement (lower part of the photo). Calcitic cement of kurkar is very heterogeneous, Figure 12a. Most pores are in micritic cement, Figure 12b. There were observed signs of recrystallization of calcite in the pores, Figure 12b.

Figure 12. Kurkar stone upon the petrographic investigation. The black areas are pores: (a) Plain light; (b) Polarized light.

The petrographic analysis, Figure 12, has revealed the substantial amounts of feldspar minerals in kurkar sandstone. XRD analyses have explained that the type of feldspar in kurkar sandstone is albite. Biotite (sodium aluminum silicate) found in kurkar sandstone is a phyllosilicate mineral in the common mica group. Unfortunately, the years 1995–2015 were characterized by extremely high levels of air pollution (NO_x, SO₂, and CO₂) in Haifa and Acre Bays adjacent to the big industrial zone and the high traffic areas (The historical data on the levels of air pollution could be found in the database of Israeli Ministry of Environmental Protection (https://www.gov.il/en/departments/topics/reducing_air_pollution)). Following a 2015 government decision, implementing the 2015–2020 National Plan to Reduce Air Pollution in Haifa and Acre Bays began in 2016. The National Plan, which has a budget of NIS 115.5 million, is expected to reduce industrial air pollution in the Haifa Bay vicinity, incl. Acre Bay by 50% [29–31]. According to the NUMBEO database, the air pollution index in Acre, Israel is ca. 75, which is high [31]). Weathering of albite feldspar and biotite mica under these conditions might cause their chemical alteration and decomposition under the following scenario:

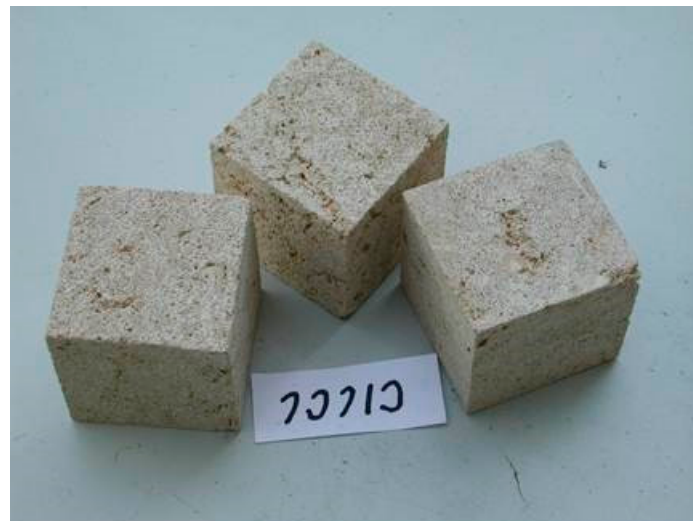
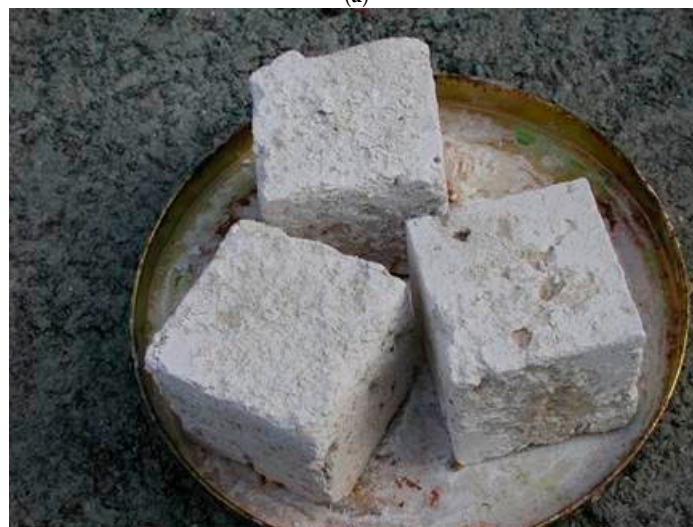
Figure 13. Kurkar sandstone before and after accelerated weathering test in a sodium sulfate solution. (a) Unweathered stone samples. (b) Stone samples after accelerated weathering test.

After the accelerated weathering test, the modulus of rupture measured perpendicular to the rift plane was 2.8 to 4.0 MPa. Thus, a drop of 30% in the modulus of rupture should be considered. After accelerated weathering cycles, a loss of kurkar sandstone weight was 0.6 to 1.7% (w. %).
