Colour Ageing in Acrylic Resin Plates and Natural Minerals on the Façade after 10 Years of Sun Exposure in the Marine Environment

Department of Architectural Constructions, University of Alicante, 03690 Alicante, Spain; victor.echarri@ua.es (V.E.-I.); antonio.galiano@ua.es (A.G.-G.); carlosrm@ua.es (C.R.-M.); isabel.perez@ua.es (M.I.P.-M.)

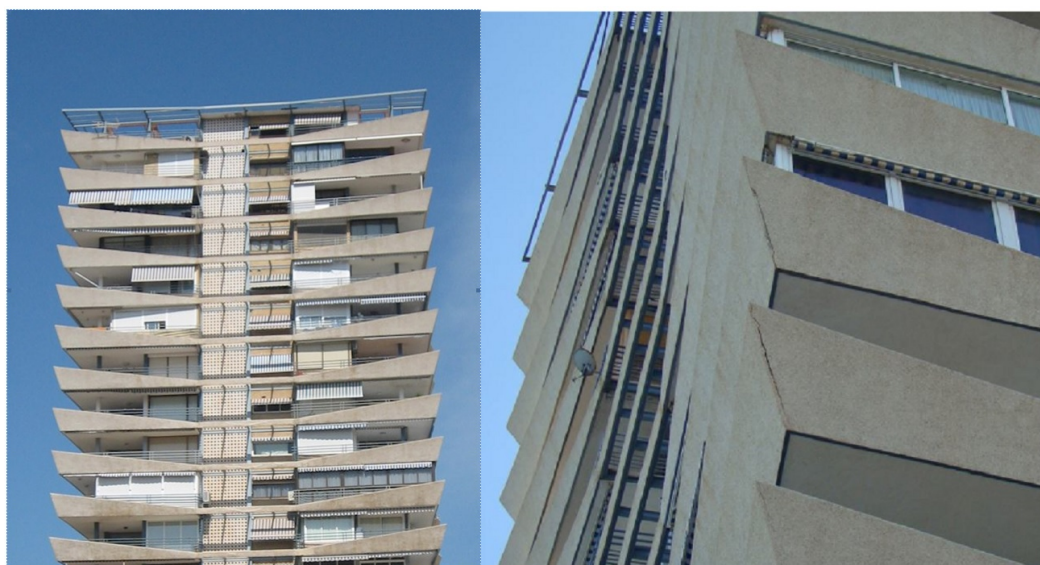
The triangular sloping parapets of the terraces were made of hollow brick, stabilised with a metal structure welded to the building's own metal structural system, and with internal metal reinforcements of platabandas and rounds. The interior finishing layer was formed by plastering and painting, while the exterior finish was plastered with projected stone, as can be seen in Figure 3. The problems of cracks in the mortar and stone enclosures with risk of detachment can be observed.

The changes in temperature, the saline environment and the action of the wind caused an irreversible state. In 2010, due to the poor state of the parapets, they were replaced by others of similar geometry so as not to alter the image of the projected building, given its protection in the Catalogue of protected goods and spaces of Alicante City Council.

Figure 3. State of the building's façades and parapets in 2010, before its refurbishment.

- Demolition of the original parapets.
- Replacement or reinforcement. In those elements whose material loss had been considerable, replacement was made with elements of similar mechanical and geometric characteristics. Those elements where replacement was not necessary were mechanically cleaned until the surface was completely sanitized.

- Anti-oxidant treatment. An anti-rust treatment was applied to the clean and smooth surface of the metal elements to support the new frame.
- Placement of auxiliary structure. The new parapet would be made up of a steel framing construction system, with lattice galvanised steel profiles similar to the original one, joined to the metal profiles of the perimeter structure of the building's floor, by means of metal elements as an extension of the profile wing. It was calculated for the own weight of the cladding and the wind actions for the exposed area according to the CTE- DB SE AE standard (Technical Building Code, Basic Document, Structural Safety, Actions in the building) (Figure 4).

- New coating. The exterior cladding was made of acrylic resin and natural mineral plates of variable height and similar geometry to the original parapets. White was chosen to minimise the degradation of the material [39]. The standard Corian® panels (3.66 × 0.93 m) were cut in the workshop and the 9 trapezoidal pieces that made up each parapet were assembled, joined and sanded on site with the appropriate safety measures for risks of pulmonary fibrosis associated with aluminium trihydrate [40]. The joints were reinforced at the back by 10 cm wide and 12 mm thick pieces. The result was a single piece more than 8 metres long which, in accordance with its coefficient of expansion, was screwed to the substructure by means of butt joints every 40 cm. The largest panel used up to that point. For its distribution, the tensile strength studies of the PMMA/ATH panels carried out by Nie et al. were taken into account [35]. These showed a 70% reduction in tensile strength when the sample was heated to 90 °C (Figure 5).

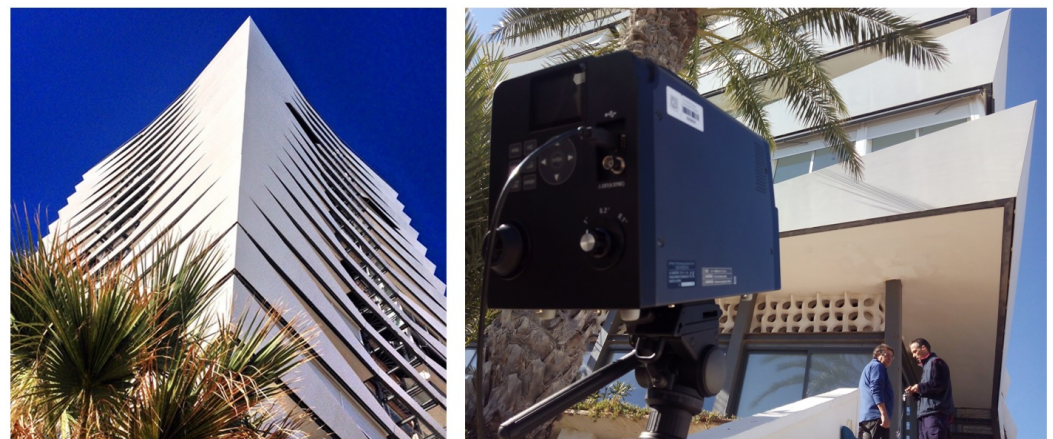
The measurements were taken with a tele-spectroradiometer on Thursday 23 January 2020, with completely clear skies, and between 11:45 and 12:45 in the morning Figure 12.

Figure 12. Measurement images of exterior finish plate.

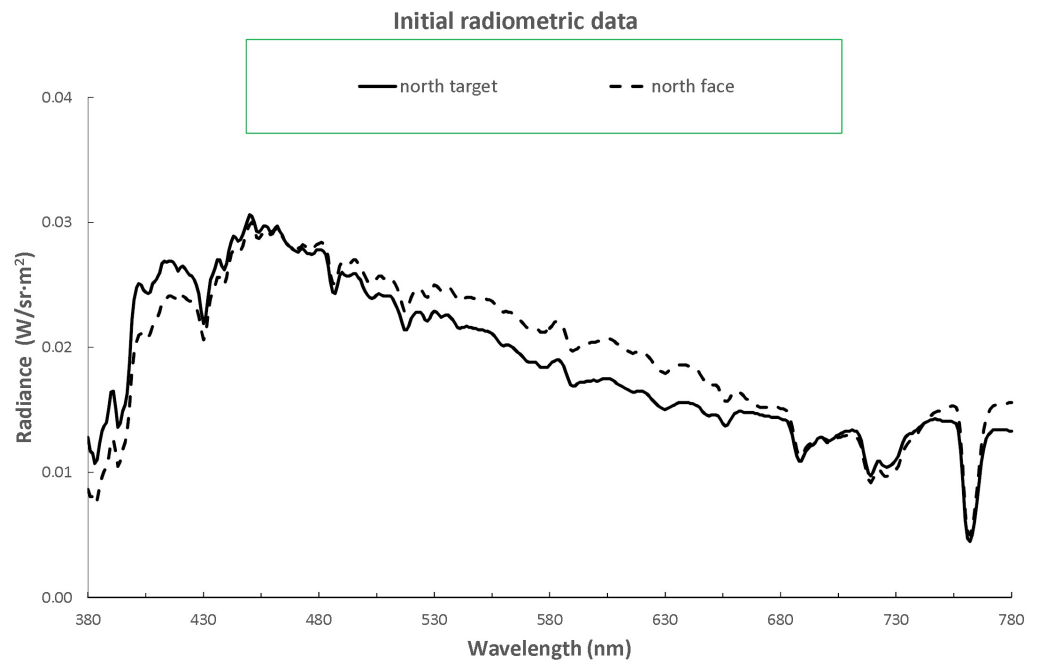
- North Face: according to the graph in Figure 14, the material's fluorescent behaviour can be seen. This is mainly due to the fact that in some spectral bands, specifically from 480 to 680 nm, the radiance emitted by the material is higher than that of the ideal target in the same position and orientation. It can be seen then that the differences between both spectra are smaller so that the reflectance factor of the material on the east side will be above 1 in some spectral bands.

Figure 14. North face radiometric data.

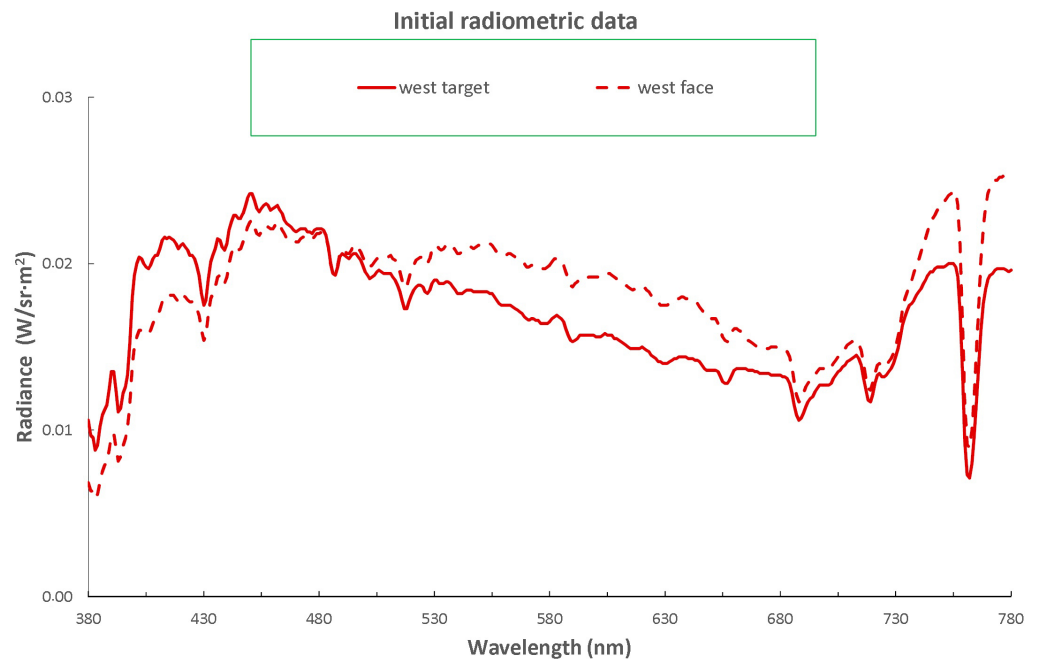
- West side: according to the graph shown in Figure 15, the fluorescent behaviour of the material on this side can be seen. As in the east side in some spectral bands, from 480 to 680 nm, the radiance emitted by the material is higher than that of the ideal target in the same position and orientation. The differences between the two spectra are therefore smaller, which will give a factor of reflectance of the material on the north face above 1 in some spectral bands. In other words, both the north and west faces appear optically and colourimetrically very similar.

Figure 15. West side radiometric data.

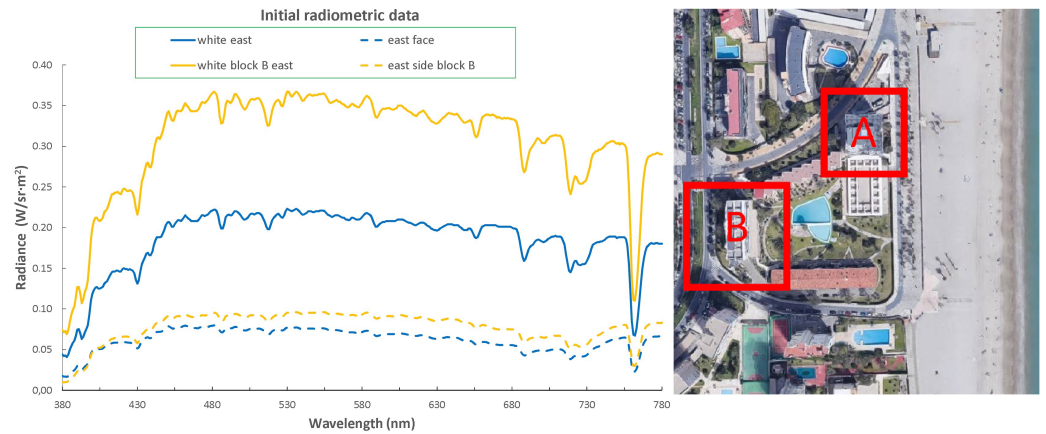
- East side: according to the graph in Figure 16, the spectral and optical behaviour is different from the two previous sides analysed. In this case the material (façade) always radiates less than the white in the same position and orientation. Therefore, in principle, there would be no fluorescent behaviour. On the other hand, the differences in height of the white vs. façade spectra are notable, implying that the material of the east façade will no longer be optically and colourimetrically the same or similar to the north and west façades, which implies a darkening of the material, which will be analysed later.

- In addition to the east side of the 17-storey tower, measurements were taken of the façade of the 6-storey block B located in the same area with the same orientation, situated slightly to the left, set back on a slight slope, and also with views of the sea.

Figure 16. Location of blocks A and B. Radiometric data for this block B.

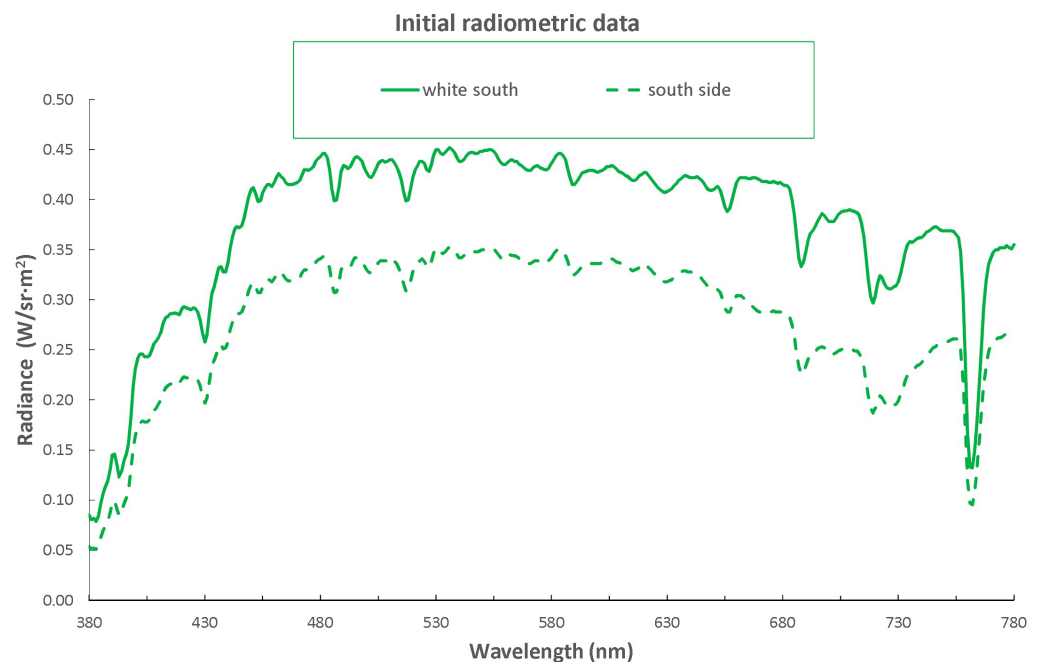
- South Face: this façade has a spectral and optical behaviour similar to that of the east façade, but not as pronounced in the darkening of the material Figure 17.

Figure 17. South-facing radiometric data.

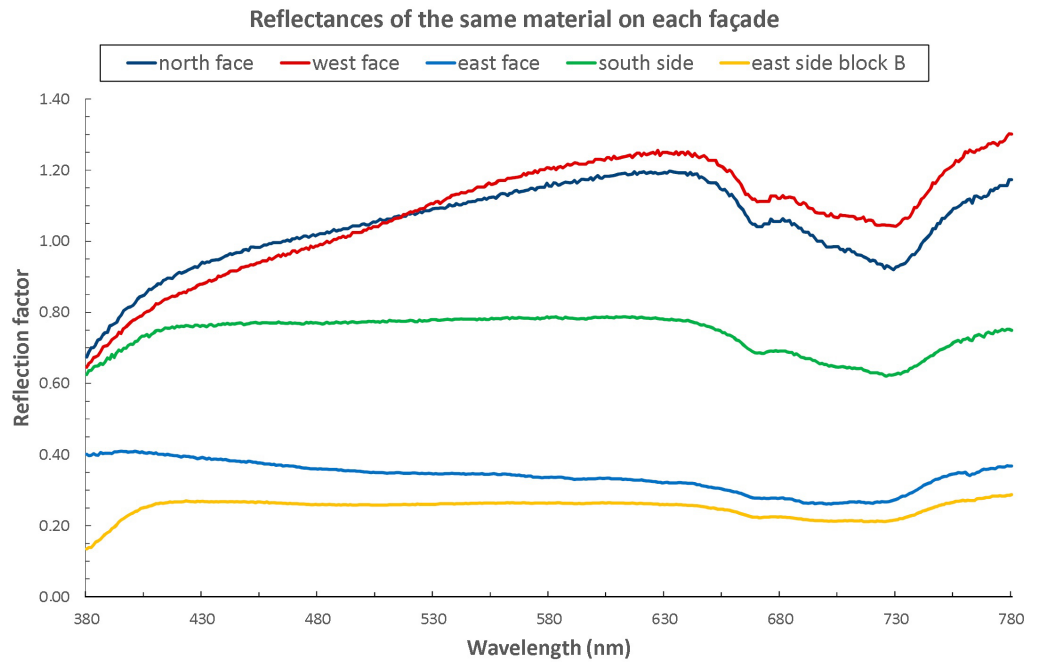
With regard to the analysis of the spectral reflectances (Figure 18), taking into account the ratio between the radiances of the sample versus the white colour, the following results were obtained:

- The north and west faces are very similar in spectral reflectance;
- The south side is darker than the west and north sides;
- The east side (in the two blocks analysed) is darker than the south side and therefore much darker than the west and north sides.

- Furthermore, as there are spectral reflection curves that are not strictly parallel to each other, there are also differences in tone and colour, but not as great as in clarity.

Figure 18. Analysis of CIE colourimetry.

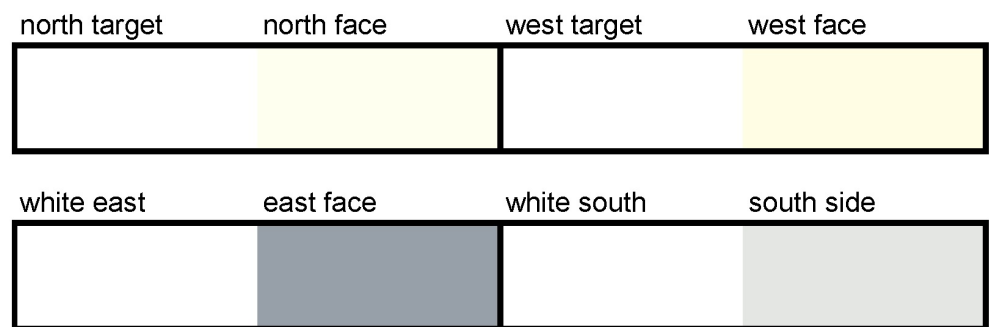
Figure 19. Visual results simulated in RGB with a calibrated monitor (sRGB) are as follows.

- The western side shows a very slight deviation in colour, more yellowish and slightly stronger, and almost as clear.
- The eastern face presents a very evident difference in clarity: it is notoriously very dark, hiding quite a few other more subtle differences in tone (+bluish) and colour (+weak). This is obtained equally, with the same order of magnitude, on the east side of block B. Let remember that wind analysis already showed a greater inclemency of the wind in this direction.
