The Use of De-Icing Salts in Post-Tensioned Concrete Slabs and Their Effects on the Life of the Structure

The so-called Nudo de Colmenar Bridge (Madrid) connects the M-607 road (Madrid Way) and the M-40 ring road (A-1 Way). The structure is located in the Nudo de Colmenar detailed in Figure 1.

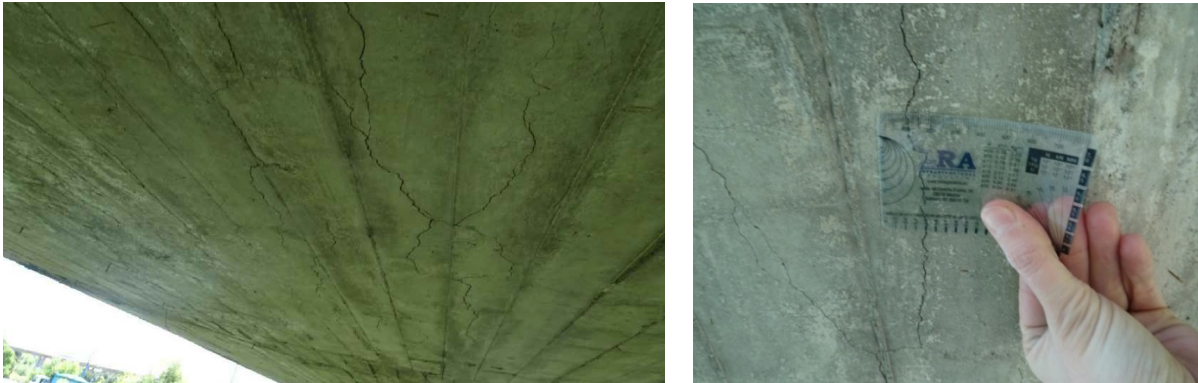
Abundant longitudinal cracking on the bottom surface of the section, oriented parallel to the main prestressing compressions, can be seen in Figure 3.

Figure 3. Longitudinal cracking on the bottom surface of the deck.

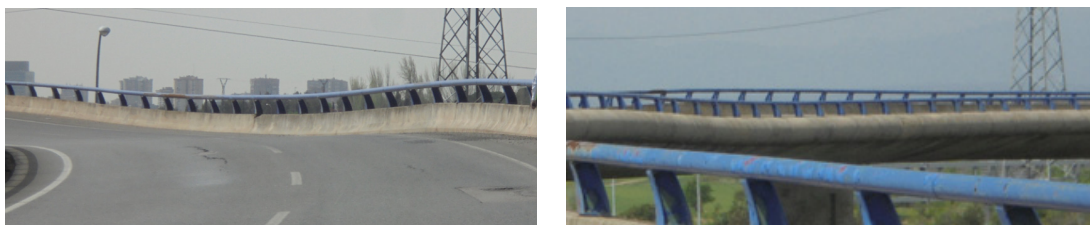
Vertical marked deflections, especially in three spans: span # 5 (longest span over the M-40) and spans # 8 and # 11. The deformation of these spans pointed to a loss of concrete stiffness because of aggregate–alkali degradation. This deformation can be observed in Figure 4.

Figure 4. Marked deflections in spans # 5 and # 8 of Nudo de Colmenar structure.

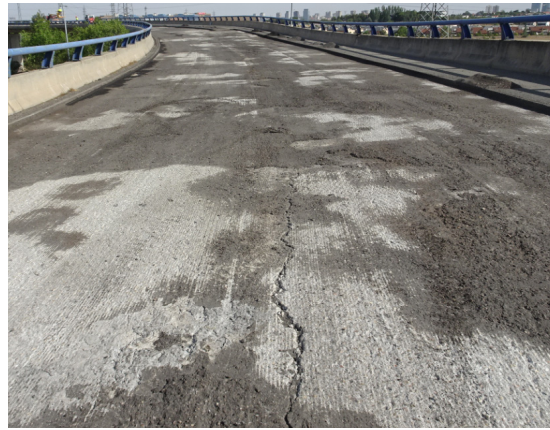
Longitudinal cracks in the deck's upper face coincide with the direction of the prestressing. These cracks, detailed in Figure 5, were observed after milling the pavement.

Figure 5. Longitudinal cracks in the deck's upper face.

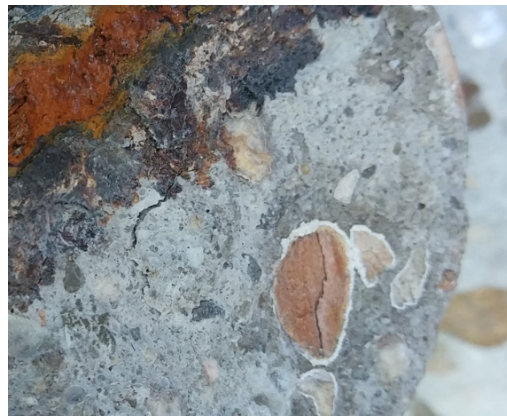
Moreover, in addition to the cracks observed on the deck's upper face, cores were extracted in the alignment of the cracks with internal fracturing of the concrete mass. In the visual examination of the cores extracted in the alignment of the fissures, the presence of a white halo around some aggregates was observed, as can be seen in Figure 6. It was compatible with the formation of silica gel of expansive nature, as a result of the aggregate–alkali reaction.

Figure 6. White halos around aggregates detected in the cores without microscopy needed.

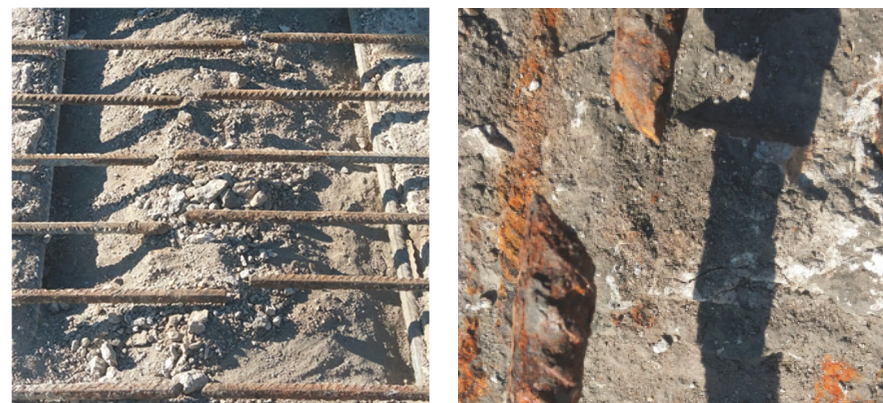
Furthermore, sectional cuts in the transverse reinforcement bars were observed with a crack alignment coinciding with some of the longitudinal cracks and with a macroscopic appearance of brittle fracture, according to Figure 7. For the observation of the reinforcement, small test cuts were made in the alignment of the deck cracks.

Figure 7. Sectional cuts in the transverse reinforcement bars.

This type of brittle fracture is probably the most relevant damage observed in the structure under study, due to the extraordinary and unexpected nature of the phenomenon. As can be seen in Figure 7, necking is not observed in the breakage of the bars. In this sense, this fact points directly to a brittle fracture compatible with a corrosion fatigue phenomenon, which suggests the existence of a localized corrosion attack by chlorides coming from the winter maintenance treatments. Chlorides can easily penetrate inside the concrete mass through the existing cracks in the deck's upper face until they reach the reinforcement bars. Multiple factors such as the width or depth crack affect that penetration. However, the paper does not focus on internal chloride diffusion. Consequently, the modeling of chloride penetration is out of the scope of this paper, and we direct the reader to the listed references [17,18].

The bars of the transverse reinforcement showed full-section ruptures with a brittle appearance. In this sense, although the breakage of steel elements by a stress corrosion process is certainly a common phenomenon, in the case of the Colmenar Bridge, these breaks are completely different from the usual forms of breakage due to chloride contamination, which appears as local corrosion that progresses inwards the bar in an inverted cone form.

In the structure covered by the paper, the bars showed a macroscopic appearance of brittle fracture that pointed to the presence of mechanical actions concomitant with chloride attack. Although the breaks detected in the bars are still being analyzed using tests in specialized laboratories, the most likely hypothesis is that it is a corrosion–fatigue phenomenon, in which the steel bars breakage was caused by the simultaneous action of cyclic stress and the presence of an aggressive medium that caused localized corrosion of the steel. Indeed, the presence of cyclic loads associated with traffic on the structure would lead to the crack progression in the pitting of the steel bars caused by the chlorides. In this case, unlike stress corrosion processes, in which the presence of a permanent—or static—stress is necessary for material rupture to occur, in corrosion–fatigue processes this stress must be cyclic. In the case studied, it does not seem reasonable to attribute the rupture of the bars to a stress corrosion phenomenon, since they are not bars with a high level of stress and, in this case, the rupture plane would have the appearance of a quasi-fragile rupture.

- Hydro-demolition of the deck until the affected transverse reinforcement is revealed. Replacement of the reinforcement and reconstruction with fine aggregate concrete up to the initial level;
- Reinjection of prestressing sheaths by vacuum injection using a fluid slurry with corrosion inhibitor improves their durability significantly;
- Execution of an ultra-high performance concrete layer (UHPCFR) for the encapsulation of the structure of approximately 3 cm to improve structure performance in terms of durability due to its high compactness and the almost total absence of pores. In addition, it provides a further improvement of the structure's performance against transverse bending due to the high performance (up to 150 MPa compression and 12 MPa flexural bending) and multidirectional strength behavior.

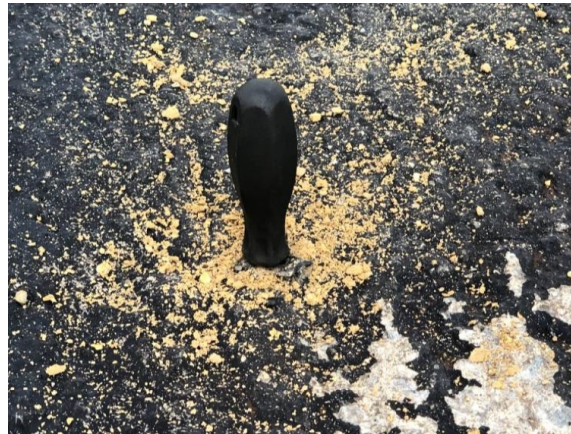
Lastly, signs of possible injection defects of the post-stressed sheaths were observed by examining the uncovered venting pipes in the milled area, by inserting a tape measure or a screwdriver inside them to check if they were clogged, as detailed in Figure 8. In this preliminary check it was observed that several of the venting pipes were not grouted up to the top face of the slab and that, therefore, it would be likely that there could be an inadequate injection of the prestressing sheaths. This led to the subsequent inspection with a borescope in the auscultation and testing campaign carried out in the structures.

Figure 8. Venting pipes check to verify the clogged conditions (see the handle of the screwdriver inserted into the hole).

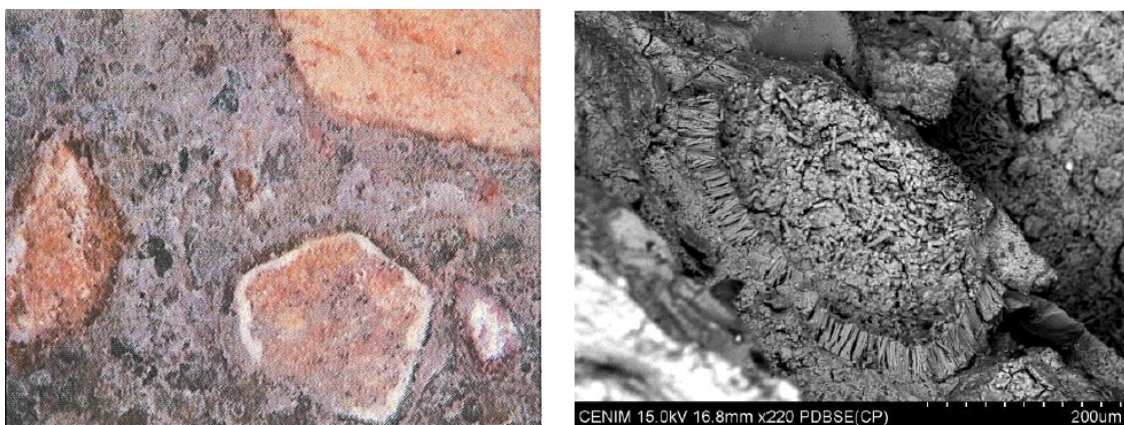
Determination of the concrete mechanical characteristics (modulus of elasticity and strength): analyzing its composition and making an electron microscopy observation, providing pictures like the ones shown in Figure 9. In both cases, the results confirmed the existence of an aggregate–alkali reaction in all the extracted cores.

Figure 9. Appearance of the gels detected by microscopy.

In the case of the Colmenar Bridge, all the cores extracted showed, to a greater or lesser extent, fractured aggregates partially altered by chemical degradation processes, with the presence of pores and aggregate–lime interfaces clogged with whitish deposits. Likewise, a 54% average loss of elastic modulus was determined in the cores extracted.

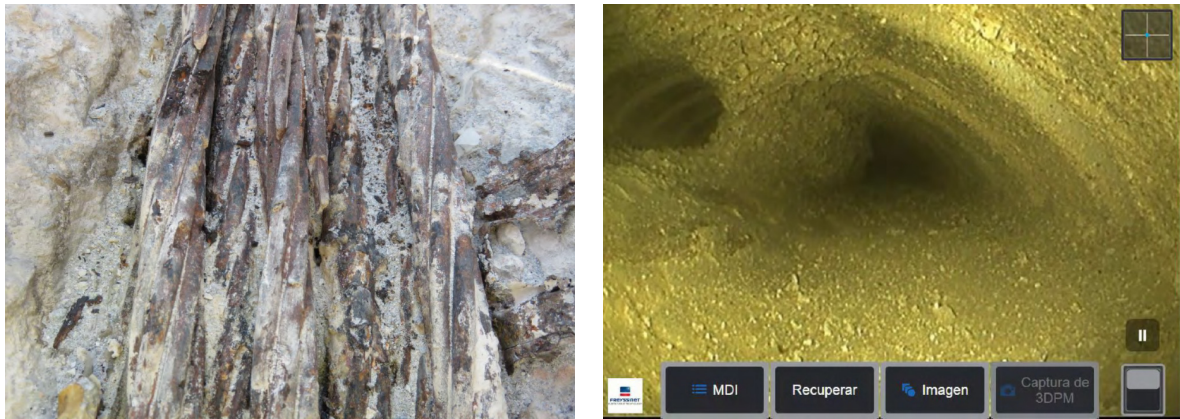
The main damage detected in this inspection was some bad connections between the venting pipes and the sheaths (lack of drill holes in the sheath), incomplete filling of the sheath to a greater or lesser degree depending on the areas, leaving unprotected strands both in high points and adjacent sections, corroded and even broken strands due to a stress–corrosion process, slurry exudation and others. Figure 10 shows some examples of the previously mentioned damages. It was also observed that the layout elevations in high points were different from the design elevations, with a vertical displacement of the tendon axis with respect to the theoretical elevation up to 220 mm.

Figure 10. On the left, corroded cords and broken wires; on the right, unusual grout consistency with foam formation.

Finally, the entry of chlorides through the longitudinal cracks, aggravated by the lack of a waterproof treatment and the injection defects of the post-tensioning sheaths, caused corrosion to reach the strands in certain sections, even causing the break of some of them due to stress corrosion cracking. It should also be noted that in any prestressing inspection, there is a high degree of uncertainty about the reliability of the preservation state since it is an element that is not accessible for inspection at 100% of its length and, therefore, it is necessary to consider this uncertainty in the assessment of the structure preservation state and the final repair proposal.

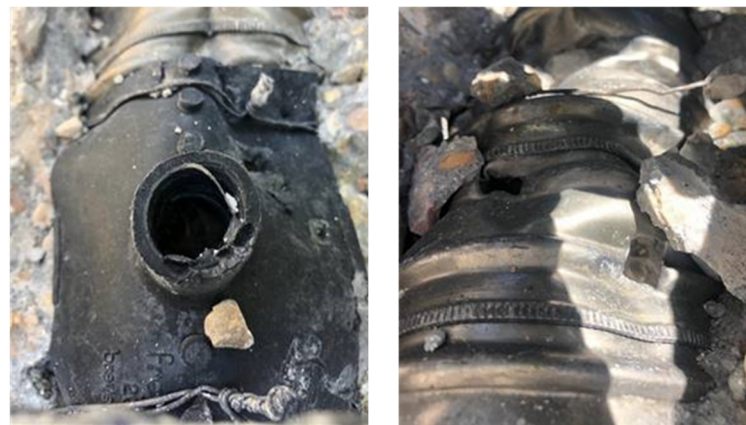
Defects that revealed malpractice in the execution of the prestressing, such as the presence of venting pipes simply supported on the sheath without any connection hole, were also observed, as shown in Figure 11.

Figure 11. Lack of connection between venting pipe and prestressing sheath (Colmenar Bridge).

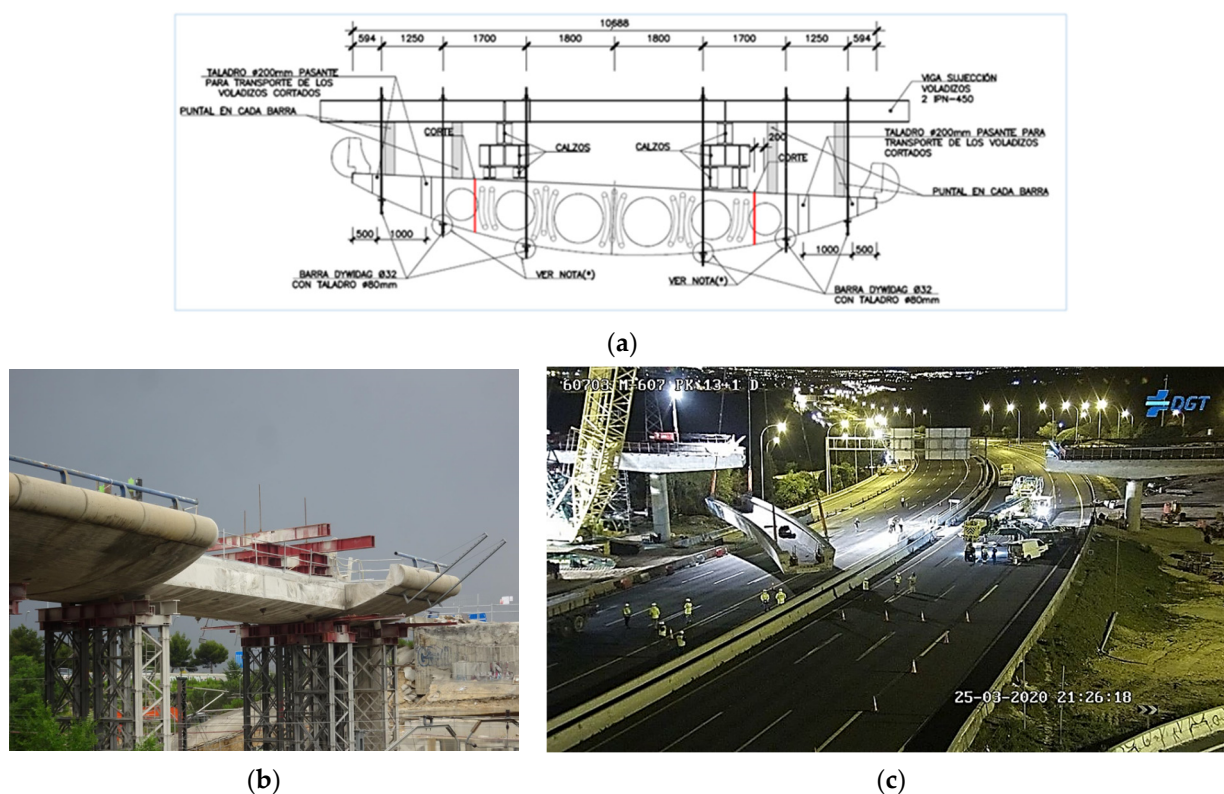
Figure 13. Dismantling of existing deck and assembly of new deck over M 40 road. (a) Section of the bridge, (b) real image of bridge, and (c) real image of operation process.

Due to the extension and evolution of the pathologies detected, and also the serious damage in the prestressing, it was concluded that the most reasonable alternative was the complete demolition of the bridge and subsequent reconstruction with a new prefabricated concrete deck. Real images of the described process are shown in Figure 13.
