Article

Application of the Kinematic Assessment of Multi-Faced Slopes Using Stereographic Projection: The Case Study of a Planar Failure on the Spondylus Coast, Ecuador

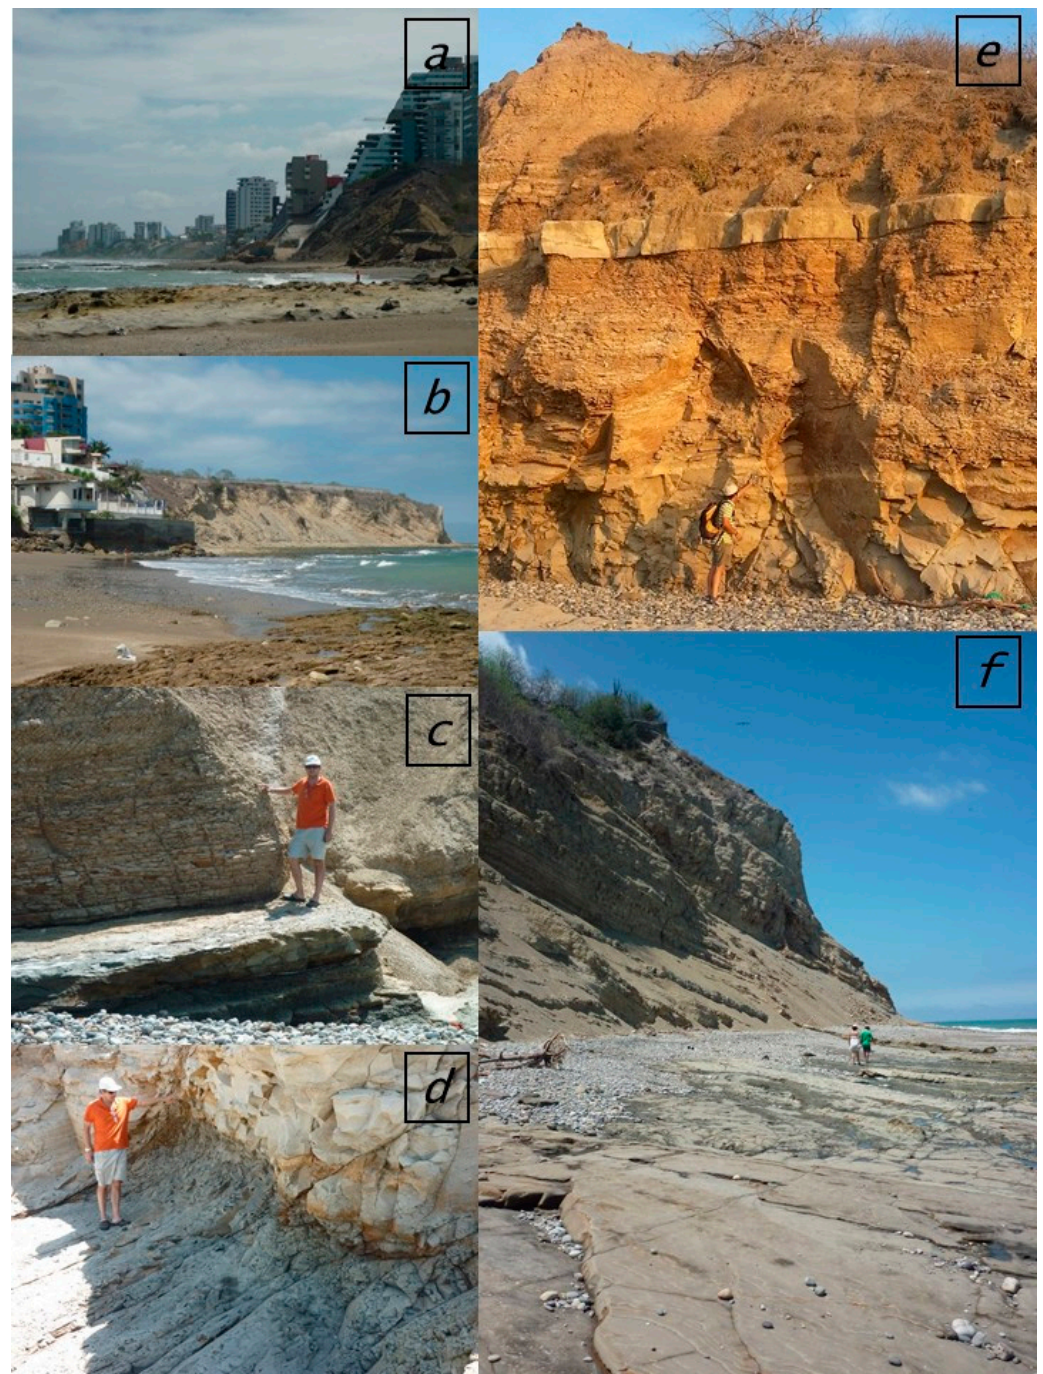
Figure 2. Panoramic view of Manta's coastline and its main types of rock cliffs: Images (a,b) hotels and buildings on top of the coast cliff, (c,d) show the basal strata, (e) shows relevant joints and (f) is the Punta Barbasquillo.

Figure 2a shows Punta Barbasquillo, vertical slopes, and dipping mudstone strata between 25 and 40°. Figure 2b,d are located on Piedra Larga Beach, where there is shallow-dipping stratification and cliffs with medium-dipping slopes with many circular failures. Playa Murciélago (bat) beach (Figure 2c) is in a part of Manta's coast where many hotel constructions and foundations are located over the unstable cliffs but far enough from the scarp limit; in some cases, reinforcement of the cliff has been accomplished. We note the alternation of mudstones and more compact siltstones affected by normal faults in Figure 2e and the difference in resistance between the cliff and the beach (Figure 2f).

Figure 2e highlights a normal fault in mudstones and siltstones. These vertical joints and faults collaborate to trigger cliff instabilities depending on the orientation and dip of the rock face. Figure 2b,f show horizontal strata with layers with diverse grades of resistance to weathering.

Figure 2d shows the beginning of the eroding process of a competent but fractured rock mass. These zones, when exposed to the iterative effects of sea waves and tides, form holes on the base part of the cliffs. This can trigger toppling failures and the filling with water and weathering of joints in planar failures. Figure 2c indicates the opposite phenomenon, that is, the lower part of the cliff is more resistant than the upper parts, causing extended horizontal platforms (Figure 2f). The image in Figure 2f is a transition between failure modes of Figure 3a,b where it is possible to notice a clear structural component in the sliding through the dipping stratification S_0 to the sea. Over that plane, failure can be of three types, depending on the resistance and weathering of the rock mass of the cliff: (1) planar failure with tension crack; (2) toppling; and (3) circular failure through the rock mass.

The wide-platform beach, which can be seen in many cases (see Figure 2b,c), comprises a level of strong mudstone and sandstone just over the tide line, and these strata dip almost horizontally. In the areas where this platform dips $30\text{--}40$ degrees, the morphology is that of a ridge of sharp escarpments (Figure 3b).

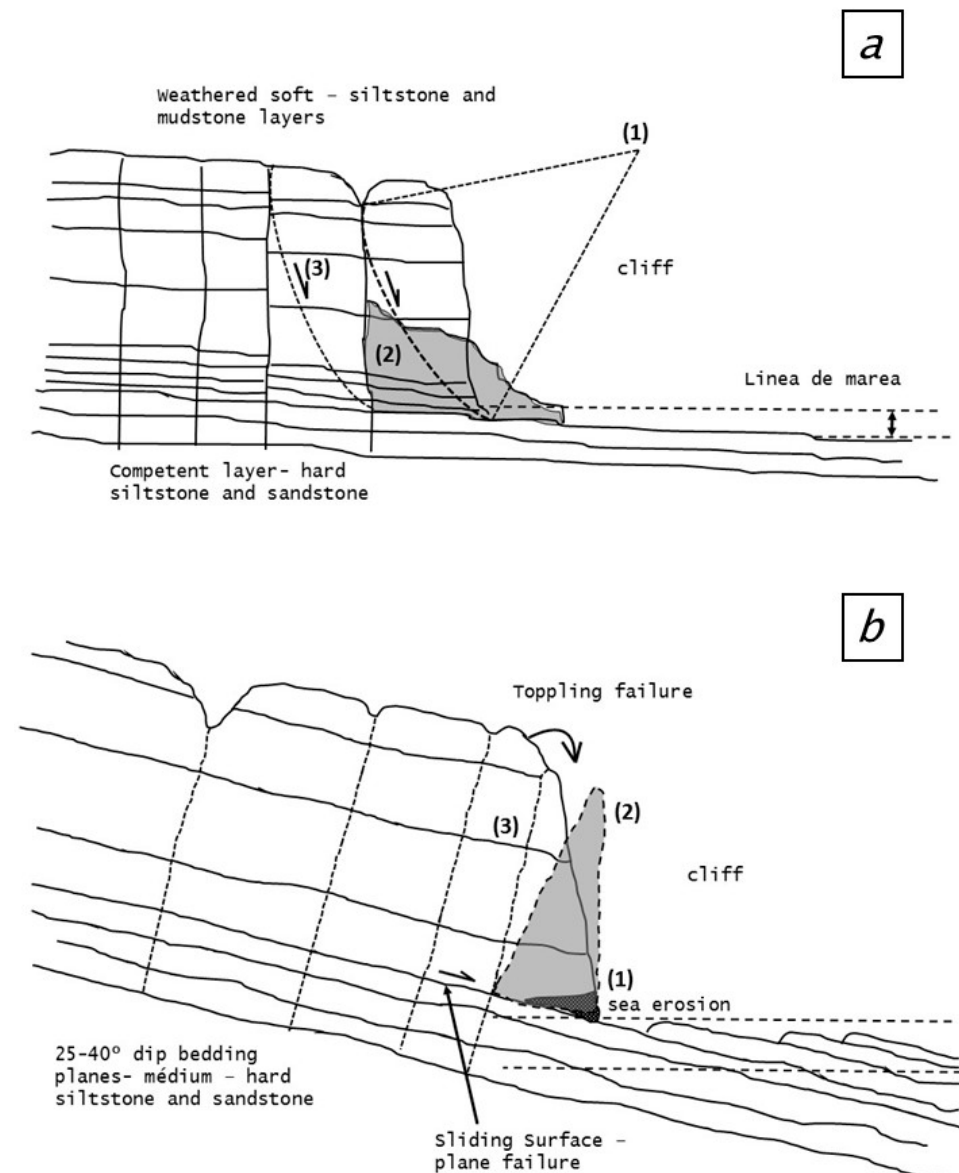
Figure 3. Scheme showing typical failure modes on Piedra Larga Beach (a) and Barbasquillo (b).

Figure 3a shows a typical failure mode in the cliffs of Piedra Larga Beach near Barbasquillo Cape. There are often circular failures through the rock mass, beginning in tension cracks (previous faults). These circular failures through the rock mass typically occur when the rock strength is very low, and they are not usual when blocks are formed in competent rock massifs. The tide line can undermine the toe of these cliffs, but it is not common. More often, the low tide exposes an extensive rocky platform of competent rock, as in Figure 2f. The failed rock mass is easily eroded, and in a short time, it is disintegrated by the action of the waves and tides (Figure 3a(2)). The instabilities continue inland in an iterative process, and the cliffs gradually lose slices (Figure 3a(3)).

Figure 3b shows schematically the most typical failure mode in the Barbasquillo Cape area and Murcielago (bats) Beach. The failure process in those locations is a combination of planar sliding and toppling. The marine erosion of the lower part of the cliff and the detachment of some toe slices collaborate to trigger the cliff failure process. Depending on the case, this can be toppling, sliding, or a combination of both. In the case of stratification dipping more than 35° , the failure process is mainly planar, and vertical joints act as tension cracks (Figure 2b,f). Once the slice is detached (Figure 3b), the remaining cliff face angle is normally 90° , but it can also overhang at $110\text{--}120^\circ$, with a clear toppling tendency. Figure 3 summarizes the process leading to the failure scheme of Figure 2f.

In Figure 3a, it is possible to notice a scheme showing a circular sliding mode and degradation of the weathered terrain and low-quality geomechanical properties on Piedra Larga Beach. In Figure 3a, (1) indicates the center of a circular failure, 2 and 3 progressive failure surfaces. Figure 3b shows a schematic of the rupture process in the cliff and the kinematic failures of block toppling and/or planar sliding in Punta Barbasquillo. In Figure 3b, (1) indicates the lower soft layer easily eroded, (2) is the detached block and (3) the final cliff coastline.

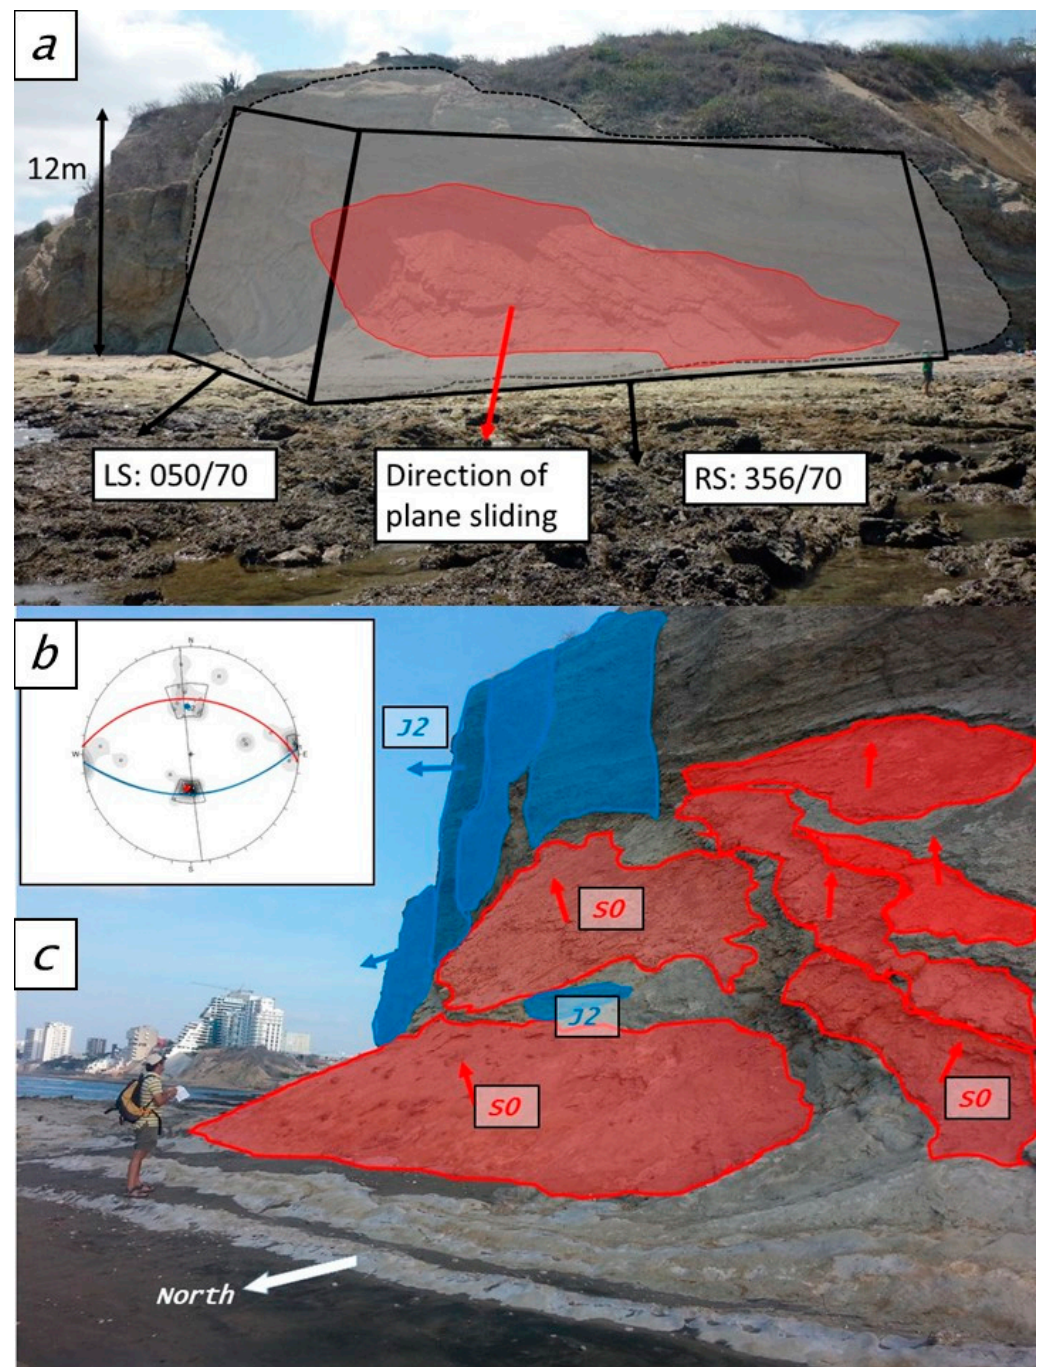
The slope of Figure 4 is the subject of the present study and is a combination of planar sliding and toppling of strata triggered by a set of subvertical discontinuities dipping inland. Barbasquillo Punta (Cape) is a very characteristic planar failure sliding through the stratification. The failure surface does not reach the upper-horizontal part of the cliff because of its low continuity and persistence. It is cut by a vertical fault and some more conjugated joints that delimit a unique block of some cubic meters in volume (Figure 4). This block fell in precedent times and has been completely removed by sea action—erosion and weathering. The peculiarity of this cliff is that it has a dihedral shape similar to a “nose”. This falls under the category of two-faced slopes (see methodology in [1,5]), with the left side of the “nose” watching the cliff from the sea—the left-side slope (LS) has a dip direction of $N 050^\circ E$ and a dip of 70° . The right side (RS) has a dip direction of $N 365^\circ E$ and dips around 70° (Figure 4).

Figure 4. Scheme of Punta Barbasquillo before (a) and after the slope failure (c). Image (b) shows the stereogram of the slope and main joint set.

Figure 4a shows Punta Barbasquillo Beach before the cliff failure. Figure 4b is the stereographical representation of the main joints, while Figure 4c is the actual situation indicating the main joint sets determined on the two-faced slope of Barbasquillo. In Figure 4, stratification, or S0, is shown in red, and the joint set named J2, which forms the tension crack and induces the progressive strata toppling, and the third joint set, J1, vertical and minor, are shown in blue.

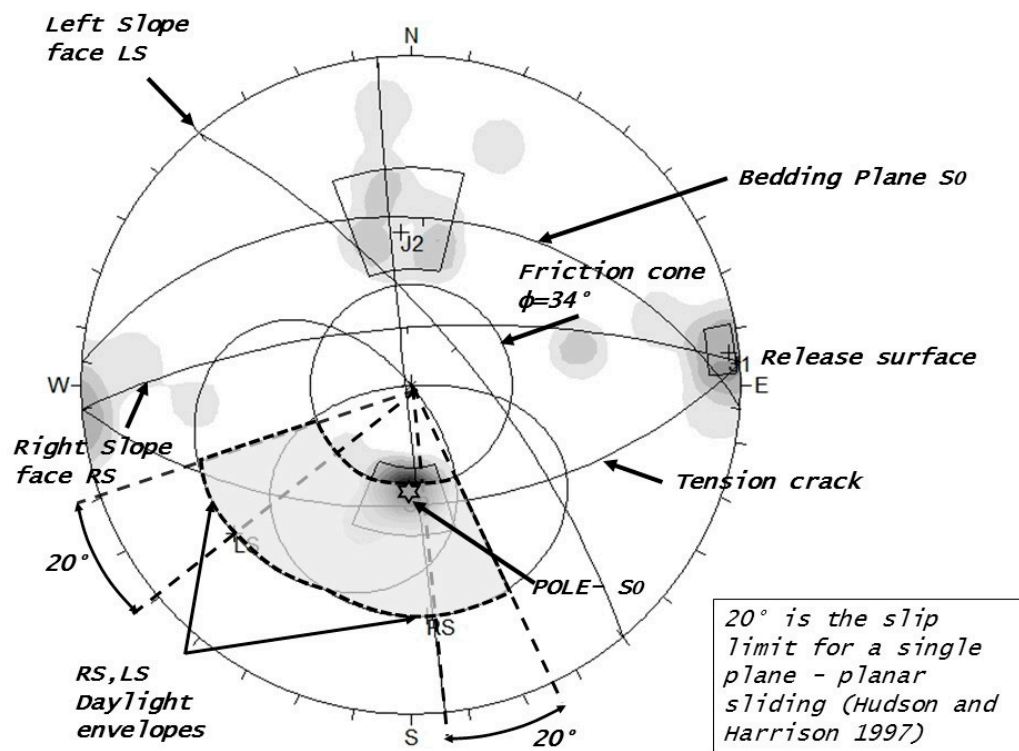
The two front faces of the slope as well as the main joint sets were represented using stereographic projection (Figures 5 and 6). The results of the kinematic assessment indicate that the slope was unstable. The instability can be observed in the joint S0 poles located inside the restricted daylight envelope (Figure 5). The toppling risk that could exist in the cliff before the planar failure was analyzed using projection (see Figure 7). The potential toppling of J2 towards the left (LS) and right (RS) sides of the cliff was also analyzed. The kinematic assessment shows a potential but not important risk: the pole of the joint J2 is not inside the daylight envelope but very close to the limit zone. The J2 should therefore be considered a tension crack. Once planar sliding has occurred, the new slope face overhanging the vertical could trigger both block and flexural toppling (Figure 7b), as can be concluded from the new and wider daylight pole envelope.

Figure 5. Stereographic representation of the joints and planes existing in the Barbasquillo slope using DIPS software [16].

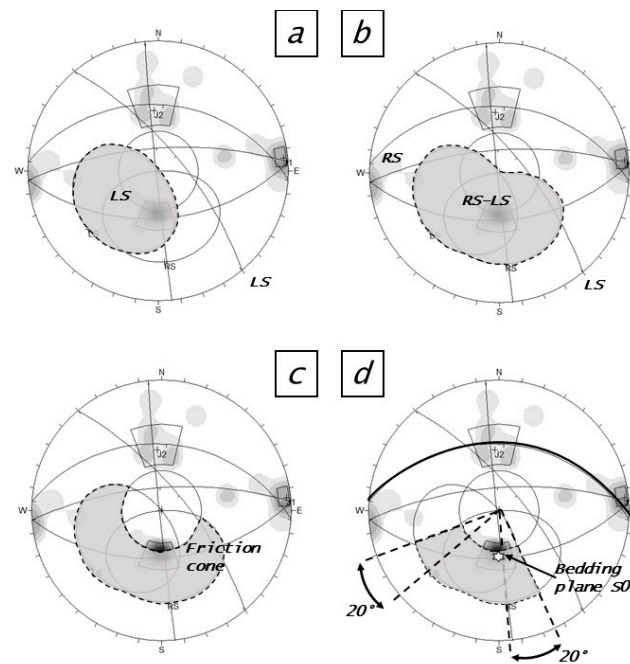
Figure 6. Process to design the restricted daylight envelope for a double-face slope **Right** and **Left** (RS-LS) following the Jorda et al. [1] methodology. Images (a,b) show the daylight envelope construction; image (c) is the intersection with the friction cone and (d) is the “restricted daylight envelope” with the lateral limits for planar failure.

Figure 6a shows the daylight envelope for a single-face LS (Left Side). In Figure 6b, the expanded daylight envelopes for both left and right faces (LS-RS) are shown, while in Figure 6c, it is proposed that the daylight envelope is restricted by the friction cone. The pole of the bedding plane is inside the restricted daylight envelope, so the plane should be considered unstable, as can be deduced by the slope slide failure.

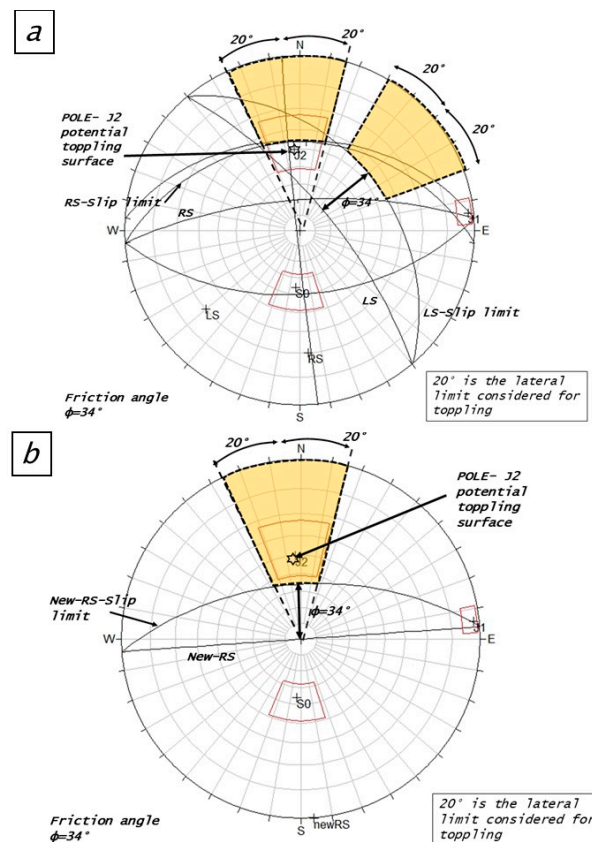
Figure 7. Stability assessment stereoplot before and after the Barbasquillo cliff’s progressive failure. Image (a) shows the actual potential toppling failure for the right and left sides of the cliff: the slope dip angle is 70 degrees. Image (b) shows an unstable J2 joint because the pole falls into the yellow envelope: that was the initial situation when the cliff was vertical (90 degrees dip).

Figure 7a shows the stereoplot assessment of the potential toppling risk in Barbasquillo before the planar sliding. Figure 7b shows the stereoplot assessment of the potential toppling risk in Barbasquillo on the RS slope face in the present situation after planar sliding has occurred.
