Article The Intersection of Architectural Conservation and Energy Efficiency: A Case Study of Romanian Heritage Buildings

3. Case Study: Câmpulung Town Hall Building

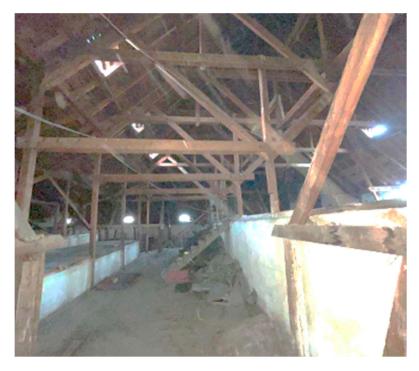
As can be seen in the image above (see Figure 5), the state of the attic was unkept and no intervention was conducted to insulate the roof space, hence the occurrence of substantial heat loss and thermal bridges.

Figure 5. Image displaying the uninsulated attic.

The rehabilitation solutions chosen for the attic slab include insulating the floor towards the unheated bridge; the heat-insulating layer will be applied to the outer face of the support layer after uncovering the ballast and/or waterproofing layers as appropriate. The hydrothermal insulation solution will be made with a layer of fireproof mineral wool of a minimum 30 cm and a maximum conductivity of 0.04 W/mK. Regarding the modernization solutions proposed for the interior lighting, the proposed strategy was to replace the interior lighting luminaires, which currently have fluorescent lamps, with efficient LED lighting luminaires.

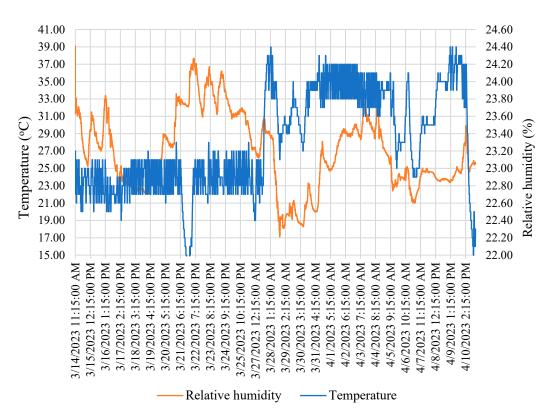
Figure 7. Results regarding the degree of relative humidity and temperature obtained from the equipment located in an office space facing the south facade of the building.

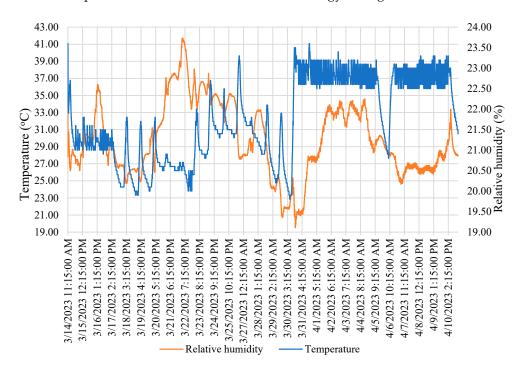
Figure 8 highlights that, because of temperature changes, the interior temperatures fluctuate considerably in the period during which the equipment monitored the building. Consequently, this means more chances of thermal bridge formations appearing, and even mold can occur over time, given the change in temperatures and the lack of necessary layers for thermal insulation. All this comes as a research validation tool for the energy audit conducted, showcasing with real-time data that the construction elements do not meet the requirements of thermal insulation and energy saving.

Figure 8. Results regarding the degree of relative humidity and temperature obtained from the equipment located in an office room facing the south façade of the building.

The south office room has a wider temperature range, with the lowest and highest recorded readings being 21.7 °C and 24.4 °C, respectively, with an average temperature of around 23.31 °C. In comparison, the north office room maintains a temperature range between 19.8 °C and 23.6 °C, with an average temperature of approximately 21.74 °C, which is lower. This suggests that the temperature in the south office is consistently higher than that in the north office. The humidity levels in the north office room typically exceed those in the south office room. The humidity levels in the north office has humidity levels ranging from 17.1% to 39.1%, with a mean humidity of 26.89%. This indicates that the air in the north office consistently has a higher level of humidity. The north office room reveals a little more noticeable fluctuation in temperature and humidity. The north office exhibits a wider spectrum of temperature and humidity variations, which could have a more pronounced impact on thermal comfort and air quality, compared to the relatively milder south office.

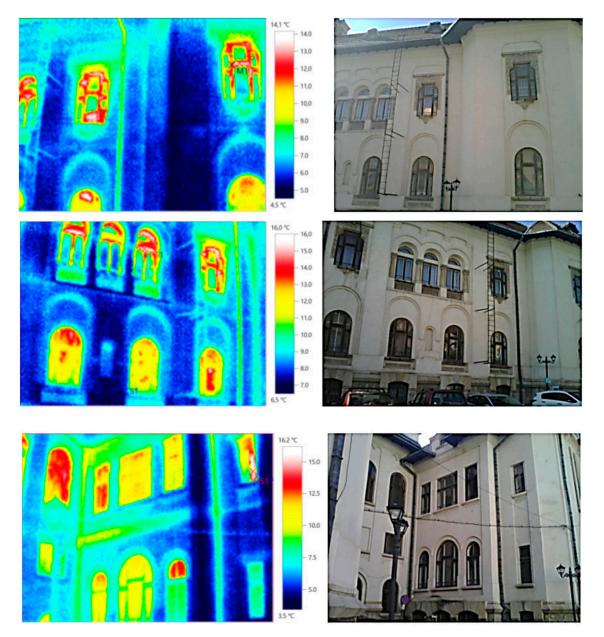
Figure 9. Multiple thermal images of the north façade of the building.

The thermographic research highlights a significant issue of energy inefficiency at the Câmpulung Town Hall, mainly caused by outdated construction materials and deteriorating architectural components. By replacing or updating the historical windows with thermally efficient alternatives that preserve the building's beauty and historical signifi-

- The sealing of cold air infiltrations in the joints of carpentry contours between the skirting board and the wall gap with a sealing film on the outside (width 29 cm), and filling the remaining spaces after installing the new windows with polyurethane foam and closing the joints with plaster;
