Review of the Failure at the Flotation Tailings Storage Facility of the “Stolice” Mine (Serbia)

Dragana Nišić * , Nikoleta Aleksić, Bojan Živanović, Uroš Pantelić and Veljko Rupar

Faculty of Mining and Geology, University of Belgrade, 11000 Belgrade, Serbia;
nikoleta.aleksic@rgf.bg.ac.rs (N.A.); r530-23@student.rgf.bg.ac.rs (B.Ž.); uros.pantelic@rgf.bg.ac.rs (U.P.);
veljko.rupar@rgf.bg.ac.rs (V.R.)

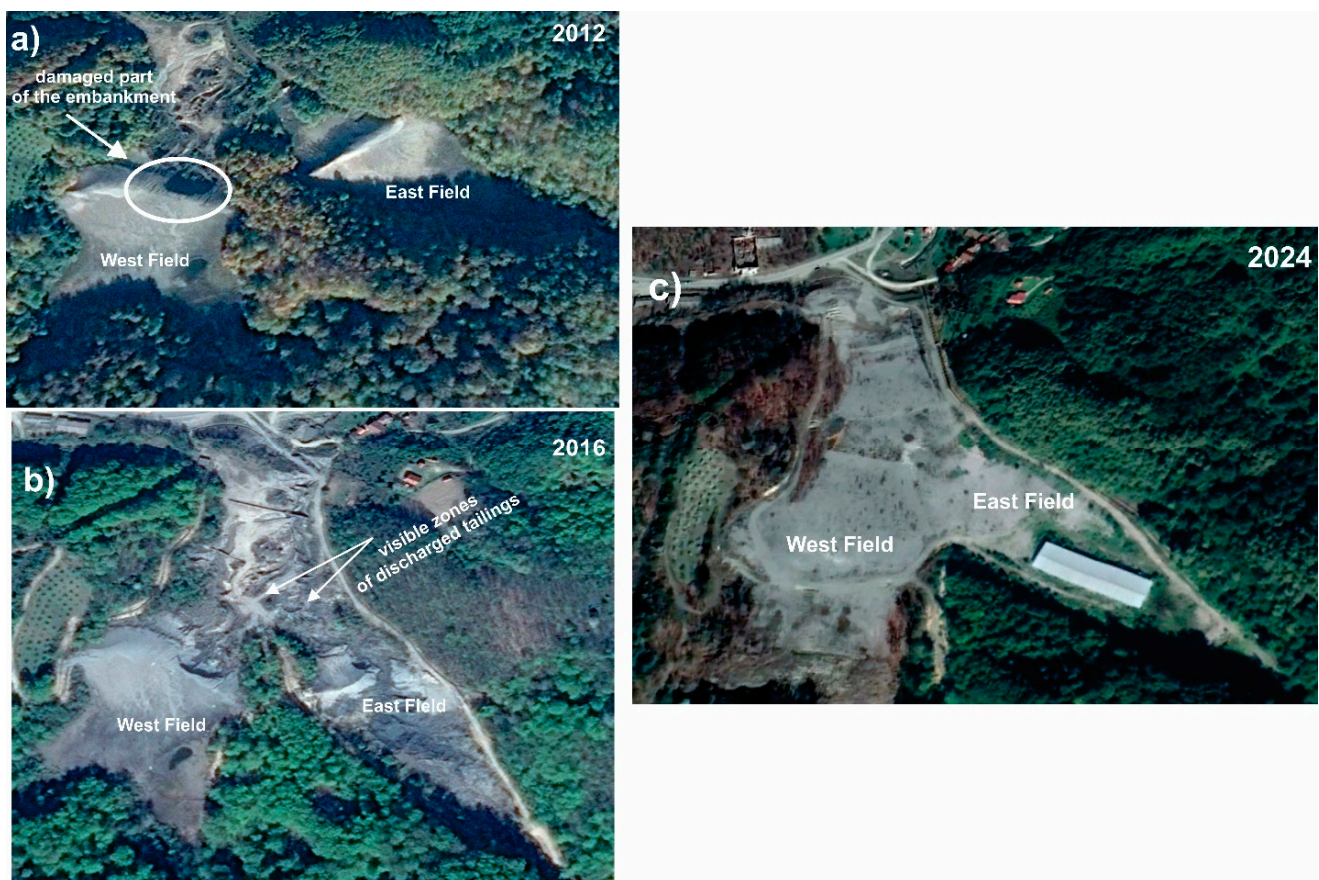
The flotation TSF of the “Stolice” mine has not been active since 1990. According to the image of the TSF from 2012 (Figure 3a), it is clear that the embankment on the west field of the TSF was already damaged. Regardless of this fact, no accidents had been recorded at this TSF before. During May of 2014, the so-called “Tamara” cyclone caused heavy rainfall and caused what are considered to be the largest floods ever recorded in certain parts of Central and West Serbia [15]. The region of the TSF of the mine “Stolice” had 200–250 mm of rainfall in only 3 days, surpassing the so-called 100-year flood [16].

Figure 3. The flotation TSF of the mine “Stolice”: (a) image from 2012, before the accident; (b) image from 2016, after the accident and before rehabilitation; (c) image from 2024, after rehabilitation [17].

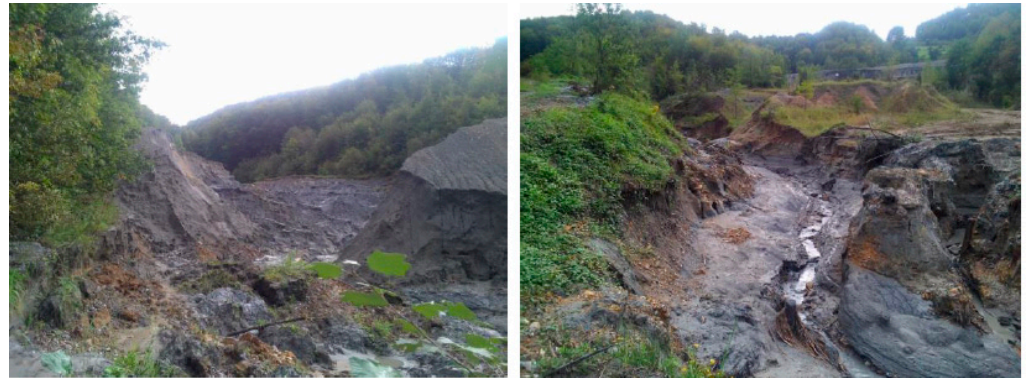
On 13 May 2014, due to the inflow of a large amount of precipitation and the saturation of tailings with water, there was a filtration disturbance in the eastern field embankment, and as the drainage worked poorly, it caused a break in the embankment and there was an overflow of the deposited tailings from the eastern field (Figure 4). On that occasion, a flood wave was formed, and the spilled tailings reached the Kostajnička River, where they were further transported to the Korenita River. Considering that there was intense rainfall for days (from 13 to 16 May), the spilling of eastern field tailings was recorded for days. Until that moment, the western field was stable, without visible water on the surface.

Figure 4. The damaged embankment of the eastern field. Reproduced with permission from the Water Institute “Jaroslav Černi” [10].

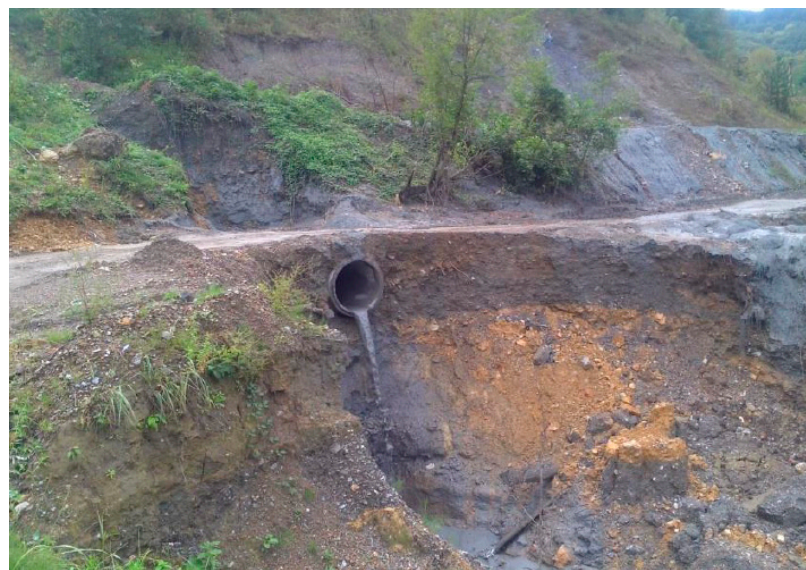
Just two days later, on 15 May 2014, continuous rainfall triggered a natural landslide above the western field. The landslide was particularly concerning because it added a large amount of debris into the western field, which was already at risk due to the heavy precipitation. The additional weight from the landslide further stressed the embankment, weakening its integrity. On that occasion, the pipe culvert regulating the Bezimeni Stream on the western flank of the TSF was damaged (Figure 5).

Figure 5. The damaged pipe culvert on the western field. Reproduced with permission from the Water Institute “Jaroslav Černi” [10].

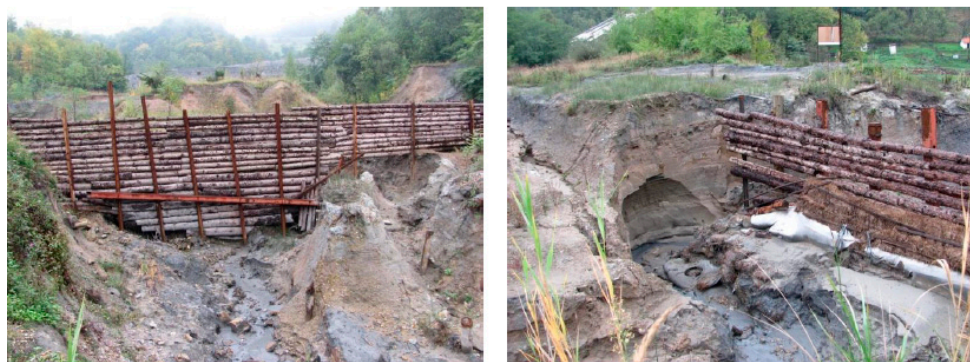
On 23 May 2014, the Bezimeni stream began to fill the western field with water, which finally caused the western field embankment to breach [5]. An even larger volume of tailings into the surrounding environment was released than in previous phases. The release of tailings lasted for days after those temporary measures for the reconstruction of the TSF were introduced. The improvised wooden embankment was installed (Figure 6).

Figure 6. The improvised wooden embankment of the eastern field. Reproduced with permission from the Water Institute “Jaroslav Černi” [10].

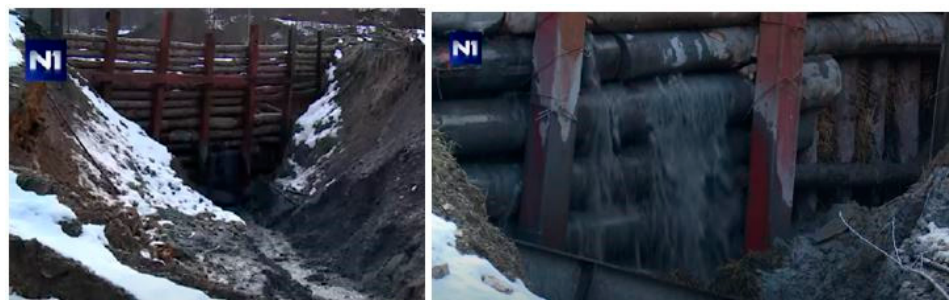
On 17 July of the same year, the tailings spilled again when the already-damaged eastern field embankment, which was temporarily blocked off by the wooden embankment at that moment, was breached and additional tailings spilled into the Kostajnička River (Figure 7) [18]. The repeated failure highlighted the need for more robust remediation efforts and long-term solutions to prevent future accidents of this nature.

Figure 7. The temporarily blocked eastern tailings field was breached again on 17 July 2014. Reproduced with permission from N1 Television [19].

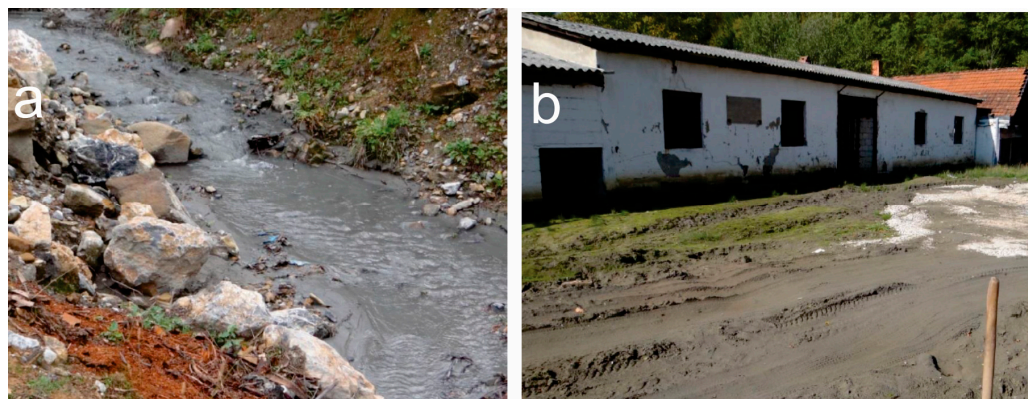
During the accident, a total of between 70,000 and 100,000 m³ of the deposited tailings spilled from the TSF, with most of the tailings spilling from the eastern field [20]. The beds of the Kostajnička River and the Korenita River were devastated, especially the unregulated parts of the riverbeds. The spilled tailings were deposited on the banks of the Kostajnička River, spanning 5 km, and the Korenita River, spanning 20 km, up to the confluence with the Jadar River [11]. Downstream from the TSF, deposits of spilled tailings were created, which were 5–10 cm thick and 50–75 m wide (Figure 8a,b) [21]. It has been estimated that the total contaminated surface of the arable and non-arable land was around 400 ha. Road No. 149 was completely closed off, and several residential buildings were completely demolished [10]. There were no human casualties [5].

Figure 8. Tailings deposits in the bed of the Kostajnička River (a) and on the surrounding terrain (b). Reproduced with permission from the Water Institute “Jaroslav Černi” [10].

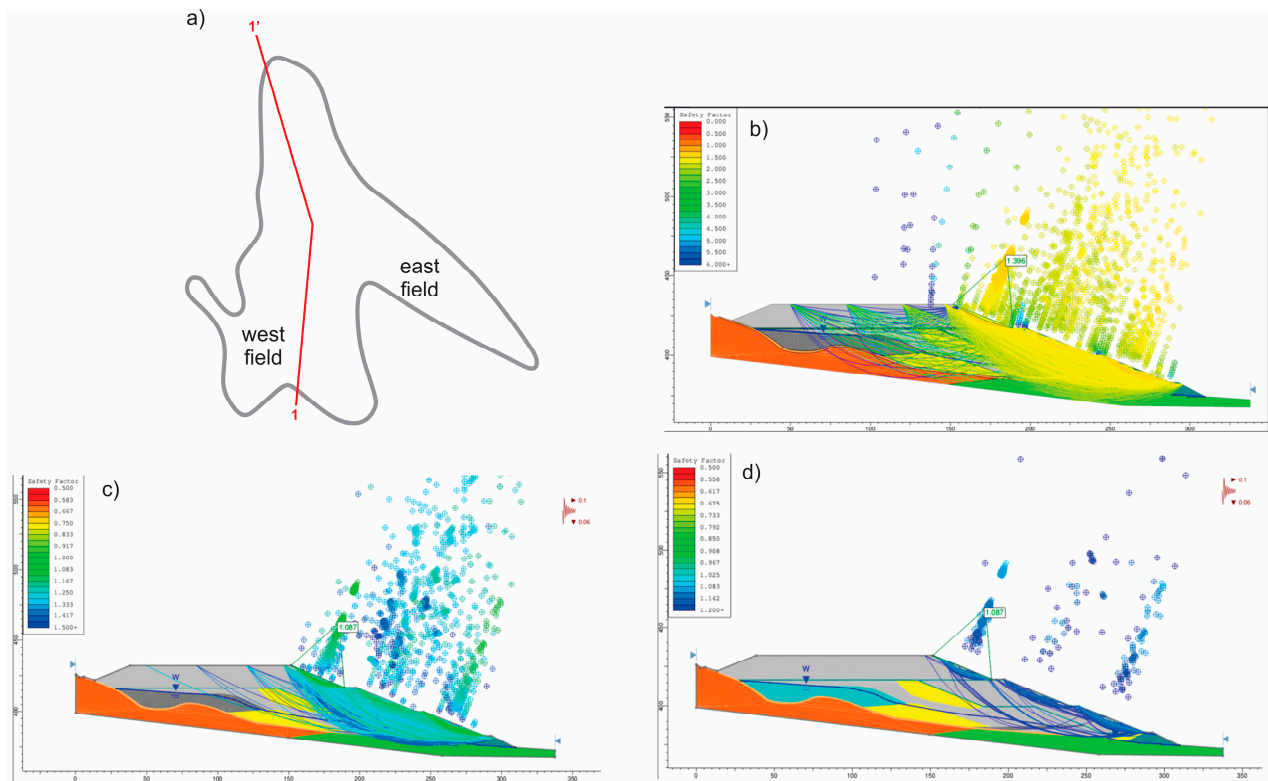
The stability analysis of the reconstructed TSF was conducted for a characteristic longitudinal section, marked as Section 1–1' in Figure 9a. This section was chosen because in the case of the worst possible scenario, it would give the worst results due to the largest amount of deposited tailings along that section and steep angles of the surrounding terrain [11].

Based on the obtained results of the stability analysis, it can be concluded that the TSF is stable in static and dynamic conditions. These data provide a good basis for risk assessment of another accident at the TSF of the “Stolice” mine. If the 3 × 5 risk assessment matrix is taken into account, the probability of an accident based on the obtained results of the stability analysis can be assessed as “low”. The significance of the consequences is equated with the significance of the already-recorded consequences of accidents from 2014,

Figure 9. Stability analysis of the reconstructed TSF: (a) position of the profile used for analysis; (b) result for static load; (c) result for earthquake load; (d) result for earthquake + liquefaction load. Reproduced with permission from the Water Institute “Jaroslav Černi” [11].

Load Type	Fs [11]	Meaning
Static	1.396 (Figure 9b)	Acceptable Fs. TSF can be considered long-term stable [32].
Earthquake	1.087 (Figure 9c)	Acceptable Fs. TSF can be considered long-term stable [32].
Earthquake + Liquefaction	1.087 (Figure 9d)	Acceptable Fs. TSF can be considered long-term stable [33].

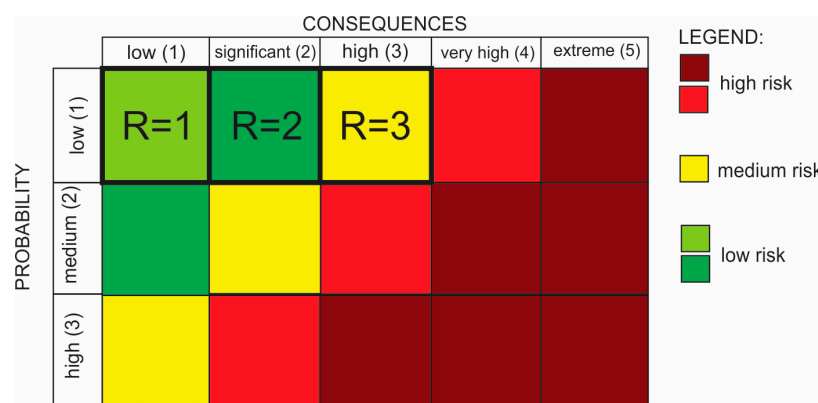
Figure 10. Risk matrix 3 × 5.

when they were assessed as consequences of “low to high” significance. Based on these two parameters, a “low-to-medium” risk level, ranked between 1 and 3, is obtained, which is interpreted as an acceptable risk [34] (Figure 10).
