Article

Operational Modal Analysis and Safety Assessment of a Historical Masonry Bell Tower

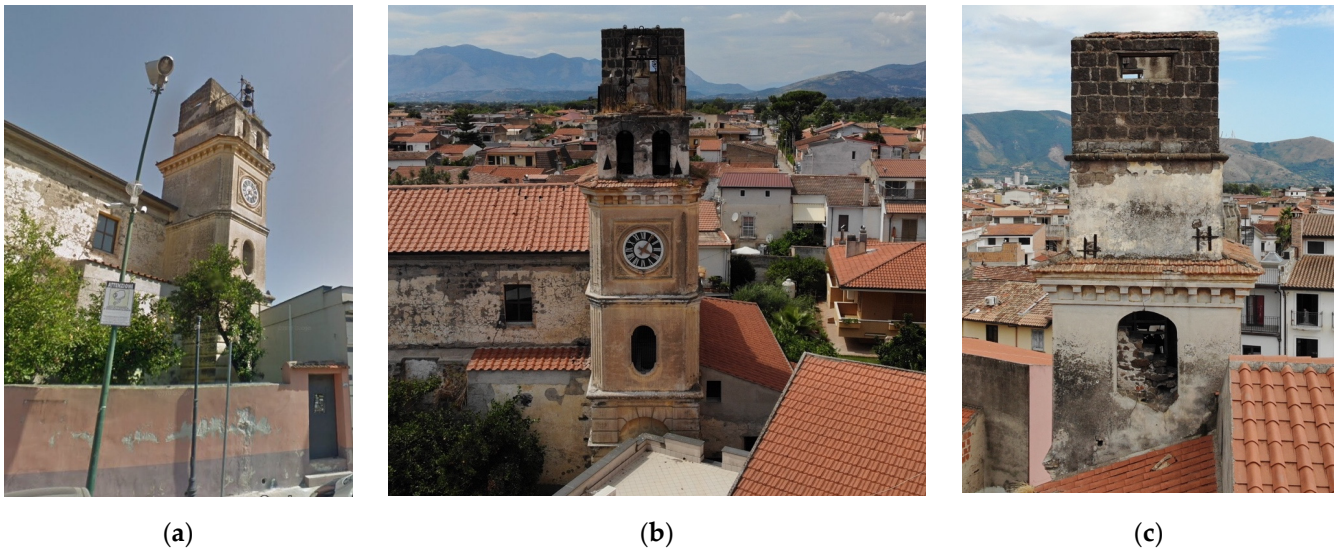
Figure 1. The tower of the St. Lucia Church in Cellole (CE): (a) south-west, (b) south and (c) north views.

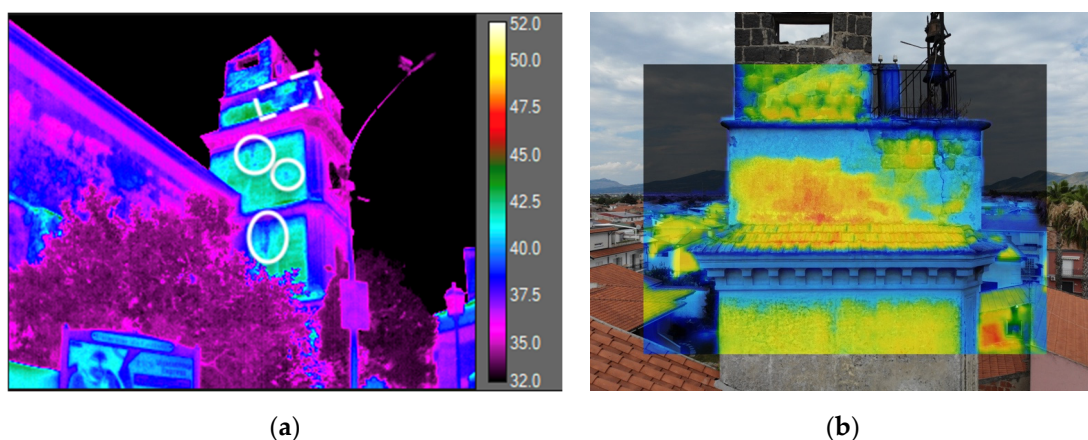
Beyond the mechanical characteristics of the existing material, the tower is in a poor state of conservation, with visible signs of degradation and cracking. Specifically, the visual inspection revealed that many of the squared gray tuff blocks showed signs of detachment, especially around the openings. In the bell chamber, many blocks appeared displaced, disconnected and infested with weeds due to the disrepair affecting the structure. The natural deterioration of the masonry, plaster and roof, combined with lack of maintenance, has resulted in a structure with serious conservation and stability issues.

Furthermore, significant vertical cracking was observed on the east and west façades, affecting the external walls of the second, third and fourth levels. The presence of cracks on the west façade was clearly confirmed through thermographic inspections conducted on-site from the ground level and with the support of a drone (Figure 4). On the other hand, the situation was even more severe on the opposite wall (east façade), where the cracks were visible to the naked eye and further confirmed by thermal imaging (Figure 5). The presence of these vertical cracks may be connected to the configuration of the last sector, whose construction clearly took place in a latter phase compared to the remaining bell tower. The abrupt change in the plan section may be responsible for the non-uniform distribution of vertical stresses on the masonry below. Furthermore, as shown in Figure 3, the tower is configured as the juxtaposition of two hollow sections, whose connection is far from perfect. This, together with the possible presence of settlements, out-of-plumb and past horizontal forces, may explain the detachment of the south façade from the north part.

Figure 4. Cracking phenomenon observed on the west façade: inspection with thermal imager from ground (a) and with drone (b). Cracks are circled in white.

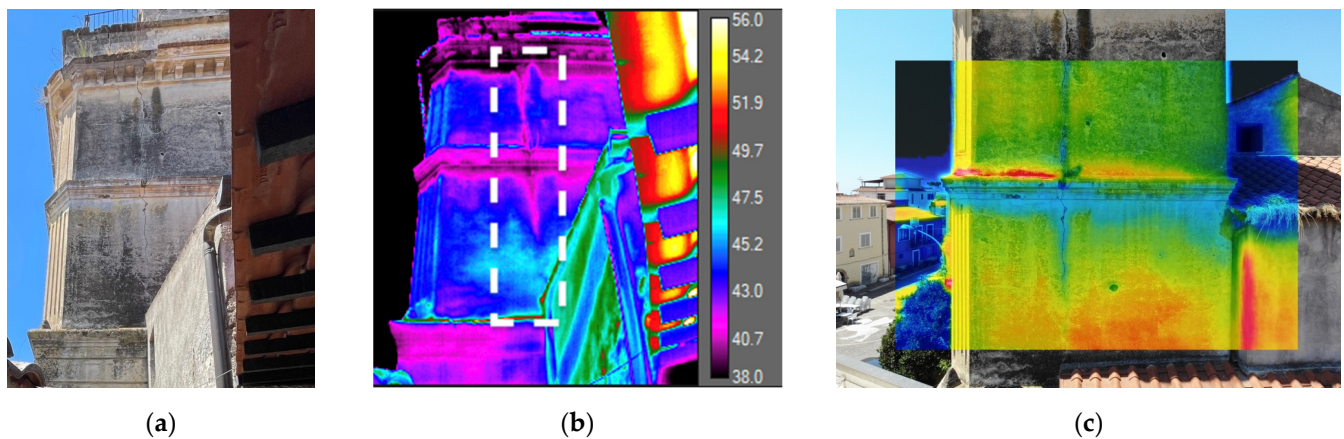
Figure 5. Cracking phenomenon observed on the east façade: (a) photo of the external wall and inspection with thermal imager from ground (b) and with drone (c). The vertical crack is highlighted in white.

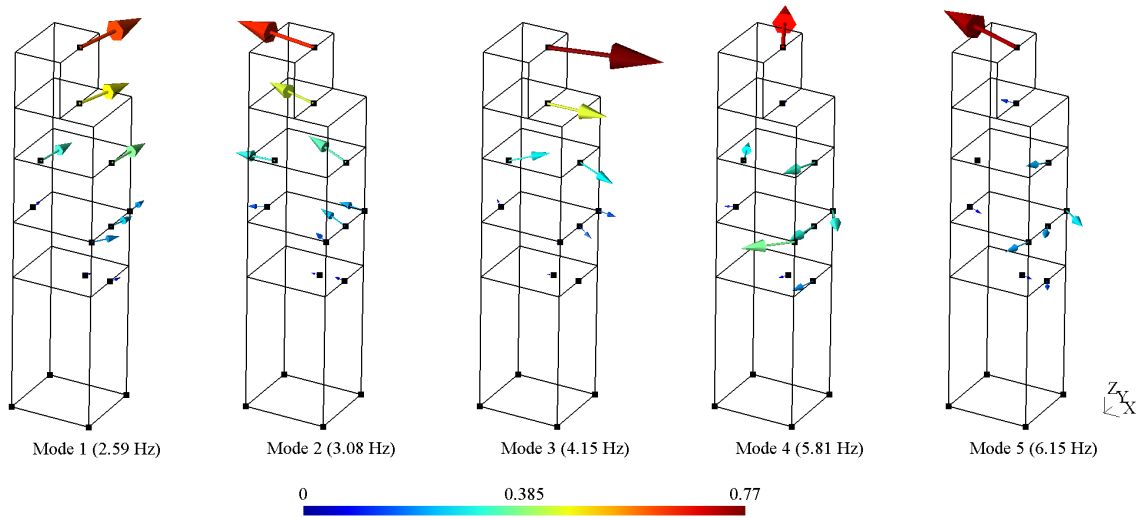
The five identified modes are depicted in Figure 9. While the first two modes are translational modes, mainly along the two principal directions, with little effect of the interaction with the church, the fourth mode rather clearly appears as a torsional mode. Interestingly, similarities between modes 2 and 3 (translational along x), and 4 and 5 (torsional), respectively, seem to emerge from the analysis of the modal shapes and associated Modal Assurance Criterion (MAC) value (Figure 10). The presence of two modes of the same type at different frequencies, according to the authors, can only be explained by the alteration in the dynamical behavior generated by the physical discontinuity represented by the vertical crack observed in the two parallel walls (Figures 4 and 5).

Figure 9. Identified modes of the bell tower.

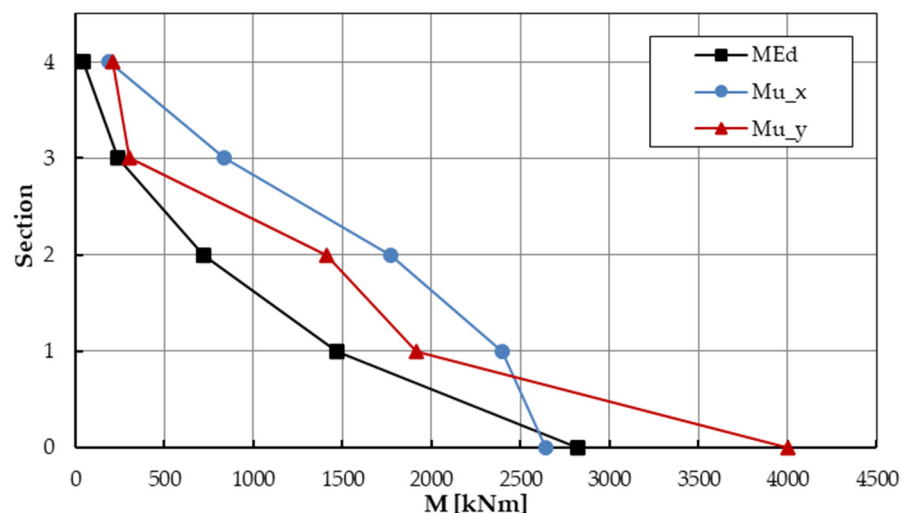
Figure 14. Comparison between design and resisting bending moments at each relevant section (linear acceleration profile).

According to EL1 methodology, which allows for performing a simplified structural check neglecting out-of-plane and shear failures, the bell tower under investigation presents a safety factor of less than unity for design seismic loads at the ULS, and thus cannot be considered safe. In particular, by assuming a linear displacement and 2nd mode proportional load distributions (along x-direction), the base section returned a safety index in terms of acceleration equal to 0.94 and 0.84, respectively. On the other hand, when a 1st mode proportional load pattern was considered, the section at the base of the 3rd sector was the sole returning a negative outcome of the structural checks. This can be related to

the significant openings the tower presents at this level. In the other cases, the analyzed sections were verified with a safety index in terms of acceleration ranging from 1.05 (section 1, 1st mode proportional) and 4.09 (section 4, linear distribution).

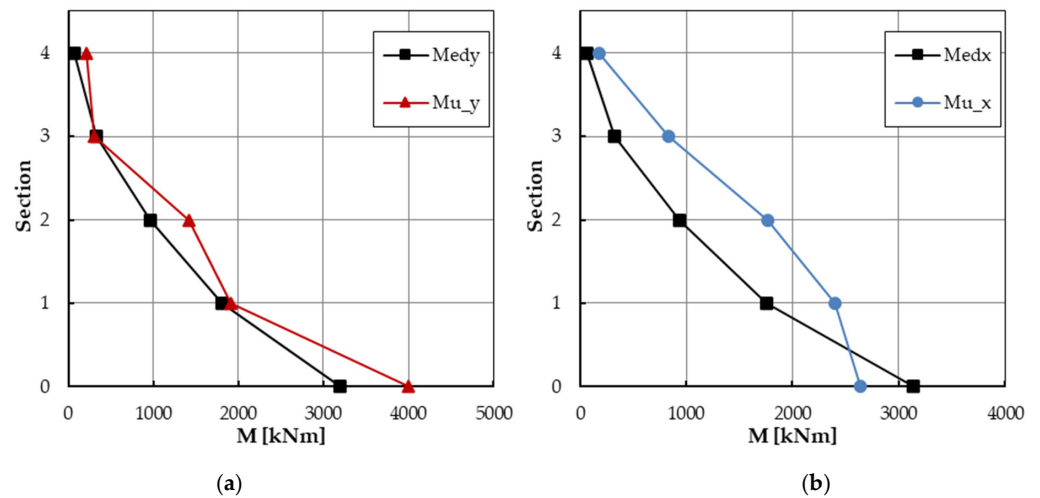
Figure 15. Comparison between design and resisting bending moment at each relevant section: (a) 1st mode-proportional and (b) 2nd mode proportional acceleration profiles.

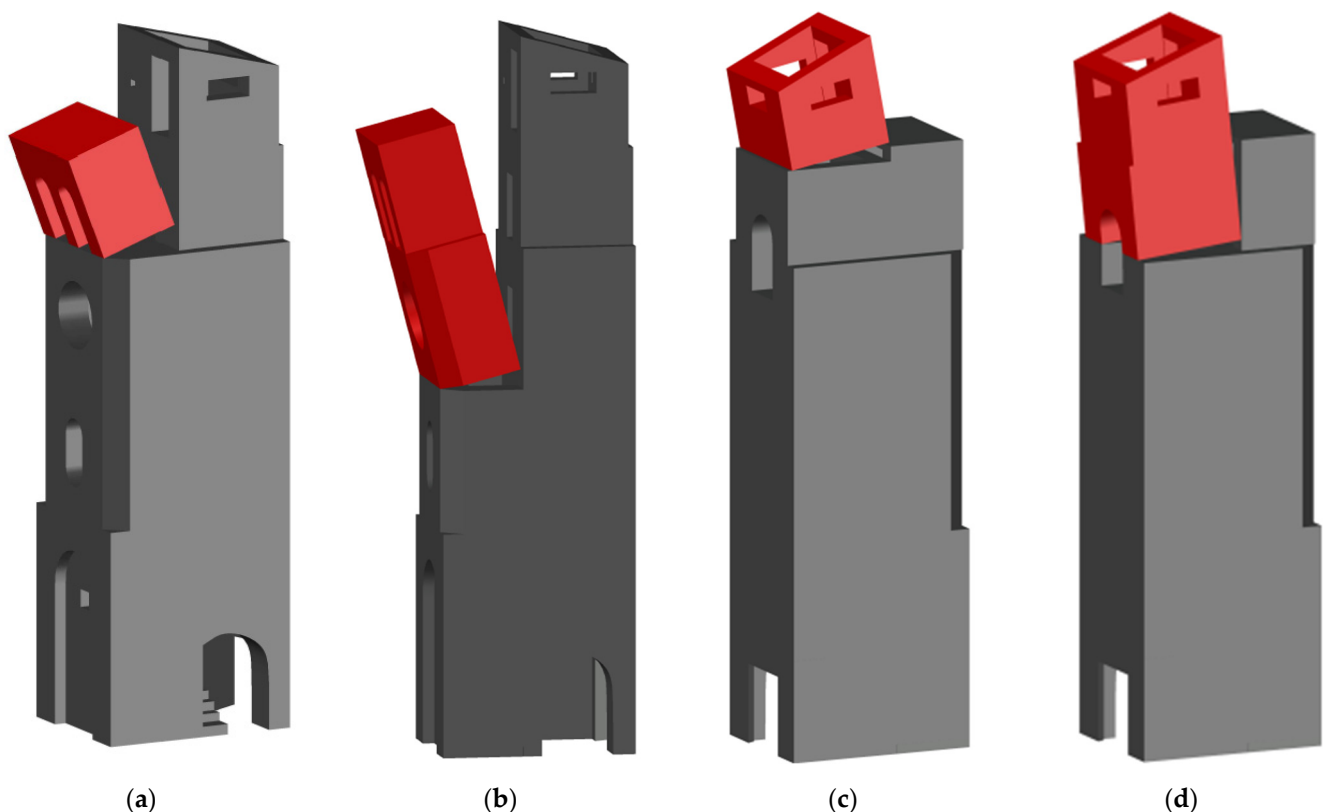
1. overturning of the portion of sector 4 due to the presence of vertical cracks (Figure 18a);
2. overturning of the portion of sectors 3 and 4 due to the presence of vertical cracks (Figure 18b);
3. overturning of the last sector of the tower characterized by different material features (Figure 18c);
4. overturning of sectors 4 and 5 due to the presence of vertical cracks (Figure 18d).

Figure 18. The considered collapse mechanisms for the EL2 assessment: (a) overturning of part of sector 4, (b) overturning of part of sectors 3 and 4, (c) overturning of sector 5, (d) overturning of sectors 4 and 5.

The results show that the minimum value of the safety index in terms of acceleration is 0.59. This minimum safety index value is associated with the collapse mechanism 1 of the masonry section in sector 4, which, in its current state (characterized by cracks where it connects with the remaining part of the masonry in the sector), behaves like a monolithic wall. The other mechanisms considered returned positive outcomes, with safety indexes in the range of 1.41 (mechanism 2) to about 5 (mechanism 3).

Motivated by these results, the final vulnerability assessment was carried out by means of EL1 and EL2 methodologies. Both approaches provided safety factors less than unity, thus indicating the need for seismic retrofitting. In particular, in the case of the EL1 approach the bottom section failure was estimated at a PGA less than that corresponding to the design spectrum at the Ultimate Limit State, as well as considering, in the authors' view, the rather optimistic behavior factor $q = 2.8$. In the case of EL2, a mechanism triggered by the observed vertical cracks provided activation ground acceleration equal to less than 60% of the design PGA at the ULS.
