# Effect of Vehicle Vibration on Interior Noise of Railway Vehicles Passing Through Rail Corrugation Sections

**Abstract:** This study involved experimental research to analyze the effect of rail corrugation on interior noise levels inside railway vehicles. Measurements taken on the Incheon Line 2 light rail indicated that the vehicle's age and maintenance condition have minimal effects on interior noise. Although wheel wear slightly reduces interior noise, it is insufficient to address the issue of abnormal noise. The analysis of the relationship between vehicle vibrations and interior noise revealed that at 80 km/h and with a 24 mm rail corrugation wavelength, vibrations at 920 Hz in the axle box and car body increase, coinciding with the dominant interior noise frequency of 926.6 Hz. Furthermore, an analysis using a car body sweep confirmed a relative increase in noise in the 920 Hz range. Therefore, abnormal noise in rail corrugation sections is caused by vibrations at 920 Hz due to the corrugation wavelength and train speed, which align with the car body resonance frequency, leading to increased car body vibrations and interior noise.

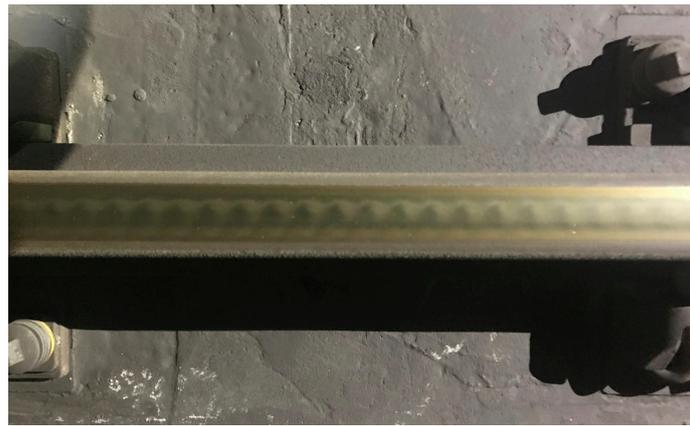
Rail corrugations have been observed on Line 2 of the light rail transit operating in Incheon, South Korea. The total length of the line is 29.1 km one way, stretching from Unyeon Station to Geomdan-Oryu Station, and it comprises 27 stations. Recently, frequent occurrences of rail corrugations have been reported in several sections of this line, as shown in Figure 1. Table 1 presents the occurrence of rail corrugation on both the upper and lower lines. On the upper line, corrugation was found at 12 locations, covering 955 m, and on the lower line, it was found at 8 locations, covering 790 m. Although corrugation is generally known to occur more frequently in curved sections, the findings of this study revealed that most corrugations occurred in straight sections with higher vehicle speeds, except for two locations, which is a distinctive feature.

**Figure 1.** Rail corrugation.

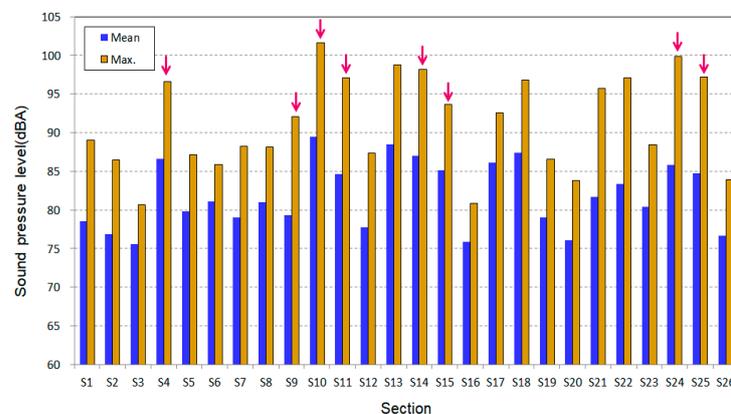
Recently, numerous occurrences of rail corrugation have been discovered in various operational sections, and as a result, the level of abnormal interior noise has also increased. Figure 3 shows the equivalent noise levels and maximum values measured in the light rail vehicle during commercial operation, segmented by sections between stations. The equivalent noise level for each section was calculated by averaging the interior noise from departure to arrival at each station, and the maximum value represents the highest noise level measured in each section. The average equivalent noise level was 81.8 dB, and the maximum value was 89.5 dB. The average maximum noise level was 91.3 dB, with the highest value recorded at 101.6 dB, which is significantly high. These results significantly exceed the interior noise standard of 80 dB managed by the urban railway operating organization, deteriorating passenger comfort during commercial operations and leading to an increase in noise complaints. Further research is required to identify the causes of these abnormal noise occurrences.

Figure 3. Interior noise levels of LRT vehicles (↓: sections with rail corrugation).

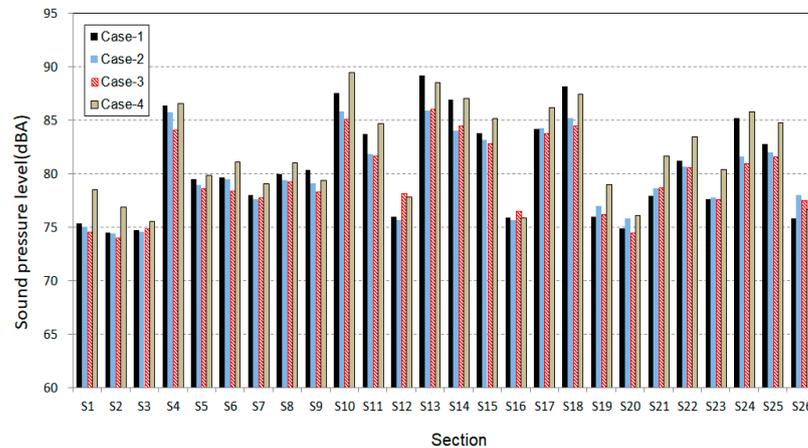
Figure 5 and Table 4 present the equivalent interior noise levels measured in each section under all vehicle maintenance conditions. Overall, the noise levels in sections with rail corrugation were significantly high, showing a similar trend across the different maintenance conditions of the vehicles.

In Case 1, which had the poorest maintenance condition, the average noise level across all sections was 80.6 dB, with a maximum value of 89.2 dB. In contrast, the vehicle in Case 2, which completed a major overhaul, exhibited an average noise level of 79.9 dB and a maximum of 85.9 dB. The vehicle in Case 3, with only machined wheels, recorded an average noise level of 79.6 dB and a maximum of 86.0 dB. Compared to Case 1, Cases

2 and 3 showed a slight reduction of approximately 1.0 dB in the average noise levels; however, the maximum values decreased by more than 3 dB. These findings indicate that wheel machining contributes to a reduction in interior noise. Comparing Cases 2 and 3, the noise levels were nearly identical, suggesting that other inspection items during the major overhaul, aside from the wheel machining, had little effect on the interior noise during operation.

**Figure 5.** Interior noise levels according to vehicle maintenance status.

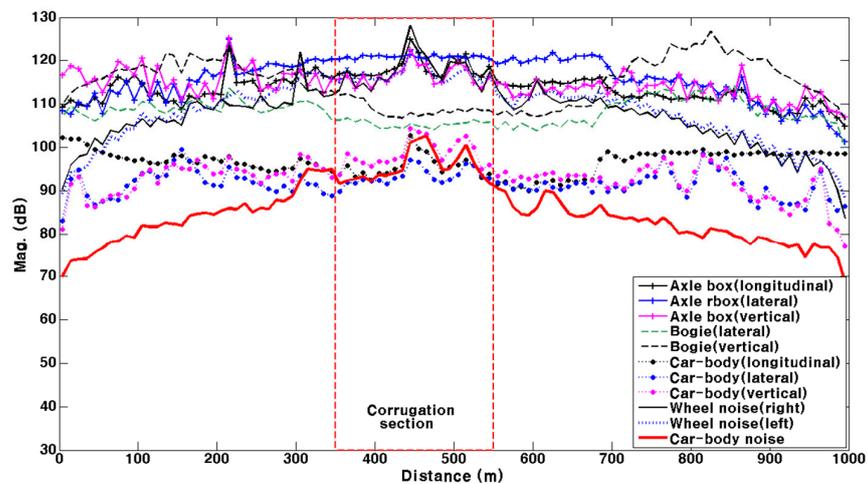
Figure 10 shows the results of calculating the RMS of the measured accelerations and noise data every 10 m and converting them into dB units. The noise signal was an A-weighted sound level adjusted for auditory perception. It was confirmed that the wheel and interior noises significantly increased when passing through the 350–550 m rail corrugation section. The interior noise levels reached 102.7 dB in the rail corrugation section, and the accelerations increased in the vertical direction of the axle box and the longitudinal, lateral, and vertical directions of the car body.

Figure 10. Acceleration and noise data analyzed at 10 m intervals.

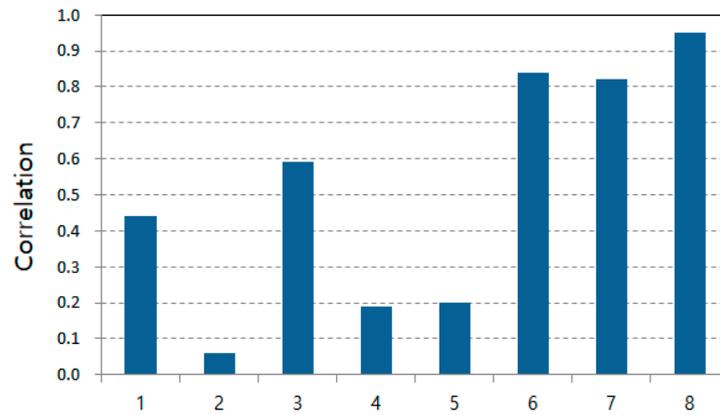
To analyze the relationship between vibration and noise in the rail corrugation section, the correlation between the vibration acceleration of various vehicle components and interior noise was examined at the maximum noise point (located at 425–525 m). The results of the correlation analysis between the RMS of axle box, bogie, and car body vibrations, measured every 10 m, and interior noise are shown in Table 6 and Figure 11. Vibrations with relatively high correlations included the vertical vibration of the axle box and the longitudinal, lateral, and vertical vibrations of the car body. Among these, the vertical vibration of the car body showed the highest correlation with interior noise, at 0.95. These results indicate that interior noise is strongly influenced by car body vibrations.

Figure 11. Correlation between vehicle vibration and interior noise in the maximum noise section.

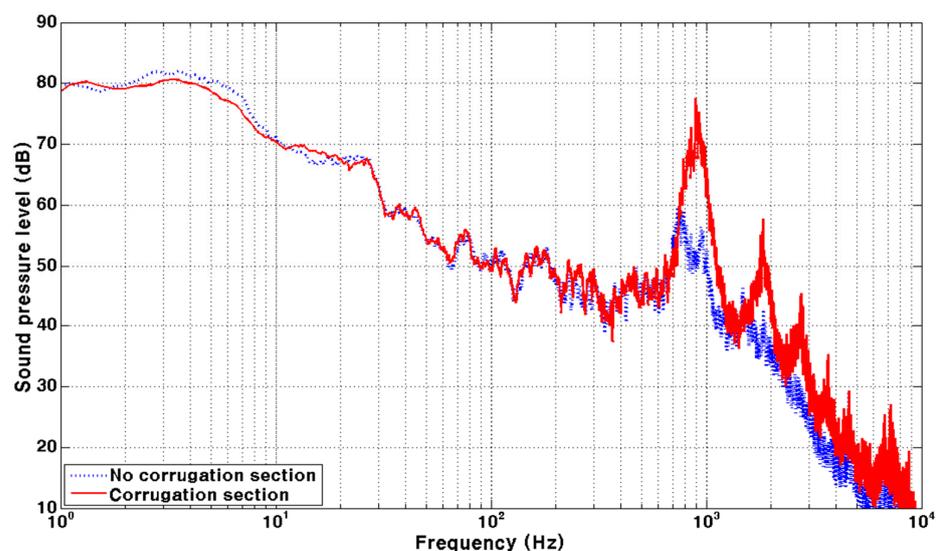
For a more detailed analysis, the frequency characteristics of the noise and vibrations were analyzed based on the presence of corrugation while the vehicle was operating at 80 km/h. Figure 12 shows the frequency analysis results for interior noise. Compared to sections without corrugation, the frequency characteristics in the corrugated section increased significantly in the 920 Hz band, and its multiples, 1840 Hz, 2760 Hz, and 3680 Hz, also increased. Figure 13 shows the frequency analysis results of the vertical vibrations of the axle box and car body, which exhibited a high correlation with the interior noise. Similar to the interior noise frequency analysis, it was confirmed that the vertical vibrations of the axle box and car body increased significantly in the 920 Hz band when passing through the rail corrugation section. This aligns with the previous correlation analysis results, confirming that the vertical vibrations of the axle box and car body strongly correlate with interior noise.

Figure 12. Interior noise in section with or without corrugation.

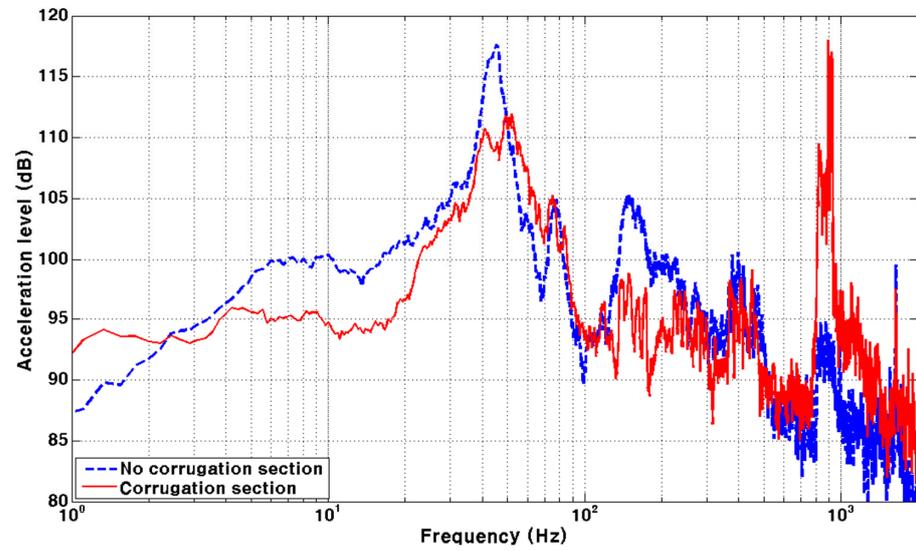
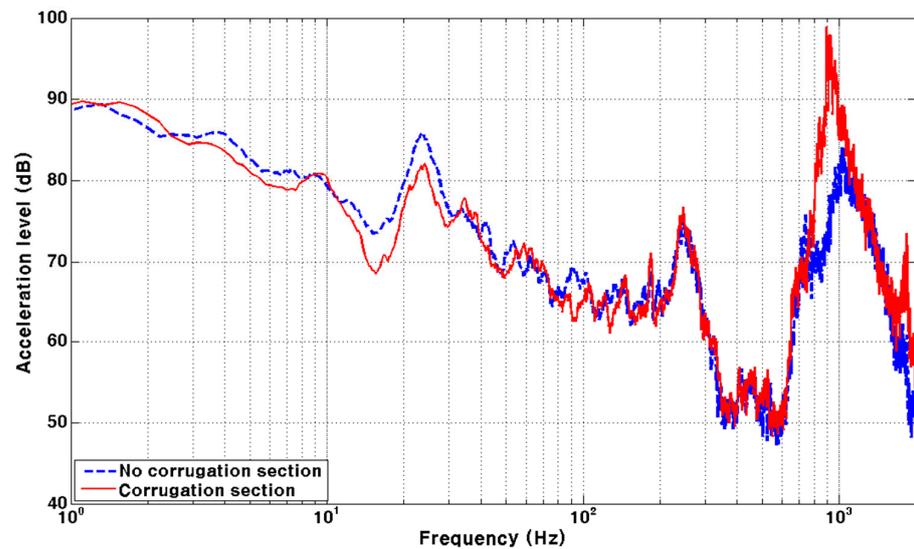
Considering the vibration transmission path during vehicle operation, it can be inferred that when passing through the rail corrugation section, the 920 Hz band vibration is

excited in the vertical direction of the wheelset, which is then transmitted to the vertical vibration of the car body, influencing the interior noise frequency.

**Figure 13.** Axle box and car body acceleration in section with or without corrugation.

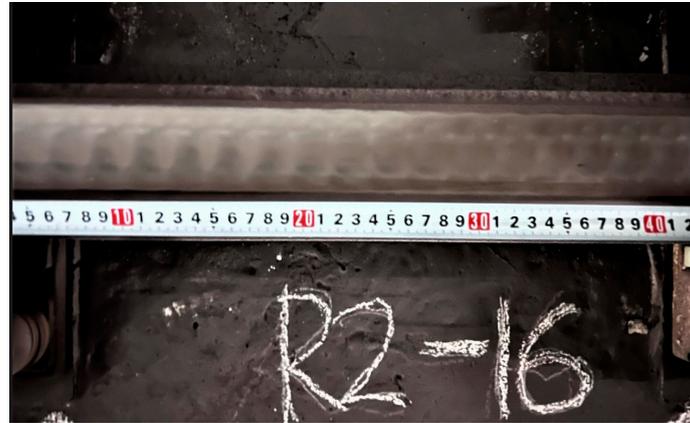
To analyze the increase in the 920 Hz band vibration frequency, the S10 section, where corrugation occurred, was examined. Figure 14 shows the rail corrugation in the S10 section. The wavelength of the corrugation was 24 mm, and when the vehicle was operated at 80 km/h, the vibration frequency caused by the corrugation, calculated using Equation (1), was 926 Hz. Here,  $V$  is the vehicle speed, and  $\lambda$  is the wavelength of the corrugation.

Based on this result, it can be confirmed that the 920 Hz frequency, which dominates the interior noise when passing through the rail corrugation section, matches the excitation vibration frequency of 926 Hz generated when passing through the rail corrugation section. Considering the vibration transmission path in the vehicle, the 926 Hz vibration induced by passing through the rail corrugation section is transmitted to the vertical vibration of

**Figure 14.** Rail corrugation in the S10 section.

Based on these results, reducing abnormal noise when passing through corrugated sections may require avoiding the 920 Hz resonance mode of the car body. However, this would require either replacing the car body or performing extensive maintenance to improve car body noise characteristics, which is challenging in practice. As an alternative, future studies will explore standard rail grinding methods or adjustments to vehicle speed and braking control when passing through corrugated sections to mitigate corrugation formation.

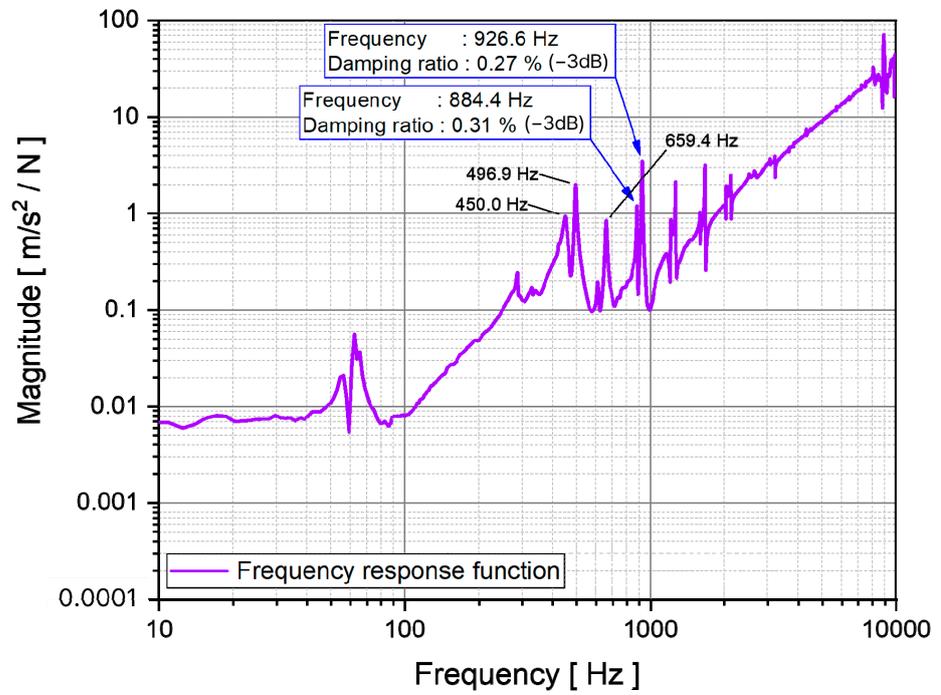
Figure 16 shows the results of testing the natural frequency of the car body according to the under-body excitation. Frequencies related to the 920 Hz abnormal noise frequency observed during the rail corrugation section operation, such as 884.4 Hz and 926.6 Hz, were detected. These frequency bands have very low damping ratios, indicating a high possibility of car body resonance. To confirm this, the interior noise was measured by sweeping the frequency band at approximately 900 Hz, which is the car body resonance frequency. Figure 17 shows the results of the car body noise characteristic test, confirming that the noise around (yellow section) the car body resonance frequency of 920 Hz increased.

Therefore, it is concluded that the abnormal noise observed during rail corrugation section operation is caused by 920 Hz vibrations induced when the vehicle operates at 80 km/h through a rail corrugation section with a wavelength of 24 mm, transmitted vertically through the axle box and car body. The 920 Hz band vibration of the car body matches the car body's resonance frequency of 926.6 Hz, resulting in increased interior noise.

Figure 16. Car body vibration characteristics.
